St HILDA
SOUTH SHIELDS
(110)

QUINQUENNIAL REPORT
on the architect's inspection on

22 March 2019

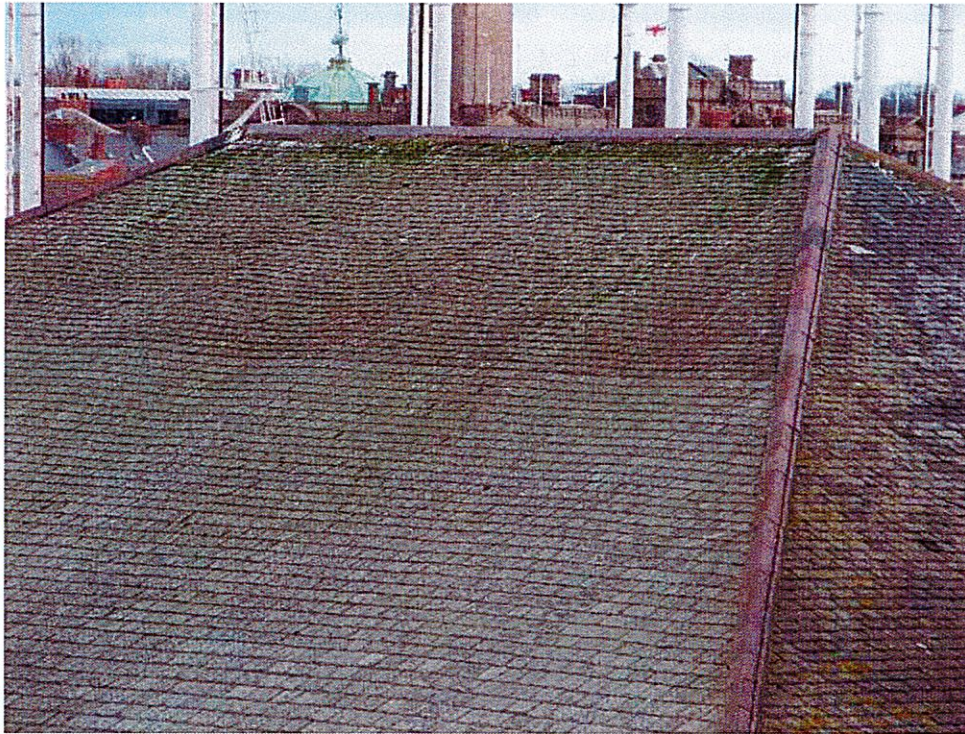
21. N slope diminishing westmorland slate, felted, seems sound. Top third is old, remainder smoother and more even, perhaps relaid after war damage. Bottom course fixed by screws and washers. Three small slates missing towards top E end.

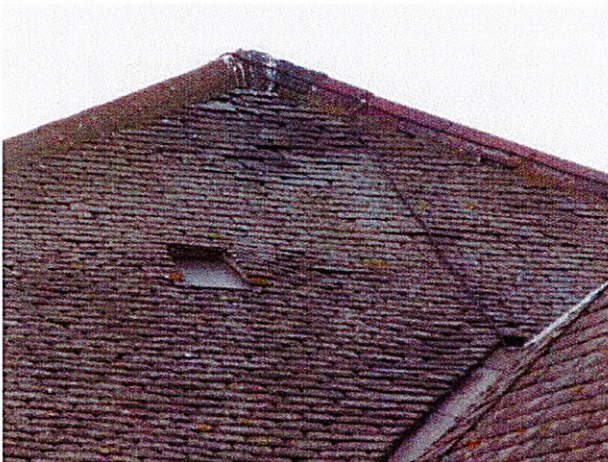
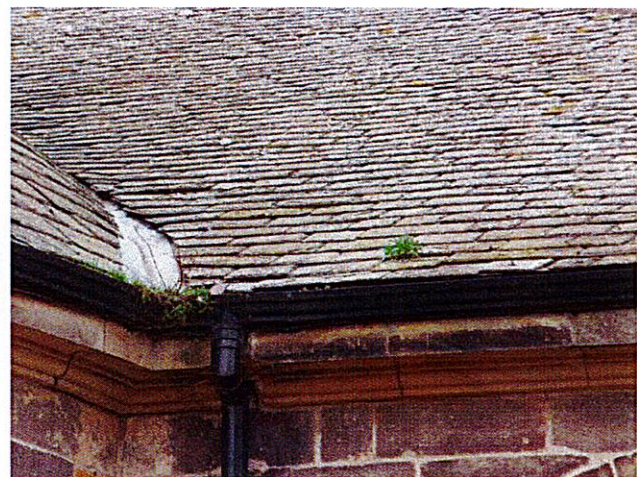
22. E hip and steeper conical apse in small westmorland, bottom course screwed like N. Lead roll ridge and valleys. Two small glass slates.

Fair but one missing near top of hip. Plant growing between slates near N side eave.

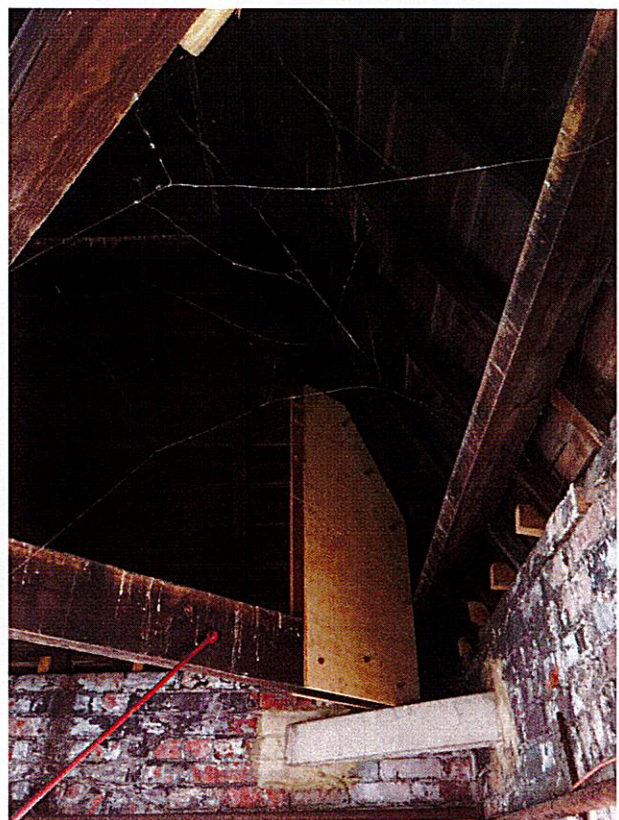
Tower roof timbers 2019 including 1999 repairs

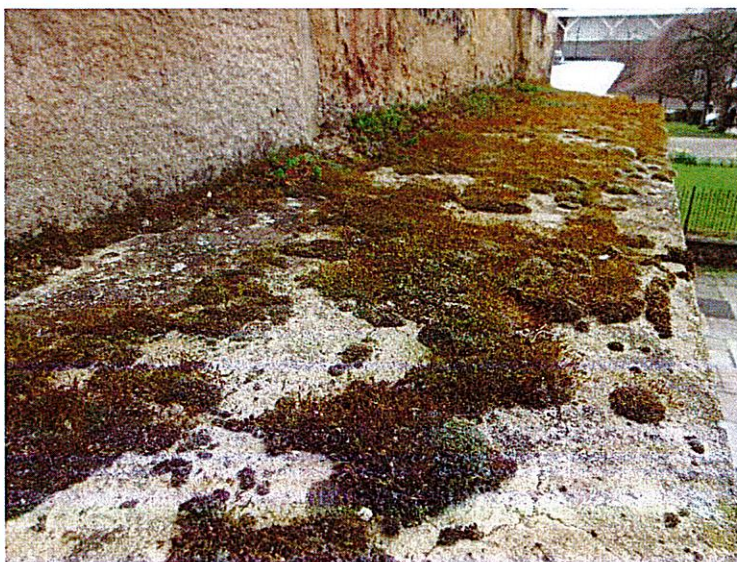
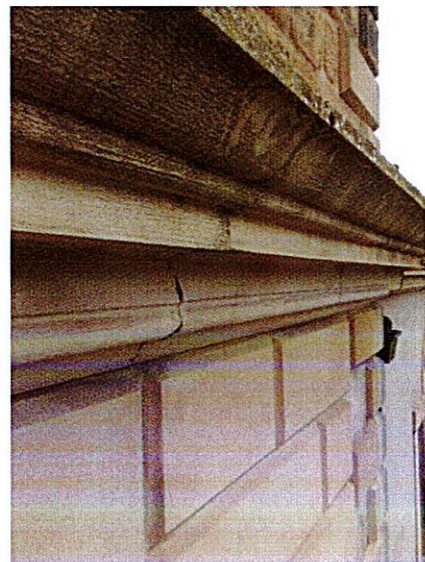
Where the Vestry/Kitchen cornice continues across the Tower ground floor it is not capped with roofing membrane. Its sloping mortar top is mossy and the cornice has cracked slightly in two places.

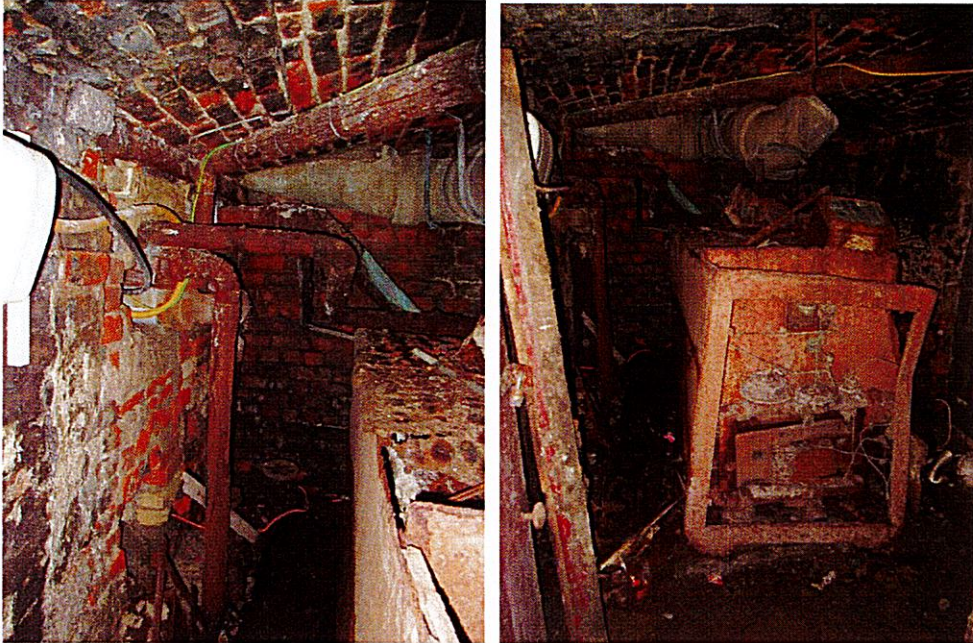
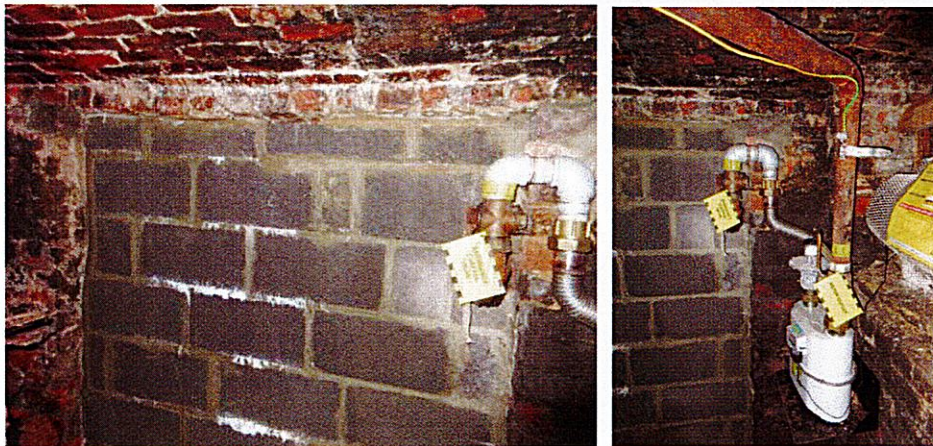
Heater and Blower Chambers and Paving over

- 45. Outside the SE corner two semi-basement rooms each side of an external stair. Bottom landing enclosed with a locked door and felt roof on boards. Ventilation between the door battens is useful but wet leaves filling the bottom step against the door should be cleared regularly.
- 46. The Organ blower room has a flat roof with parapet. After flood the door lintel, electrical switching and blower were replaced, the blower now raised on blockwork as a precaution. The lintel is decaying again. Both doors are pierced and air is drawn through into the Organ so the blower room is ventilated and dry at last inspection (no access 2019).

- 47. The disused boiler with disconnected asbestos cement flue pipe remain (suggesting a former chimney). The room contains a live gas meter and supply pipe though the Nave wall. Decayed lintels at openings in the stone walls were removed and filled with blockwork to prevent the brick vault collapsing.

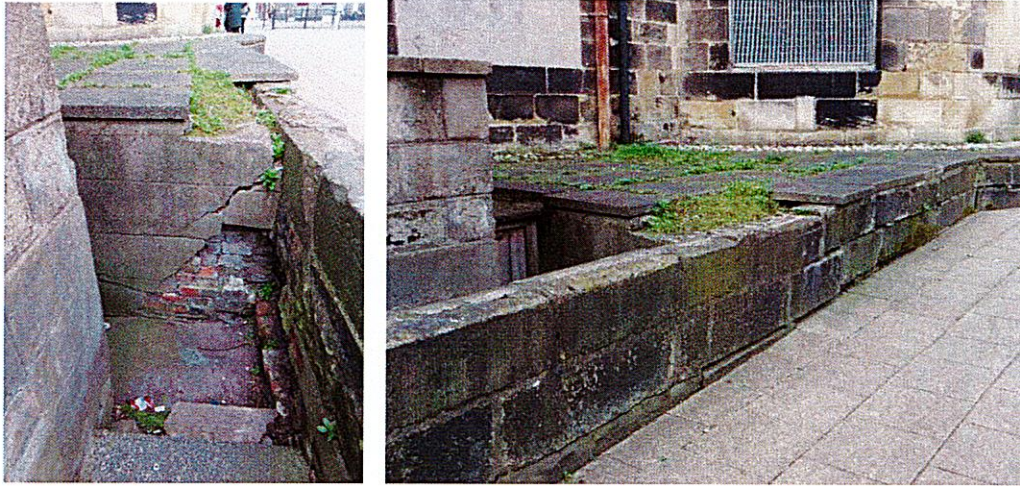
48. Cracked render beside the stair and open joints in the low stone wall next to the public paving remain. Not known whether the lintel at the (now concealed) former coal drop under the stone wall is sound.

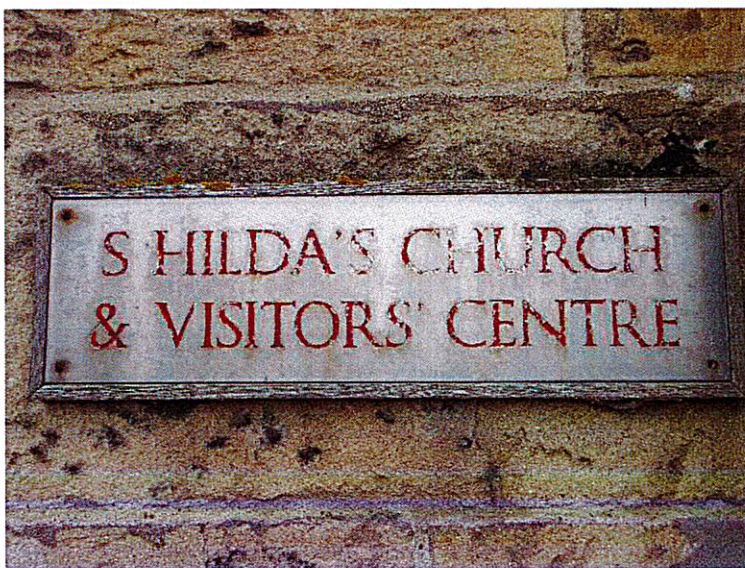
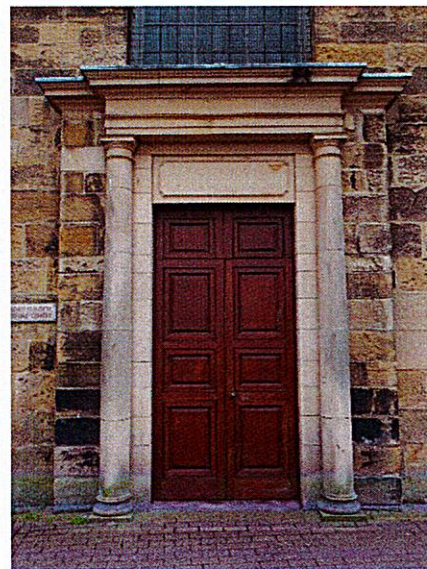
61. The Song Room windows have timber frames and lintels, appearing sound. Paint is poor at all windows. A ply cover over the W door deteriorates and the whole door needs repair and paint.

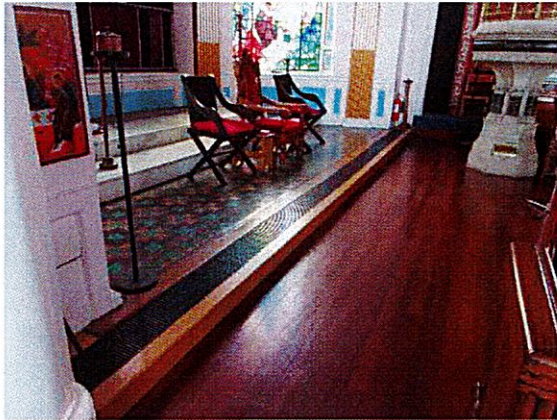
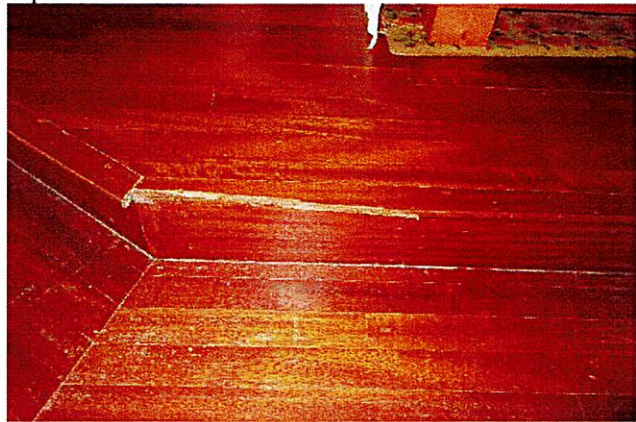
91. In **Apse** small tiles, some encaustic decorative. Rough cement infill where a former altar stood. Two very wide marble steps. Oak step extended with heating grill.
92. Hardwood altar dais on two levels with self supporting kneeler rails. Part of the upper nosing is missing. Rather than repair with matching hardwood replacing all nosings in paler hardwood for slight contrast (similar to the apse step) would help the visually impaired.

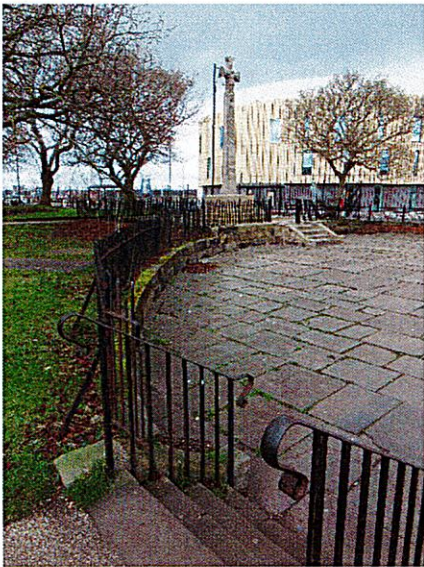
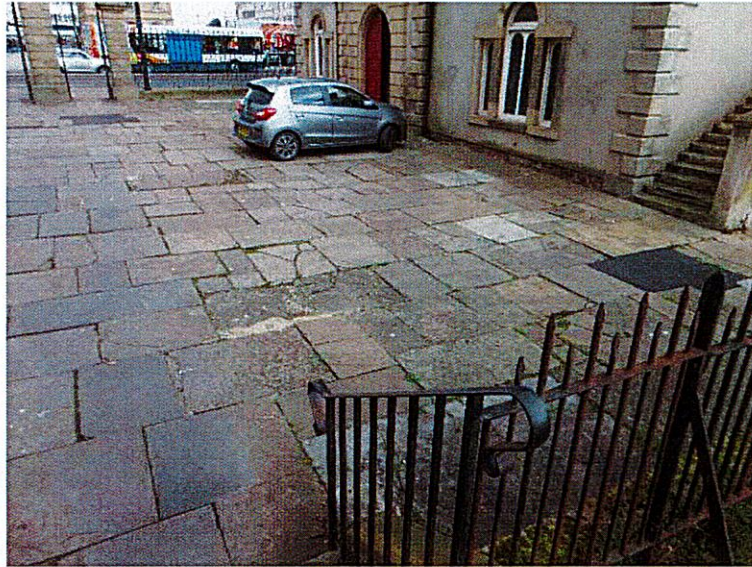
128. Forecourt flags have been replaced or tarmac patched but vehicles continue to damage the flags. The base must be too weak for vehicles. Better to lift all flags, excavate, lay new base overall suitable for vehicles and relay sound and further replacement flags. May be Council responsibility. There may be archaeological interest in such excavation in a historic churchyard.

129. Modern steel handrails at the forecourt steps and S railings are ungalvanised, rusting and need to be thoroughly derusted, prepared and repainted to high standard and repainted regularly.

130. The earlier iron railings around the rest of the churchyard are painted only. There is severe rusting and delamination. Such ironwork rusts slowly but it will destroy the railings unless they are thoroughly chipped, rust treated, primed and painted with suitable paint such as Hammerite.

Remove broken monument on NE Gallery and repair plaster	101
Act on broken headstones on ground by Song Room	126
Make robust repair and improvement of the forecourt flags (Council?)	128
Prepare & paint all railings around forecourt and churchyard	129, 130
