## Church of St John, Stillington

### Quinquennial Report

**1<sup>st</sup> February 2024**

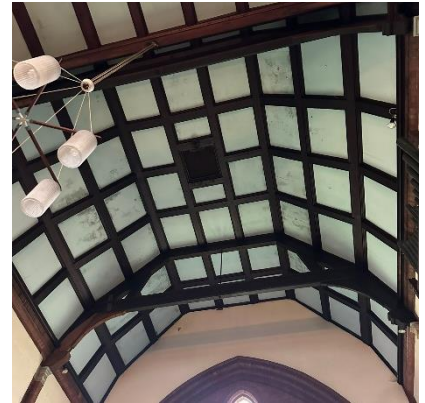
Figure 17 – Chancel ceiling

13.1 **Nave & Chancel** - Open roof of six trusses. At the junction between the chancel and the nave, there is a double truss and there has been some repair work at the corbel and knee bracing in the past. There are large laminated plywood bosses on the North side in all but two locations at the Western end, the churchwarden reports this was due to rotten timbers, perhaps as a result of defective rainwater goods. The ceiling has purlins and principal rafters with plastered infill panels. At the chancel there is black water staining to the infill panels, reported at the last inspection but no photograph included so unable to comment on whether this is historic. There is an enclosed loft to the apex, but no access to inspect.

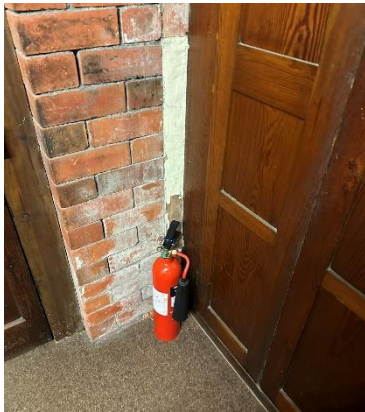
15.3 **South Aisle:** The walls on the South elevation are exposed brickwork, there is a lot of equipment up against them. Some efflorescence to the brick and flaking plaster between the lancets. In places there are open joints to the brickwork and some bricks are moderately eroded. The mortar pointing here is very black as if it could have had ashes mixed in. To the south west end the aisle, the plaster damage continues, un-reported previously but appears to have been painted over so unable to comment if this is an ongoing issue.

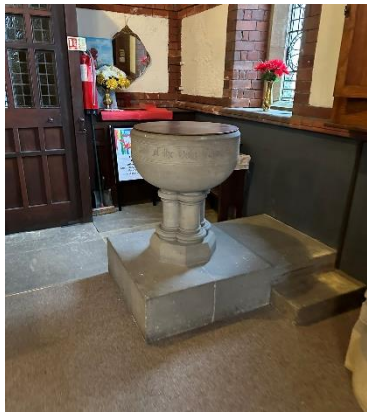
Figure 29- Font

20.2 A stone **font** at the rear of the church has two steps up to it. Engraved text in a band and a lightweight timber lid.

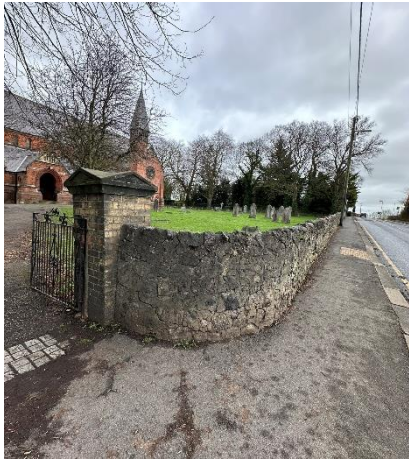
Figure 30 – S Churchyard from footpath

28.1 The churchyard is open and contains trees on the boundaries principally. The South has fewer trees. It is laid to grass and there are various memorials. The PCC should check all graves and memorials for stability and safety on a regular basis. The path to the porch is in tarmac with block kerbs, and is breaking up slightly. The other areas of tarmac on the West side is in better condition, but still needs some patching. The area towards the porch on the West side is not well retained and is breaking up into the gravel area.
