QUINQUENNIAL INSPECTION REPORT

HOLY TRINITY with St. MARK

UPSALL GROVE, FAIRFIELD, STOCKTON-ON-TEES, TS19 7QU

JULY 2022

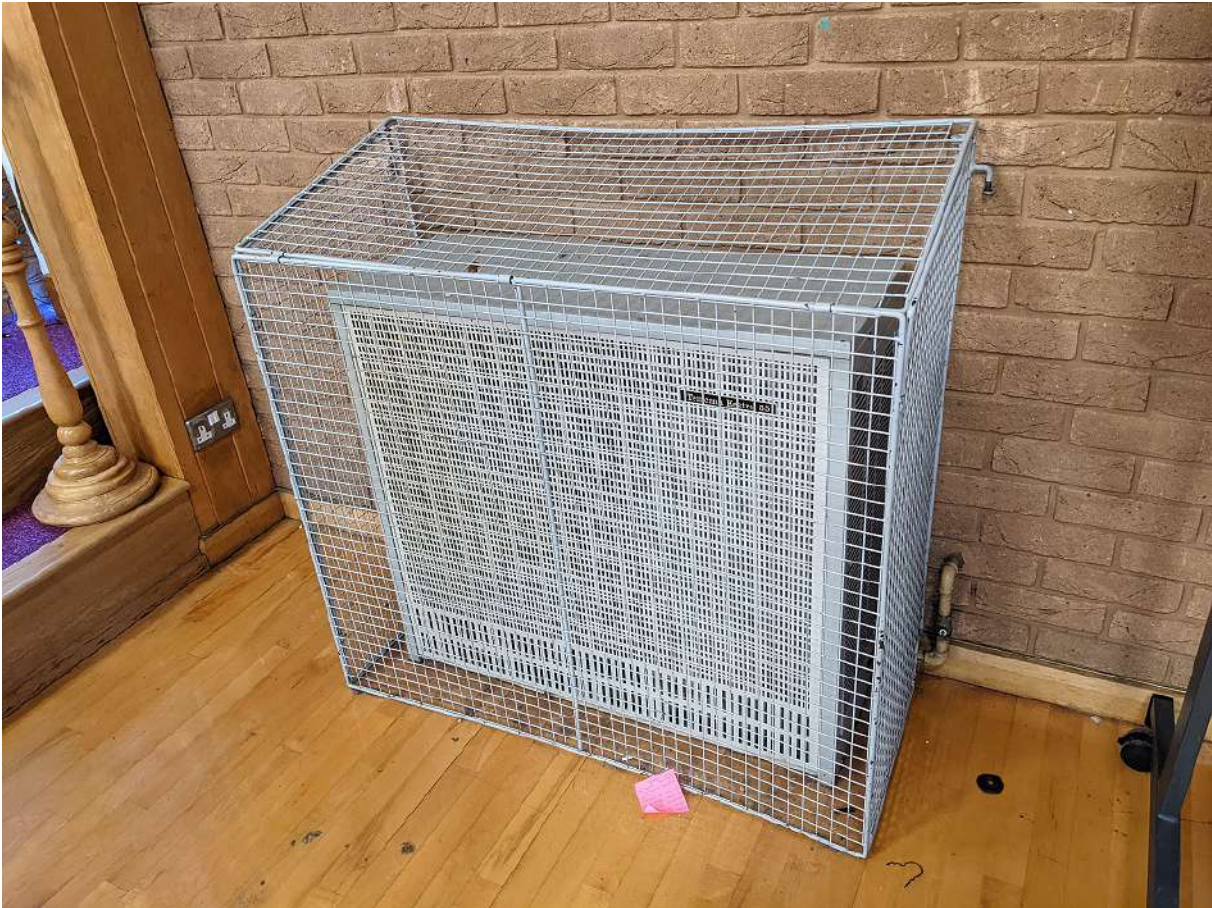
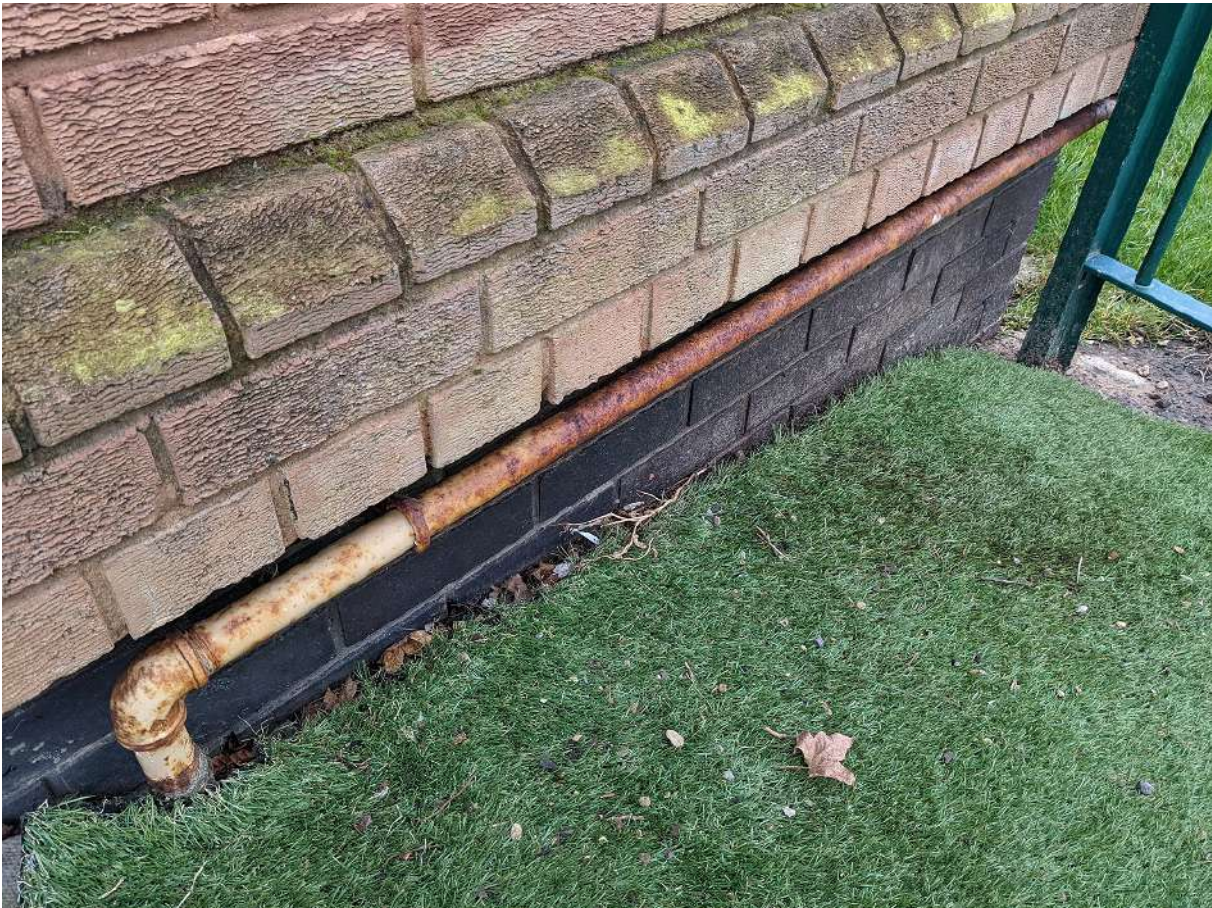
24.1 The existing distribution boards 1 and 2 are located within a wall mounted cupboard on the East wall of the vestry. These are linked via underground cabling to the existing main switchgear room within the adjoining school.

The last testing and inspection of the installation was understood to be carried out in 2018, the next cycle of testing is therefore due in 2023.

The electrical installation should have a Fixed Wiring and Inspection Testing (FWIT) at least every five years by a registered National Inspection Council for Electrical Installation Contracting (NICEIC) or NAPIT full scope or ECA full competence accredited registered electrician.

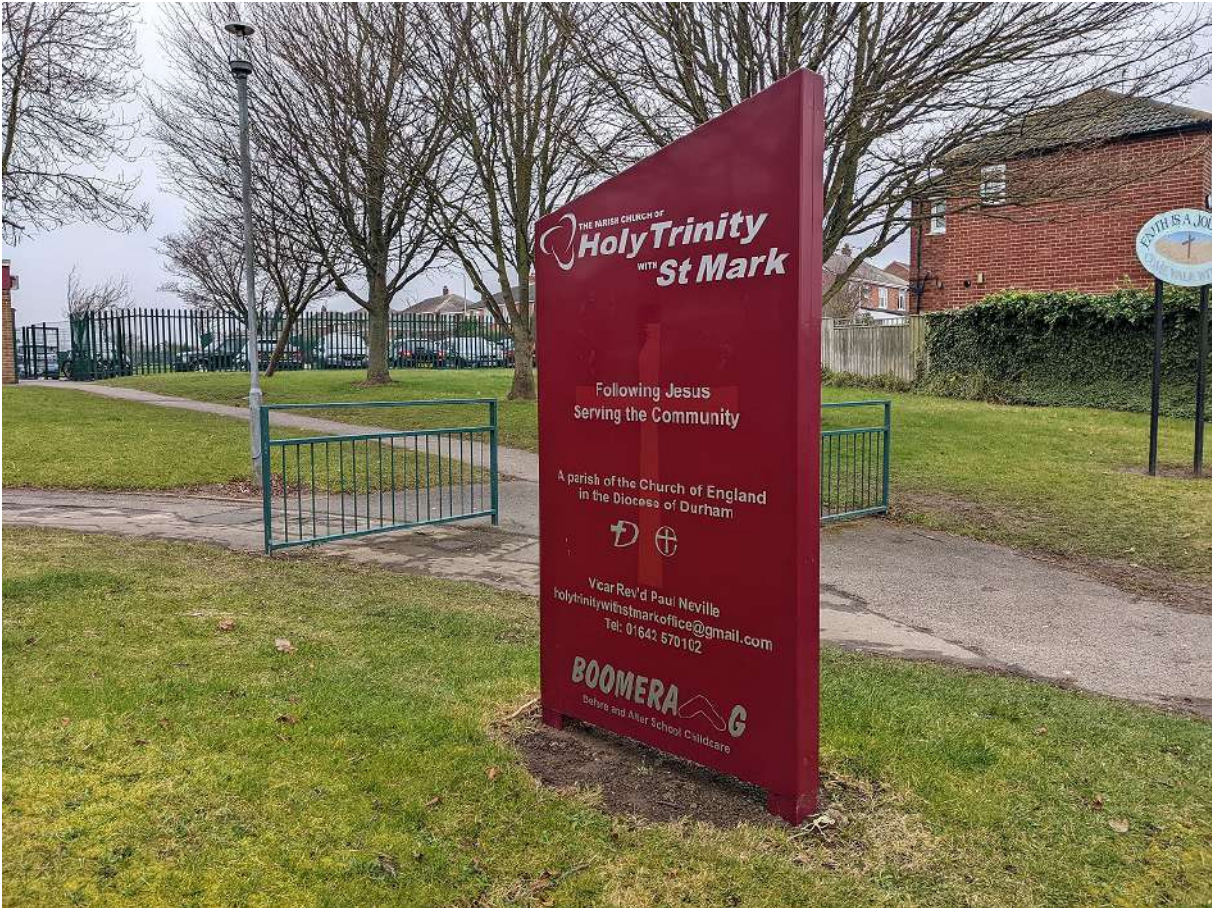
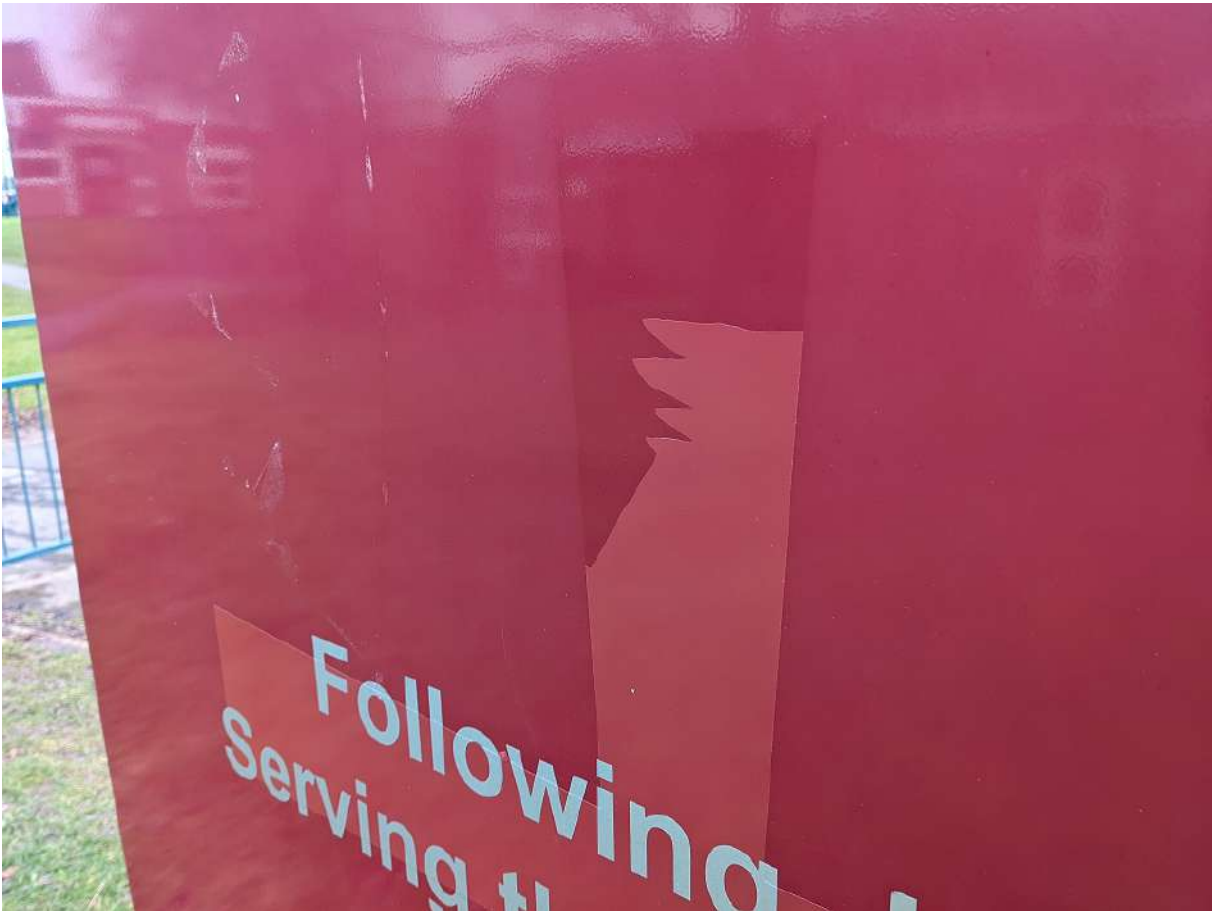
Otherwise, all in a sound, satisfactory condition.

R1 Carry out repair to cross emblem on signage.
