Parish Church of All Saints  
Stranton

Diocese of Durham  
Archdeaconry of Durham  
Deanery of Hartlepool

Quinquennial Inspection Report  
June 2022

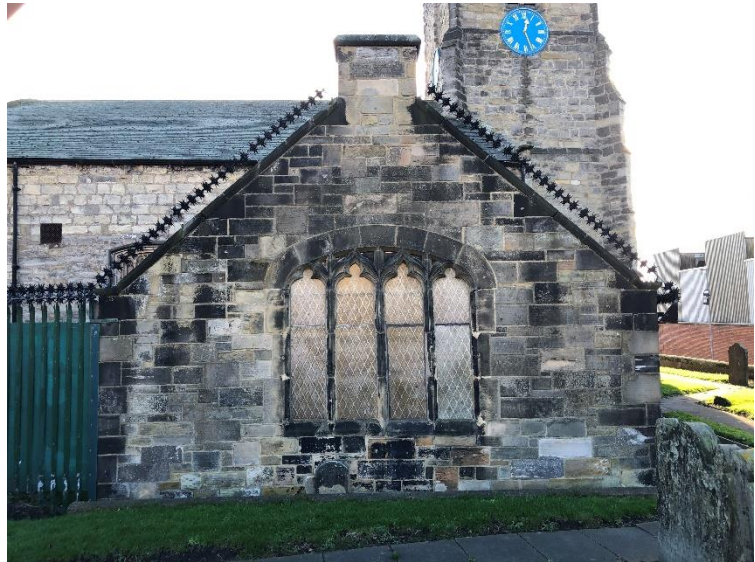
Fig 16. Choir Vestry windows  
(external)

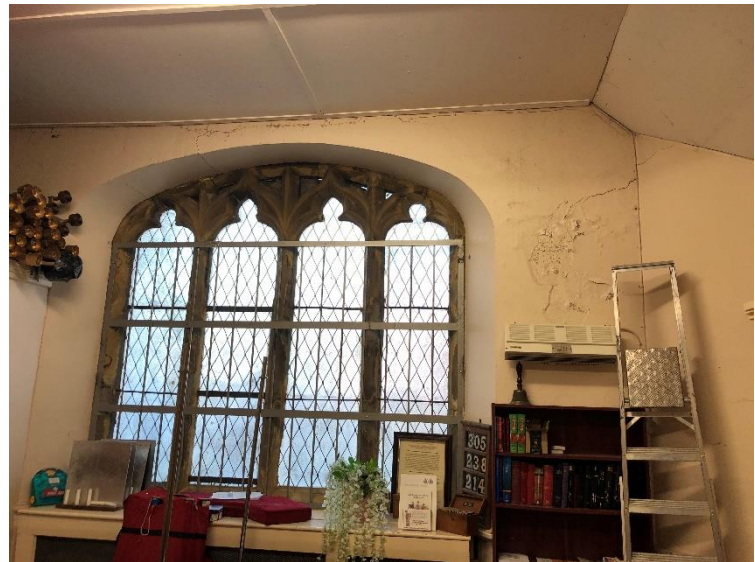
Fig 17. Choir Vestry windows  
(internal)

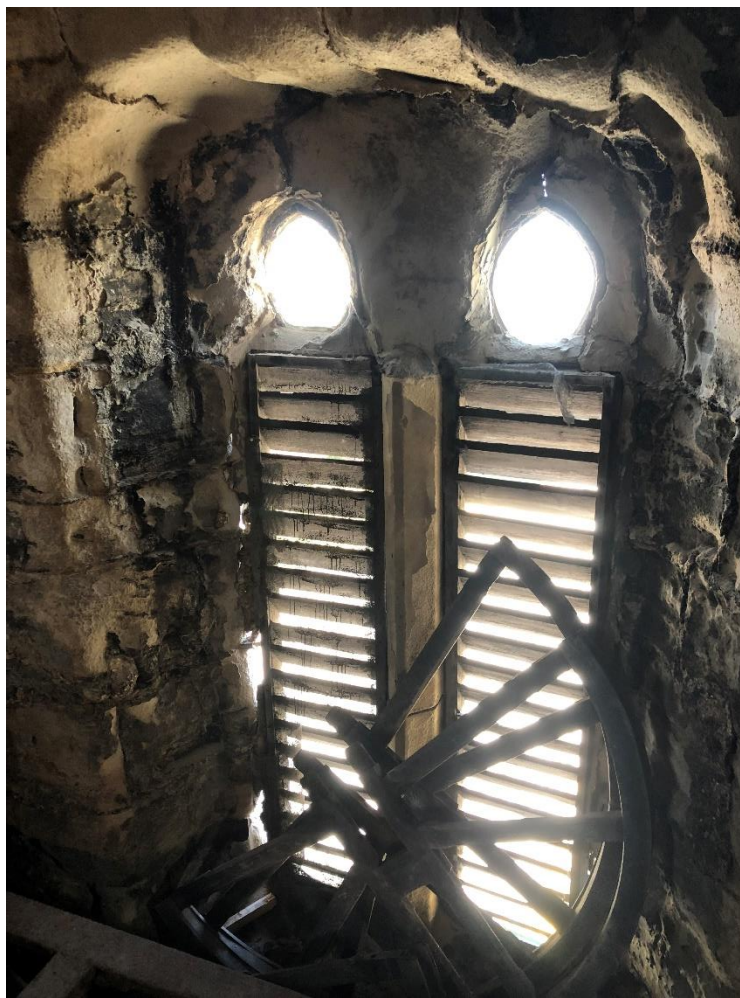
Fig 19. Loft space,  
exposed timber

Check woodworm treatment to loft spaces/exposed timber (see Appendix B, Fig 19)
Stop up roof eaves gap in north aisle loft space
Testing of lightning conductor installation
Continuing attention to churchyard trees (by Local Authority)
<b>WORK RECOMMENDED TO BE CARRIED OUT DURING NEXT 5 YEARS - Category 3</b>
New limewashing of upper walling in Ringing Chamber; creation of safe access arrangement to roof
Re-painting of handrails, railings, fencing, etc., in Churchyard
Keeping structural movement of Clergy Vestry (now Kitchen) wing under observation
Re-covering of Tower roof
Consideration of replacing 'Meshlite' glazing with something better
Minor re-pointing and consolidation of boundary walls and stone paving; keeping possible movement in south-west retaining wall under observation.
<b>WORK TO BE CONSIDERED BEYOND 5 YEARS - Category 4</b>
Further repair and re-pointing of masonry externally and in Belfry

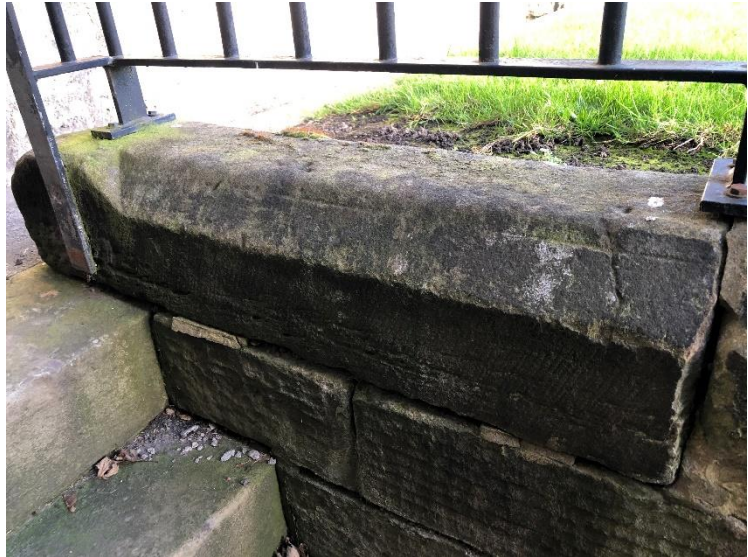
Fig 20. Steps to boiler room;  
stonework to wall

Stonework repointing to walls/steps to boiler room (see Appendix B, Fig. 20)
<b>ITEMS FOR FURTHER INVESTIGATION</b>
See Belfry works
