## QUINQUENNIAL INSPECTION REPORT

**St. NICHOLAS' CHURCH**  
RECTORY BANK, WEST BOLDON, NE36 0RF

FEBRUARY 2021

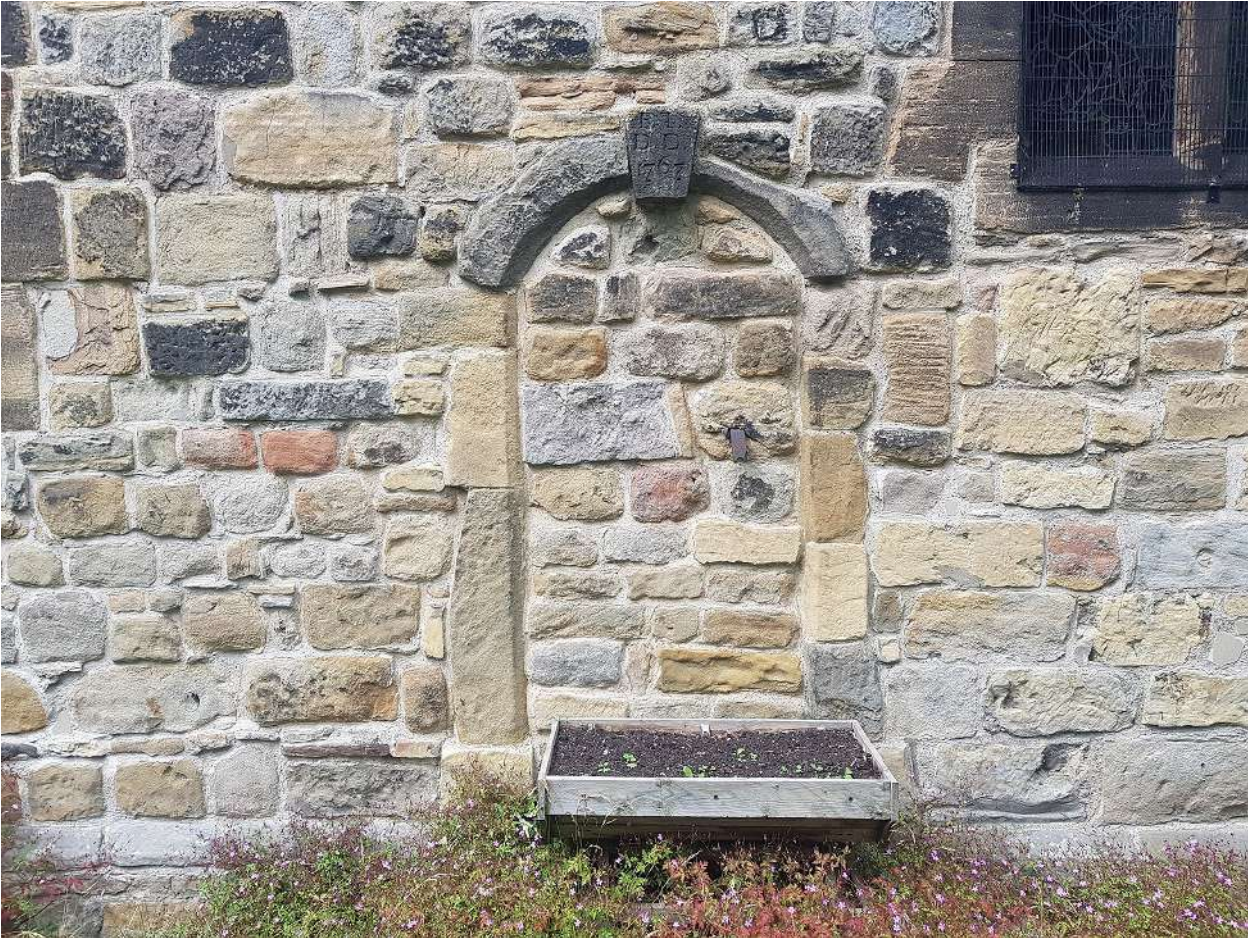
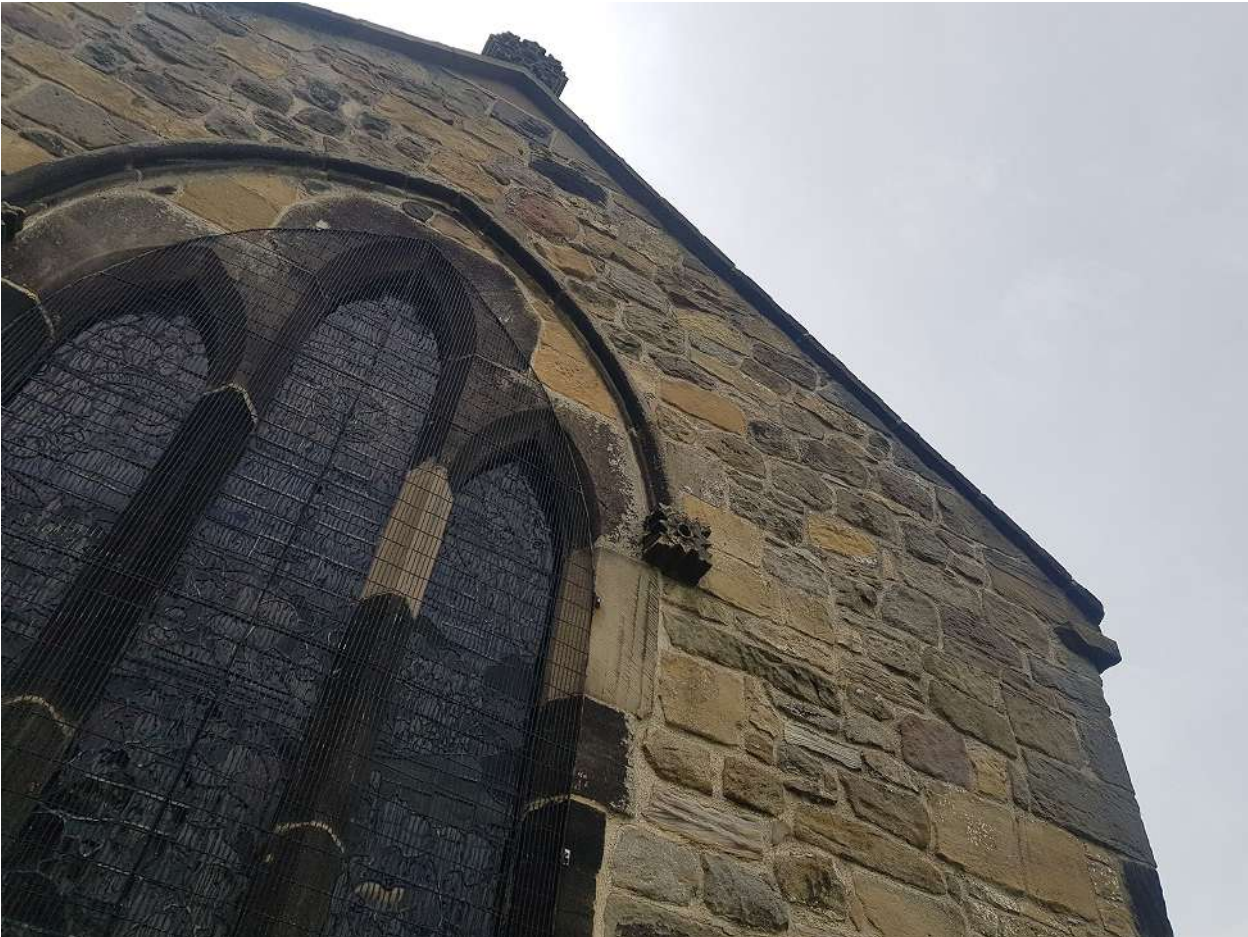
At the east end of the wall c 1 m of an old string-course, chamfered above and below, survives, of late 12<sup>th</sup> or 13<sup>th</sup> century character. The east end of the chancel now has a 19th-century window, set in a disturbed area of masonry and cutting down through the string-course. The window is of three stepped lancets, sharing a common moulded hood that has foliate bosses as stop; the shallow-pitched gable above is capped by a decaying finial that echoes the form of these stops.

The eastern quoins of the chancel are large gritstone blocks; some at least are probably Roman in origin (the lowest block at the south-east corner retains a lead clamp, a good indicant of Roman work) ; they were almost certainly re-used in the Anglo-Saxon church, and have been recycled a second time in their present position - or even a third time, as there is good evidence to suggest that the chancel was rebuilt in the 12<sup>th</sup> (?) century and then extended by an extra bay.

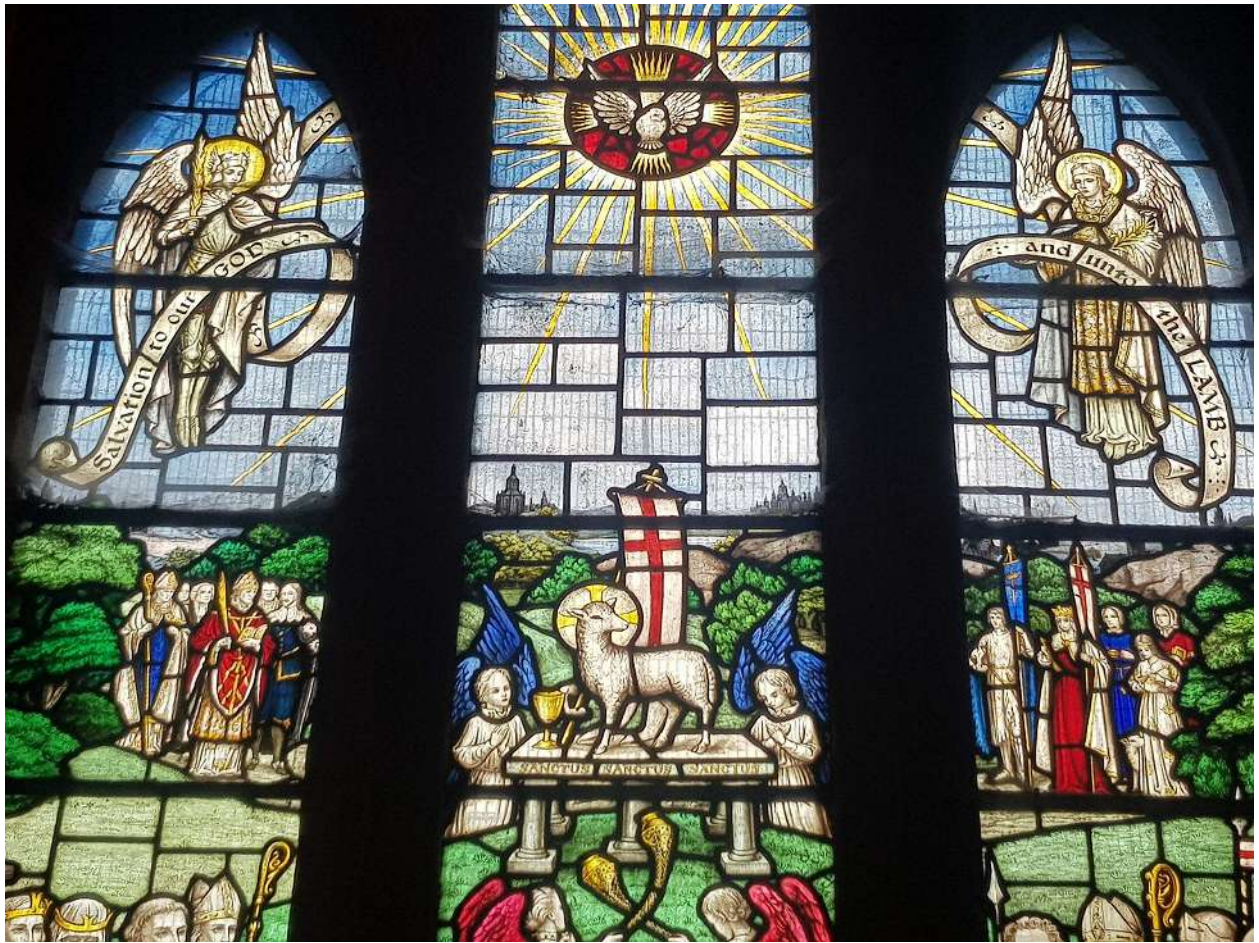
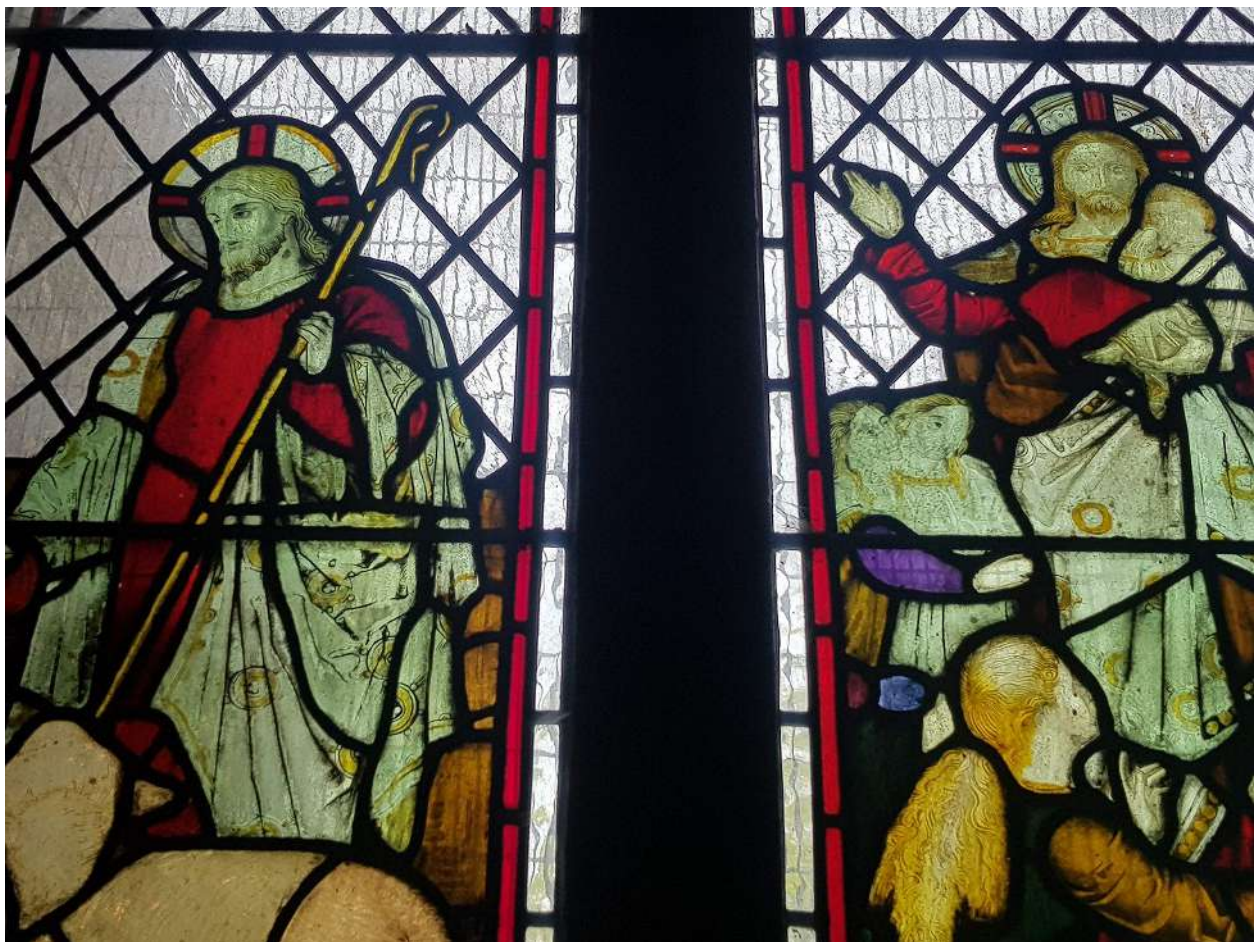
9.1 The church possesses a good mix of both stained and plain glass. The glazing is protected externally by black mesh grill, screw fixed into the face of the masonry surrounds.

9.1.1 The window units are maintaining a weathertight seal with the masonry fabric surrounds. There is an additional layer of security with the presence of external protection in the form of the external black metal grills.

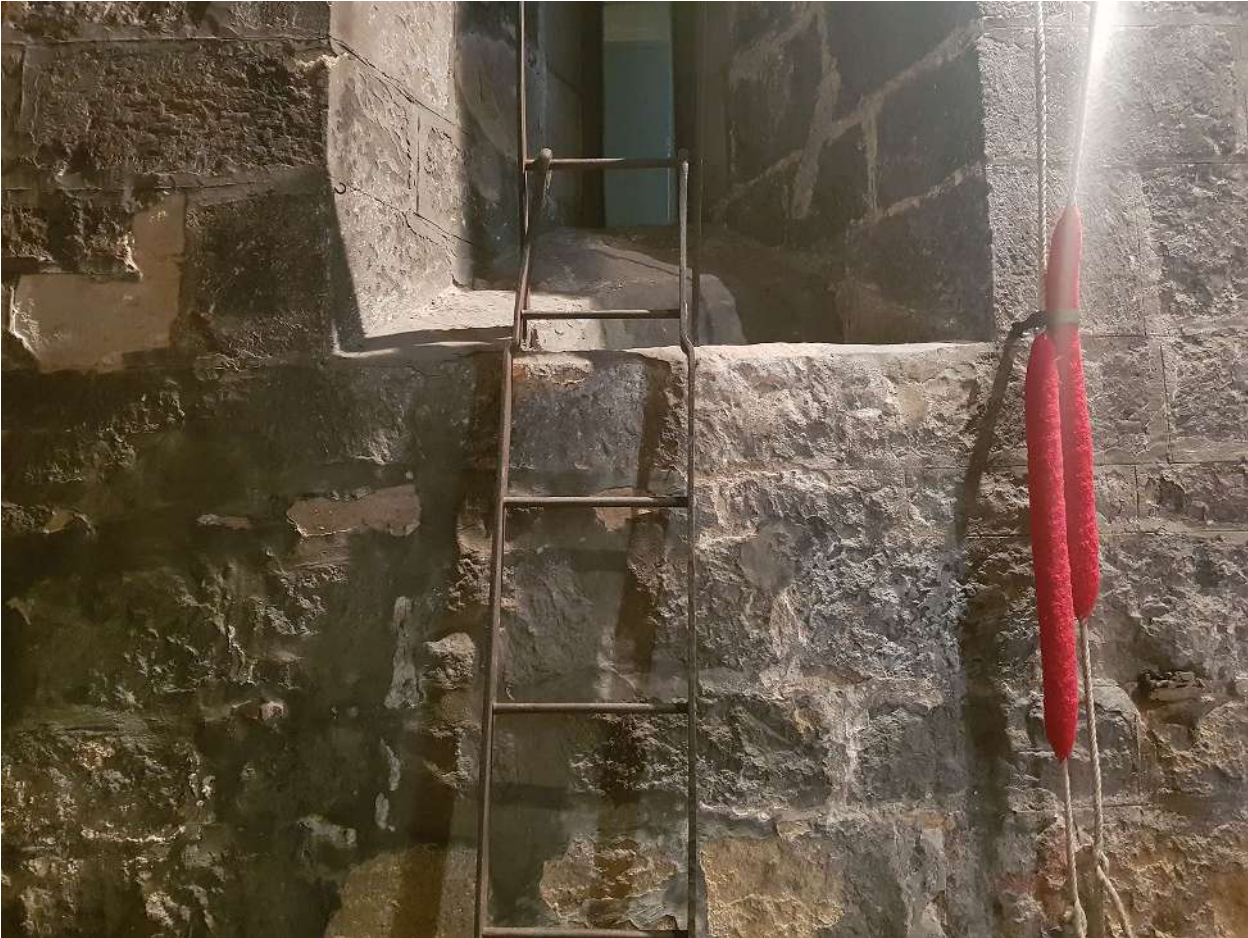
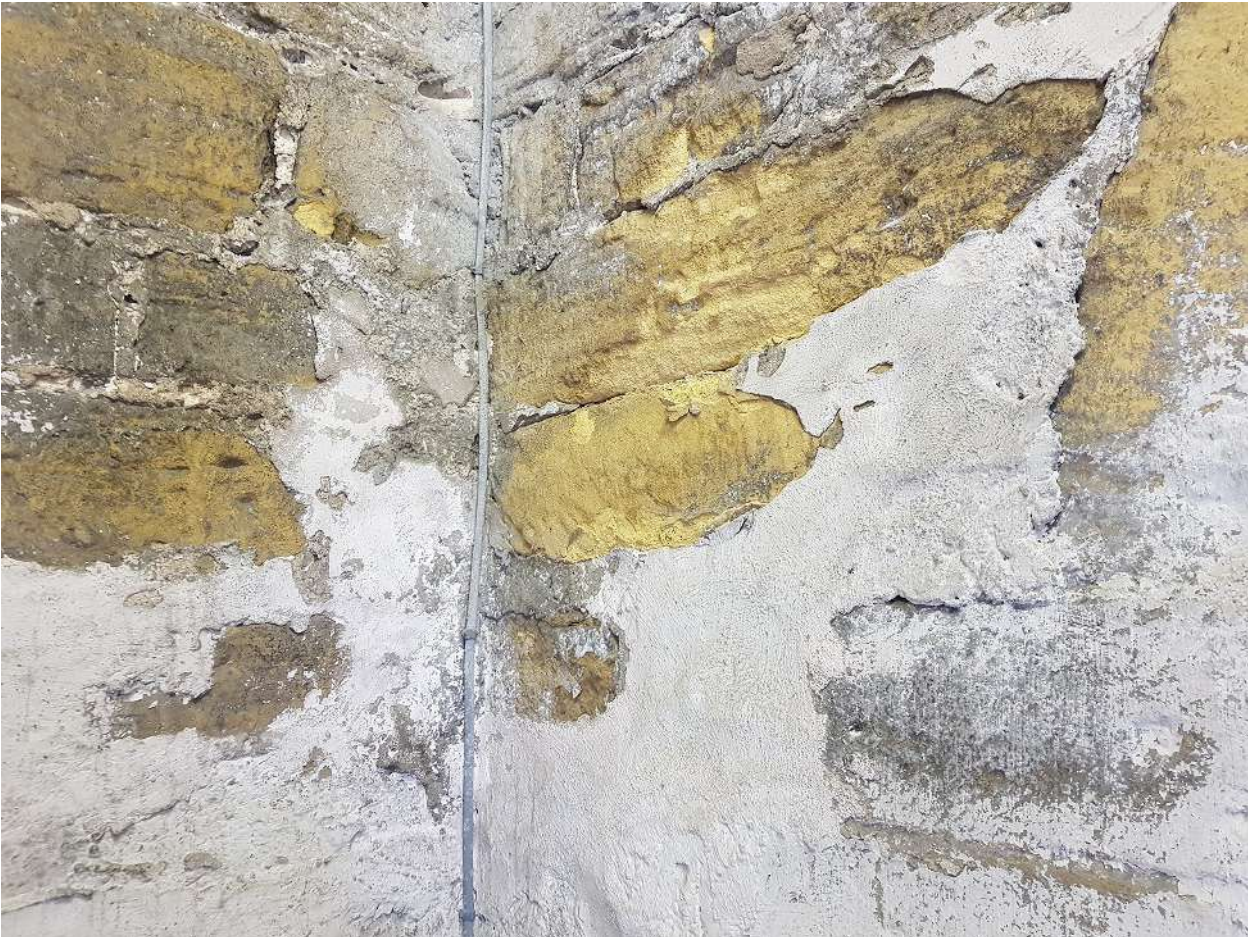
*The good news is that none of these observations have a structural impact, more aesthetic in nature therefore monitoring of the stone condition is all that is required for now.*

Stonework and whitewash finish is generally in a sound, good condition, some deterioration of the whitewash at the north east corner which reveals use of cementitious mortar, smeared in places across the stonework resulting in some erosion of the stone face. There are numerous instances of historic graffiti etching into the wall face which is generally in a sound, legible condition.

<b>M</b>	It is recommended that as a routine item of maintenance the stonework is checked annually for any change in appearance and/or deterioration.
----------	----------------------------------------------------------------------------------------------------------------------------------------------

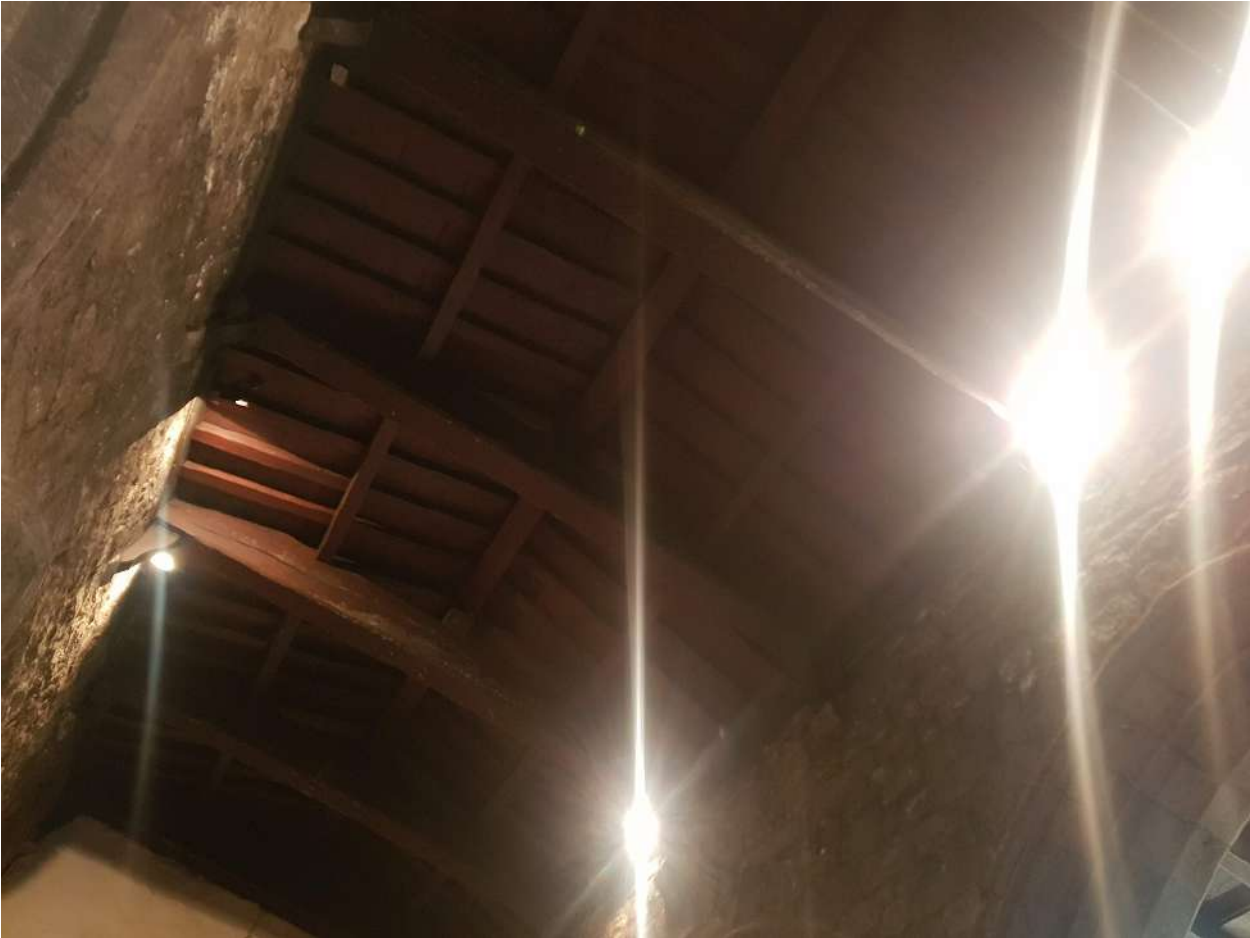
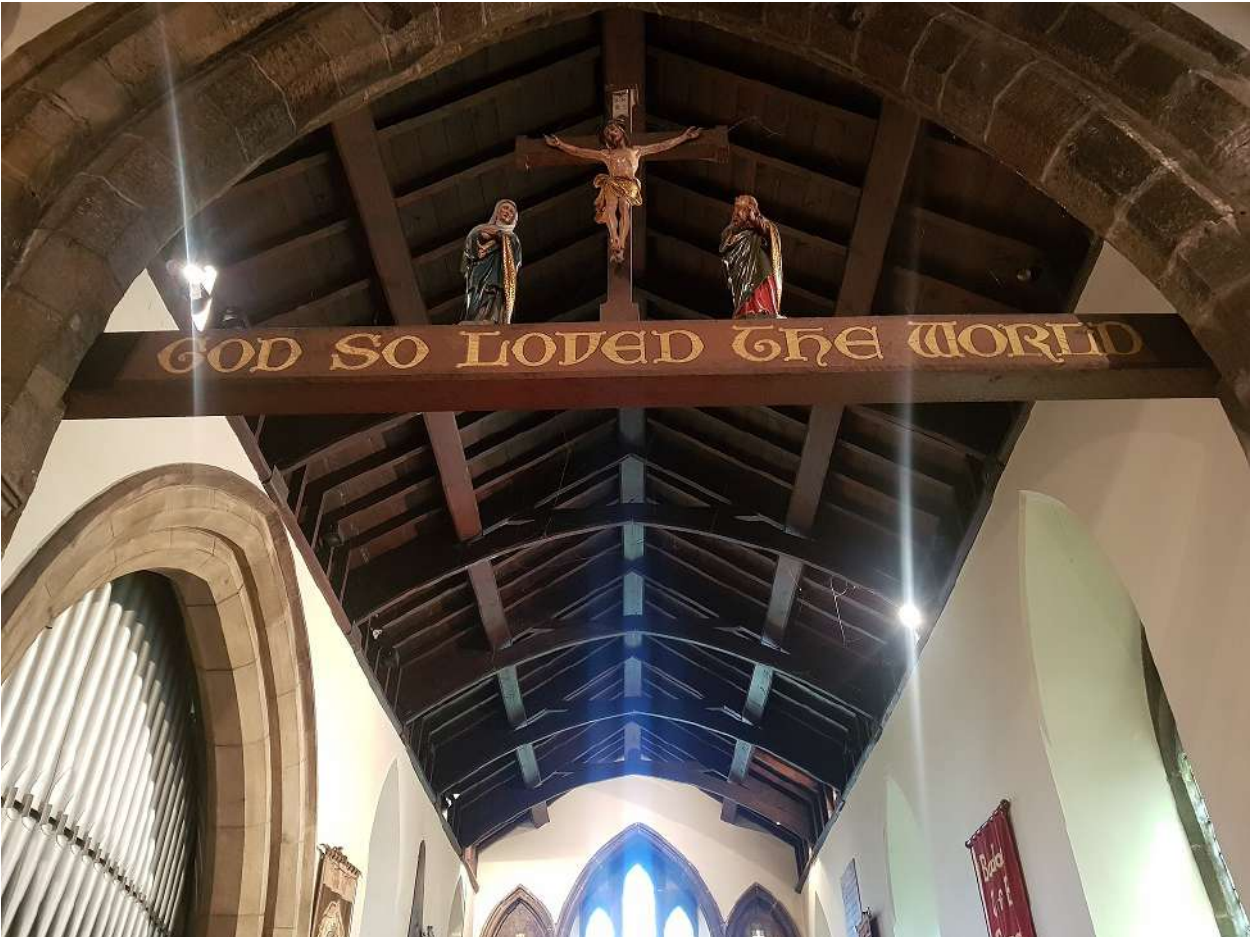
13.2.1 The roofing timbers appear to be in a sound condition as far as can be ascertained from floor level.

<b>M</b>	It is recommended that as a routine item of maintenance regular checks are carried out for any signs of new and active timber beetle attack and/or rot.
----------	---------------------------------------------------------------------------------------------------------------------------------------------------------

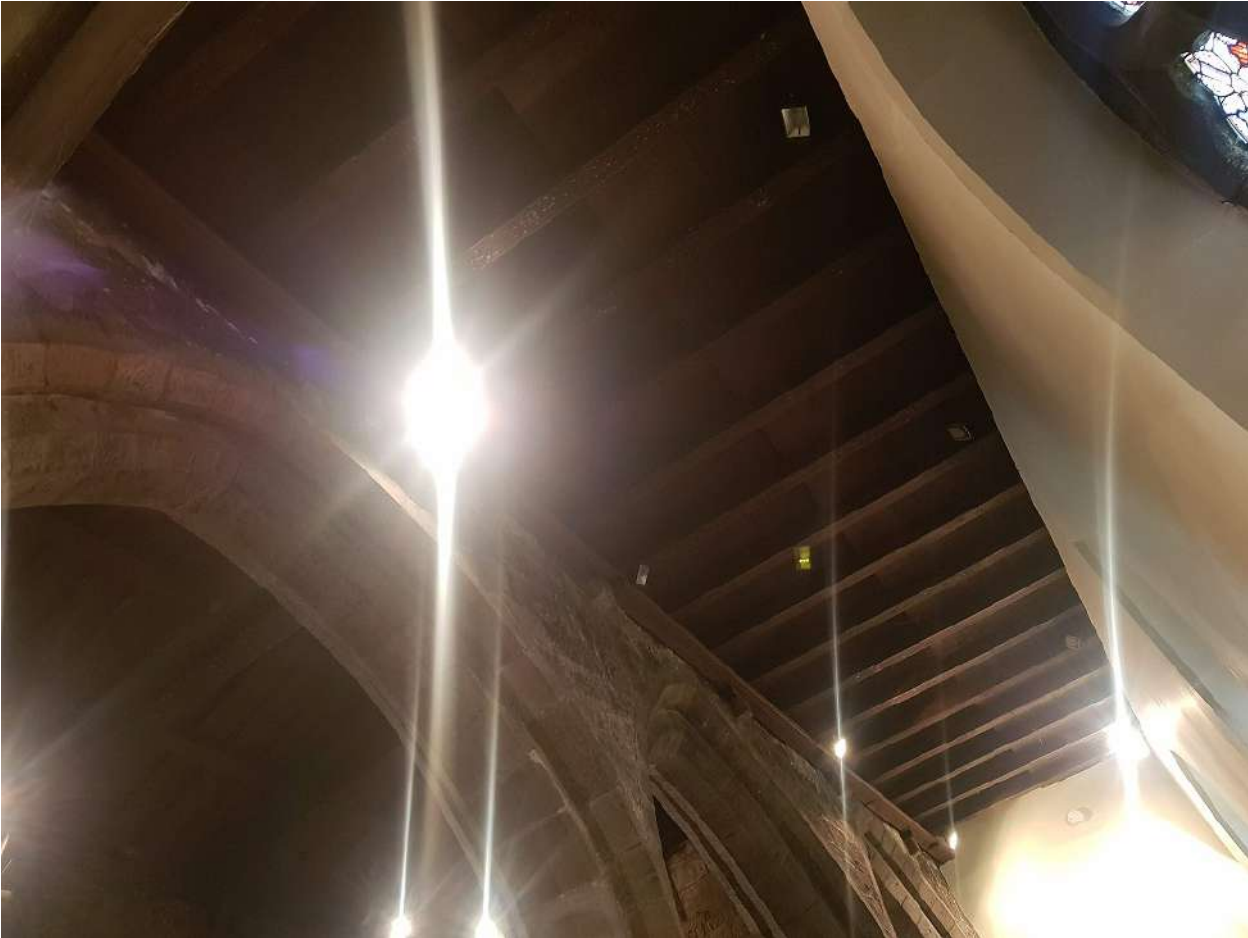
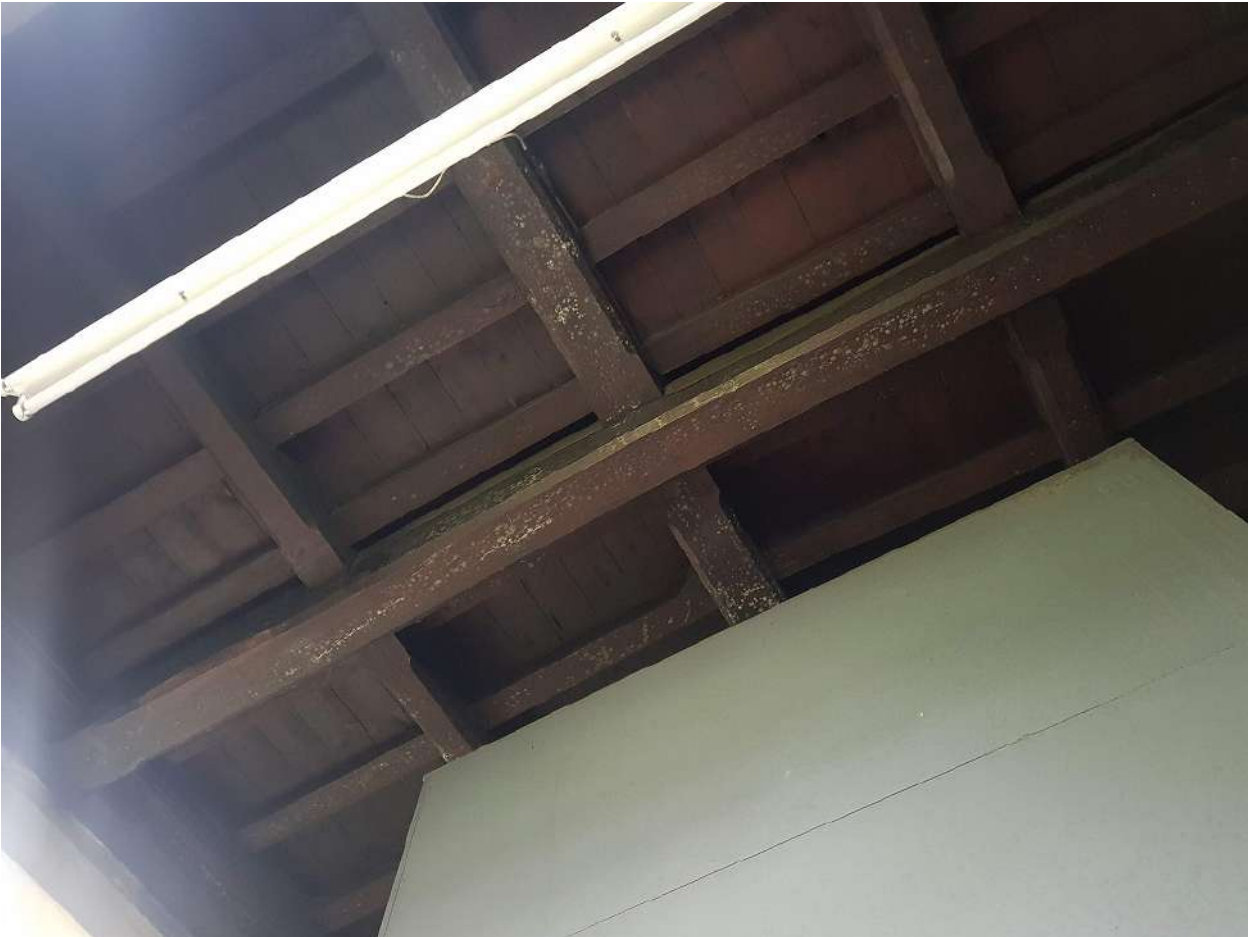
15.1.1 Woodwork all appears to be in a sound condition.

<b>M</b>	It is recommended that regular checks are carried out for any signs of new and active timber attack due to woodworm and/or rot.
----------	---------------------------------------------------------------------------------------------------------------------------------

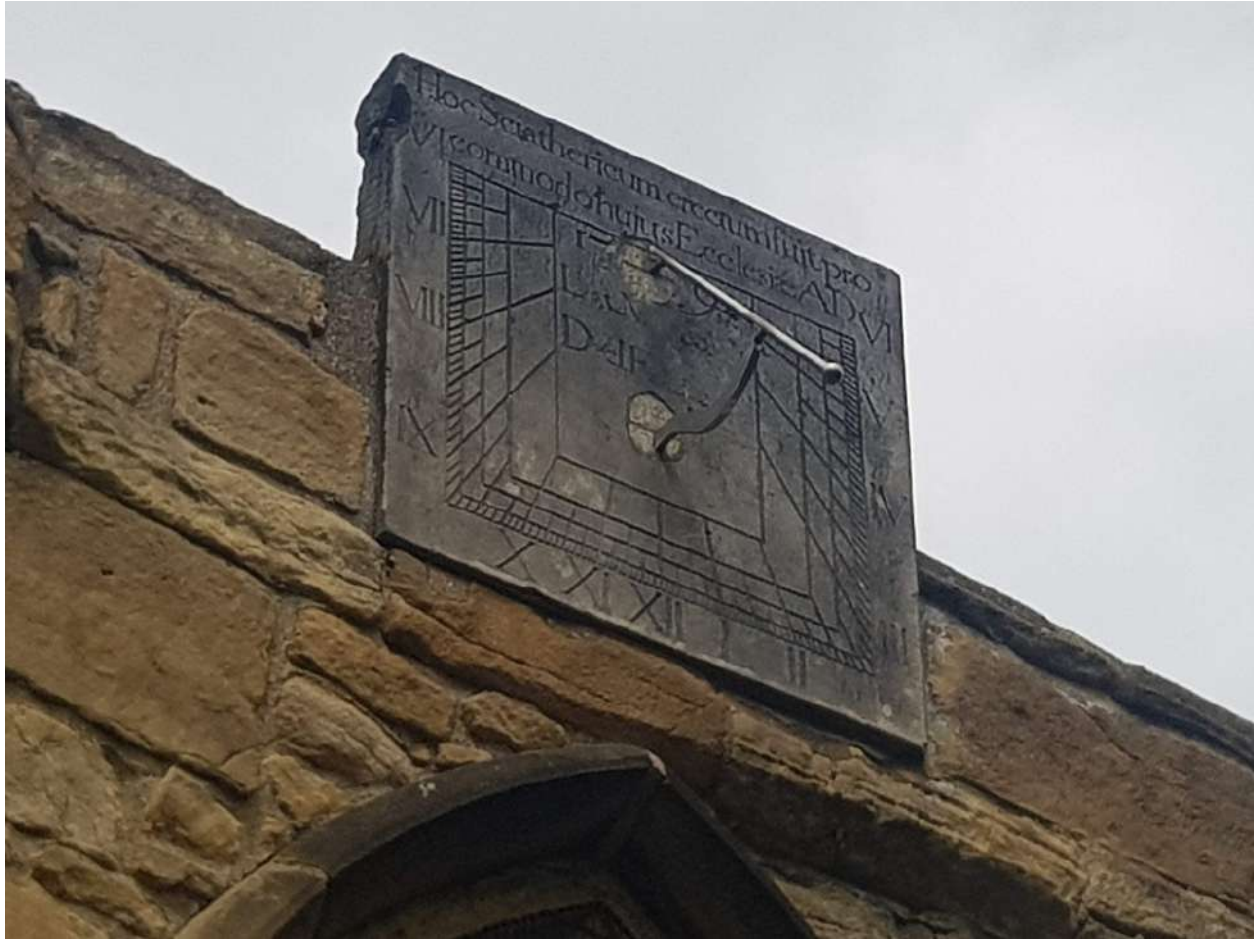
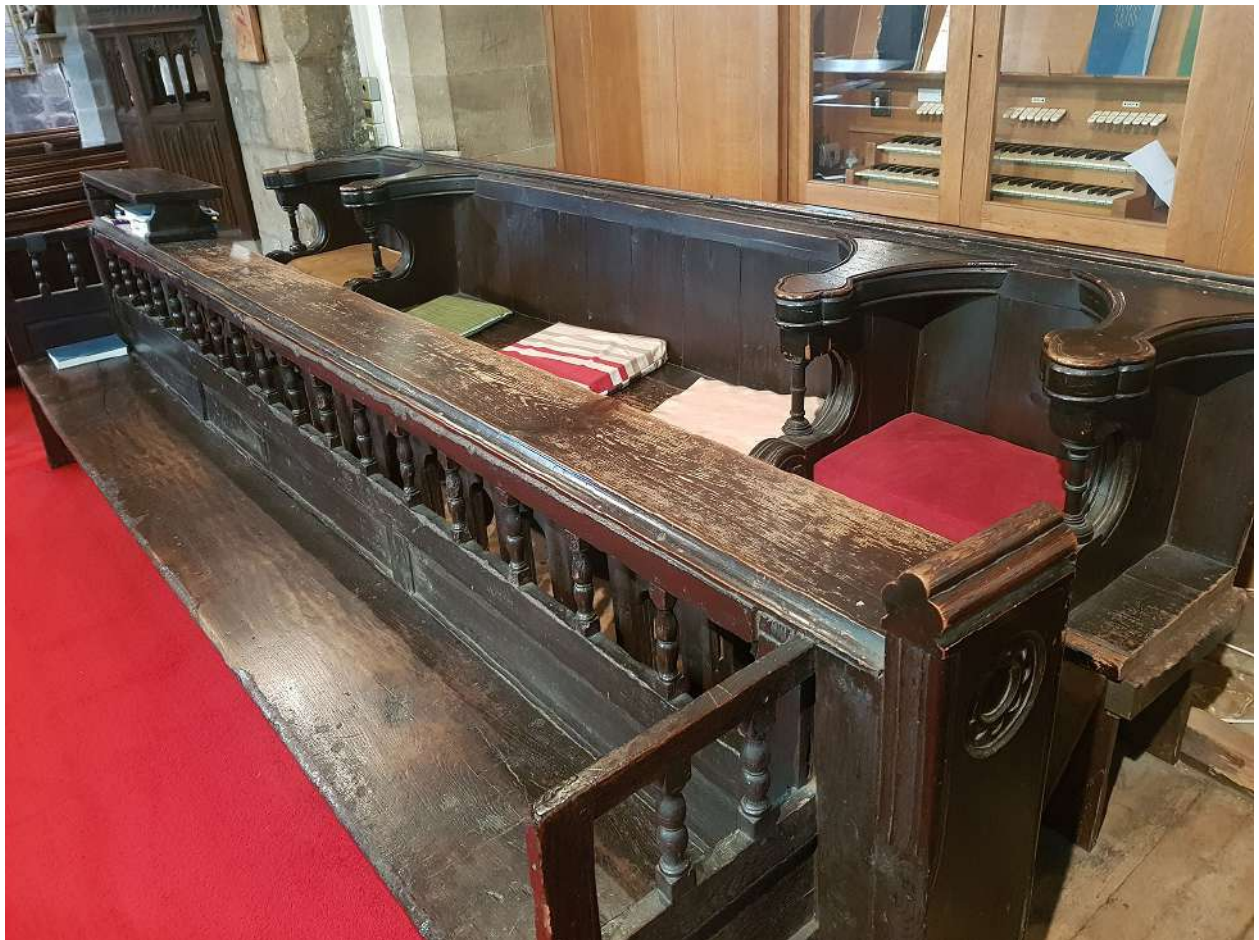
18.6.1 Font is in a good condition. Re-sited in 1956.

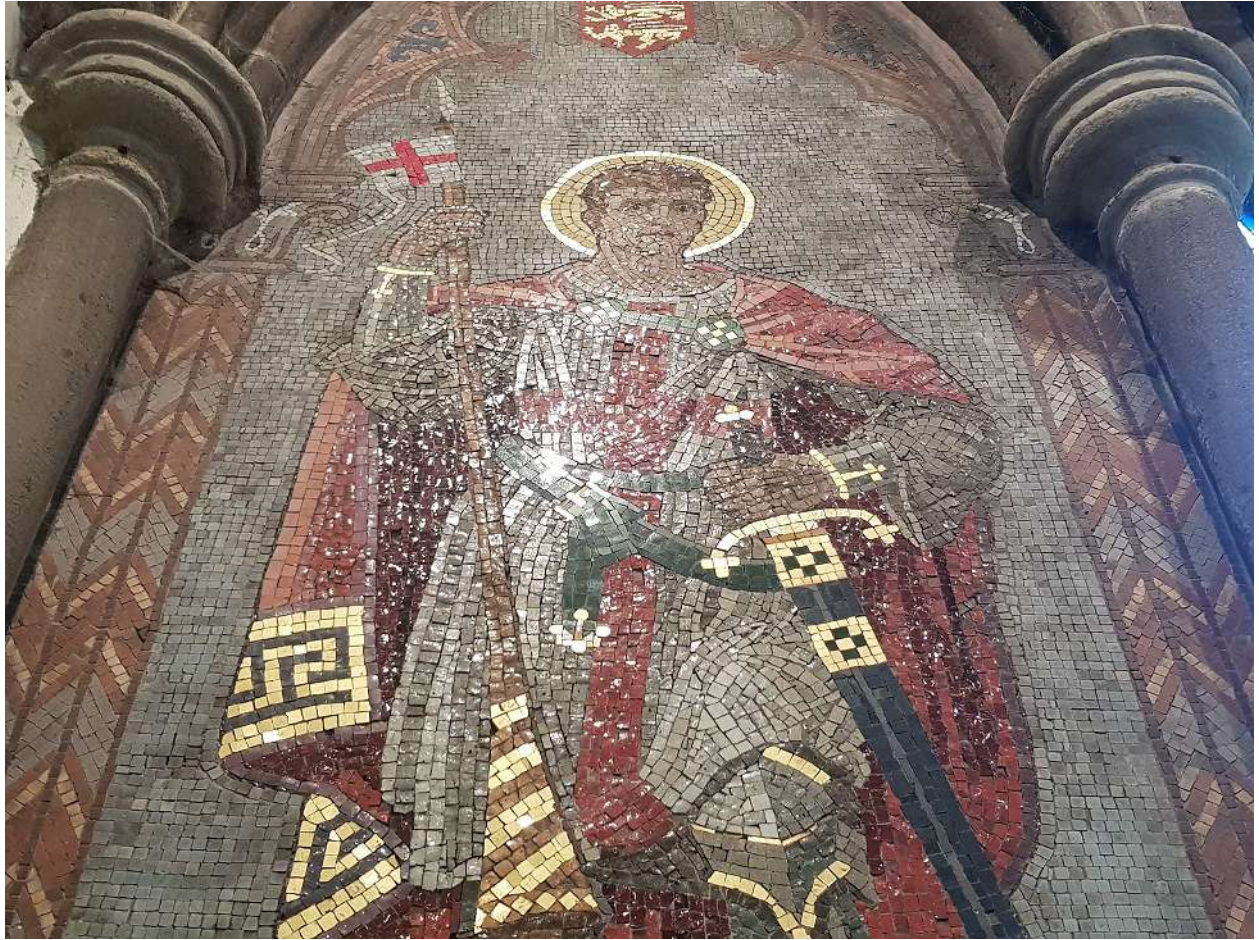
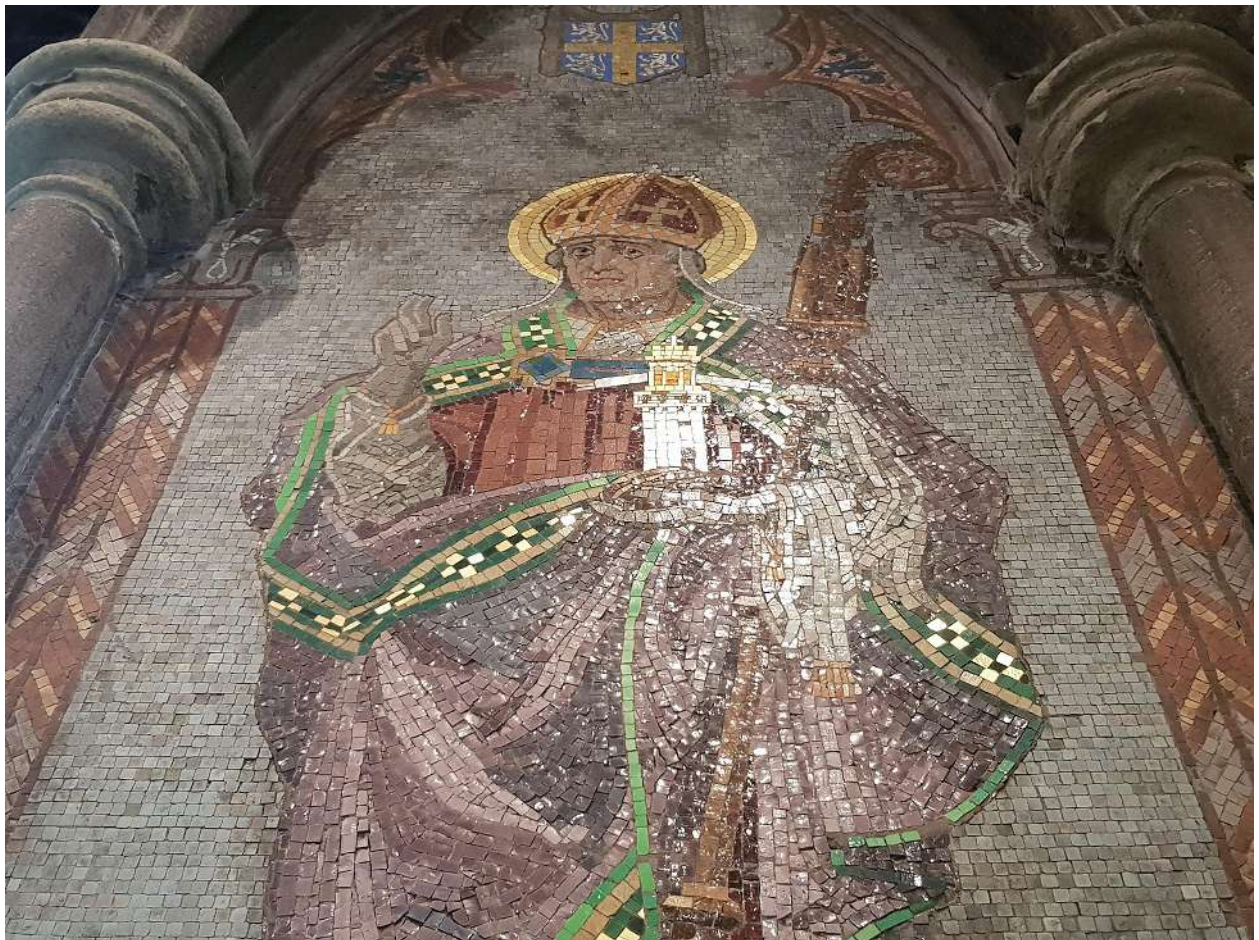
Memorial plaque and mosaic all appears in a sound, stable condition.

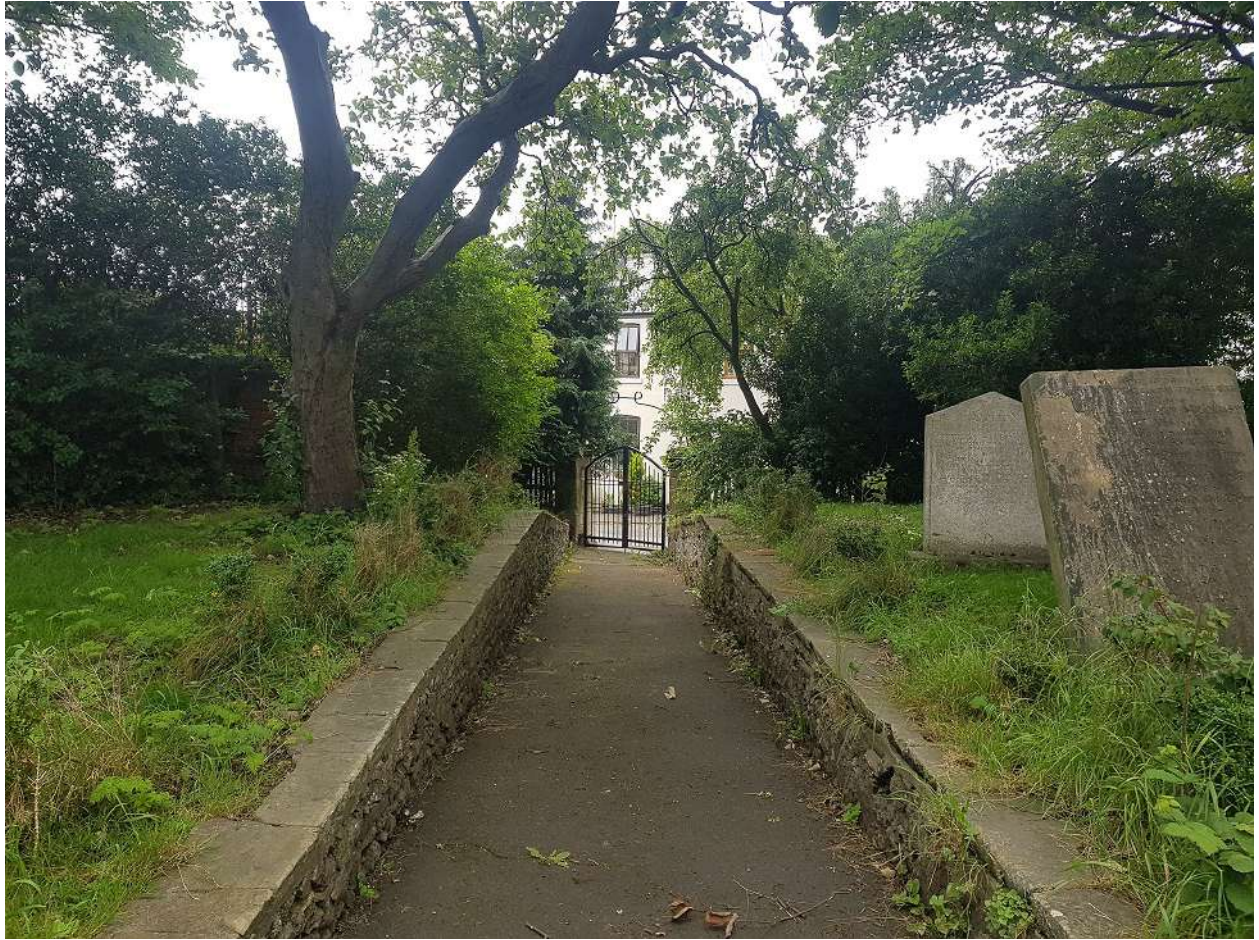
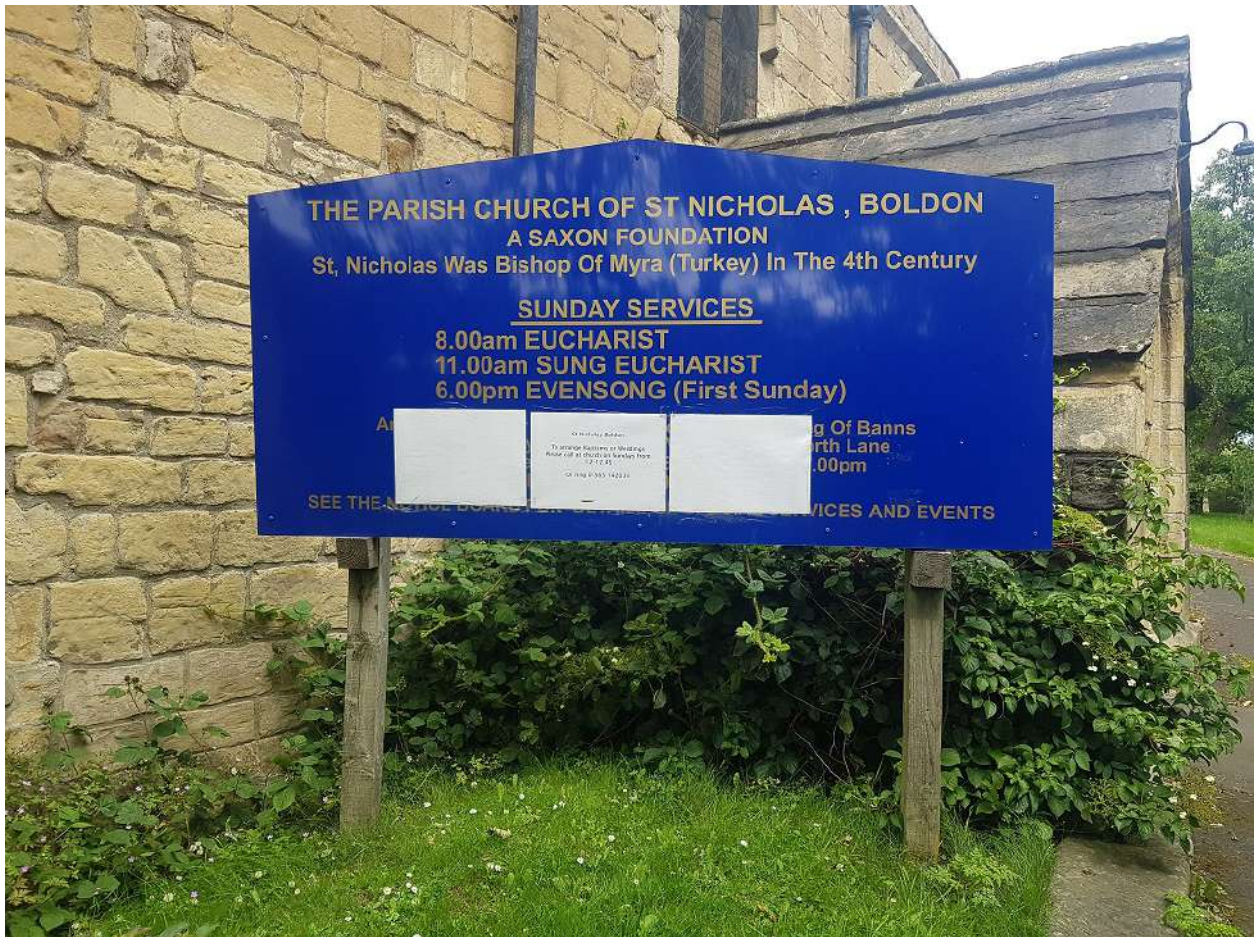
It could benefit from updating and adaption that includes capacity for changing advertisement within a slim perspex case. Further consideration to the positioning and number of noticeboards may well be beneficial to cover both west and north-east entrances.

<b>R1</b>	Refurbish existing church noticeboard.
-----------	----------------------------------------
