PARISH CHURCH OF ST AIDAN
ANNFIELD PLAIN

QUINQUENNIAL INSPECTION REPORT
SEPTEMBER 2014

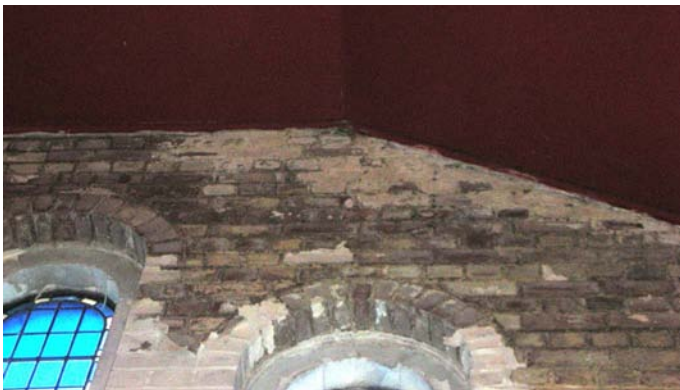
Friable paintwork and salt damage to brickwork, above and below.

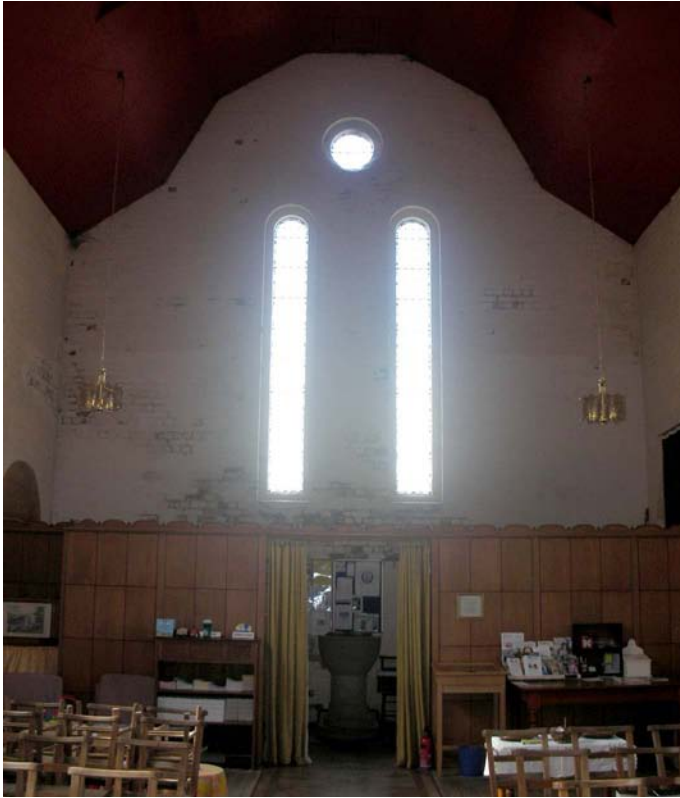
4.06 Partitions, screens, panelling, doors and ironmongery

There is an internal porch partitioning to the south east entrance door (liturgical south-west) which leads into a space similar to a narthex. This space, at the south end of the nave, which liturgically would be considered the west end, is screened off at approximately 2 metres in height with timber panelling reflecting similar design as the original porch. This timber panelling partition is in reasonable condition although slightly scuffed and worn with wear and tear. The timber may benefit from cleaning and waxing for protection, although this would only be a nicety.

The internal doors to the south porch enclosure are set within the panelling, and are in good condition with the original ironmongery still present.

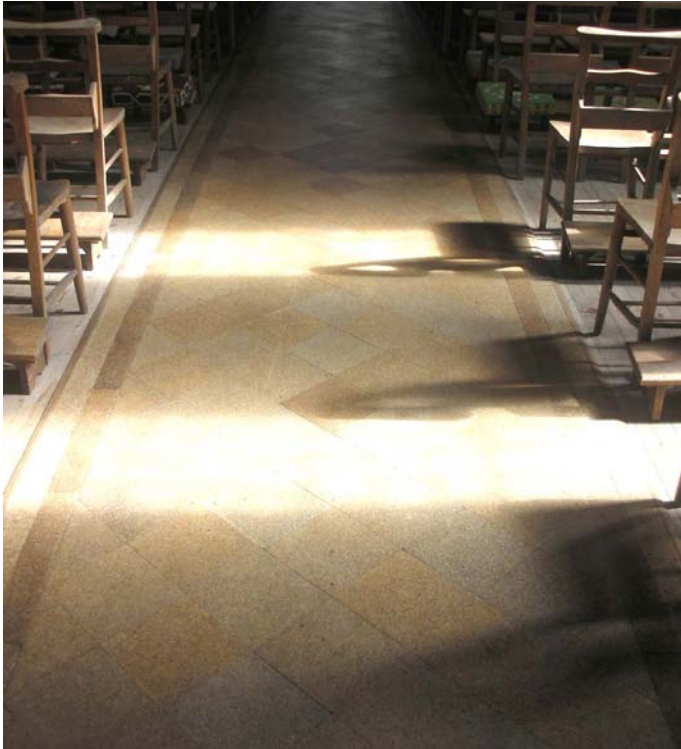
4.07 Ground floor structure, timber platforms, under floor ventilation

The main floor throughout the nave and side aisles is a suspended timber floor with softwood pine floor boarding throughout. There is cork tiling to the south narthex area and along the full length of the central aisle of the nave. This also extends east and west in front of the chancel arch. The cork tiles appear in good condition for their age, although towards the south end of the central aisle there is a deviation in the floor level indicating softness or movement of timber boards below.

The pine floor boarding to either side of the central aisle is all in good condition. There are no visible ventilation or heating grills within the floor, nor are there any signs of access voids visible.

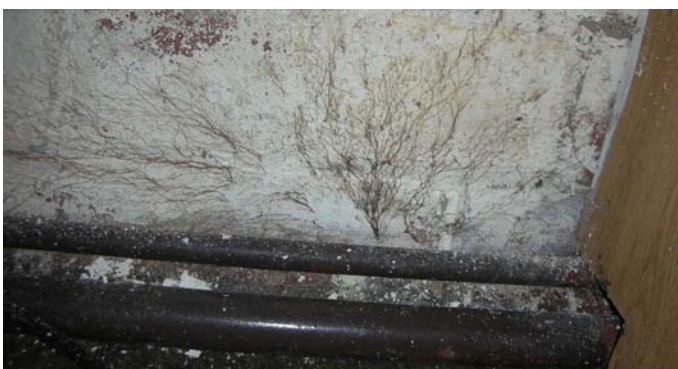
Possible signs of wet rot, damp timbers & wet ground
