**QUINQUENNIAL INSPECTION REPORT  
OF  
BELMONT, ST. MARY MAGDALENE**

**DIOCESE OF DURHAM  
ARCHDEACONRY OF DURHAM  
DEANERY OF DURHAM**

**QUINQUENNIAL INSPECTION AND REPORT**

**February 2020**

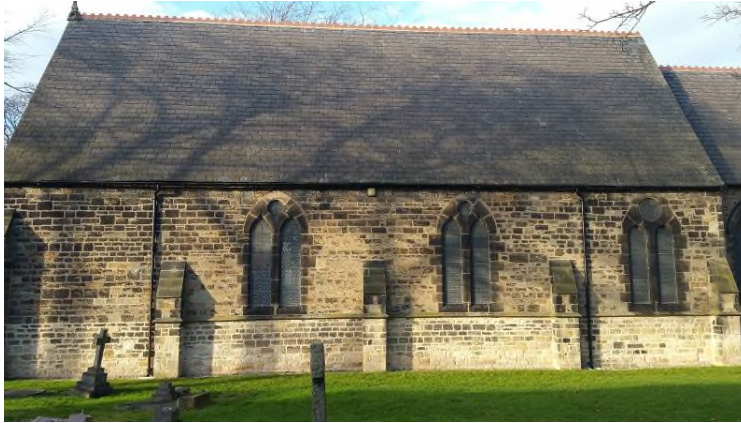
#### **B Nave:**

- Ridge – Ornamental ridge cresting ok.
- West abutment – Pointed verge ok.
- East abutment – Pointed verge ok.
- General roofing – Welsh slating, one slipped towards the eastern end, a couple at the ridge are just tilted out slightly.

**Recommendation:** fix slates

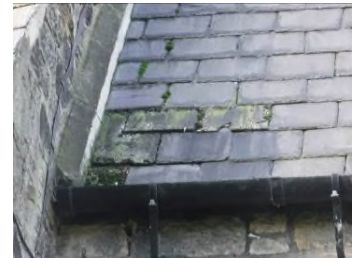
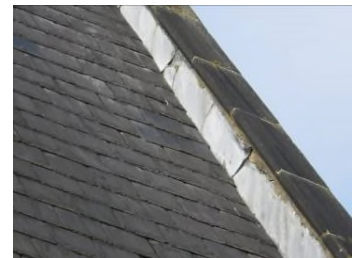
- Ridge – Slightly fancier ridge cresting.
- West abutment – Pointed over in cement with lead soakers and flashing ok.
- East abutment – To gable water table in leadwork, one flashing looking to be coming out and the pointing to the underside of the water table is breaking up.
- General roofing – slating has some chips and a couple close to the nave looks as though they have been siliconed in in the past.

**Recommendation:** refix abutment flashing, check the siliconed slates

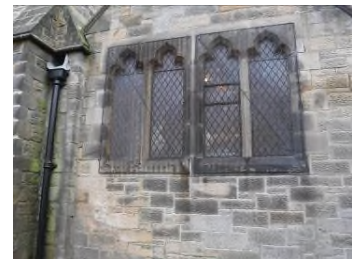
Vestry – This wasn't part of the repoint works as the condition was good. Slight green on the stonework by the hopper outlet and buttress. Some open joints at low level, open joints to the tracery dressings. Slightly rusting metal grille to the windows. Glass is obscured diamond leaded pattern, looks ok. The apex has a timber block infilling a hole looking rather warped now. It could probably survive another 5 years.

**Recommendation:** none

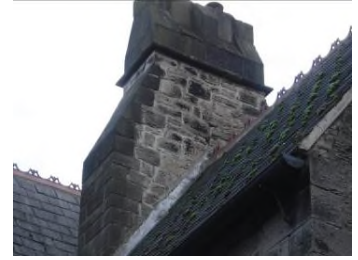
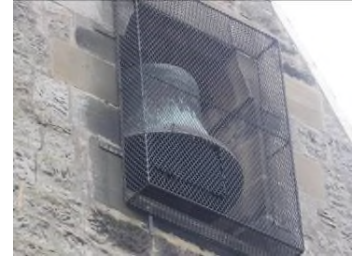
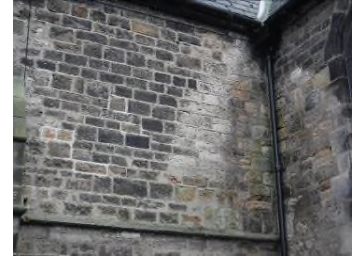
- **Transept:**

**Eastside** -Slight breaking up of cementitious patch over the vestry where there is a hint of a crack but not really a defect.

**Northside** -Cement plastered has had cracking in the past to the left of the bell and looks probably old, as is the one below the window, there is no movement here. Plate tracery looks ok there has been some movement but its fine, the galvanized guards look ok. Above it is a handsome bell which has a metal cage to it, this is tolled and apparently ok but hasn't been inspected for a while-see section 7 for recommendation. Two little lancets below in timber look ok. Some minor open joints on the buttress.

**Westside** - Some wear to the stonework in the corner where previous running leaking downpipes effected it and made it a bit green, a couple of stones looking a little worn now but generally alright and a couple of open areas could do with infilling when next carrying out stonework repairs .

**Recommendation:** none

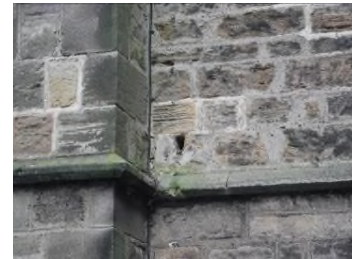
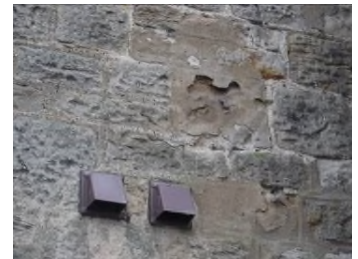
- **Nave:**

Larger area of cement pointing here above the string course, the string course itself has some open joints. Three windows, two of which are twin light plate tracery, the other is a single light plate tracery and they are all ok. They have galvanized mesh guarding.

**Recommendation:** none

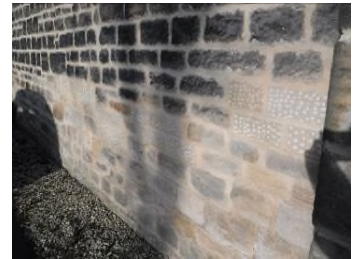
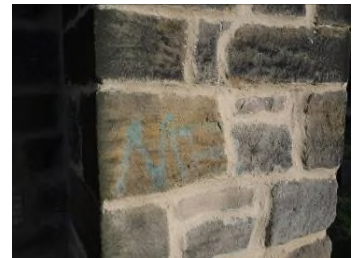
This whole elevation was repointed and all looks ok. Plate tracery is ok this had new clear polycarbonate added to it by Chris Chesney and this looks really good. But there is graffiti at one area that needs prompt removal.

**Recommendation:** remove graffiti

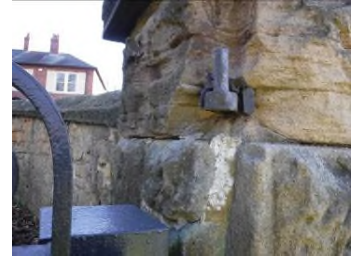
**Westside:** the gates are no longer on their original piers and are now on separate steel columns, the pintles hinge on the south side is beginning to expand and will break the stone eventually, the pier caps and piers are ok they are a bit worn, open joints to some of the copings above the letterbox.

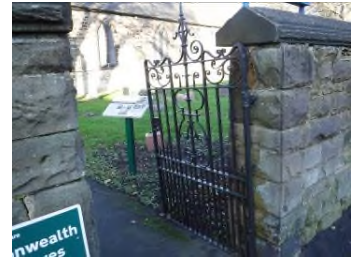
**Southside:**

Fine metal gate rusted into position now and has lost its bottom pin, not operating now it's lost its lock. The walling is generally sound and it's not been attacked by too much cement in the past, the local authority should be reminded that any repair works should be in lime.

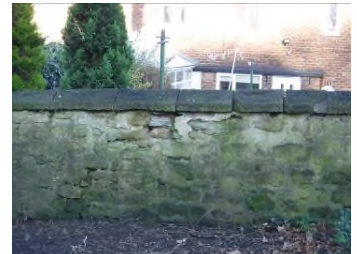
**East Walls:** They abut the neighbouring properties and quite a lot of work has been done now to reduce the level of spoil up against them and they are looking much better now. There are the occasional areas of missed pointing or deep open joints.

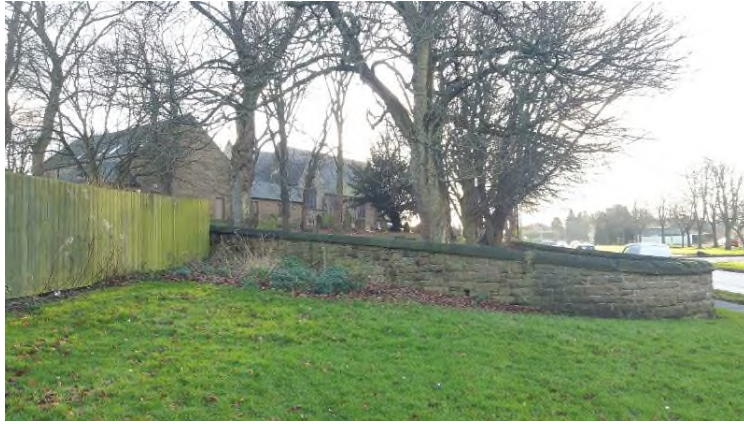
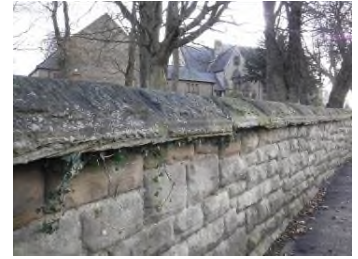
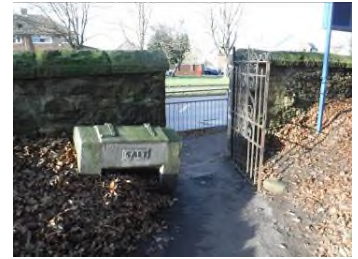
**Northside:**

On the outside facing eastern wall by the War Memorial there is a hole and a chipped coping. Some open joints to the coping.

Some Ivy beginning to take hold again.

Metal gate on its hinges but rusting and trapped by the raised level of the tarmac. Salt bin close by looks a bit incongruous.

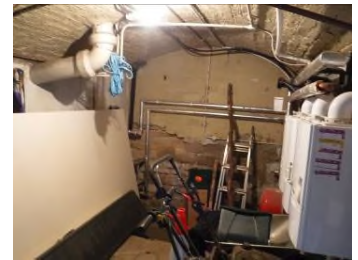
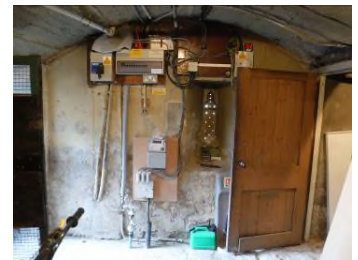
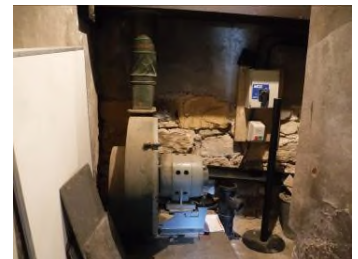
- **Ceiling** – Brick barrel vault, some cracking in the past but ok.
- **Walls** – Stone walls, some deep recesses to the pointing joints and loss of plaster at low level but actually reasonably sound.
- **Floor** – Cracked stone but all sound.
- **General** – The room is dry and contains the three Vaillant boilers expansion vessel and pump. Has the distribution board and also joining blower room and there is some bits of lumber that could do with being cleared away. Door joinery ok.

**Recommendation:** remove lumber

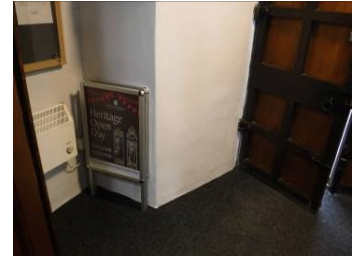
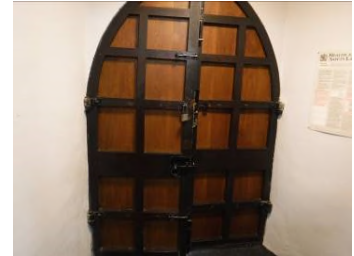
### C **Porch:**

Redecorated porch that used to have damp at low level, has an Aertex kind of coating now, seeming to manage it. Pair of entrance doors, heavy boarded, ok, bit stiff on the hinges, pair of part glazed doors with panelling leading into the narthex ok.

**Recommendation:** oil hinges

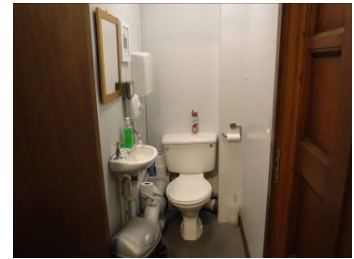
### C **W.C.:**

Modest loo to the side in the porch with fairly basic fittings generally ok. Door catches slightly on the carpet.

**Recommendation:** ease door

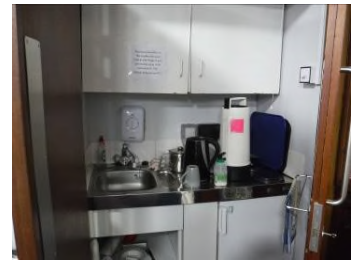
Modestly fitted out with 'all in one' base unit with fridge under. Wall mounted chipboard cupboards in fairly poor condition now and some exposed heavy duty electrics. Hot water looks to just be by a small spray heater. There is also a couple of kettles and a water boiler. Opening door slightly warped but closing ok.

**Recommendation:** none

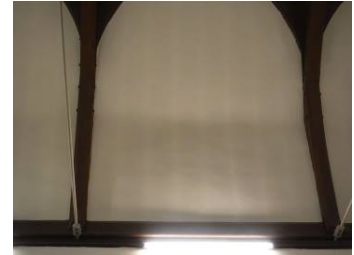
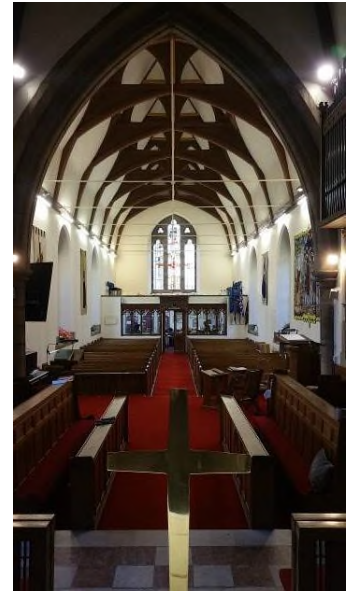
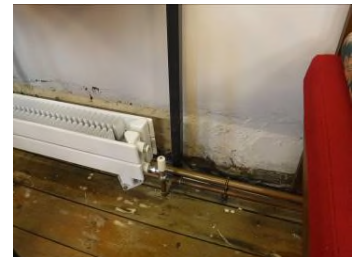
- **Nave:**

cracking to some of the surface suggesting it might be plaster and lath. Decoration is looking a little tired now, there is some bloom on the painted timber work.

- **Walls** – Redecorated and looking in good condition. The lower parts of them behind the skirting heater units is a little rough and unfinished but rather difficult to attend to, is in the shadows and probably best left alone.
- **Floor** – Timber pew platforms level with the carpeted circulation, which is solid. There is a step up to the chancel arch in a suspended timber floor.
- **Windows** - Plate tracery windows, all clear glazed with diamond leaded patterns, apart from pictorial glass at the south eastern end, all in good condition.

**Recommendation:** none

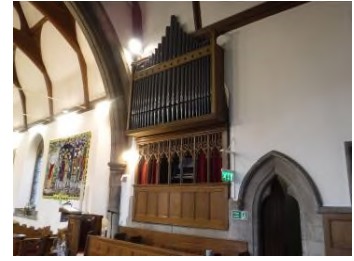
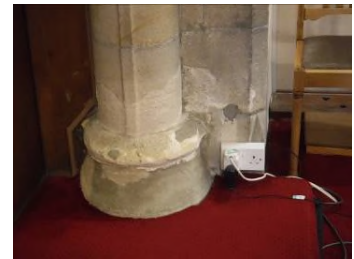
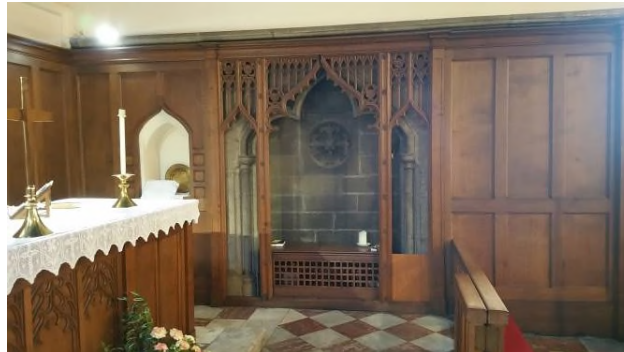
**Chancel:**

- **Ceiling** – Trussed roof a little like the nave but without the tie rods. This is also showing some ghosting on the decoration.
- **Walls** – redecorated.
- **Floor** – Is a combination of suspended timber and white and pink marble at the sanctuary, there is a couple of chips to the marble but generally ok.
- **Windows** – The east window condition is very good. The north and south windows are ok.
- **General** – Large organ recess, arch isn't visible behind the pipes but seemingly ok.

- Lovely oak panelling reredos. Altar, altar rail and choir stalls all by Thompsons of Kilburn. The pews, also by Thompson also match the choir in style. The chancel arch is in good condition though there is some slight wear to the bases which have had some cement repairs in the past.

**Recommendation:** none

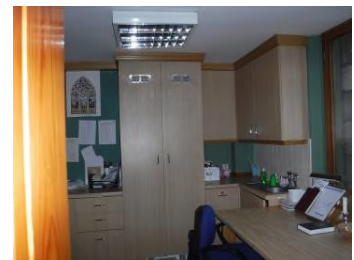
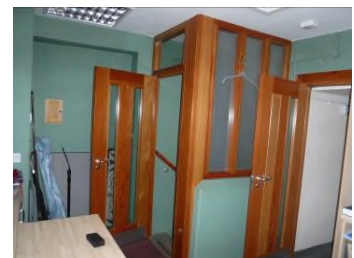
Slight crack to the lancet arched doorway from chancel to lobby but ok. Lock missing on the door which isn't held back. The floor has got slight depression and probably could cause a trip. Granolithic stair up to an office formed at first floor within the north transept. Modestly fitted out with sink and kitchen fitments.

Solid floor, attic above but not inspected on this occasion. All the doors are ok.

**Recommendation:** level lobby floor, inspect attic

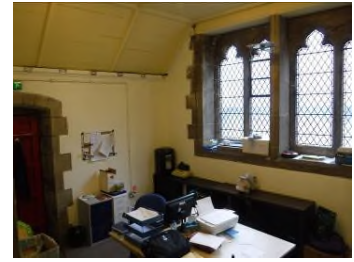
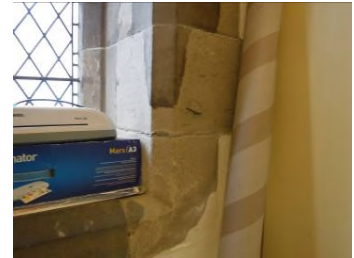
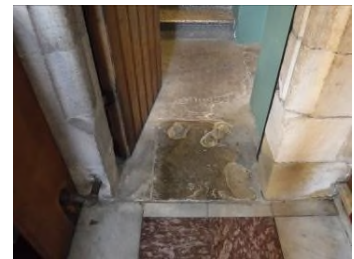
- **Vicar Vestry:**

- **Ceiling** – Open boarded, slight gaps.
- **Walls** – Painted stone, some stonework exposed at dressings.
- **Floor** – Solid floor with rather old carpet.
- **General** – The room contains a rather nice heritage radiator and some old fashioned cupboarding and various bits of lumber.  
Lobby door leading into the room is ok, as is the external door. Elementary track lighting here.
- **Windows** – Are ok, though they have just lost a little bit of face on the stonework.

**Recommendation:** none
