**Church of St Anne, Bishop Auckland**

**Quinquennial Report**  
On the architect's inspection of

**24<sup>th</sup> July 2025**

**Sarah Harrison** RIBA

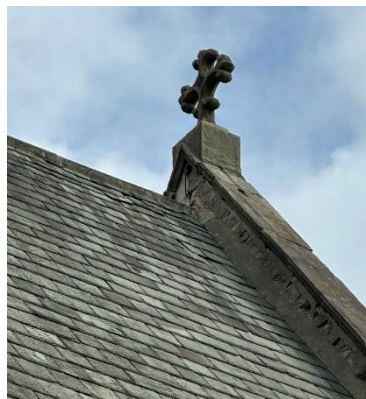
*Figure 5- E Nave finial*

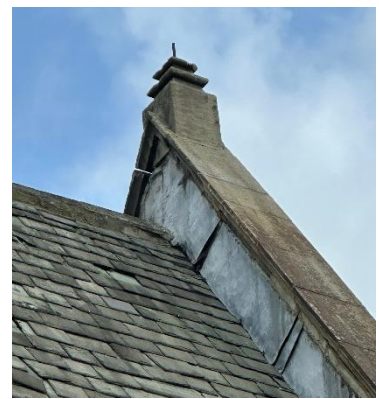
*Figure 6 – E Chancel Finial*

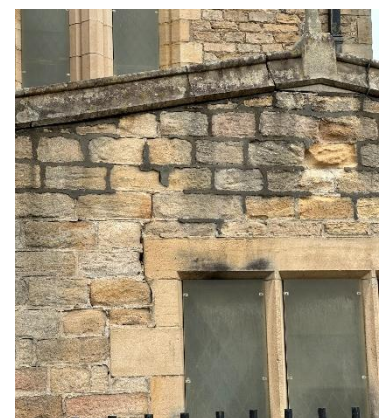
- 8.8.1 The Vestry extension at the south-east corner is constructed in stonework similar to the main church, with a shallow gable facing south and the former boiler room located beneath. Some areas remain in poor condition.
- 8.8.2 **South Elevation:** The stonework shows widespread erosion, with some stones decayed up to 30 mm deep. The crown coping has shifted and requires re-setting (as per item 6.8.4). Much of the pointing is open or badly recessed, and earlier use of hard cement mortar has exacerbated decay. The majority of this elevation requires repointing in the near future<sup>29</sup>, and the overall condition is poor. The top left-hand corner of the window has very open joints, symptomatic of some movement, that need

*Figure 21 – WCs south elevation*

to be filled with an appropriate lime mortar and monitored. There is a minor fracture to the stone below the corbel but not currently of concern.

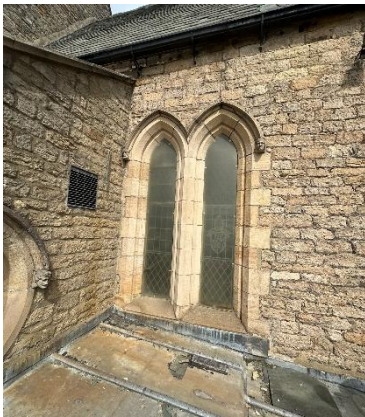
Figure 22 – S Chancel

8.9.1 **South** - Above the eastern part of the South Aisle roof there is a short section of rubble walling, only three courses high, which is in fair condition. One or two open joints are visible and require repointing. The eastern half of the Chancel wall is of similar rubble stonework, also in reasonable condition. There may be an open joint at high level, though this could not be definitively confirmed from ground level. An external spotlight is fixed to this elevation; its electric cable is loose and requires securing.

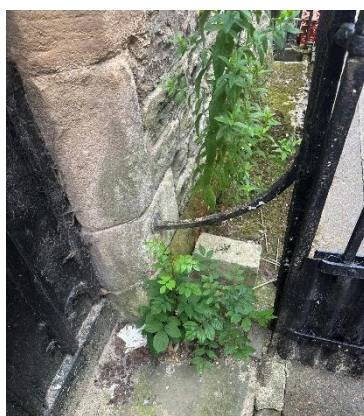
Figure 25 – vegetation nr door

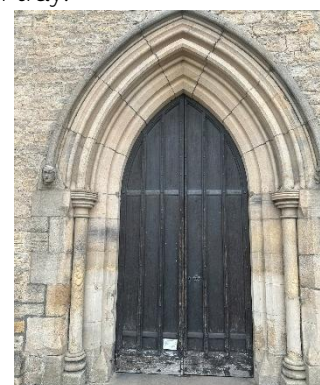
Figure 27 – West doors

9.4 The main **west entrance doors** are made of oak, boarded and battened. The decorative finish is deteriorating, most noticeably at the base where weathering has exposed bare timber, and at hand-height where repeated contact has caused surface wear. One board is split at the bottom, and areas of exposed timber are now vulnerable to decay if left untreated<sup>35</sup>. The doors are no longer in regular use and remain closed.

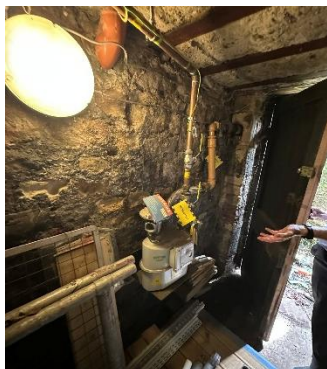
Figure 30 – boiler room

10.1 **Roof** - The roof structure comprises steel beams with in-situ reinforced concrete infill, likely reinforced (concrete type is unknown and unchecked – further advice should be taken by the PCC)<sup>40</sup>. The beams themselves are rusty and require brushing down and repainting.

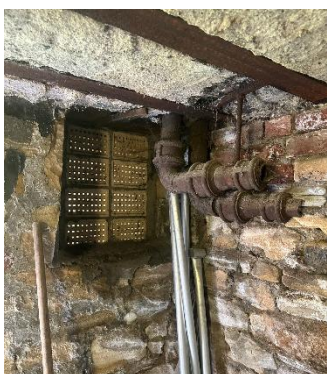
Figure 31 – ceiling and former window

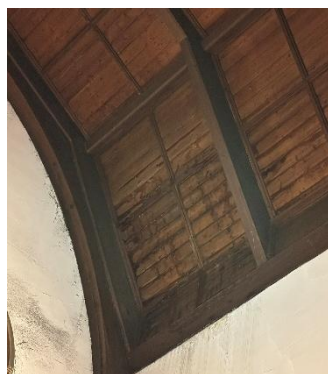
*Figure 37 – Chancel South roof*

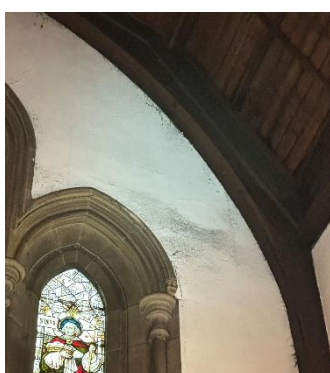
*Figure 49 – staining to SE*

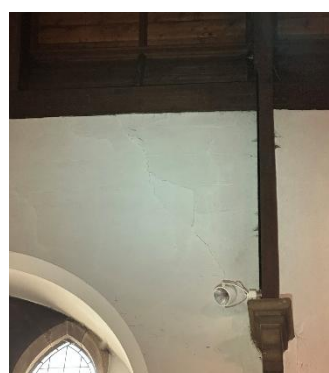
*Figure 50 – easing to S*

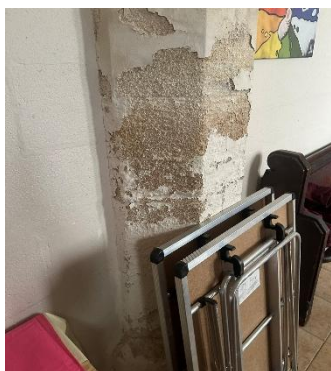
*Figure 56 – Columns with damp issues*

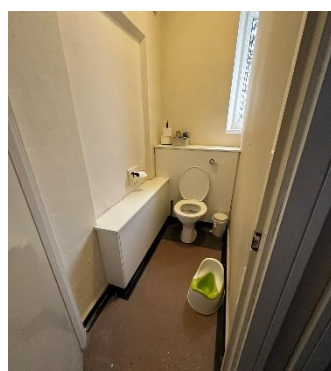
*Figure 57 – WC area where floor had temp repairs*

- Tea room: finished with new ceramic tiles, generally in good condition.
- WC area: vinyl sheet flooring. In the easternmost cubicle, the floor had previously collapsed due to severe timber decay and was partially replaced. The remainder of the floor is bouncy, particularly near the door, suggesting ongoing structural issues. This requires urgent investigation and a programme of repair.

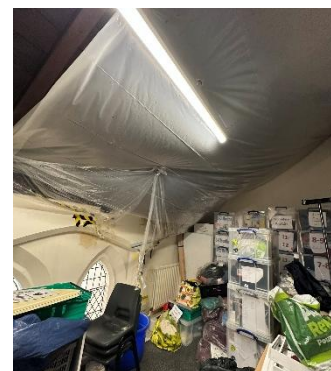
16.1.1 The South Aisle roof structure is closely visible at this level. It is currently covered in polythene sheeting to channel roof leaks into receptacles, but this is a temporary and unsatisfactory measure. The structure remains just intact but will soon deteriorate further as damp leads to rot. Daylight is visible through parts of the ceiling boarding. Urgent external roof repairs are required (see section 6).

Figure 58 – ceiling S aisle W end

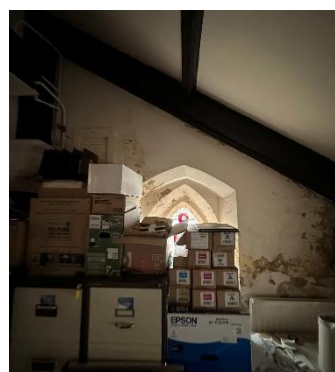
Figure 60 – damp to E wall

16.3.1 West room: Signs of penetrating damp are evident on the south wall, likely related to defective gutters and outlets at eaves level.

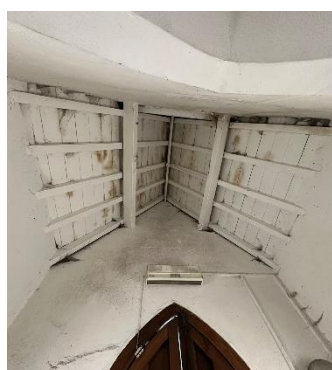
17.1 **Roof Structure and Ceilings** – The porch roof is formed with painted pine purlins, ridge, rafters, and boarding, all generally in good condition. The rafters are stained, and external roof repairs should be carried out before any internal redecoration is undertaken.

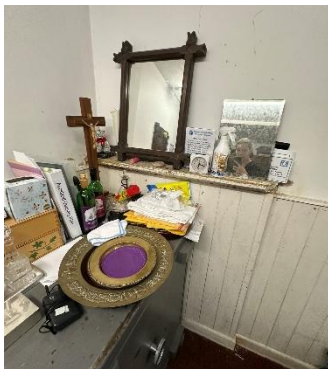
Figure 63 – mantel to N wall

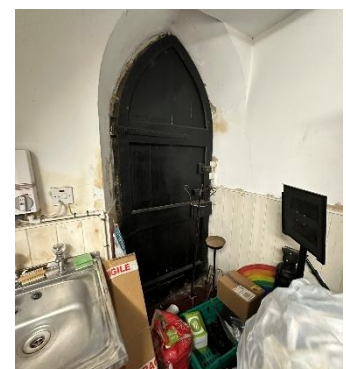
18.3.2 The internal entrance doorway from the area adjacent to the organ chamber is set beneath a shouldered arch. The softwood boarded door is in reasonable condition, but the threshold and base of the external east door show signs of water ingress.

Figure 64 – Vestry door

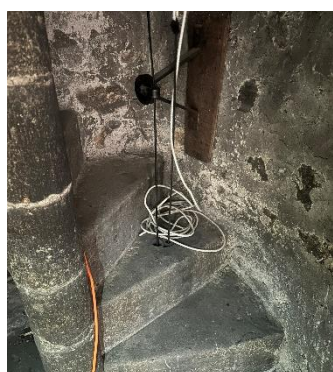
*Figure 66 – staircase wires*

the aesthetics. The floor of this area (which is also the ceiling of the west entrance/store) is rotten in places and not currently safe to stand on; this needs to be repaired or replaced. An irregular narrow stone spiral stair then leads up to the bell turret. The stair has no external windows, and lighting should be introduced as the current arrangement of exposed cables running up the centre, with some hanging from the side, is unsatisfactory. A more formal power supply should be installed, and a central rope handrail would improve safety.

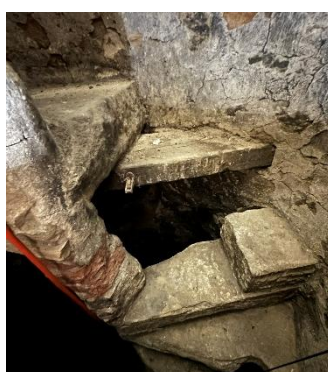
*Figure 67 – missing step*

- 20.2 Staircase Stonework - The walls of the staircase are of rough rubblestone and generally in fair condition. The steps are mostly ok except for the top five, which are broken, missing, or badly eroded. A timber board has been substituted for one step. Consolidation of the stonework below the access hatch is also required. The defective steps should be replaced and consolidated within the next couple of years.

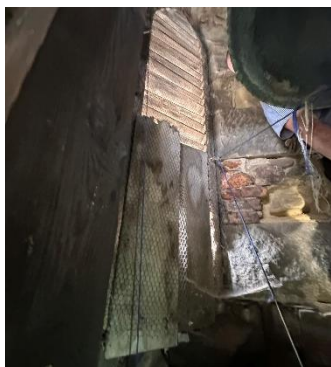
Figure 69 – bell chamber

- 20.4.1 The timber louvres to all sides are defective, with several missing or dislodged and at risk of falling. They were originally slotted into the masonry, but many are now loose. Bird mesh has been installed and reportedly repaired, yet gaps remain and the risk of bird ingress persists.

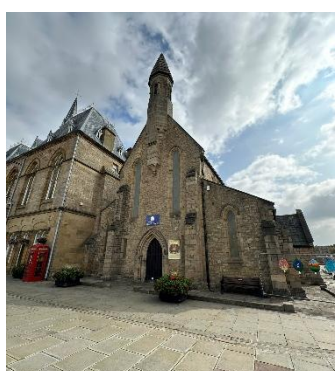
*Figure 37 – cracking to W wall*

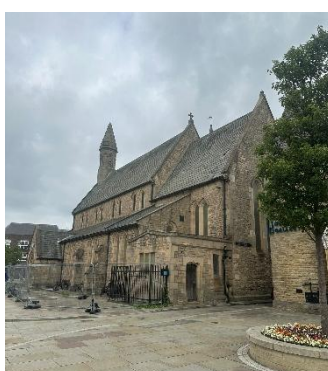
*Figure 38 – new fence and gravel*

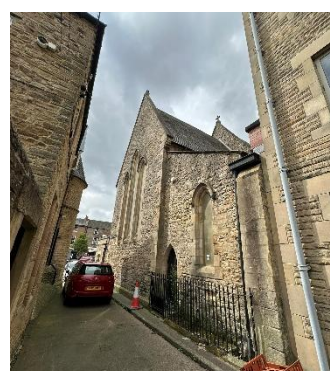
*Figure 39 – raised areas*
