QUINQUENNIAL INSPECTION REPORT

BISHOP MIDDLEHAM, ST MICHAEL

**QUINQUENNIAL INSPECTION AND REPORT
June 2018**

David Beaumont BA (Hons) Grad Dip, RIBA, AABC

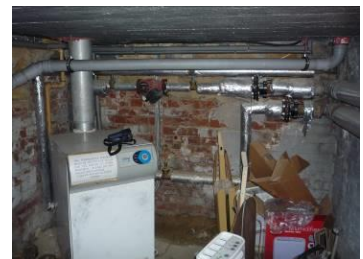
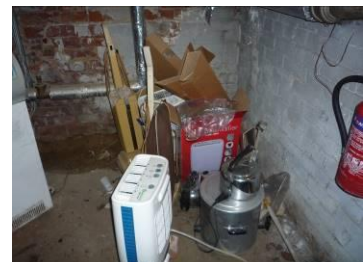
D Boiler Room:

- Ceiling – shuttered concrete, good condition.
- Walls – brickwork, some spalling of bricks at the east side and west, which has then been cemented over and this looks to be as a consequence of damp coming off the stairs. They have also been overpainted and that decoration is coming away now.
- Floor – concrete, good condition. Some brick dust at the margins – might this contain asbestos from previous lagging?
- Timber louvered door, has a bottom panel that needs to be removed for ventilation purposes.
- Decoration required on the outside and a general clean down. Lumber in the room needs removing.

- Room contains Ideal Concorde CXA boiler with Grundfos pump with new stainless steel flue. Modern drainage to sink that was installed in the vestry in 2003 looks in good condition.
- 4kg powder extinguisher.
- Room contains a Miko DD8L Junior Meoco dehumidifier that drains to the external gully at the bottom of the steps, the gully is blocked.
- The stairs are rather damp and have a lot of moss on them and some open joints at the risers that have sunk a little bit. The return wall with the balustrade above very wet. Handrail is rusting significantly at the bottom of the slope. The balustrade above is in fair condition.

Recommendation: clear stair gully, clean down steps, repoint steps, remove lumber and brush down - but assess if there is asbestos dust first, repair door panel, decorate door

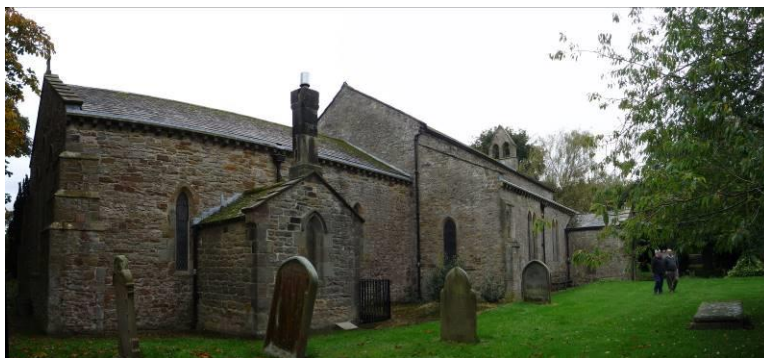
North Vestry:

- West slope:
 - Ridge – angled stone slate, bedding okay. North abutment flashing and soakers to rebated water table.

- South abutment - step flashing to chancel in leadwork that is okay. It has a back gutter by the buttress and this needs checking.
- General – Westmoreland slating has had some repair with tingles, looks okay.
- East slope:
 - Ridge – as west.
 - South abutment – as west.
 - North abutment – as west but the pointing is holding up here. Slight lift of the flashing to the chimney stack.
 - General – a lot of moss on the slating could do with being removed.

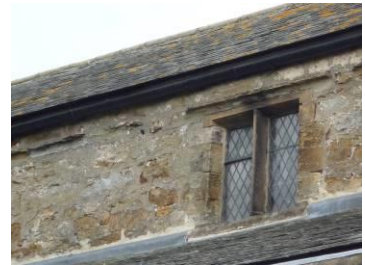
Nave:

- North Slope
 - Ridge – as south.
 - East abutment – raking lead flashing. A couple of areas where the pointing has come away under the water table.
 - West abutment – raking flashing at the bellcote, pointing come away just at the corner and also under the water table towards the bottom.

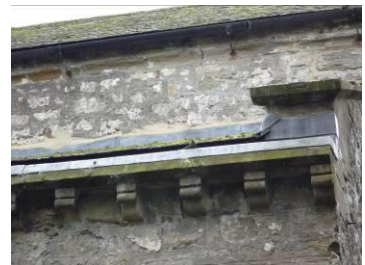
North porch:

- East slope:
 - Rounded top ridge tile perhaps – okay.
 - South abutment – raking flashing with soakers pointed in with cement. Slight crack but no action needed.
 - North abutment – to water table okay.
 - General – slating in good condition.
- West slope:
 - As east.

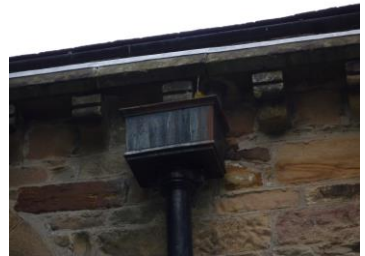
North Vestry:

- West – Half round gutter leading to downpipe which discharges to open ground. This is wetting the retaining wall to the boiler steps and really needs a better way of discharging – perhaps to bring the pipes out on the northern side?
- East – half round gutter, possible leak midway along, planting at the top end. Cast iron circular downpipe to salt glazed gulley looks okay.

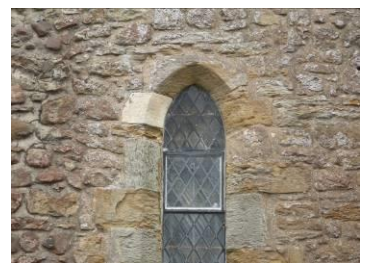
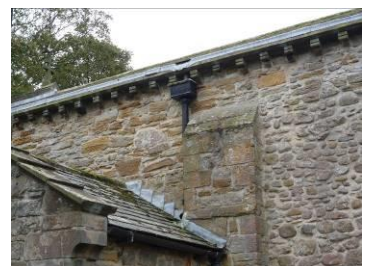
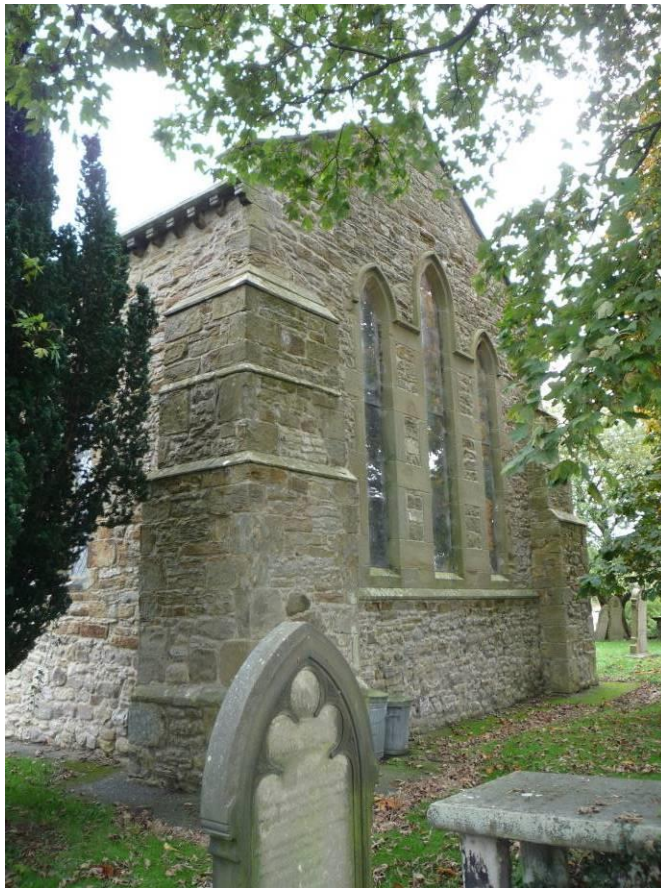
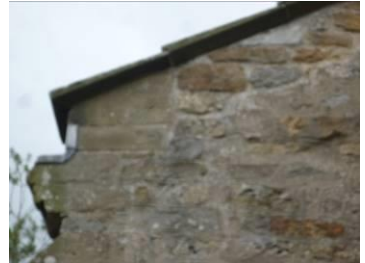
Chancel:

- North – random coursed rubble in the older western part and brought to course a little more on the newer eastern part. Parapet formed from over sailing gutter table supported by stone corbels – all looks okay. Walling is generally sound though there are a couple of open joints at lower level.
- West buttress – angled, open joints to the sloping copings at the stages. Mid buttress – slight breaking up of one of the sloping stones that could do with being re-pointed. Open joint at the elbow of the gutter and a bit damp at the bottom of the basement steps. Slight erosion to the stonework closer to the gulley on the west side.

- East – water table okay. Slight crack to the kneeler on the south side. Walling generally in good condition. There are open joints on the string course below the lancets. Triple lancet window, the stonework is in good condition and there are just some slight open joints in the very narrow jointing of the arch stones and jambs that can wait. Clear polycarbonate guarding over pictorial glass with many cobwebs behind. Wall has two buttresses: south – open joint to the sloping stage caps. North – some erosion to the south facing stonework and the west but okay for the present. Some open joints to the raking capping.

- South – random walling, generally okay. A couple of eroded areas above the second lancet and beneath that open joints at the foot of the wall. The wall has a mid-buttress with open joints at the top stage and as it adjoins the wall by the downpipe. Four windows reading from left to right:

Recommendation: deshale flaking stonework, repoint open joints, replace/repair nook shaft, repair missing door moulding, redecorate ferramenta

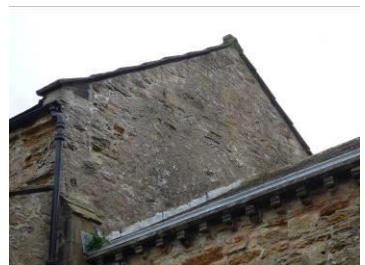
Nave:

- East –
 - North side – water table okay. Pointing missing above chancel ridge and breaking away at foot of the flashing of the chancel. Slight cracking below the water table as the two constructions meet.
 - South side – cross missing at apex. Water table okay. Hint of cracking inboard of the water table – this is where a re-facing of the

clerestory has taken place. Some evidence of brick showing through the over-restored walling with cement and some erosion to stonework above the buttress and also above the chancel ridge area. The water tables look to have been raised in the past. The gable will do for the moment but will probably some work next QI.

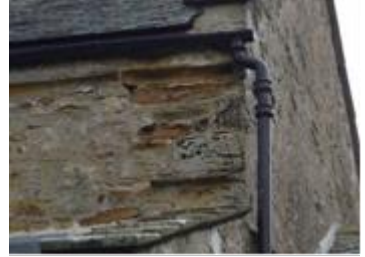
- South – moulded string course to former parapet now heavily eroded though it is no longer performing a water throw function. Walling has been over cemented in the past. There are some open joints. The flashing to the aisle has been cemented in. Area of major erosion at the south-east corner and you can see into the core in some places there. There looks like three or four stones need to be replaced and this needs an inspection by a stone mason.

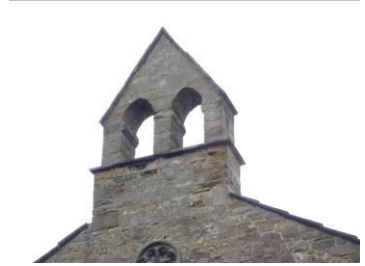
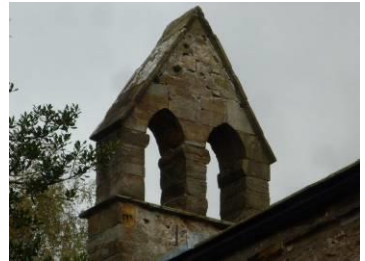
- Whilst the water tabling is okay, the eastern side stonework within the apex of the arch is breaking down a little and there are some plants in there. The eastern face is a bit more weathered. The cill below the two arches is broken in one place and below that, the stonework just above the ridge has open joints. The western face is in fair condition, though there are some cracking lines and it will be wise to restore the bellcote before the bells are installed.

Recommendation: restore the bellcote masonry before bell installation

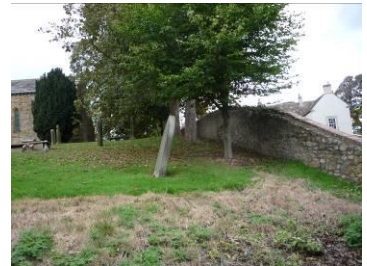
East Boundary:

Magnesium limestone random rubble boundary wall, Has had a new doorway installed last year. Some erosion to the base of the buttress on the right-hand side and it seems to be drifting away slightly. The pier caps to the entrance are somewhat eroded now. Ivy growing on the walls in certain places. Has a brick capping that is generally sound with much cement pointing over it. Probably had a better capping than this that may have been robbed in the past? Quite mature trees on this boundary – a mixture of sycamore and chestnut. At the southern end, the wall slopes down as the ground runs away and it is not possible to see. The southern boundary runs down to a dene type area, likely chance of a wall right at the very bottom of the land, somewhat obscured by ivy and shrubs.

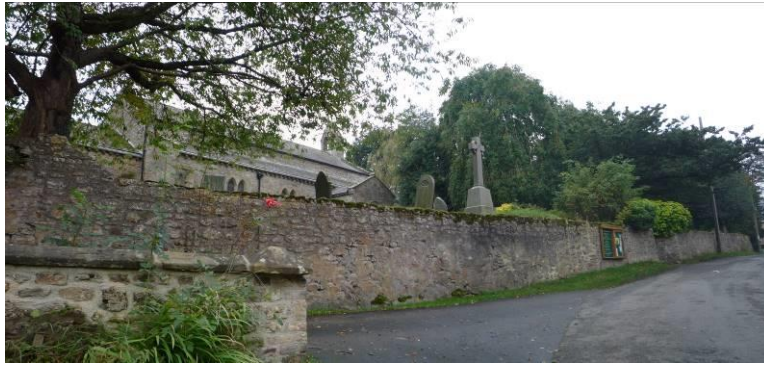
There is an extension to the churchyard on the north western side (1909). It is surrounded by field walls in stone, some coping missing on the southern side. The western side has a significant amount of laurel against it which is hiding the farm buildings. The wall is not able to be inspected. The same applies to the majority of the northern side and where the wall is visible, the wall tops require some consolidation.

The extension graveyard boundary walls need some repair.

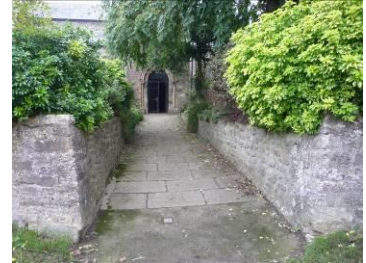
Northern Boundary:

The northern boundary wall retains the high-level churchyard. Has been patch pointed in the past. Some of the copings need re-bedding. Large holly tree at the corner threatening it. Pathway made in the centre of the wall leading to the entrance gate, the return stone wall is okay.

North boundary copings need rebedding, inspect holly tree

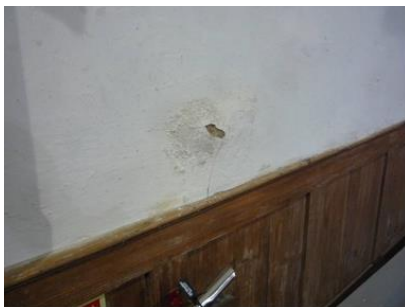
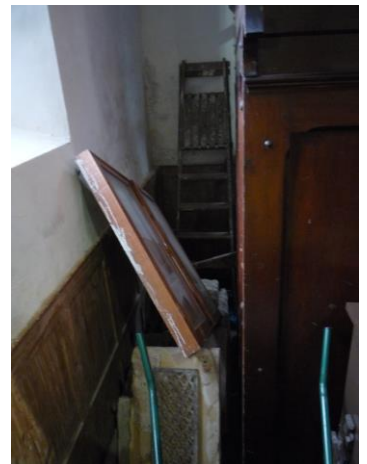
North aisle:

- Ceiling – sloping with exposed truss rafters and purlins. Plastered and painted panels in fair condition.

1906). Some evidence of discolouration at window sills and plaster blowing a bit above the dado. Damp in the organ corner.

Recommendation: remove lumber from organ area to encourage air movement

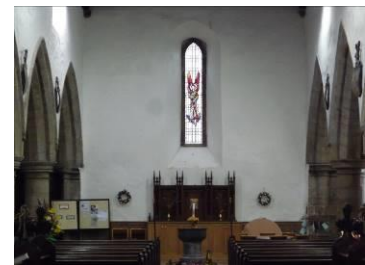
- Ceiling – exposed truss roof with exposed boarding. No evidence of water marking.
- Walls –
 - West – painted plaster with dado below. Some marking from water penetration from the bell rope pipe.
 - Window masonry okay, the glass is dirty and features St Michael in pictorial glass. New cabinet below supporting relocated reredos in good condition.

Recommendation: none

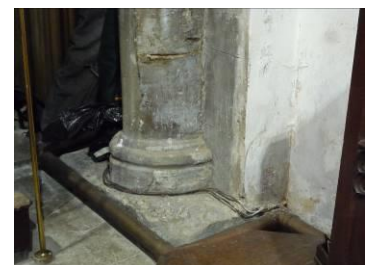
- Arcade - Lancet pointed aisles with circular drums and keel responds. Structurally in very good condition – there is no cracking evident to them, on either sides including that within the aisles. There have been some cement repairs to the bases as they have suffered from damp. Joints to the drums are circa 8mm and they look to have been

lime washed in the past.

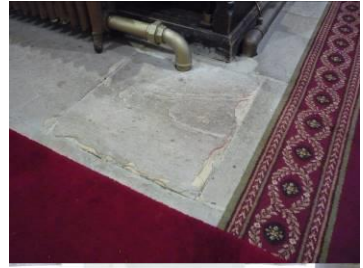
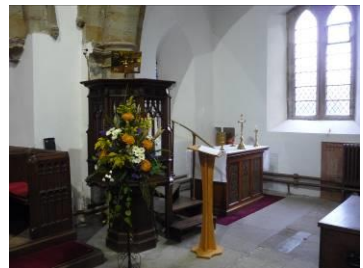
- Floor - Solid floor to all circulation spaces comprising concrete at the west end and stone slabs elsewhere. Some patching has occurred in the past and there is one raised slab close to the end of the pews on the northern side. A couple of open joints towards the front of the nave and areas of concrete by the lectern. Circulation areas are covered by carpet, in fair condition, though the entrance carpet is not fixed down. The west end has had its pew platform lowered to form a level surface with the reused pew platform boarding.
- The font has been relocated to the centre and set in a stone surround, all of that looks serviceable. The font itself has repairs that seem to have held up well. The pews are on pew platforms in exposed pine, they are generally sound. The pews themselves are fairly basic and slightly uncomfortable.

Recommendation: fix down entrance carpet edges.

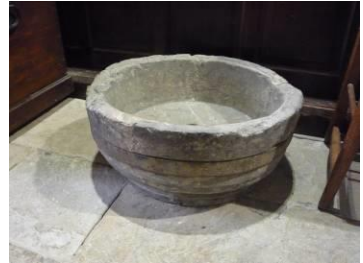
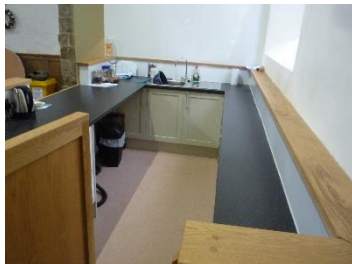
- **Servery:** kitchen sink and fitments all in good order

Recommendation: none

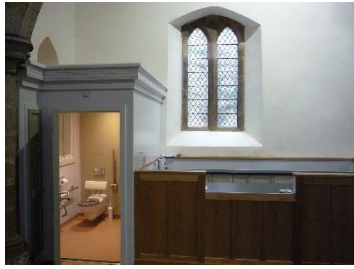
- **WC:** wc and basin in good condition. Door lock is catching

Recommendation: replacement door lock has been arranged to be done

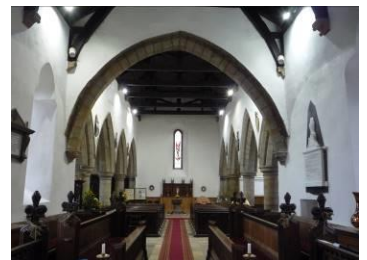
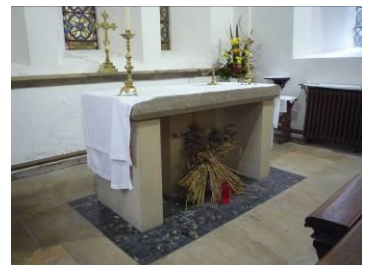
- Ceiling – exposed roof, better quality than the nave. Exposed trusses with no water marking.
- Walls – painted plaster walls on all elevations.
 - East - has three light window with a shelf with some open joints to it – probably old screw fixings for cloth and some damp at low level.
 - South - wall okay. The eastern most window has been re-glazed in the recent past and is undecorated though there are cobwebs.
 - West- formed by the chancel arch, whilst this has depressed slightly there is no cracking evident to it now, neither on the nave side.
 - North- ok. Contains the majority of the wall

memorials in the chancel. Good condition.

- Floor – as nave, apart from choir stalls on two stage timber pew platforms- all in good condition. Timber step up to sanctuary level with the pews. The decoration has worn away and is mostly covered by the carpet. There is a loose board. Sanctuary flooring step up paving, slight chip out of some of them and a couple of open joints. Black marble central feature supporting the stone altar.

Recommendation: fix down loose board

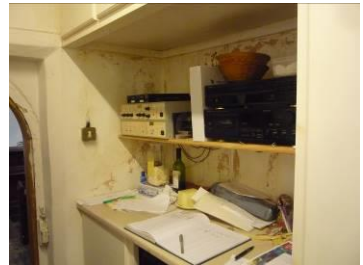
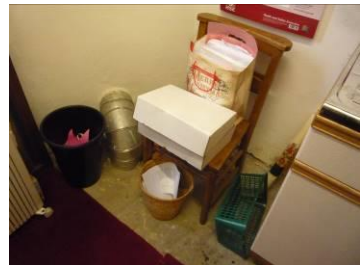
- Ceiling – low boarded ceiling, painted and in fair condition.
- Walls -painted. Has had water penetrating the south west corner of the room – probably from the flashing above. Cupboarding on the west wall, no evidence of damp. Contains an elementary sink unit with hot water and looks like the walls have been re-plastered in the past as there is no skirting.
- Floor – Concrete
- Door – catches in the frame.

Recommendation: ease door

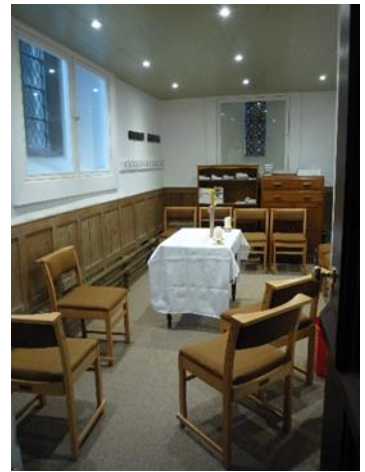
Choir vestry:

Victorian screened vestry converted in the 2014 works to provide a quiet space with new ceiling and secondary glazing to the windows.

Recommendation: none
