**QUINQUENNIAL INSPECTION REPORT  
OF  
BISHOPTON, ST. PETER**

**DIOCESE OF DURHAM  
ARCHDEACONRY OF AUCKLAND  
DEANERY OF STOCKTON  
THE STOCKTON COUNTY PARISH**

**QUINQUENNIAL INSPECTION 2019 AND REPORT  
David Beaumont BA (Hons) Grad Dip, RIBA, AABC**

# REPORT ON THE 2019 QUINQUENNIAL INSPECTION

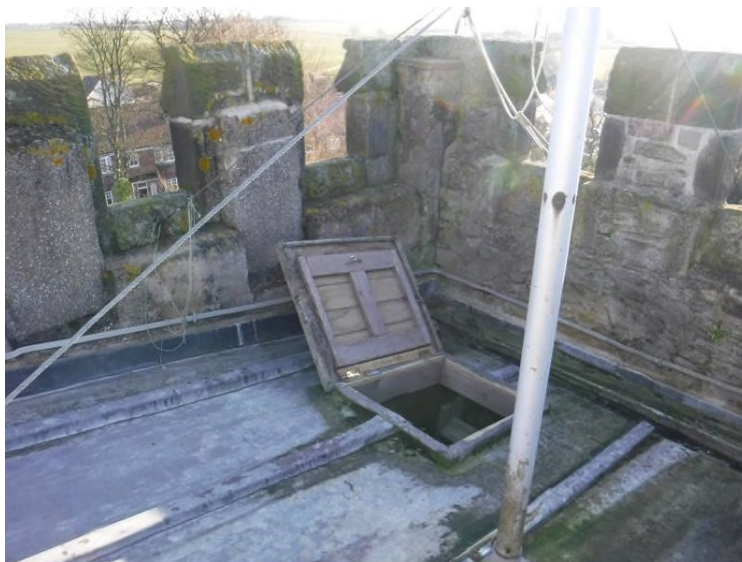
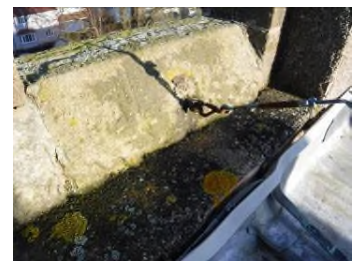
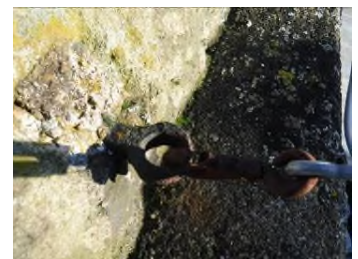
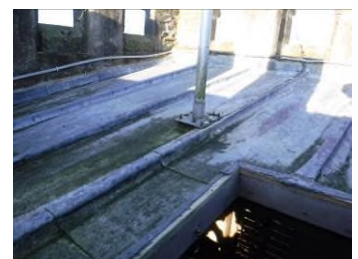
##### **C Tower Roof:**

All the crenulations are ok, the backings to the merlons which are brickwork with cement render are ok albeit that one is breaking up by the hatch.

Lead flat roof solid rolls all ok, flashings are good.

**Recommendation:** look over the cable stays, establish if gutter leaks, and allow for raising the slope. Replace hatch lid metal for lighter, add stay. Add grab rail on parapet.

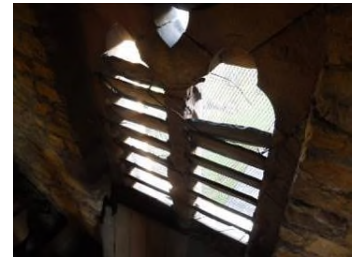
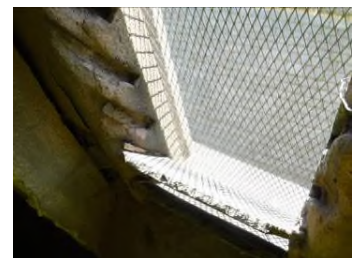
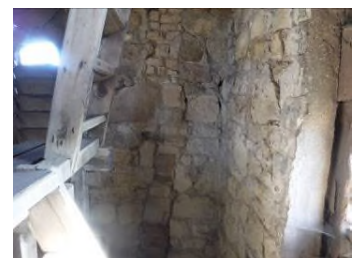
**C Belfry:**

- **Ceiling** – The raking flat roof is made of boarding with joisting, the boarding's a bit wet on the South East corner (that is the head of the parapet gutter). The gutter beam, which has been strengthened in the past, looks as if it might have a bit of rot in it. The lifting beam for the bells is rusting and really could do with being painted but it is not really causing any difficulties. The support beam for the clock weights looks ok. The base of the flagpole penetrates through the boarding and the bolts are rusting. Looks ok and I don't think there is going to be a problem with that.
- **Walls** – Random rubble, some open pointing, cracks in the South East corner as noted previously and they haven't moved and also on the South West corner. It will be worthwhile pointing those up so we can monitor their movement.

The sandstone quatrefoil belfry louvres are eroding significantly now, principally at their transoms and as a consequence a lot of the slate louvre sheets are becoming dislodged, are loose and a falling threat. There is external expanded metal mesh sheeting that looks in good order that is stopping them falling but only for so long. The louvres and tracery need repair now.

The ladder access up to the Tower roof is poor, the rake of the last stair up to the access needs to be improved, it needs to be shallower, and also there needs to be grab rails both up on the parapet walling and at the top of the ladder to assist transfer.

**Recommendation:** replace upper ladder, provide grab rails, mason assessment of repair needs of the louvres and belfry tracery, repoint wall cracking, sweep up floor and examine

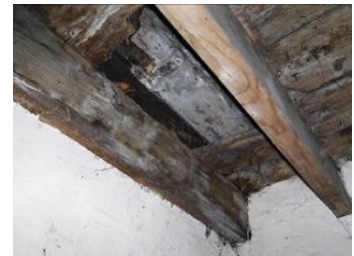
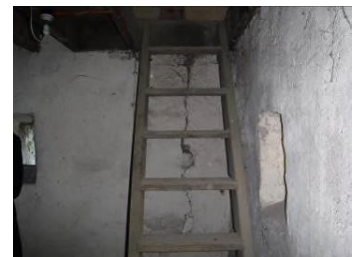
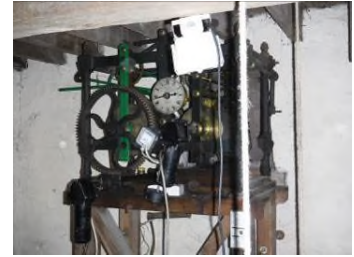
**C Clock Chamber:**

- **Ceiling** – Rot in the South West corner and the last joist and boarding into the wall looks pretty poor. The floor looks perhaps modern as it were though there is a date of 1774 carved into one of the joists, query is why is there

rot in that corner and not under the top of the box gutter? One floor joist cut away for the clock mechanism

- **Walls** – White painted, all ok apart from cracking to the East and the South East corner which is as seen before, so no real change there. The walls have small single glazed windows in, some of them are broken and one is missing its secondary glazing.
- **Floor** – The floor is slightly soft at the foot of the stair ladder otherwise generally ok.
- **General** – Contains the 1847 clock by Windle of Stockton on Tees, also the clock weight cupboard, query if this is redundant now, I think it must be because there are weights and pulleys about, the boxing is also incomplete now.

**Recommendation:** look over the floor with a joiner to assess condition, also check the ceiling joists and damp corner.

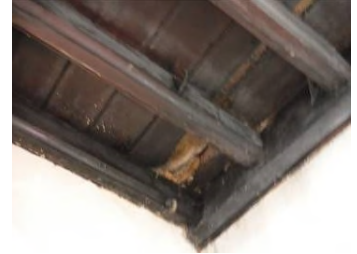
**C Gallery:**

- This has rot to the floor on the West side (wall is green outside from possibly overflowing rainwater pipe). The floor is unsafe and the space should be barrier taped off.
- It all needs a clean down as it's a mess from the decoration- perhaps considered unsafe by the decorators. It would be wise to repair the floor then clean up.
- A piece of timber on the ceiling that has not been decorated.

**Recommendation:** exclude access until repaired, repair floor, complete decoration and clean up

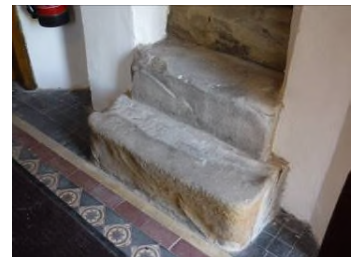
**D Tower Stairs:**

- **General** – Are all ok, some slight damp showing but not unexpected, glazing ok. Steps are ok and hand railing fine. The door to the ringing chamber lock doesn't lock if that is required. At the foot of the stairs is a collection of cleaning materials and lumber just underneath the spiral. The Tower door is ok but doesn't have a lock to it- needs one?

**Recommendation:** review door locking requirement, clear up lumber

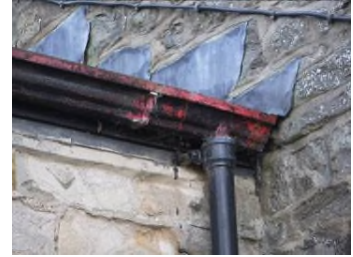
**B** **Organ:** Paint coming away from the gutter now, revealing red. Downpipe looks ok, goes into a gutter and could do with cleaning out.

**Recommendation:** redecorate gutter, clean out gully

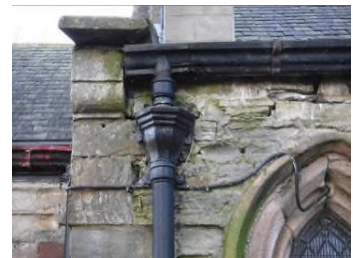
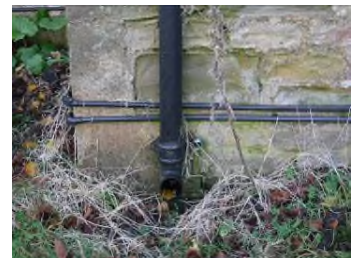
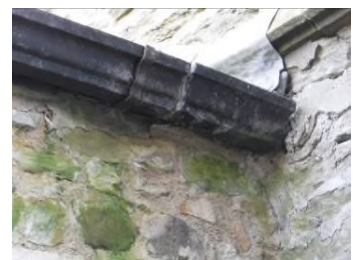
**B** **North Aisle:**

Gutter brackets rather rusty here, downpipe looks ok but the gulley appears to be silted up. Leak at the tower end of the gutter?

**Recommendation:** clean out gully, investigate possible gutter leak

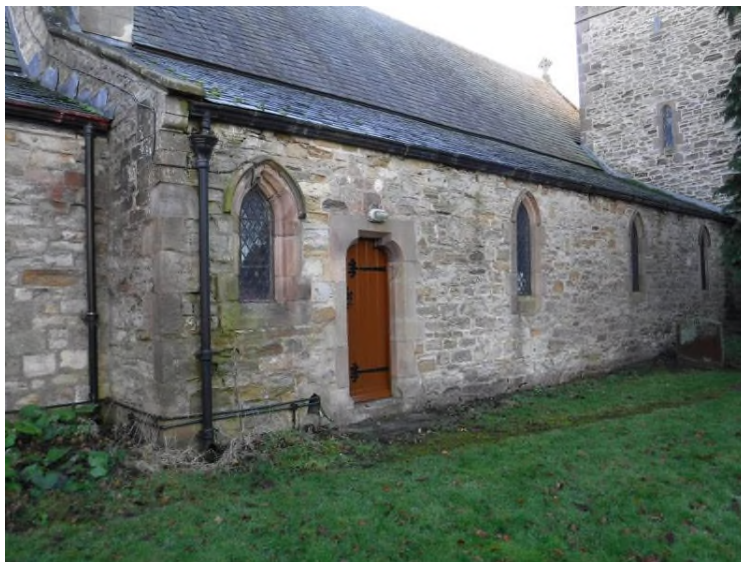
C **North Aisle:**

**Eastside** – Erosion to the stonework as a consequence of hard cement I think and there has been a bit of patching in the past but it seems ok.

**Northside** – Rather random mixture of materials here being at the downpipes suggesting that there has been rainwater there, some erosion to some of that stonework, large hole where the pipework in coming through where there used to be a foot scraper, some green on the wall as well and quite a few holes in it. The eaves isn't very good, it is very patchy and there is some green on that as well. Window dressings of lancets are all ok.

At low level there is some erosion and open joints, rather green at the Tower end suggesting there might be a gutter leak.

**Recommendation:** repoint open joints and infill hole alongside vestry door

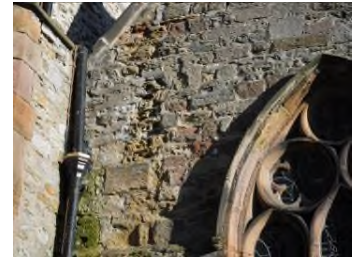
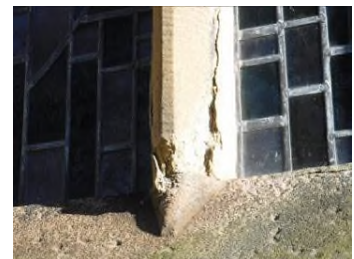
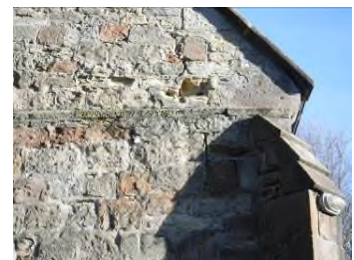
**C Nave:**

**Westside** – Water tabling all ok. Some green showing at the downpipe which is looking disjointed and not very vertical, there is also some mesh at the (former box gutter?) outlet which suggests there might be trouble there.

Slight movement at the buttress corner on the South West corner. One very eroded stone above the springing point of the arch, also area to the Northside of the arch stonework is quite eroded, there is also cement up there, leaking/blocked pipe is wetting the walls.

Below the springing line walling is just ok, it will do. There are open joints on the plinth course. Set within the wall is a large lancet window, 3 light. With pictorial glazing. Hood moulding beginning to fracture as is the intrados (inner arch). The Northern jamb is eroded but it is ok. The tracery within it is fundamentally alright but there is some cracking to the most Northern at the bottom of it, probably as a result of rusting dowels, the Southernmost upper is also beginning to crack, both top and bottom are cracking slightly and I wonder if it is the hardness of the pointing of the window. The 3 circular lights all have some elements of erosion and they have been patched in the past.

**Recommendation:** repoint open joints, stonemason to assess west window condition, allow for mullion and hood moulding repairs, rebuild part of the gable walling to the left of the window.

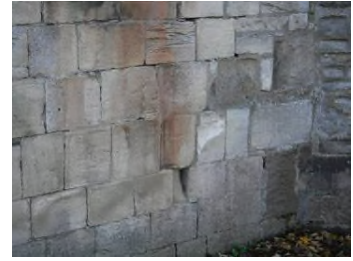
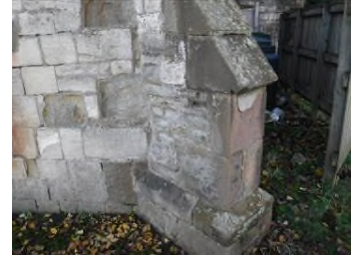
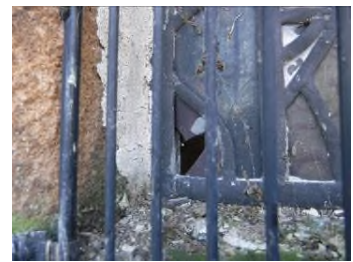
–Quite a lot of open joints to the elevation. There is some movement in the South East corner but nothing major. The three lancets dressings are generally ok though the Northern most is a bit more worn than the others, the glass is protected apart from the middle whose upper section is missing.

**C**      **Northside** – Open joints to it and some erosion by the oil tank. Lancet window looks ok.

**Recommendation:** address rusting window frames, repair guarding, infill holes in cills, repoint open joints,

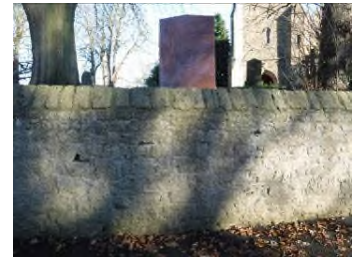
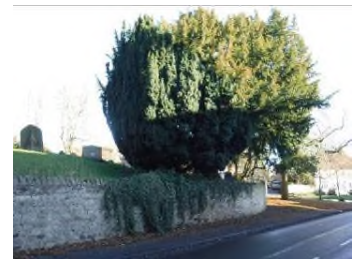
Double gates ok, rusty and could do with oiling and painting.

There are Yews to the South West part of the West boundary, these all seem to be ok and don't seem to be effecting the walls though the one closest to the Church is overhanging the road now and is also going in amongst a pine tree and that could do with better management. The ivy over the boundary walls needs removal.

**Recommendation:** remove evergreen on south nave wall, oil and paint double gates, cut back west yew and pine- or weed out the pine, remove ivy, remove the killed trees, repoint the walls- with lime

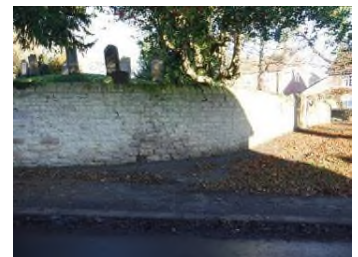
**Southside**

The cement repair to the South gate pier is particularly abominable in cement. Use lime!

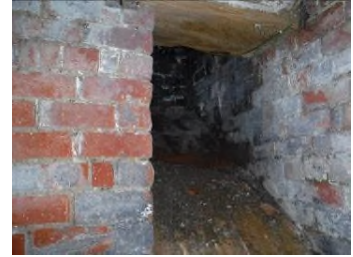
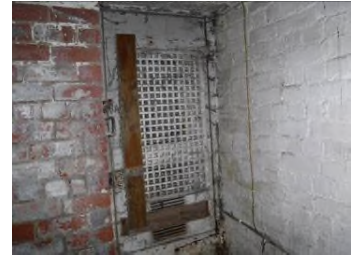
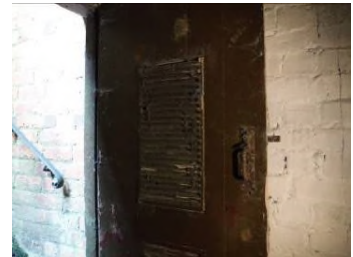
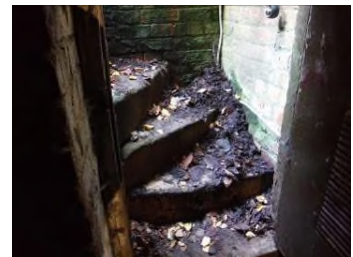
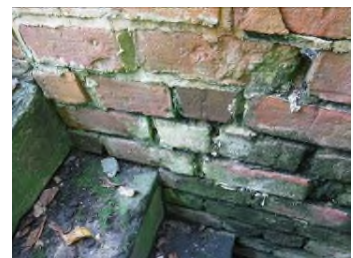
C **Boiler Room:**

Barrel vault ceiling in brick, as is the walls and floor. Relatively dry for a subterranean space, some spalling of brickwork, lime wash is coming away in places particularly on the Northern side, some open joints, there is a former coal chute looking a bit damp, part of the barrel is held up by a lintel stone that is eroding can't really tell if its adequate.

The door ironmongery needs renovating and the door easing in the opening. The light switch needs to be made sensible for illuminating the space.

The room contains the oil fired Trianco boiler TRO37/45 it is in a heavily rusting case and it has Mectron 10E burner and a Grundfos pump, rusting distribution pipework that has some insulation on it going up through the ceiling and rather bodged sealant into the brickwork.

Floor is a bit dusty and has got some remnants of slating in here, these are very large handsome slates for repairs in the future.

**Recommendation:** check lintel, improve door ironmongery and decoration, ensure room light is working- make a light switch within the room , sweep up

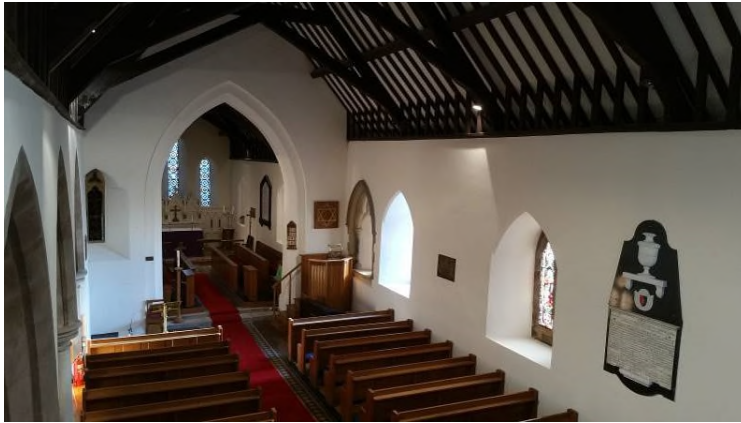
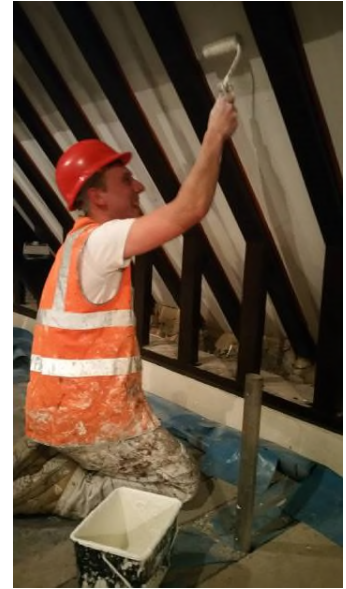
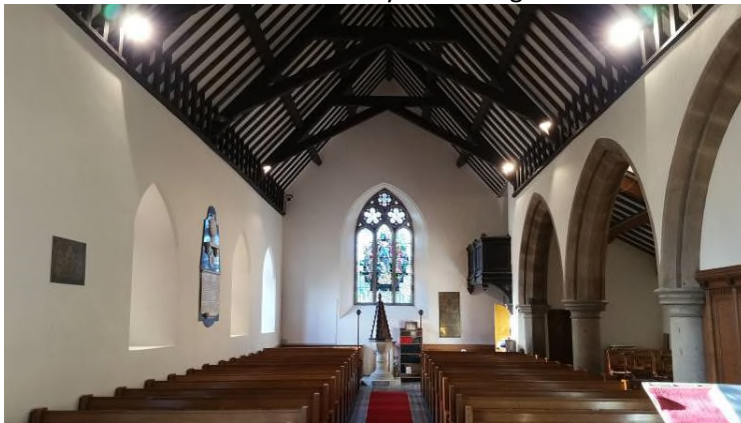
- Ceiling – These were redecorated in June 2016 as part of the LPOW works and they are all in good condition.

- Walls, including the vestry and north aisle – Redecorated in 2019 and in very good condition. Redecoration revealed that there were remnants of Victorian stencils that had been overpainted in the past. These were recorded during the works. The lower walls in the nave south and west are Newton Lath- over boarded in gypsum plaster (the remaining walls are all lime) Suggesting that there could have been a timber dado in the past but this was lost to damp and the remedial plaster introduced. There's little to be done other than accept it but to improve the capacity for the walls to be dry, the outside face of the masonry needs its cement pointing replaced in lime- otherwise the decoration will be spoilt. The west wall by the gallery floor beam is wet though because of the poor condition of stonework outside and probably downpipe overflowing wetting the wall.

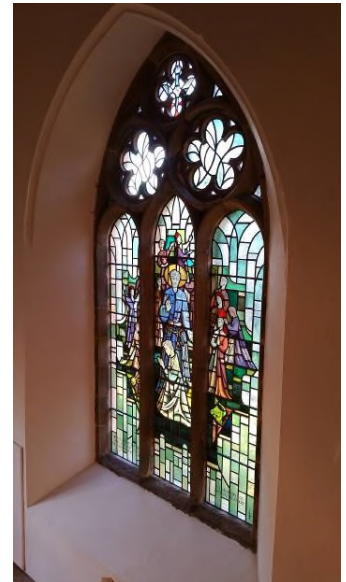
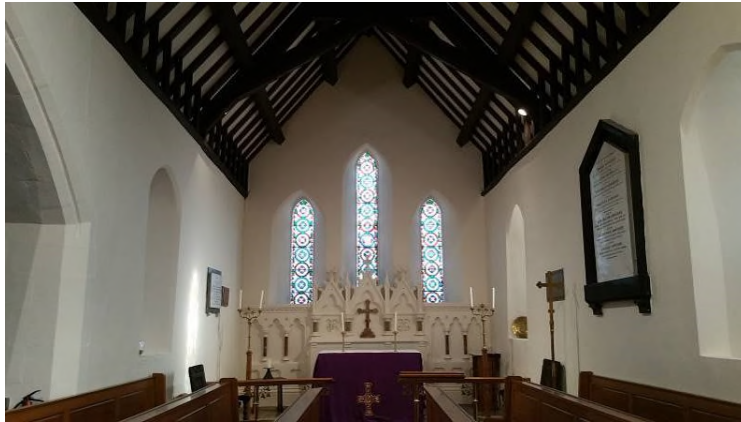
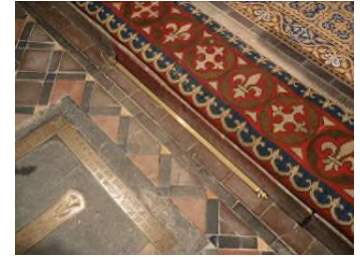
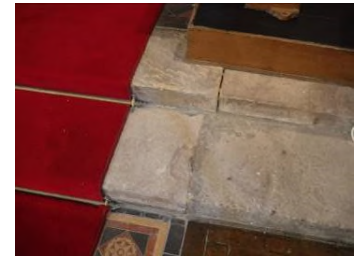
- Floor – A mixture of timber pew platforms and ceramic tiles for the circulation areas which are carpeted and ok. Some of the herringbone flooring is a bit scratched but ok. Pew platforms redecorated as part of the wall work.

The Chancel choir stalls are on a pew platform that's all ok.

Some slight blowing of the plaster on the North Wall at the Chancel step. Otherwise everything is fine within this part of the building.

**Recommendation:** none

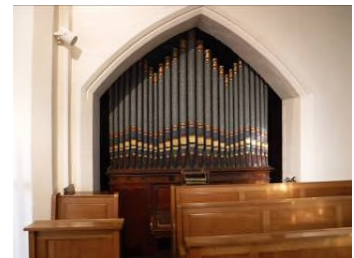
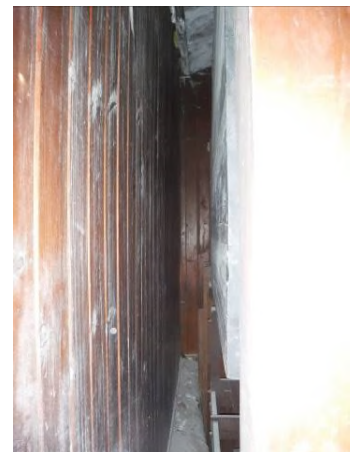
- **Organ Loft:**

- Ceiling – It has a ceiling of (probably zinc) metal sheets which are a lean-to that go to the Northside where there is a little gutter with a small hopper but the downpipe is short and leading nowhere, it must be there to pick up condensation or wetting from roof failure.
- Walls – The walls are a combination of timber boarded and some bare walls where the boarding has come away they are themselves poorly plastered and dusty.
- Floor – The floor is below the Chancel and Vestry level, in a pit, timber boarded from what can be seen- seems ok, though there is a lot of dust and there is also a few stone items here- whether they are of value is questionable.

**Recommendation:** none
