**QUINQUENNIAL INSPECTION REPORT
OF
BLACKHALL, ST ANDREW**

**DIOCESE OF DURHAM
ARCHDEACONRY OF SUNDERLAND
DEANERY OF EASINGTON**

QUINQUENNIAL INSPECTION AND REPORT

March 2023

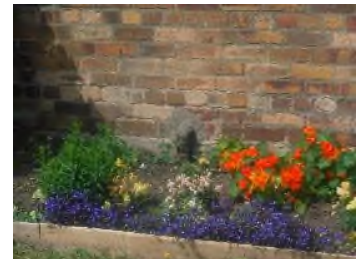
South side – Upper brick band erosion to the bricks and pointing coming away its cement I think, everywhere, I can't tell what the original is. You can see the concrete foundation showing at the foot of the wall.

Recommendation: none

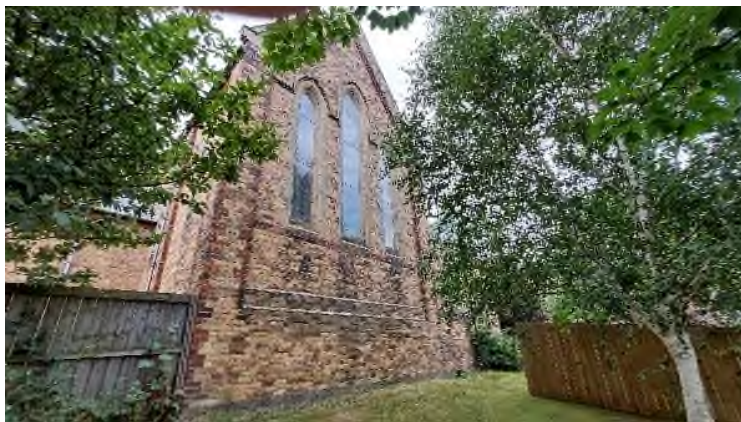
- **Chancel:**

South side – Two lancet windows with polycarbonate glazing, ashlar surrounds look ok.

East side – Three lancet windows, middle one higher than the others, pictorial glazing looks ok, and polycarbonate is ok. Masonry is good. The northern most hoodmould looks to have had a cement patch up rather than an indent.

Recommendation: none

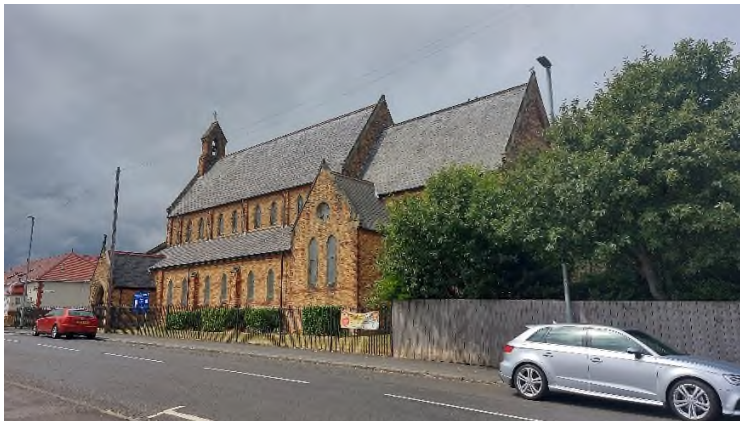
South Aisle:

Six windows, two in each of the three bays.

Bay one from left to right – polycarbonate to all of the windows is ok, ashlar surround is ok.

Bay four – OK.

Recommendation: repair s side glass

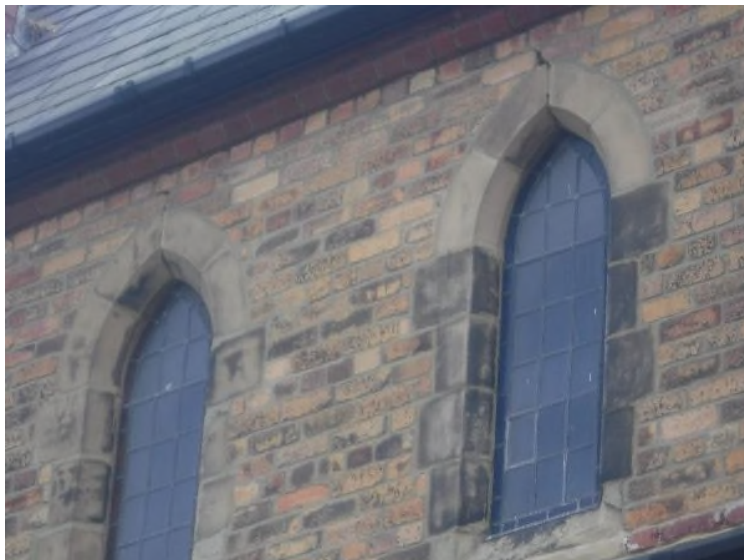
North side – Four bays same design as south.

Bay one – Unprotected glazing ok.

Single light has major buckling to it and rusting ventilator, and it looks like the ventilator fixings have expanded so much that they are pushing out the northern most jamb stone underneath the lintel.

Recommendation: repair ventilators, update door draught stripping, decorate

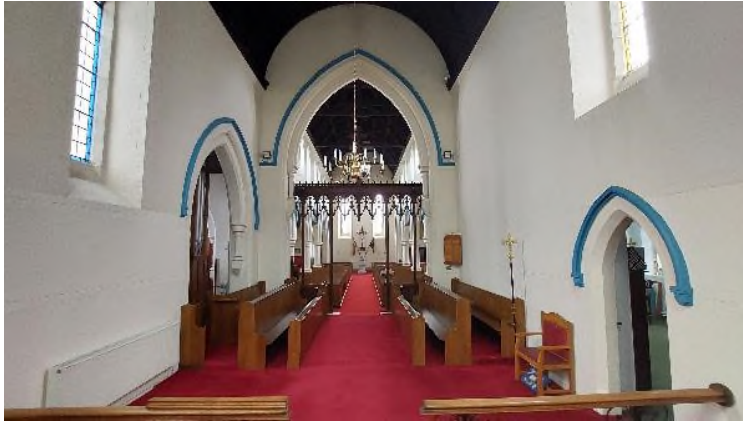
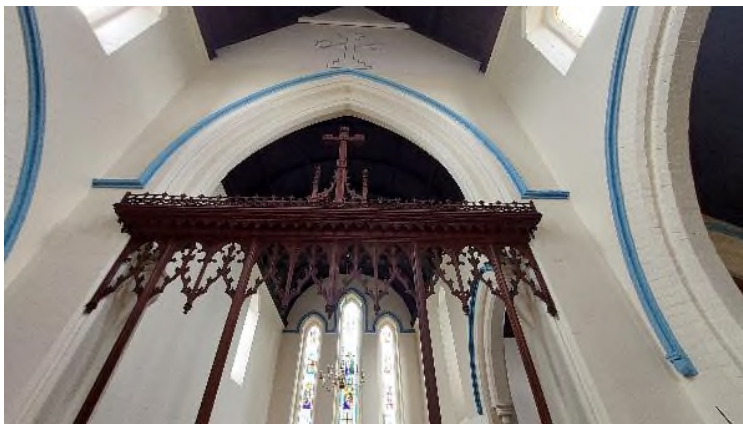
- **Chancel Arch:**

Pointed arch in painted stonework ok. No cracking.

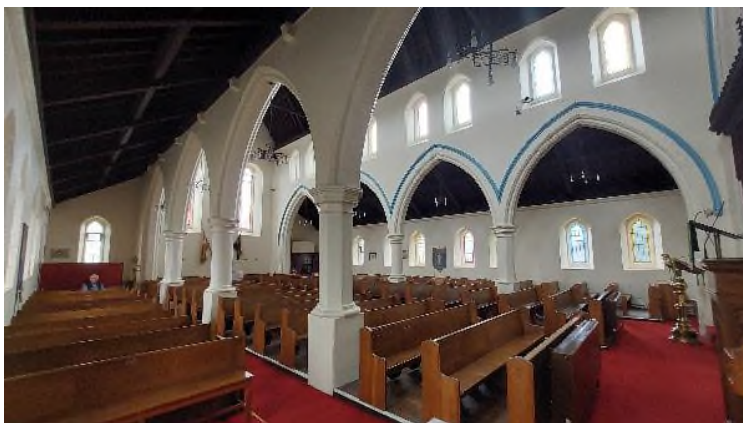
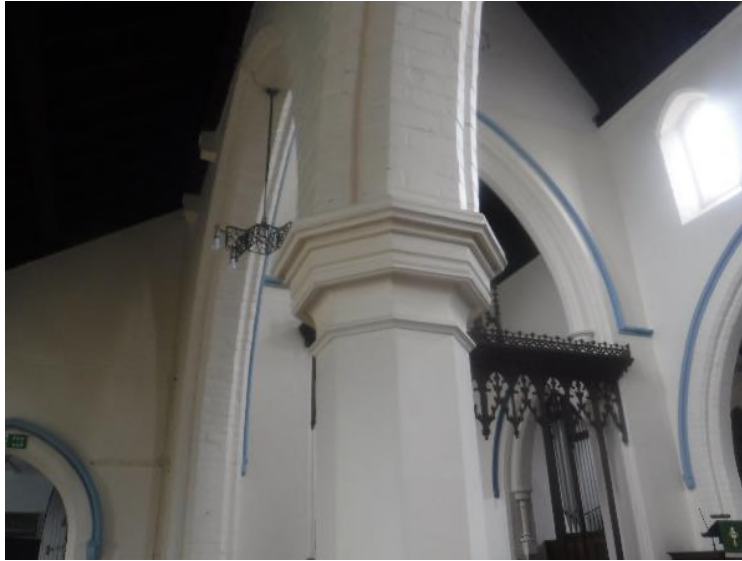
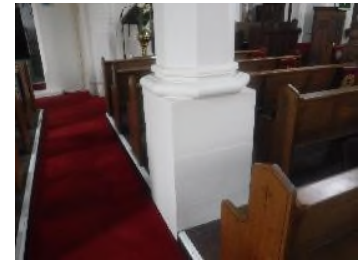
- **Arcades:**

Arcades in painted brickwork with pointed arches, they are ok, they are supported by circular and hexagonal columns and these sit on high pedestal bases and they are all in good condition.

Recommendation: none

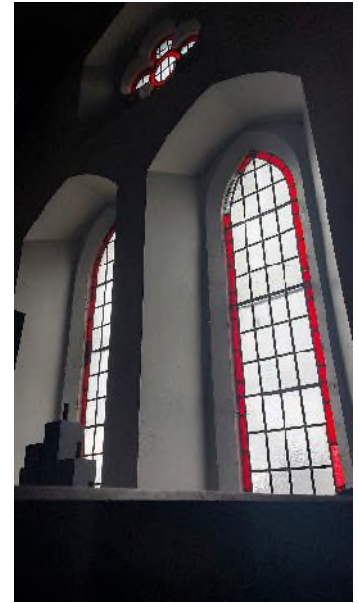
Houses the organ around the back, obscure rectangular glass with colour margins the western most red margin infilled with clear when repaired otherwise ok, can't see too well but I think the eastern most is buckling slightly on the saddlebars.

Recommendation: repair buckling glass

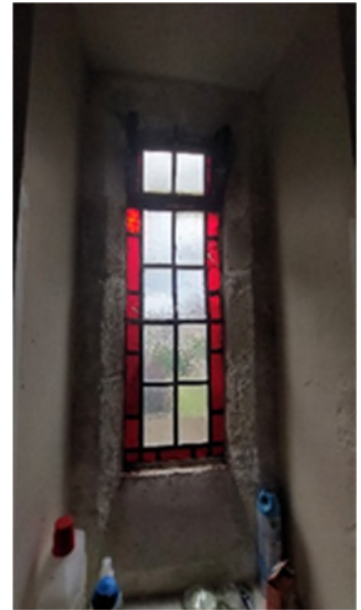
W.C.

Single lancet with top ventilator, metal expansion breaking the stonework and buckling the window and cracking the glass.

Recommendation: repair ventilator

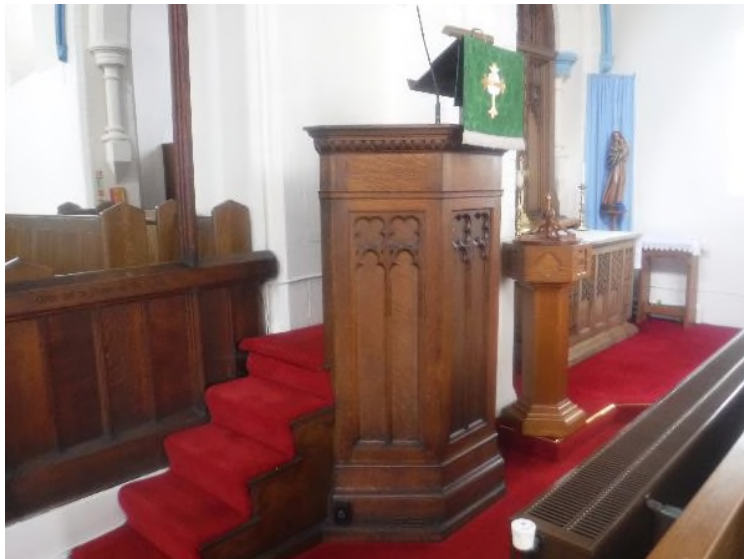
Oak pulpit reached by steps; it feels a little rocky though it is stable, perhaps a handrail would help coming down.

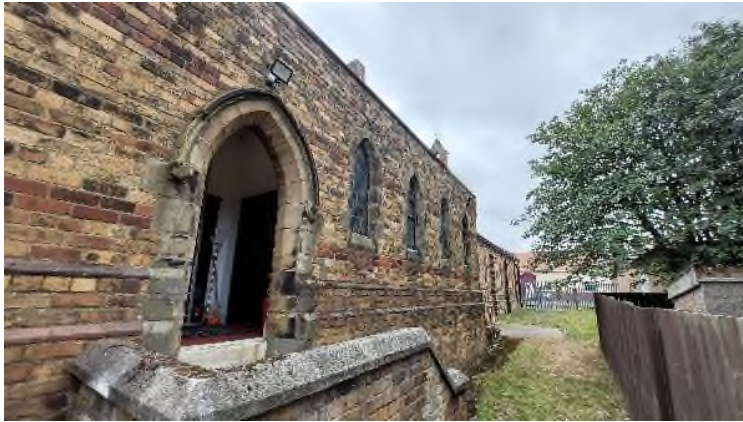
North side

– A mixture of tarmac, cement and grass kept reasonably tidy. Galvanized fencing with padlocked gates encloses this area.

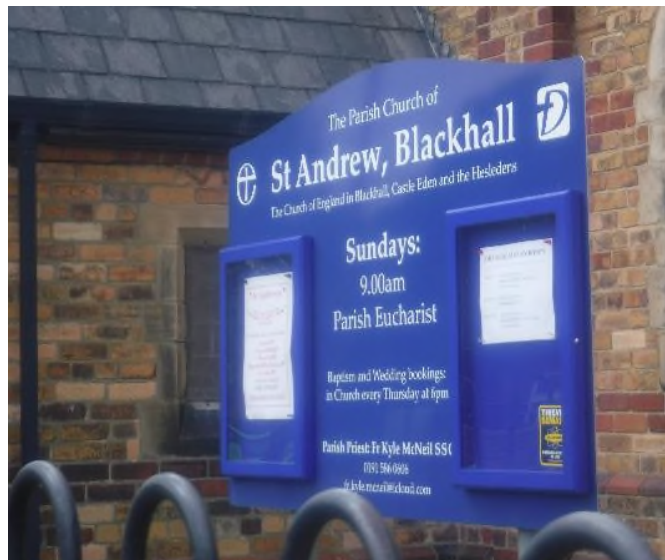
- There is no churchyard.
- The boundaries are well defined as described in externals.

- There is a new church sign.
- The site is small so there are limited paths.
