**QUINQUENNIAL INSPECTION REPORT
OF
THE CHURCH OF CHRIST THE KING, BEDE TERRACE,
BOWBURN,
CO DURHAM DH6 5DS**

**DIOCESE OF DURHAM
ARCHDEACONRY OF DURHAM
DEANERY OF AUCKLAND
CASOP CUM QUARRINGTON BENEFICE
PARRISH OF CASSOP QUARRINGTON**

**QUINQUENNIAL INSPECTION November 2017 and REPORT
July 2018**

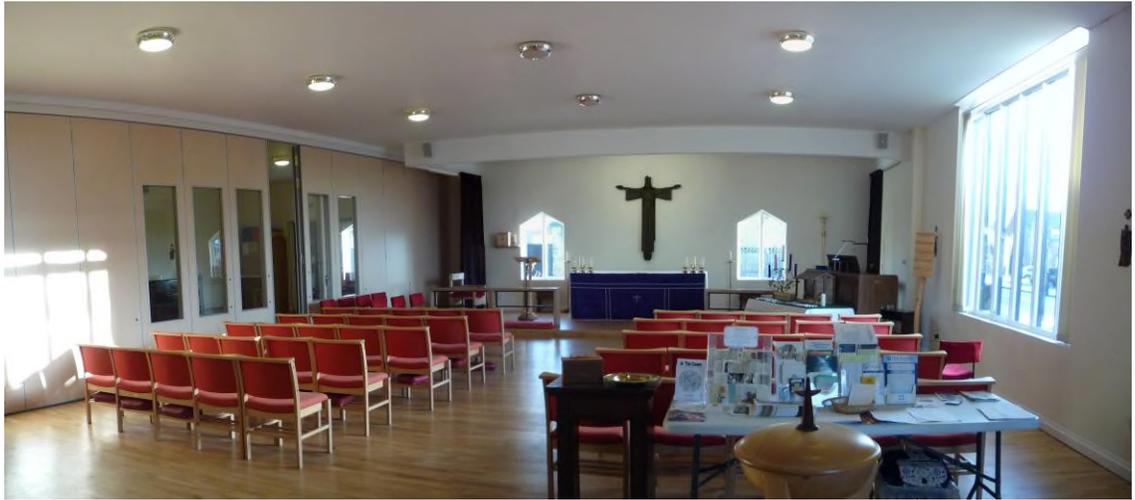
Walls: The brickwork is in good condition and there are areas of modest repointing required where cracking has occurred. Though consideration should be given to whether the area of repoint at the south east corner should be carried out as the ground movement might close the gap. So as there is nothing major here, leave alone and keep an eye on it. The silicone expansion joint at the south gable brickwork could do with better packing.

Inside: It is light, airy and very welcoming. Recently had an acoustic screen installed to divide the hall from the church nave and this has proved to be very satisfactory. There are some cracks to the junction of the nave ceiling but these are no different to what was seen at the last inspection.

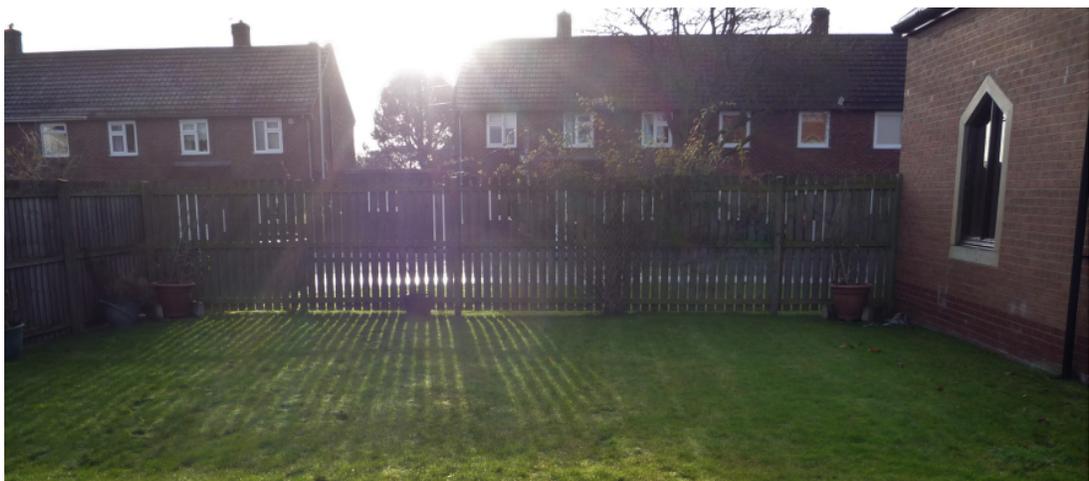
Externals: The church externals are all reasonably tidy particularly to the two roads. Its car park is rough and covered with road planeings but quite serviceable. The eastern garden is an excellent asset for the church. The boundary fencing is good, apart from the northern side to the dwelling which is looking rather down at heel. The entrance tablet is planned for relocation in the south east corner of the rear garden (left side in image below). The tower base is on the other side of the fence.

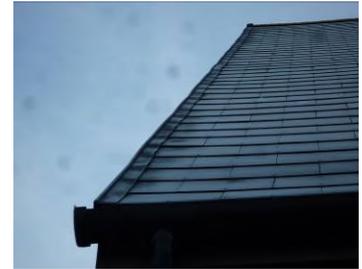
- **Roof Coverings:**
Dry ridge and recent dry verges with Eternit type slating with lead alternative with valleys over the doorways. All in good order.
Recommendation: none

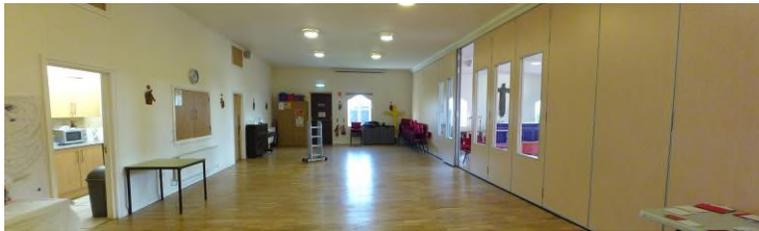
Meeting Room:

Same details as the Nave.

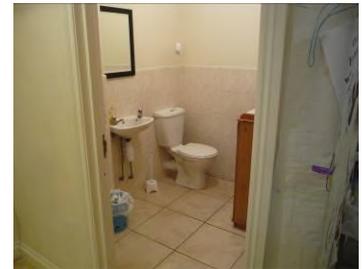
Ok has some water marking and scuffs on the wall. The whole area including the W.C.'s has floor tiling and a dado of ceramic tiling.

Recommendation: none

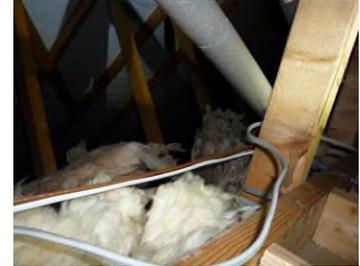
D Roof Void:
 Unable to gain access safely.

Recommendation: carry out inspection.

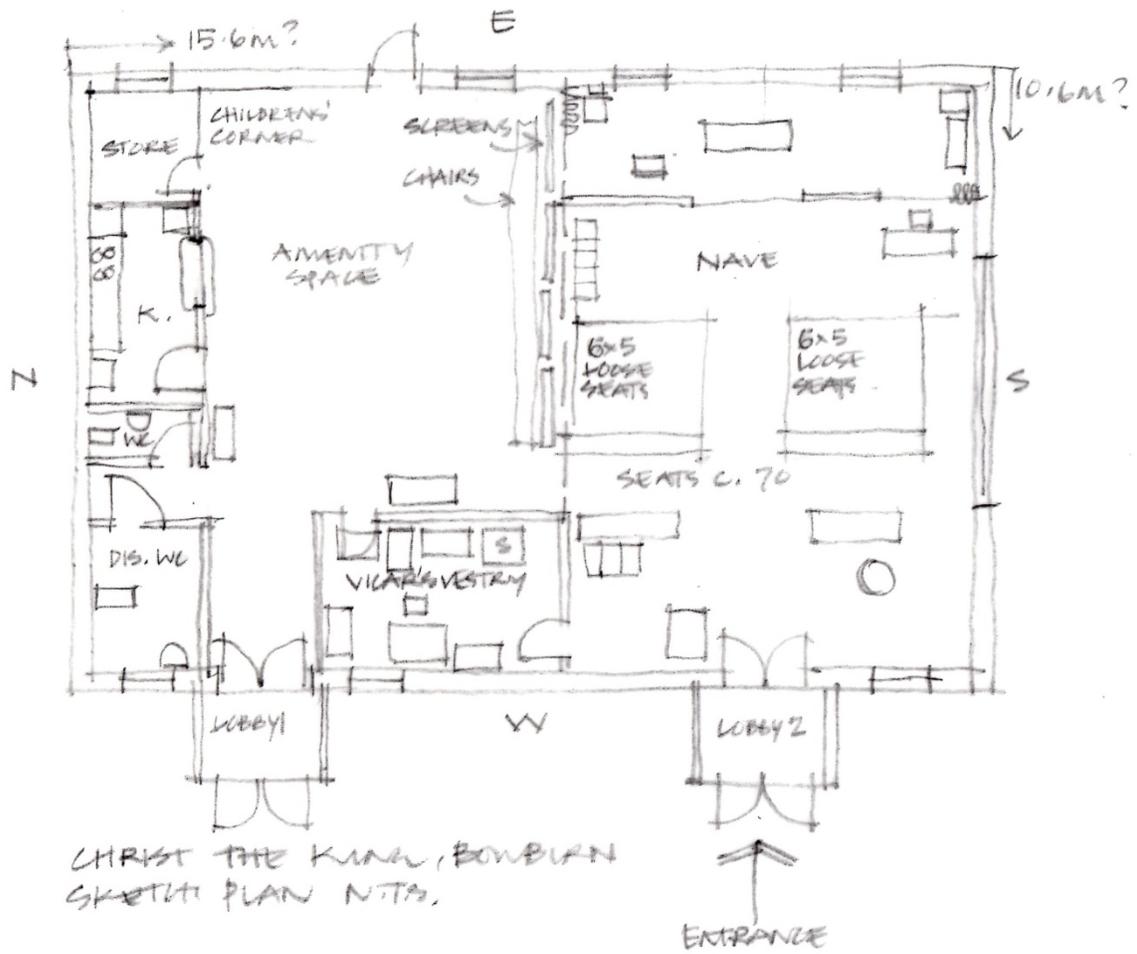
Crack Positions recorded in June 2011

The last QI reported significant defects in construction to the roof trusses and brickwork. There was troublesome cracking (see record of cracks at June 2011 at the end of the report) suggesting differential settlement, this was all reviewed by the Architect and Structural Engineer and works were carried out quickly by the PCC in the roof space to stiffen up the trusses, remedial wall ties were inserted and open joints were pointed up after a period of waiting to see if they would close up following recent tree removal.

From the inspection now it is evident that the crack locations are still there and noticeable. The south elevation and south east corner has the most of the cracking but there is very little to be done here other than to repair the expansion joint and monitor. The foundations are known to be shallow and the engineer didn't advocate underpinning corners or parts of the structure as it could induce further cracking. Because the movement was caused by trees in close proximity on the south and west, now removed for over c.8 years, a complete underpin was also considered unnecessary.
