# Quinquennial Inspection Report

**Church of St John the Evangelist**

**Chopwell**

**Date of inspection:** 3 October 2025; weather conditions - dry and overcast

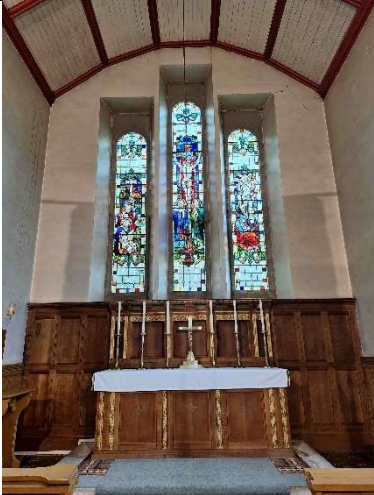
| | <p><u>Nave altar, lectern and chairs:</u><br/>Oak framed altar; finely carved oak lectern and chairs – all in good condition.</p> <p><u>Chancel altar:</u> (see photo)<br/>Oak framed with some painted and gilded detail in good condition.</p> <p><u>Reredos and war memorial:</u> (see photo)<br/>In carved oak, some gilding to the reredos. All in good condition.</p> | |
