**CLEADON PARK**  
**St MARK and St CUTHBERT**  
(4)

**QUINQUENNIAL REPORT**  
on the architect's inspection on

**20 November 2017**

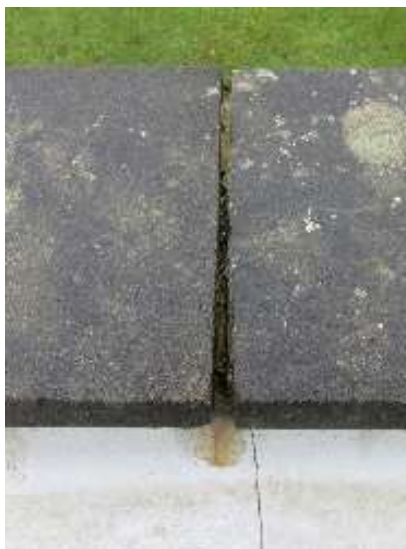
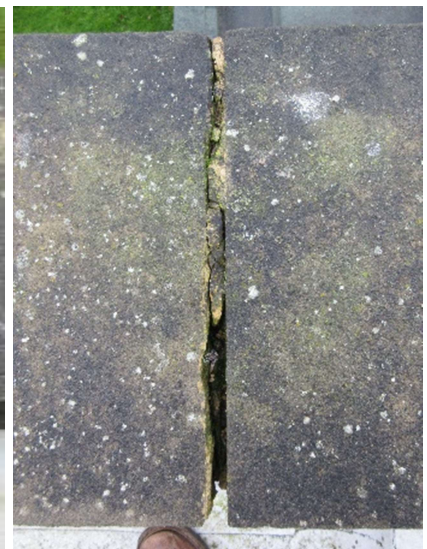
Felt patch where copings missing

18. The concrete flat roofs over the **high stair**, lower **Vestry and Meeting** room have green bitumen felt in fair condition carried over the parapets and copings. Ponds over the landing and at the gutter. Larger ponds in Vestry corner next to Church. Blisters in the wide gutter. No known leaks at present. Felt badly damaged where it carries over the decayed copings at both roofs facing the Hall.

Replace decayed copings at Stair, Vestry, Meeting room	18, 29
Restain Church doors and windows	33, 35
Repaint windows at Hall and rooms	36, 37
Repair and paint ceiling at Church wc	42
Renew Hall ceiling, insulated unless in renewed roof	43
Add draught strips at Church and Hall doors	46
Renew Gents floor	2, 59
Change to permanent relighting of Church when possible	73, 74
Provide hot water in all lower wcs	82, 83

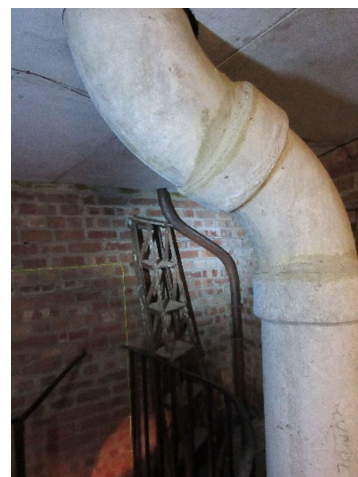
24. All pipes are internal and appear to run freely. Some visible as bent copper pipes in the store over the church entrance. Other parts may be horizontals in false ceilings. A cast iron foul drain vent pipe in the same store.
25. The drainage appears to be earthenware combined foul and surface. Brick manholes with cast iron covers. In 2011 the branch from the wc at back of Church was relined in two 1m lengths between manholes with 10 year guarantee.

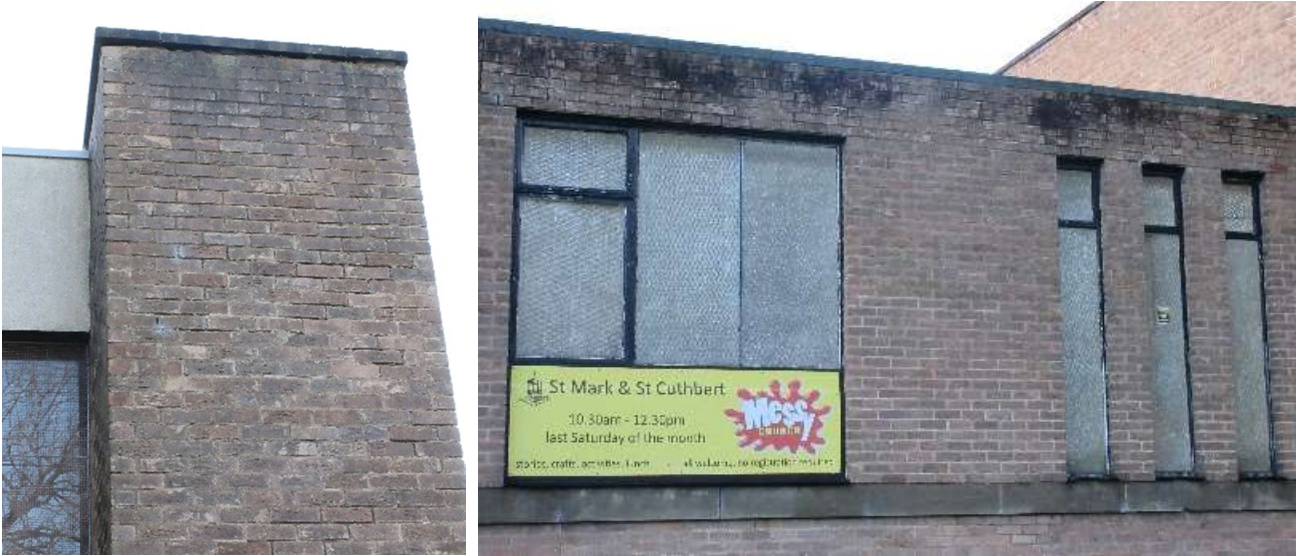
26. Cavity facing brick, flush pointed and in good condition except under the Hall copings (where previously galvanised twist wall ties and no cavity insulation were seen). Two full height vertical joints in both leaves of the Church NE wall were formed in preparation for an intended 'transept' extension.
27. Patches of poor pointing
- at two panels R of the former W Church door
  - at N corner of the Church lobby
  - at Church high level at E side, NE corner and N end
  - around large diameter NE overflow pipe through parapet
  - at N end of Hall high level under open coping joints
  - at S end of Hall
  - at the S and E end of the Church (where accessible joints seem to have been picked out)

28. At the Meeting room window a movement crack in joints and bricks at the W end of the long lintel.

Repoint open brick joints at Church and Hall	27
Replace polycarbonate 'glazing' over stair with UV resistant type	53
Consider same at Vestry and Meeting Room	55
Obtain new Periodic Electric Installation Test in 2020	71 and Addendum

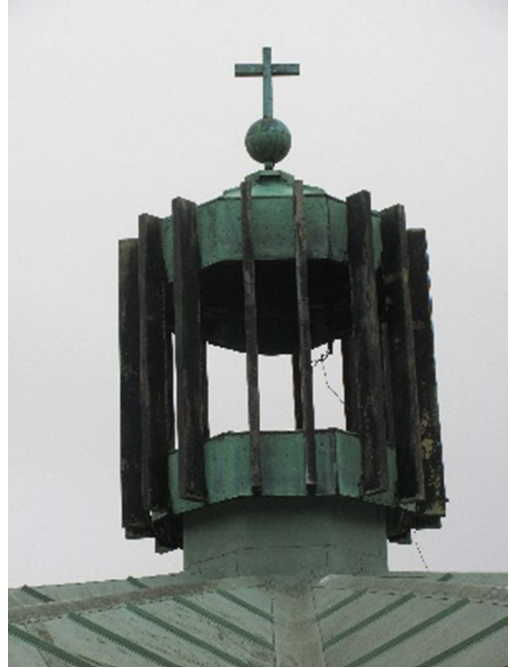
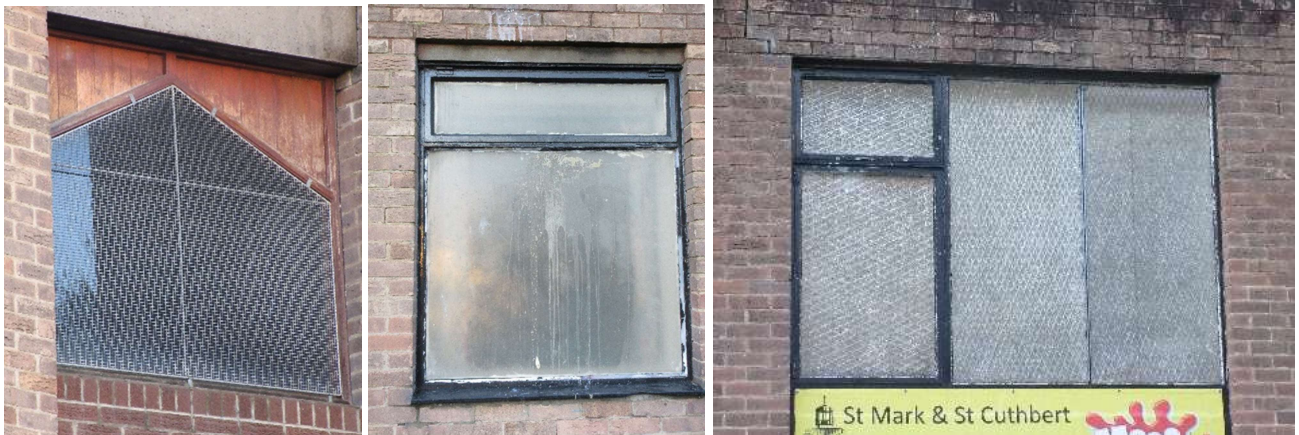
32. Paint flaking at the bell drum uprights.
33. The remaining Church doors are good stained hardwood.  
Glass upper panels with mesh protection. Lower panels made more secure with added external ply. Fresh stain needed.
34. The Hall entrance doors are battered hardwood with ply panels, metal sheeted inside.  
The two escape doors now decorated as murals facing the park.
35. The HW infills around the Church high level windows need stain.

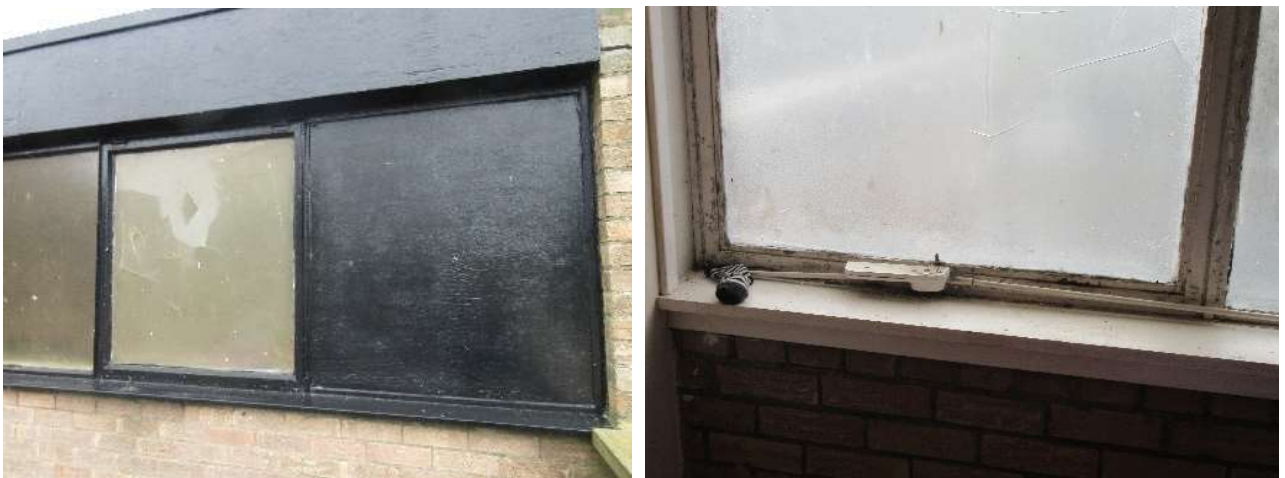
36. The strip of painted steel windows over the stair are sound. Three top hung vents now painted shut were opened by remote hand turn, now disconnected. Paint poor inside.

37. The Vestry and Meeting room metal windows lack paint outside. Similar W of Hall have lost paint from flexible polysulphide used to 'putty' polycarbonate into the frames.
38. High and low level ply fascias over the Hall and Church entrances, well painted.

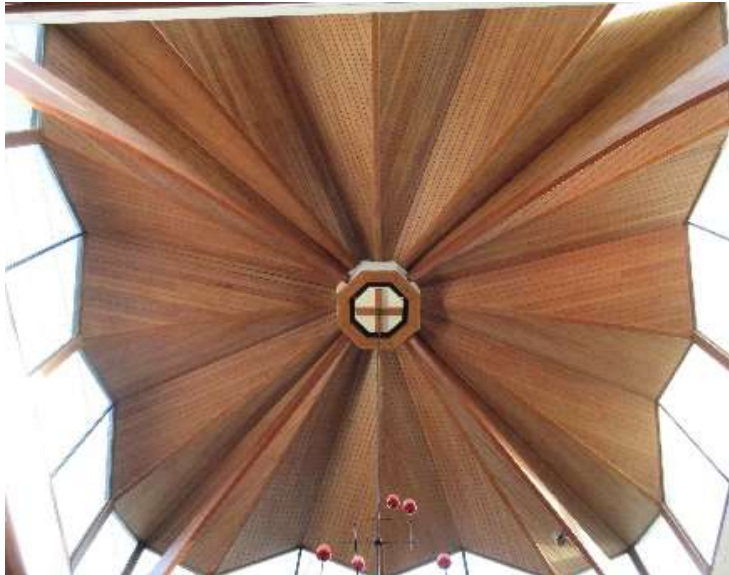
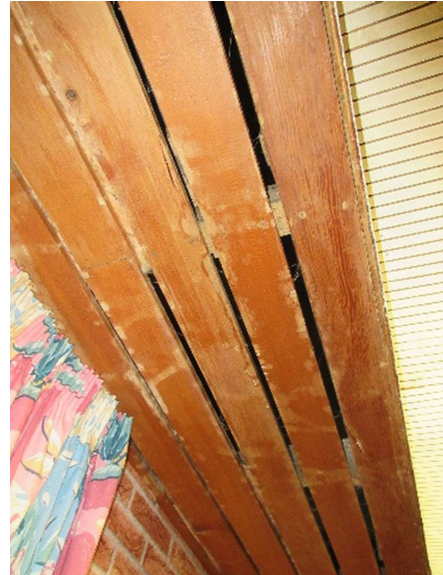
41. Hardwood boards at Church and lobby, sound. Water marks over doors to stair, now dry.
42. In the Church wc and upper and lower rooms sound painted plaster except holes where two wc lights removed. Minor plaster crack in Meeting room ceiling.
43. In Hall mainly fibre boards on suspended battens. Some sagged and broken. At three sides a downstand duct for hot air (and perhaps roof drainage) clad in Douglas fir boards. Softboard at the corner store (former stair). No insulation.

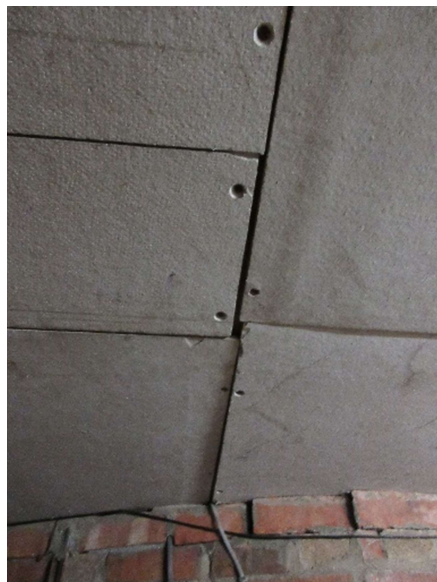
44. Mineral fibre fire board in the Hall boiler room and store over Church lobby. See paragraph 2.

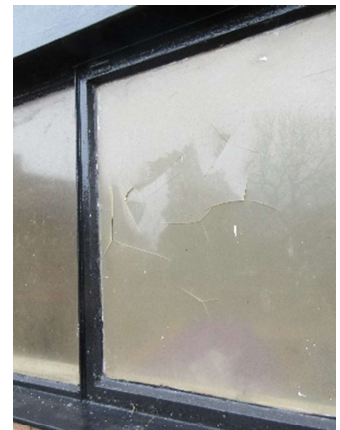
52. Church lobby and lantern clear single glazed with galvanised mesh protection. Sound but appears defensive. Church upper infills are polycarbonate sheet in hardwood frames. Some dirt.
53. Landing glazing polycarbonate puttied into metal frames. Polycarbonate is dirty, paint splashed and clouding (as this material does in sunlight before modern light resisting type). The 'pane' next to the Store is clouded and cracked, letting heat out. The Store window is filled with painted ply.
54. Hall windows clear single clouding polycarbonate with internal mesh except two at NW small panes of clear polycarbonate in painted timber frames.
55. Vestry and Meeting room aged clouded Meshlite (metal mesh cast into glass reinforced plastic) with internal mesh for double security. Looks poor outside.
56. No visible room ventilation and no subfloor ventilation (solid floors).

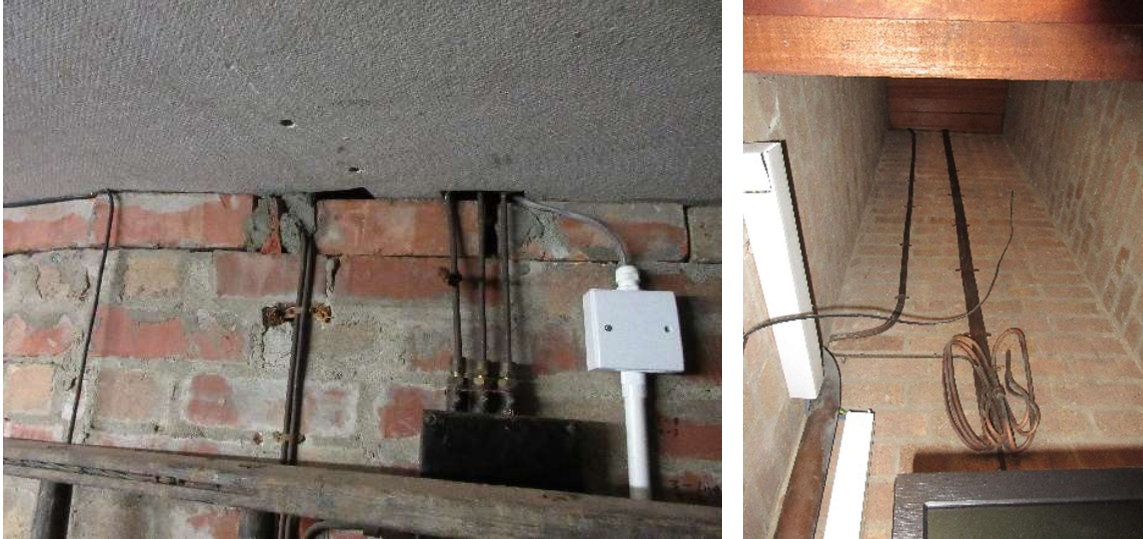
71. Earthed supply cable. At Church two single phase distribution boards. Three meters and main fuses under the stair with two three phase DBs and a separate DB in the Hall entrance. The DBs have stickers saying system last tested September 2015. The DBs have been replaced with modern RCD circuit breakers.
72. Most wiring concealed so cable type or types not known. Visible MICC cables from Church DB (said to continue into Church roof void) and pvc/pvc from DB under stair.

73. MICC wiring in the Church ceilings has been damp and not providing proper earth so the Church is lit with temporarily wired LED down floods around the lantern and each side of the entry doors.
74. Former lighting in Church (none now working) was:  
Recessed downlights in Church, Church lobby landing and outside the Church doors. Some small spots  
Around the lantern base a continuous strip of fluorescent lights.  
Special lighting:  
- in the Church lobby a small corona of up and downlight tungsten lamps  
- in church switches behind the president's bench controlled 4 floods around the lantern base, and groups of lights in two metal pendants with random bracketed glass shades one over the tabernacle with 3 white, the other central over the altar with 7 red.
