QUINQUENNIAL INSPECTION REPORT

CHURCH OF THE HOLY TRINITY
THE GREEN, CORNFORTH, FERRYHILL, Co. DURHAM, DL17 9JH

JULY 2022

Michael Atkinson Architecture + Heritage

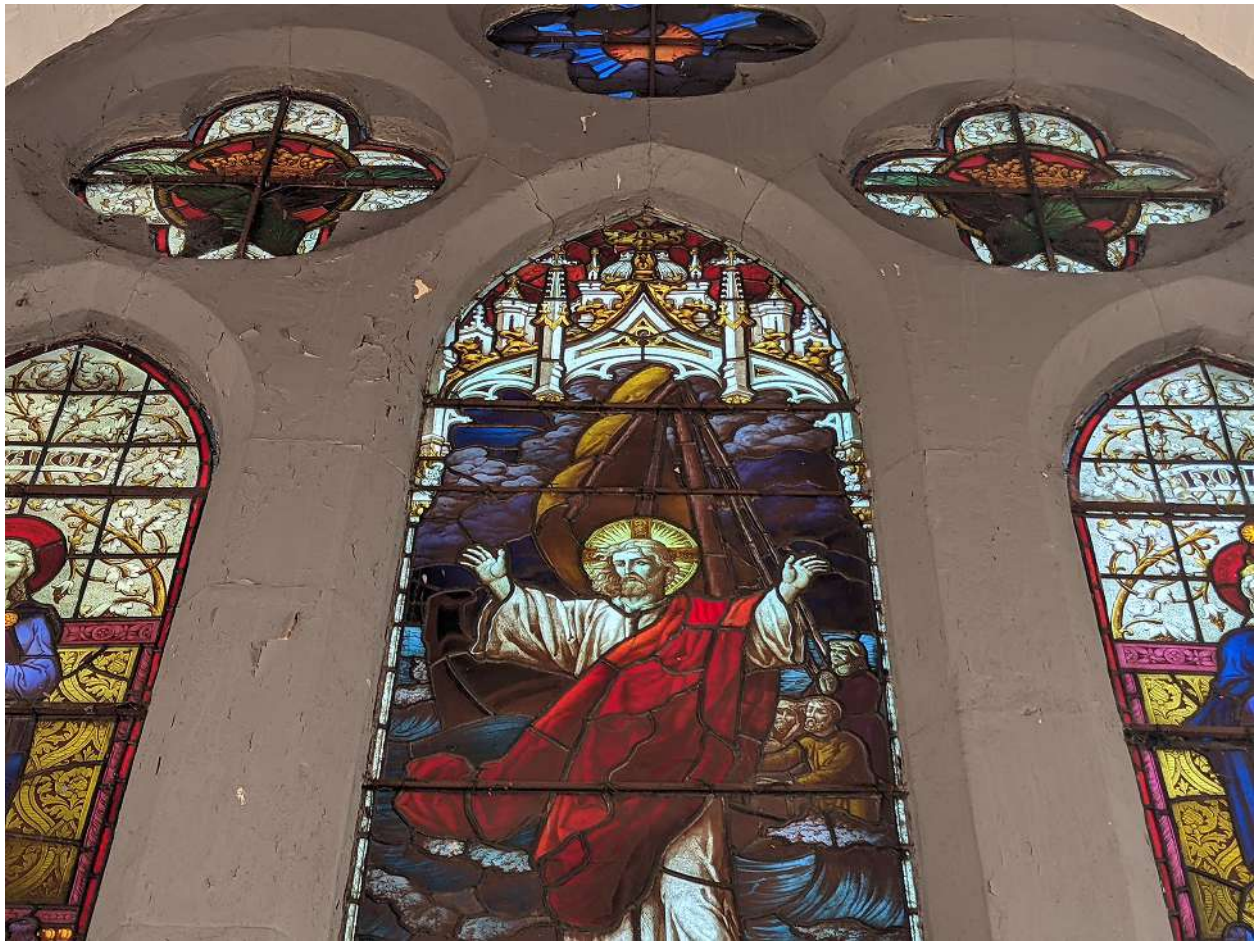
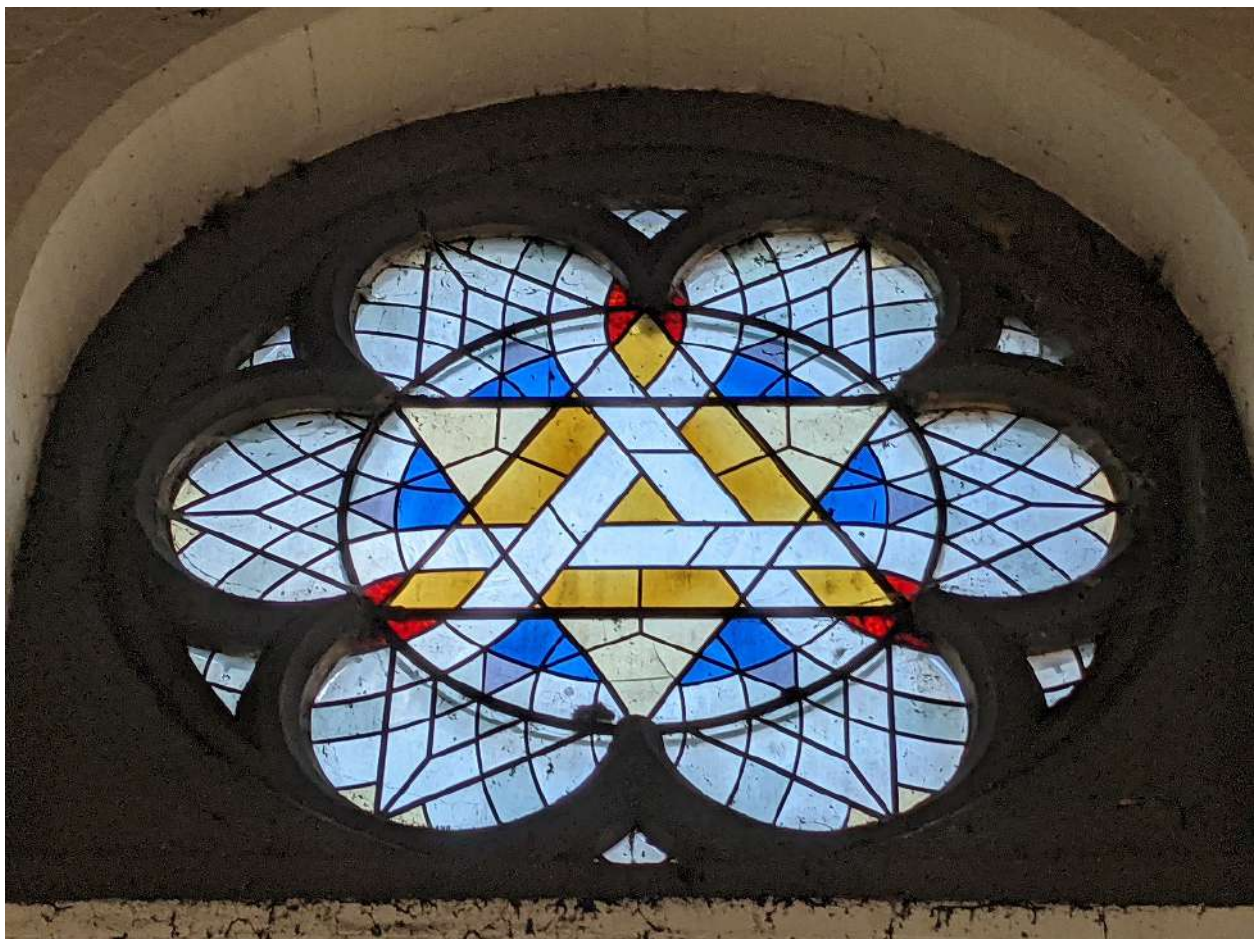
9.1.1 The condition of the glass is generally in a sound, satisfactory condition.

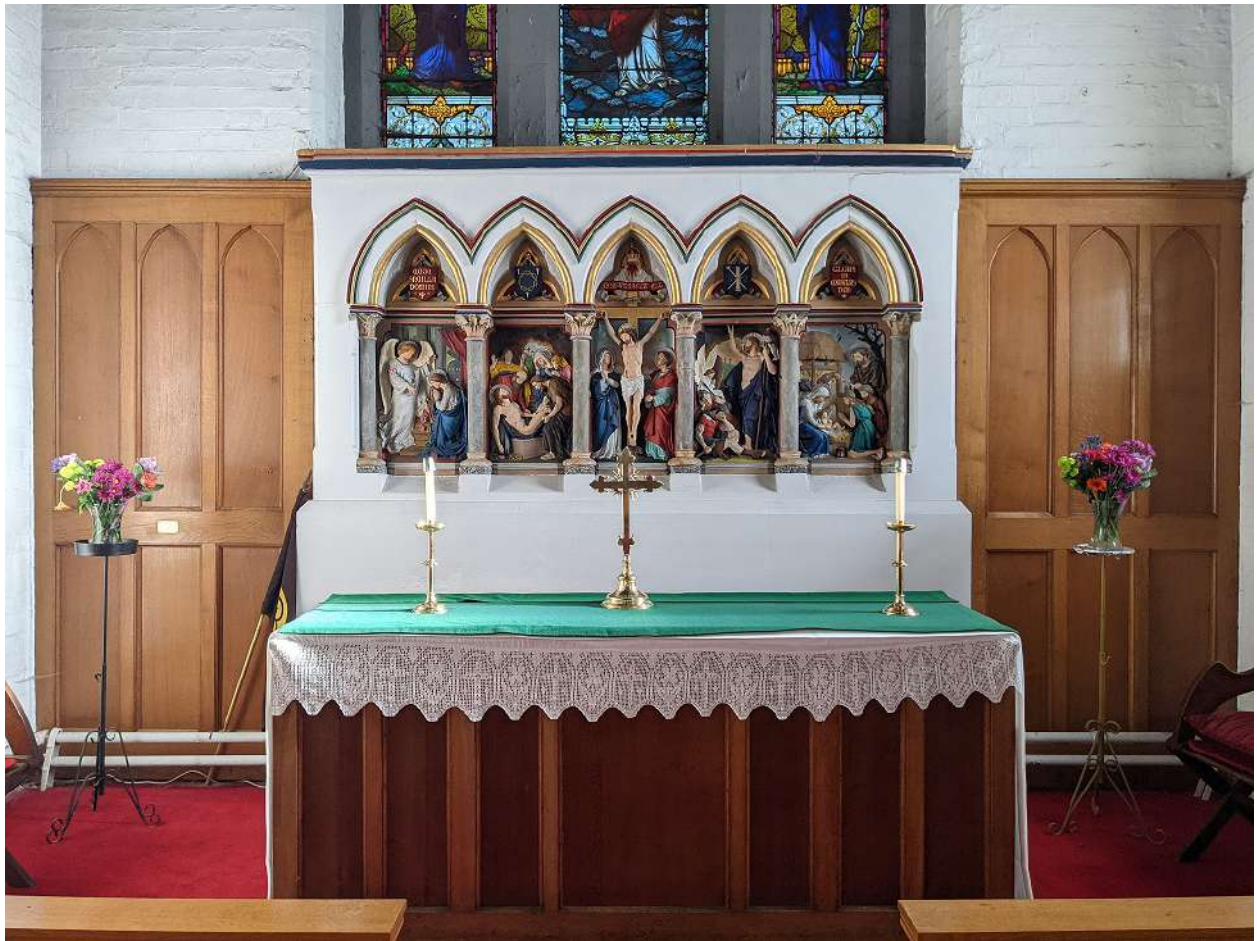
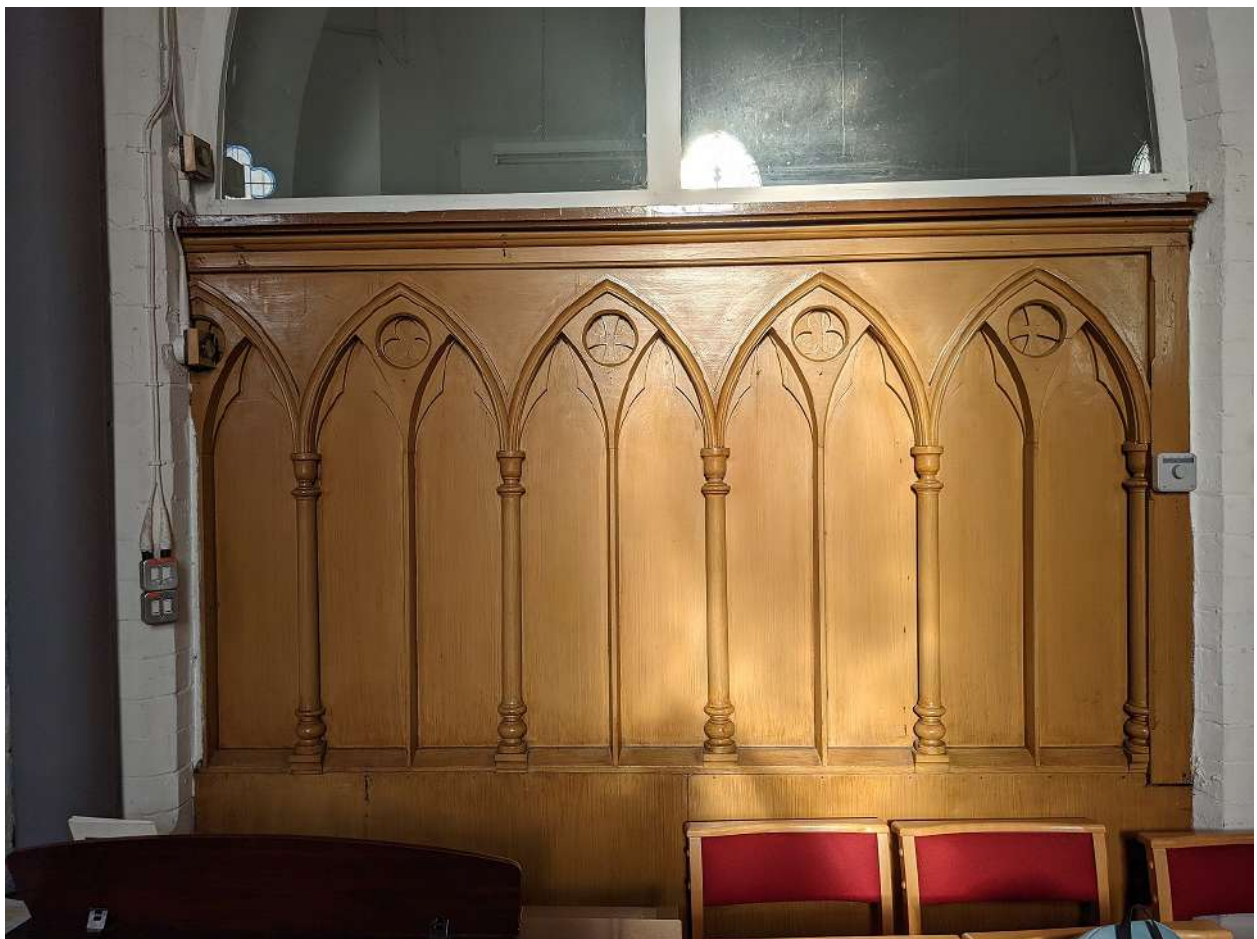
15.3 CHANCEL PANELLING (FORMER ORGAN CHAMBER)

Oak panelling rising to the springing point of arched opening above. Carved design depicting gothic pointed arches, mimicking form of reredos niches. Possibly relocated due to vertical cut noted through left hand side arch.

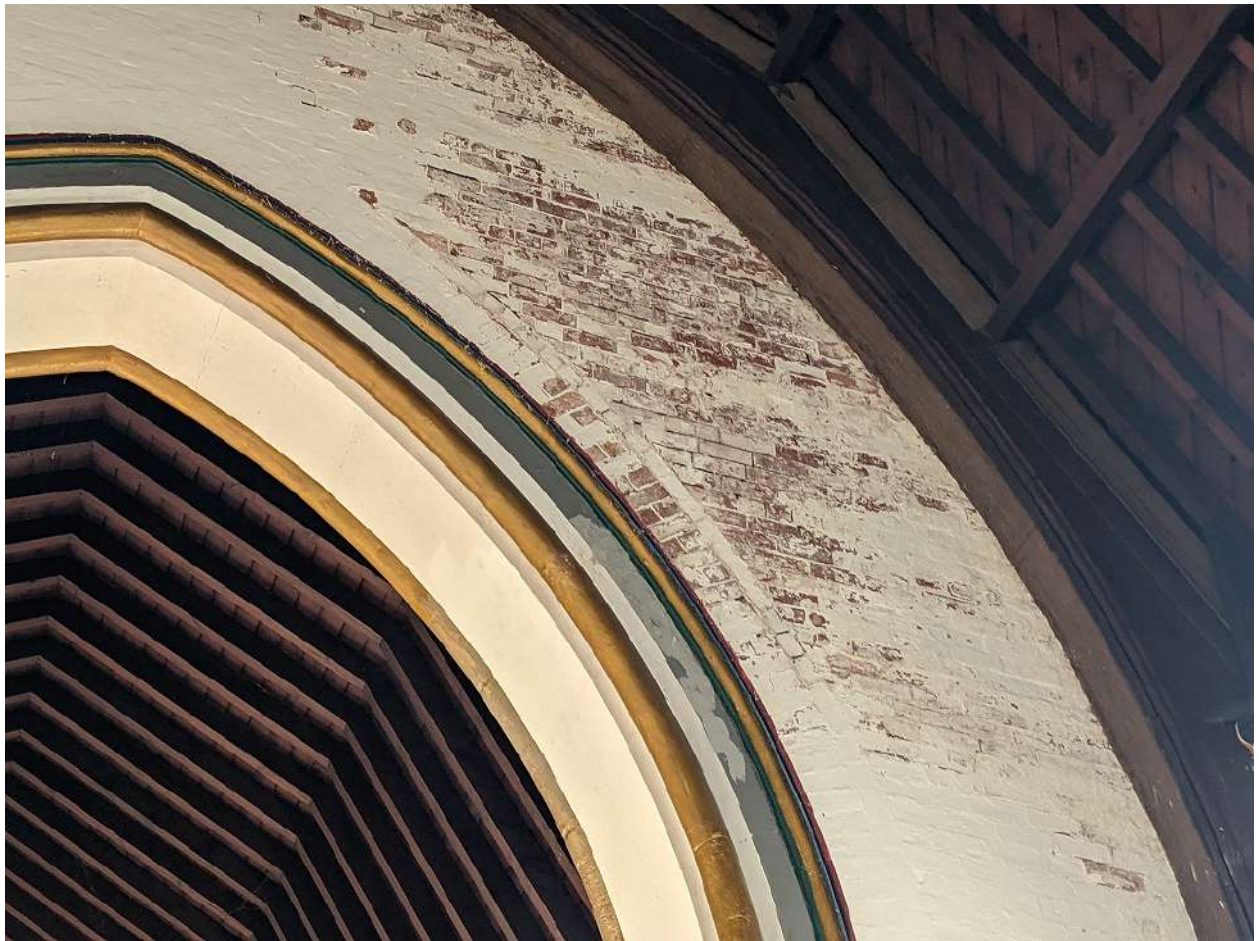
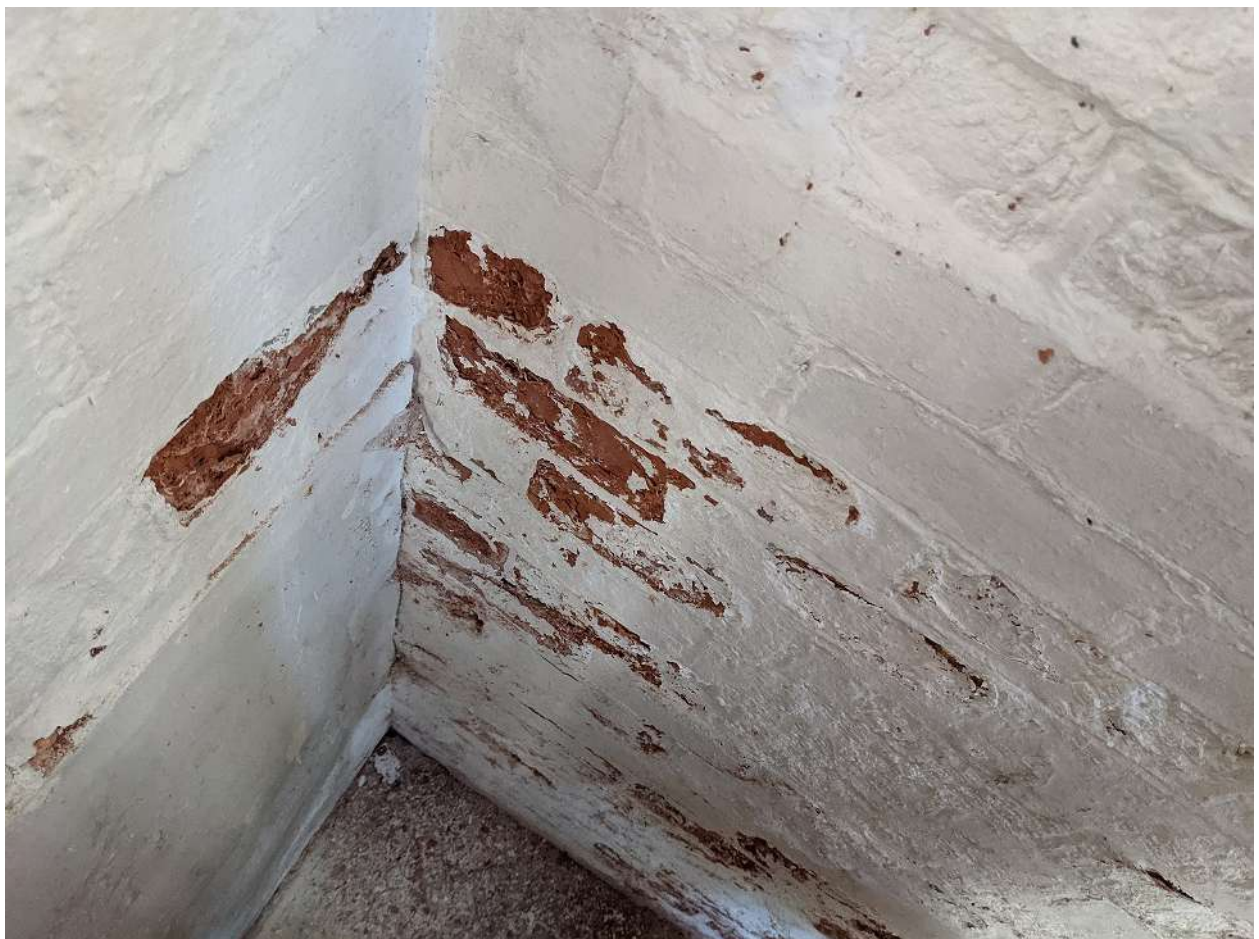
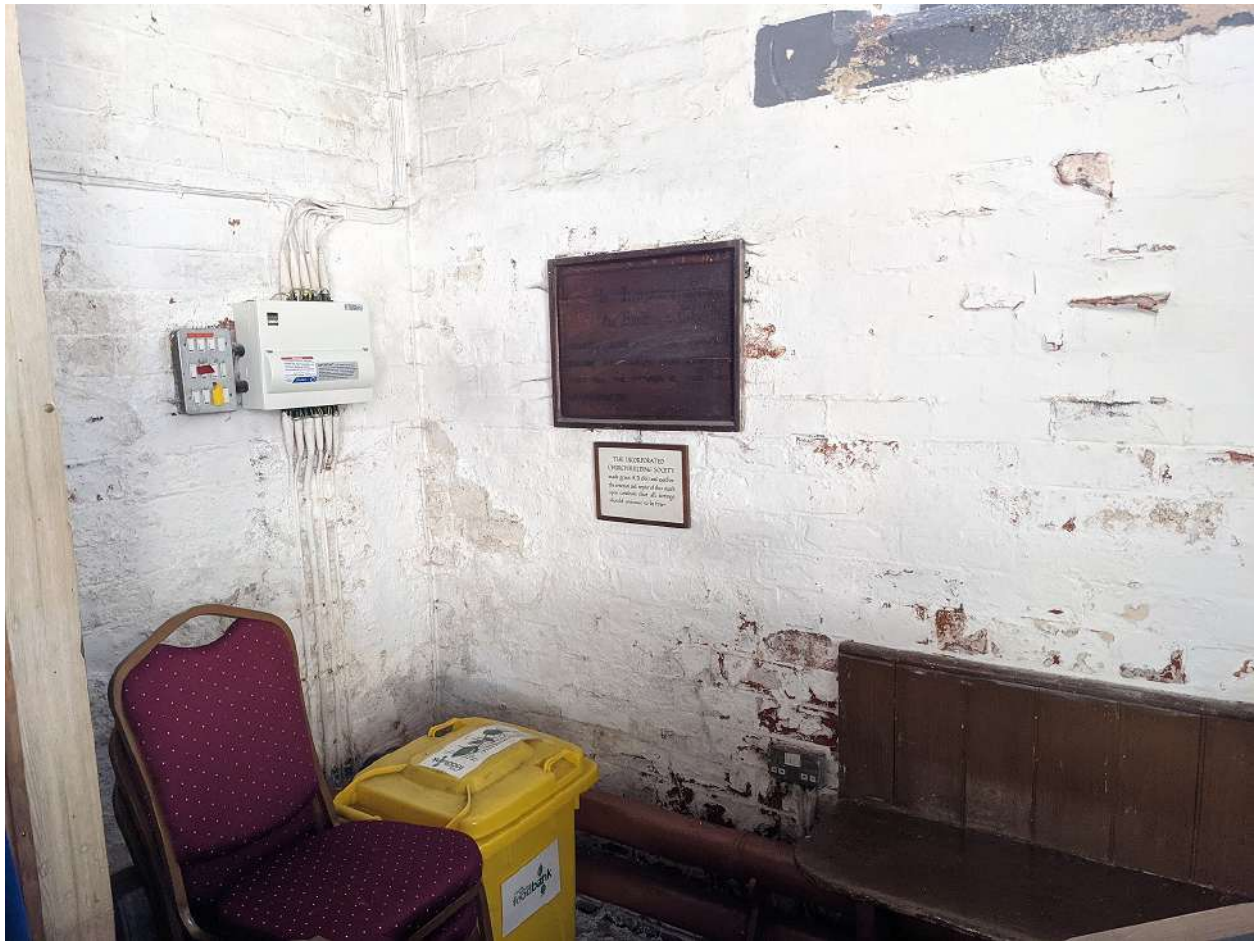
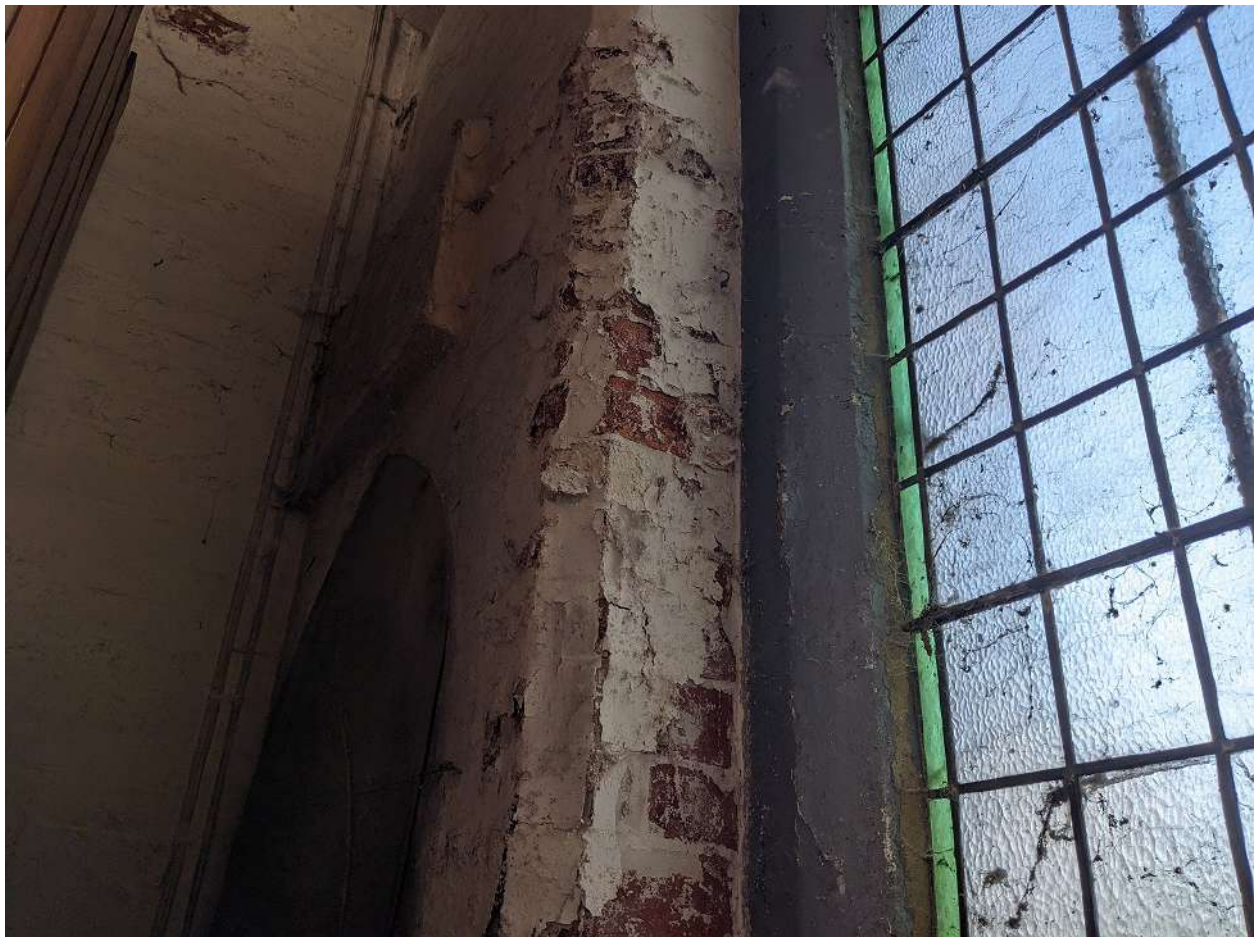
17.2 CHANCEL + VESTRY

White painted brickwork throughout, with grey painted ashlar surrounds. Head-stops to drip mould over vestry door; chamfered organ arch. All carving now painted in vivid colours.

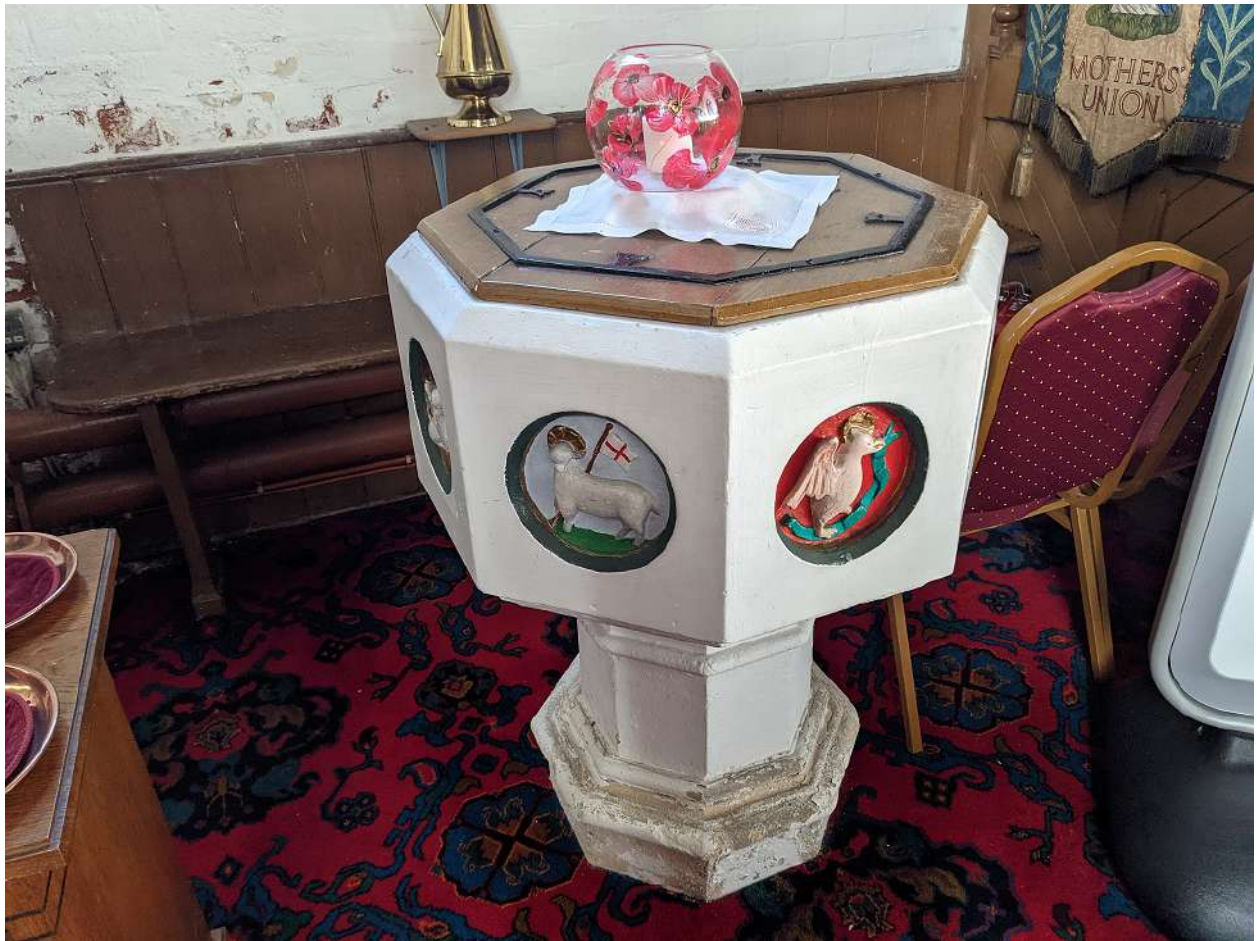
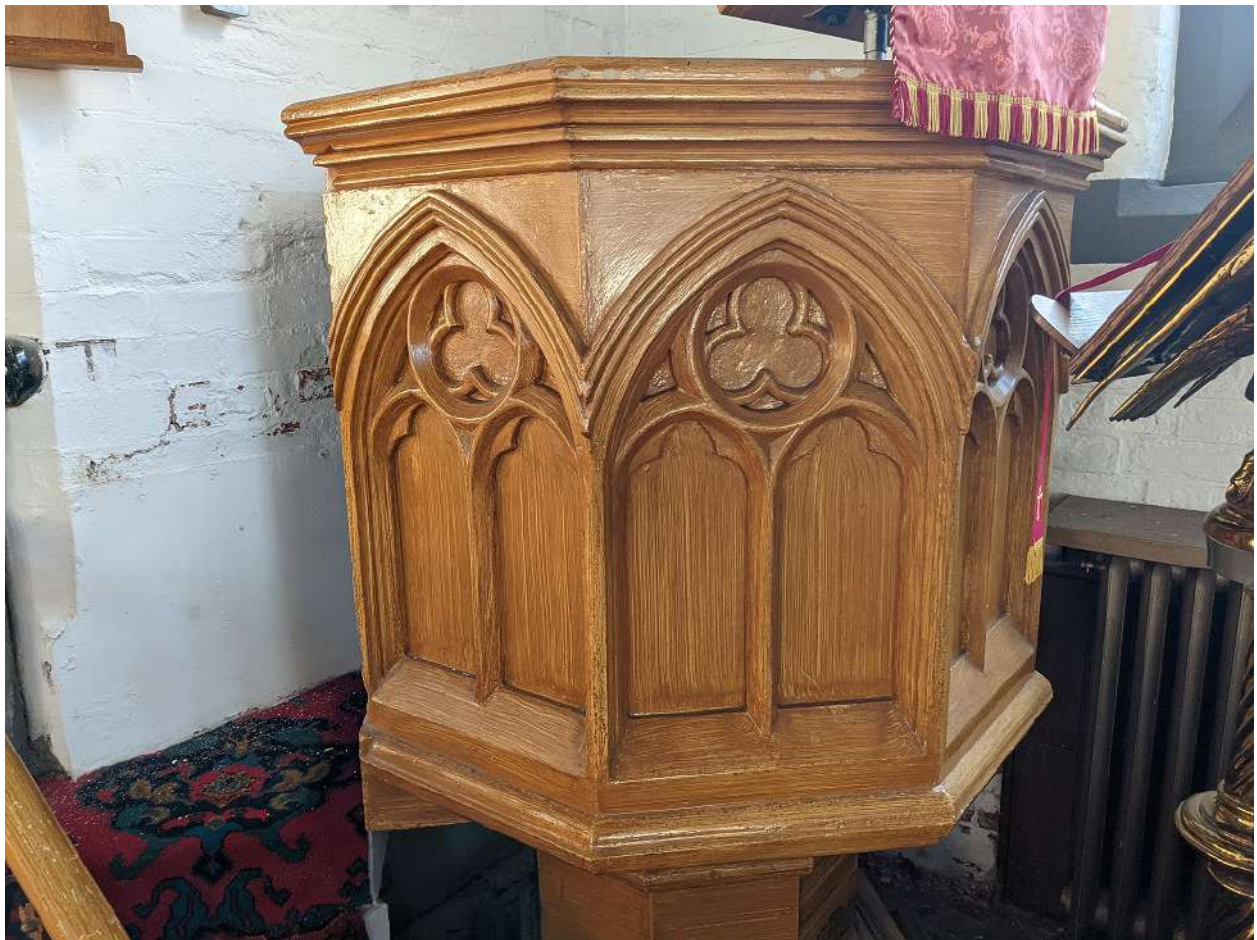
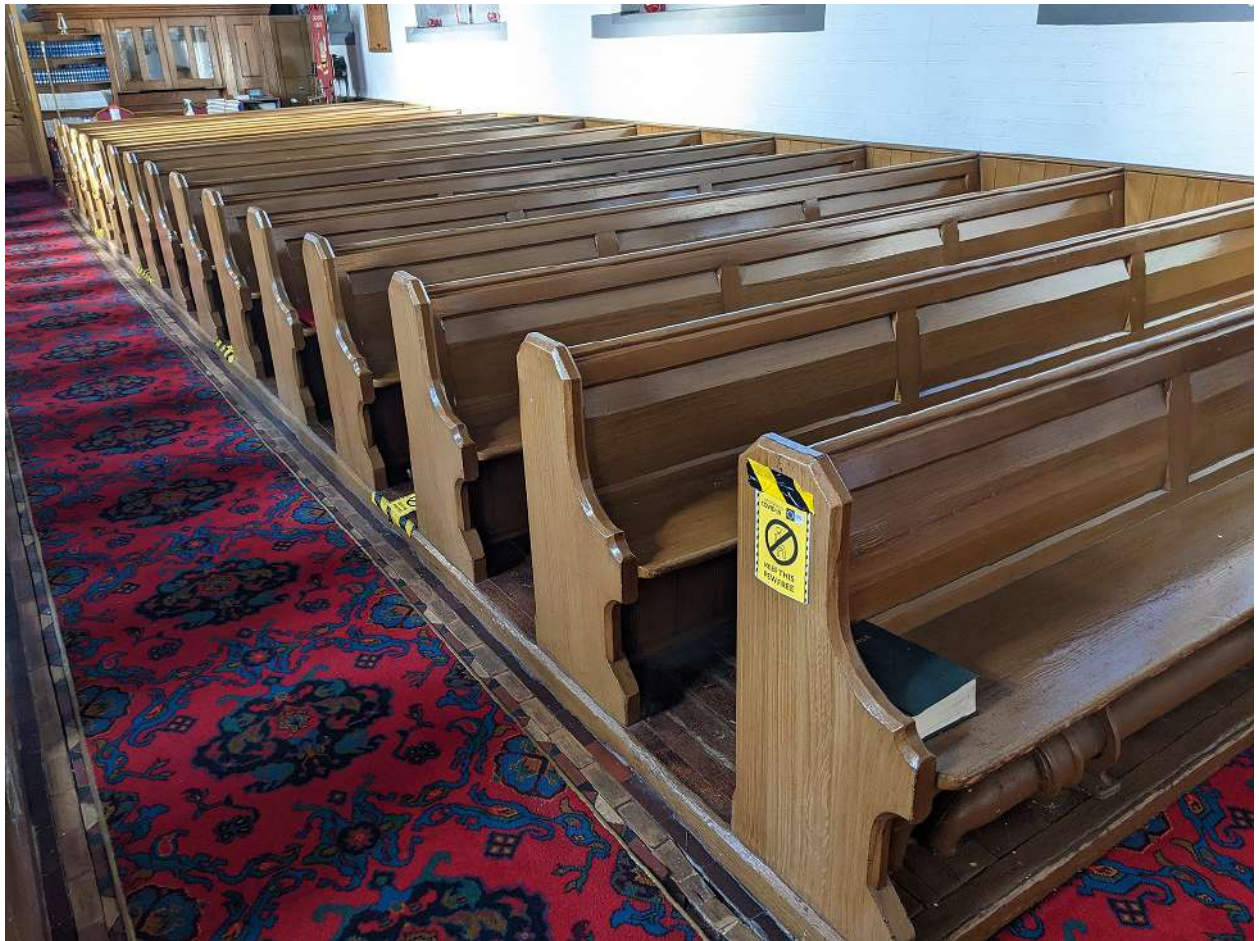
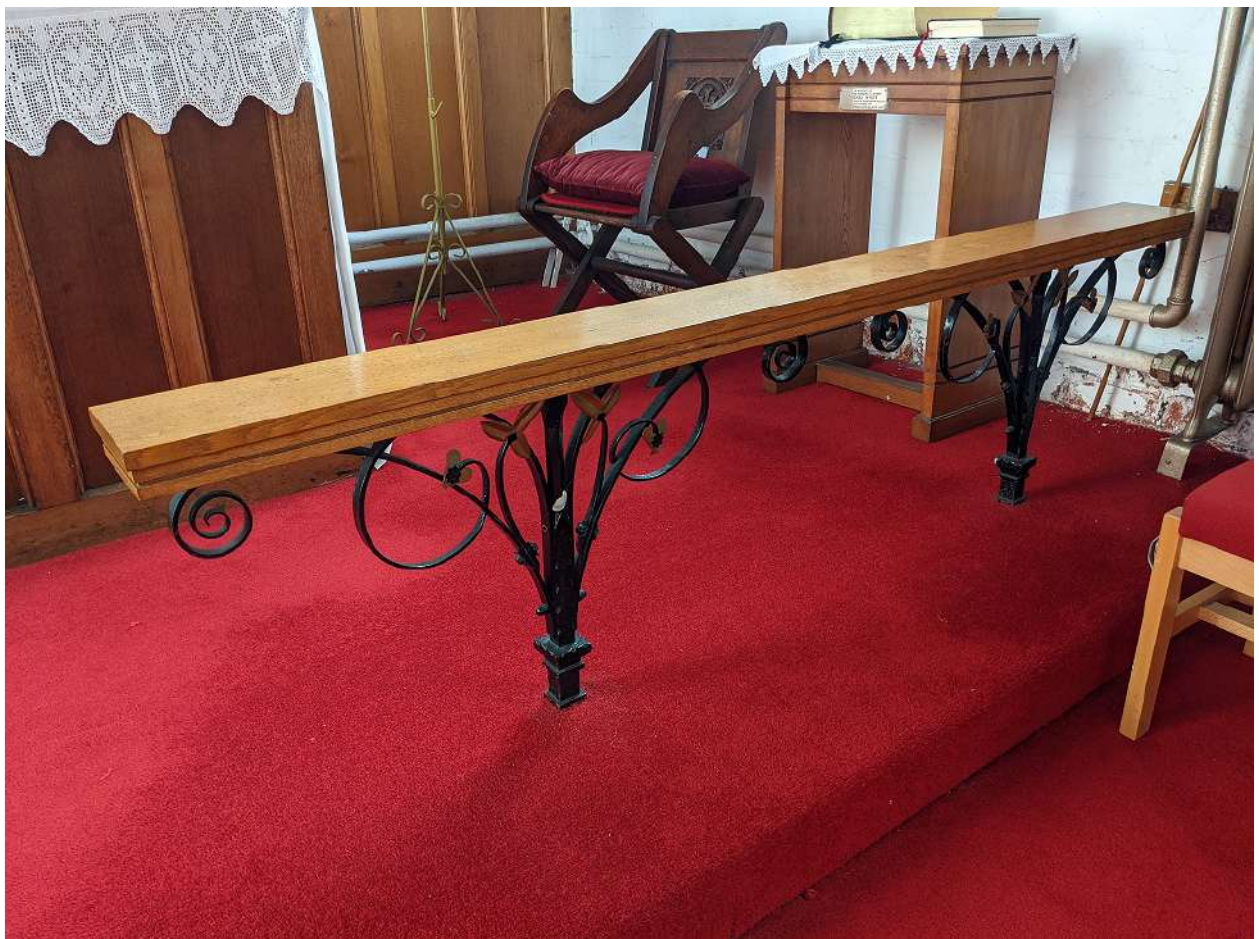
18.5.1 Generally all in a sound, good condition.

M It is sensible to be mindful and regularly check for any signs of insect and/or beetle activity in this area.

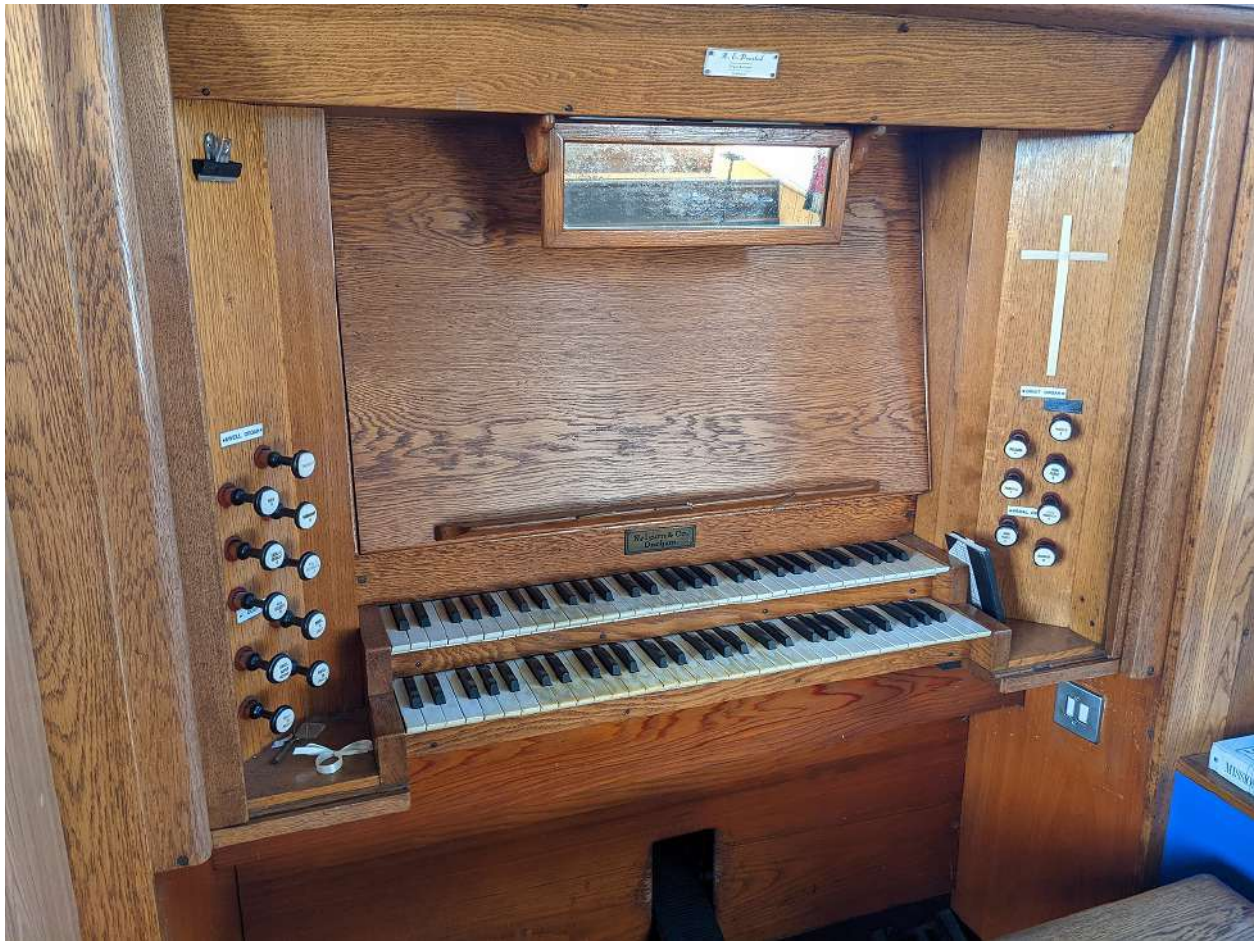
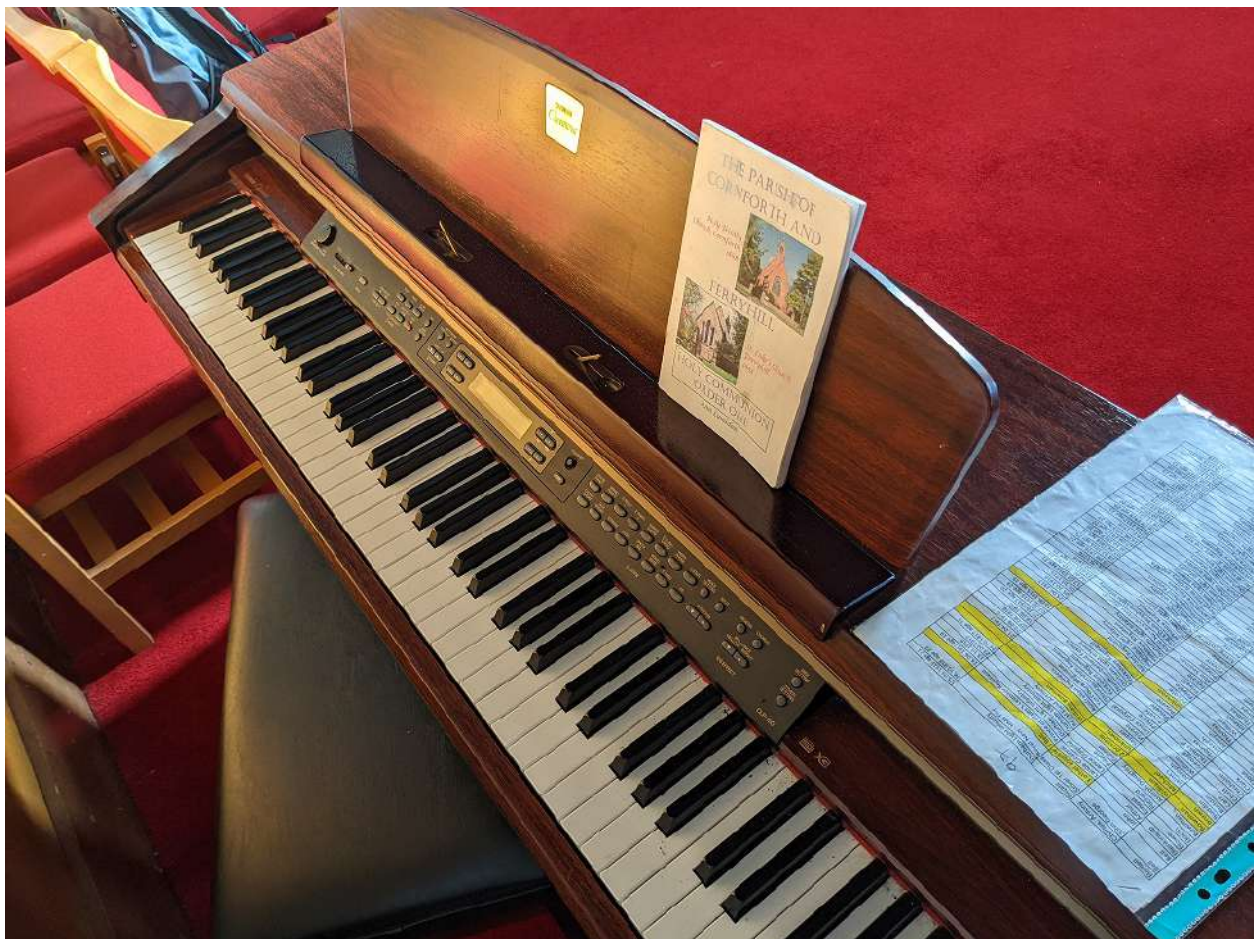
20.1.2 A Yamaha Clavinova electronic piano exists within the chancel, north side.

It is understood to be in a satisfactory working condition.

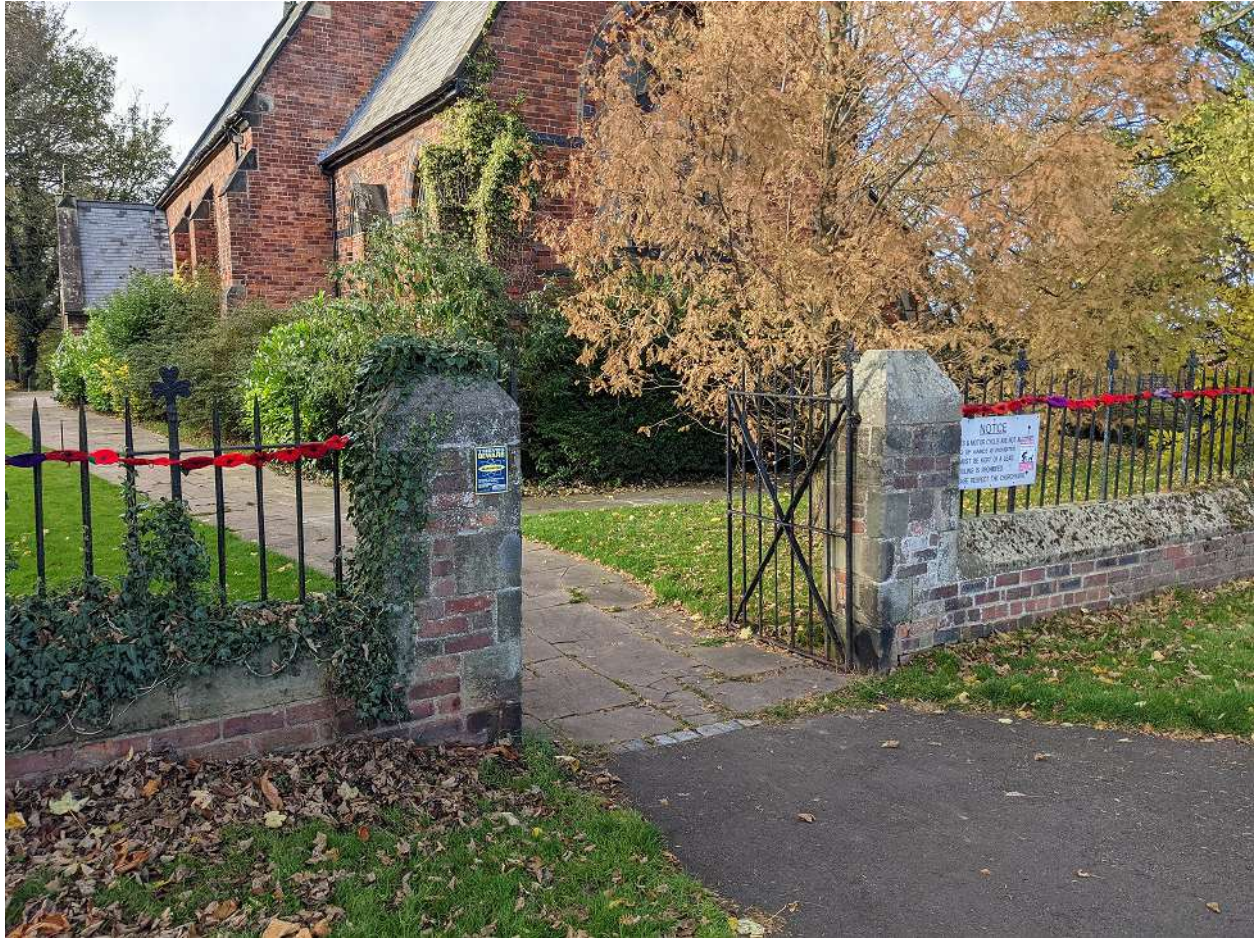
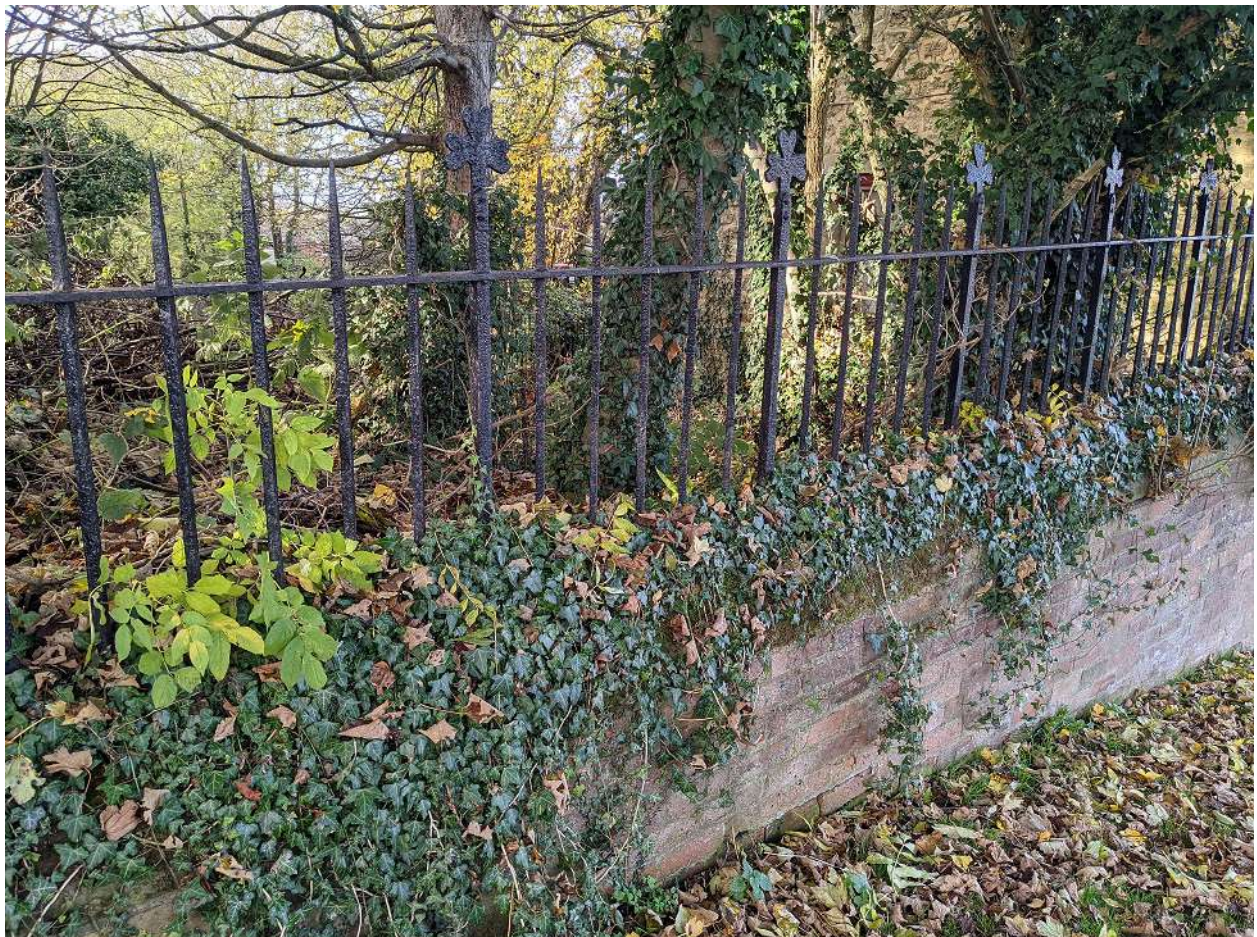
37. BOUNDARY WALLS, LYCHGATES AND FENCING

37.1 Boundary walls generally consist of limestone random rubble or private housing walling. Past repairs have been carried out to the limestone walls, presumed under the direction of Durham County Council. There is evidence of heavy cementitious mortar pointing which ideally should be raked/hacked out and replaced with lime:sand mortar. Vegetation, in particular ivy growth is slowly taking over the limestone walls. This too should be treated and kept under control.

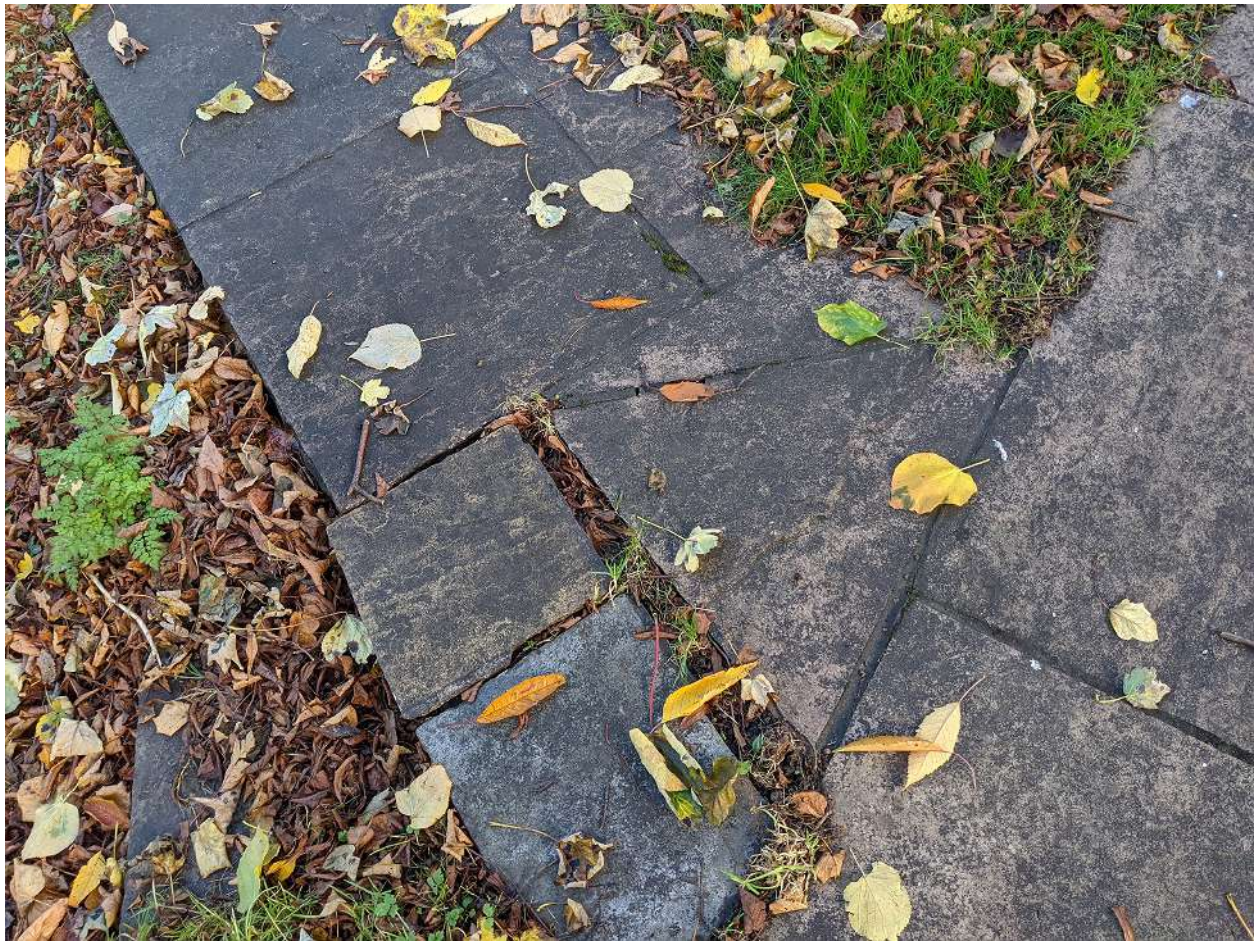
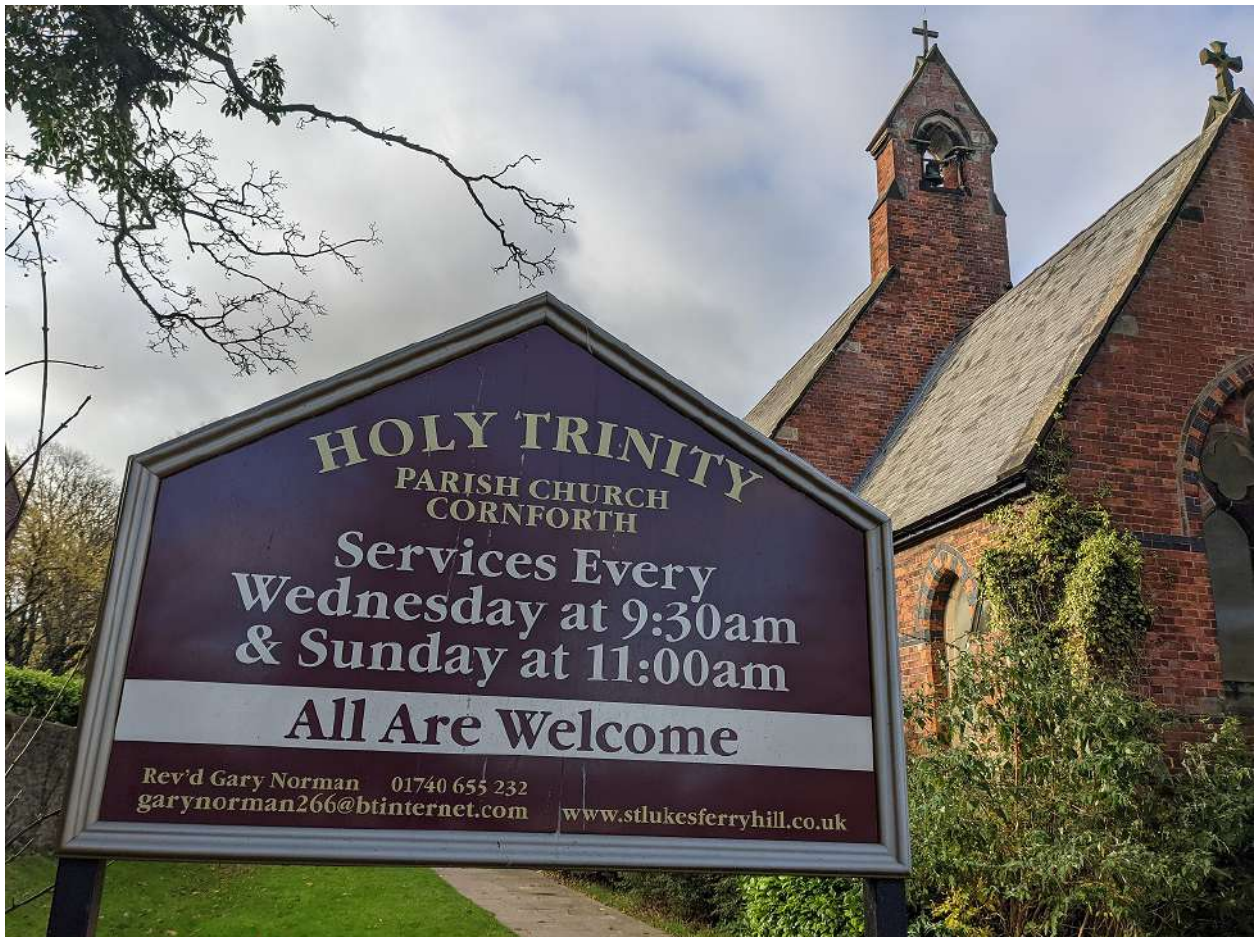
40.1.1 It is in a sound, satisfactory condition albeit could benefit from a clean.

M	Clean noticeboard.
----------	--------------------
