# ST ANDREW'S CHURCH, DALTON-LE-DALE

ST CUTHBERT'S TERRACE, DALTON-LE-DALE, SEAHAM, CO.  
DURHAM, SR8 8QX

This inspection was carried out on 16th October 2025. The weather was predominately dry and overcast. This was the author's first Quinquennial inspection of the church.

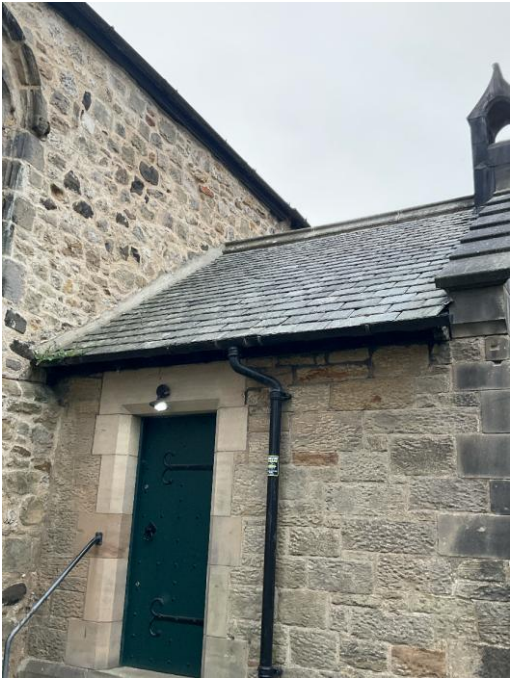
### Vestry Roof

| | <b>Condition</b> <ul style="list-style-type: none"> <li>• Slates appear sound</li> <li>• Ridge tiles well bedded.</li> <li>• Mortar flashing to chancel wall is sound.</li> </ul> | |

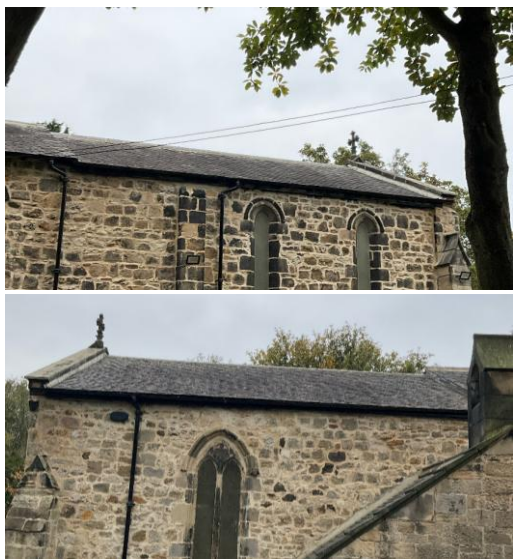
### Chancel Roof

| | <b>Condition</b> <ul style="list-style-type: none"> <li>• South slope - slates, ridge flashing appears sound.</li> <li>• North side - slates, ridge flashing appears sound</li> </ul> | |

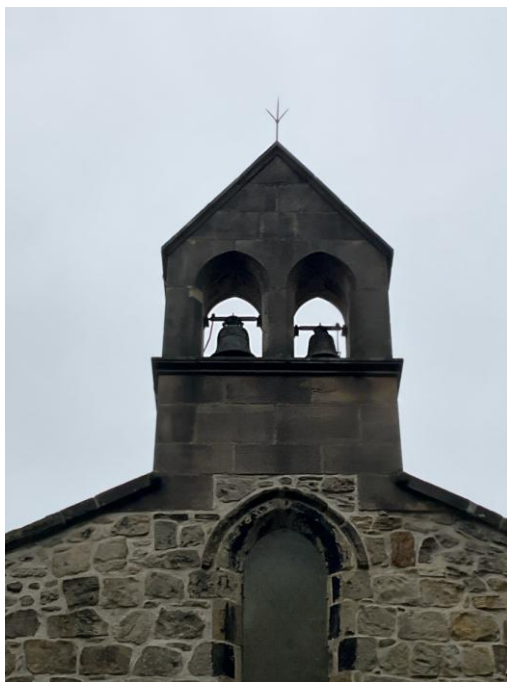
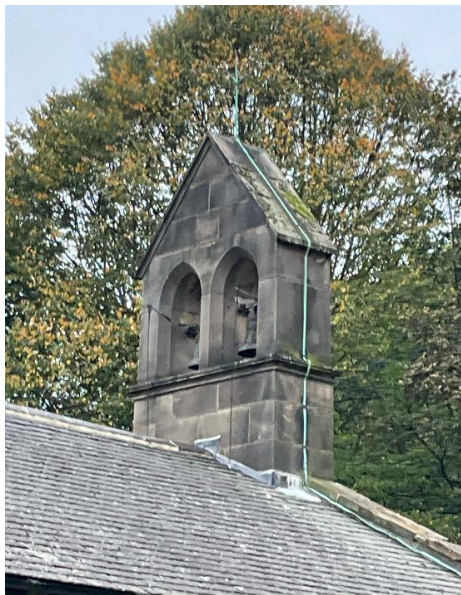
| | <b>Condition</b><br>Stonework appears fine. | |

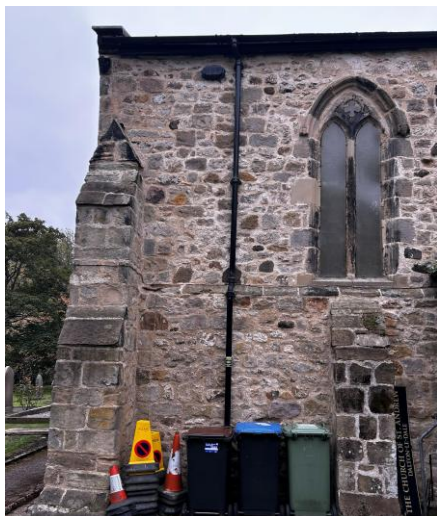
| | <b>Condition</b> <ul style="list-style-type: none"><li>• Stone and pointing seems generally sound.</li><li>• There is some delamination to buttress stone face.</li><li>• Some dark staining to window surrounds and buttresses.</li><li>• No obvious sign of water penetration causing the internal dampness.</li><li>• Some moss growth on north facing buttress below window.</li><li>• Stone water table appears sound and well bedded.</li></ul> | |

| | <b>Repair Needs</b> <ul style="list-style-type: none"><li>• Monitor moss growth on buttress and brush off if it becomes excessive.</li></ul> | M |

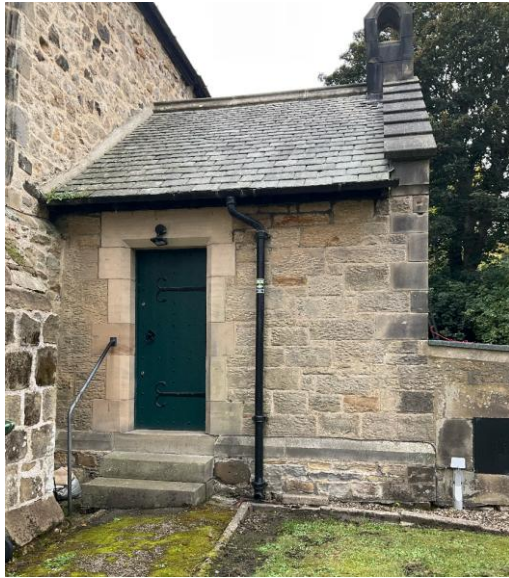
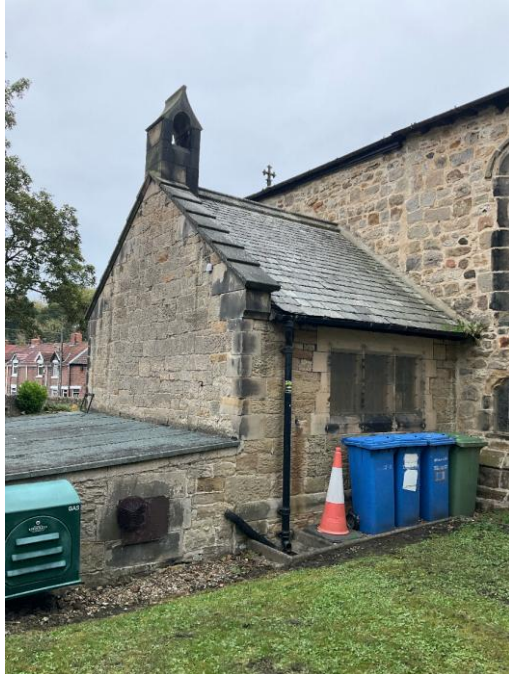
## Vestry

| | <p><b>Condition</b></p> <ul style="list-style-type: none"> <li>• Stone and pointing is generally sound.</li> <li>• Newer stone surround to door appears sound.</li> <li>• Water table is sound and well bedded.</li> </ul> | |

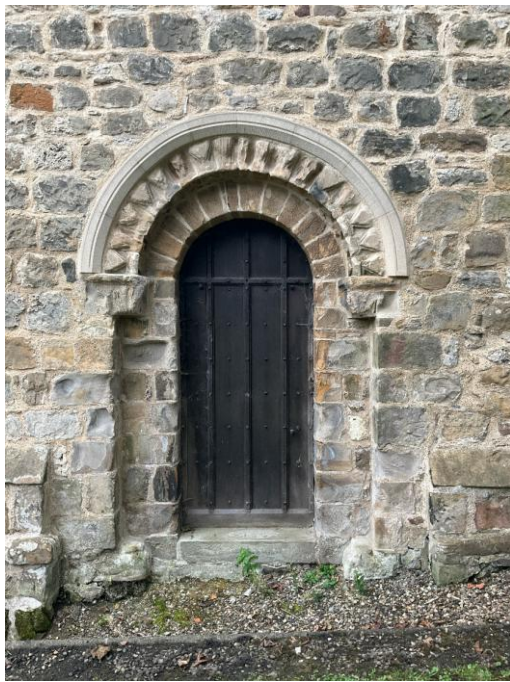
*Nave North Door***Condition**

- Chancel lancet door appears sound externally. The door is not accessible internally.
- Internal porch door is draughty as the door doesn't fully sit flush up against the wall. The timber is rotten at the base.
- External porch doors and gates appear sound.
- Vestry door appears sound.

Investigate potential draught proofing and repair of existing door to establish if repair is feasible before considering replacement.

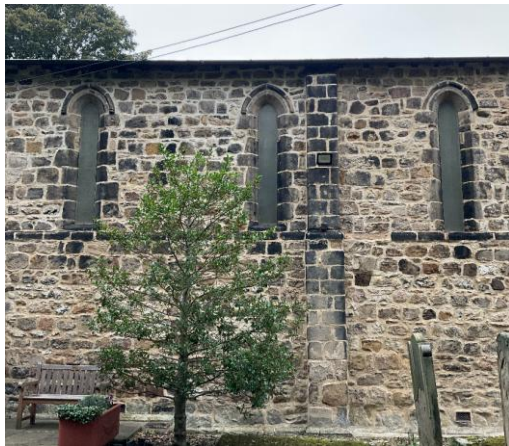
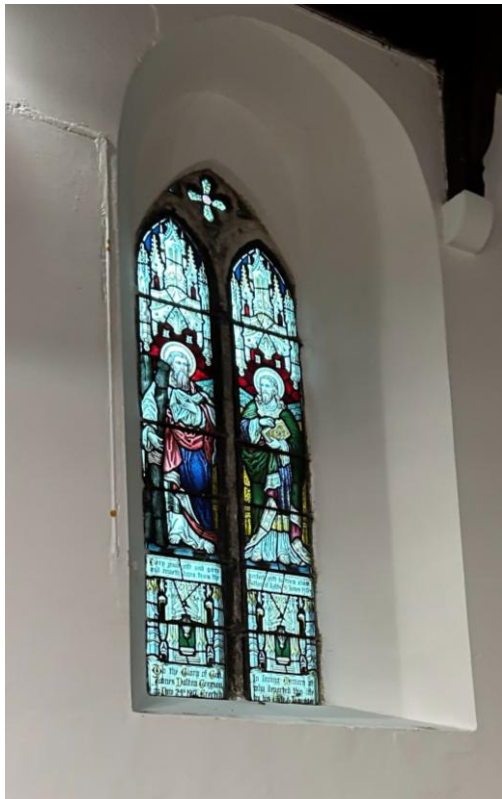
- Polycarbonate covers externally are sound, but rather grey and frosted.
- Surrounds are heavily stained.
- The eastern most Nave window on the southern elevation doesn't appear to have a sill stone. This may limit the ability for water to run off which could lead to water ingress.

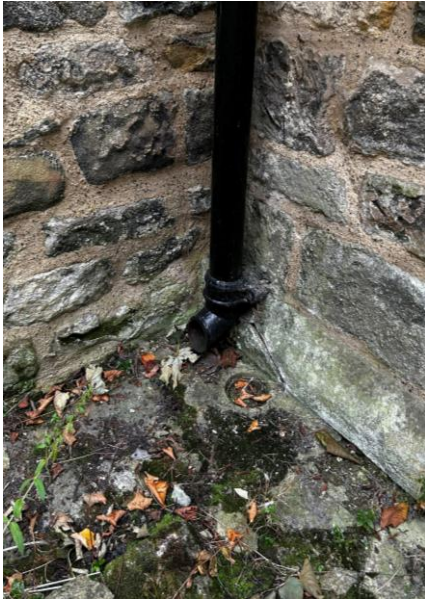
- Some downpipes don't directly align with gullies.
- There is some dampness around the internal porch area which could be a result of the downpipes discharging onto the concrete to the side of the porch.
- There is a high-water table on the north side which was noted in previous QQI report, possibly attributed to road drainage within the boundary retaining wall. Dampness is present on the walls internally at low level suggesting rising damp.

| | <p><b>Repair Needs</b></p> <ul style="list-style-type: none"><li>• Consider installing new gullies and drainage system around the porch to direct water away from the building.</li><li>• Consider installing a land drain and planting shrubs to mitigate high water table.</li></ul> | <p>D</p> <p>D</p> |

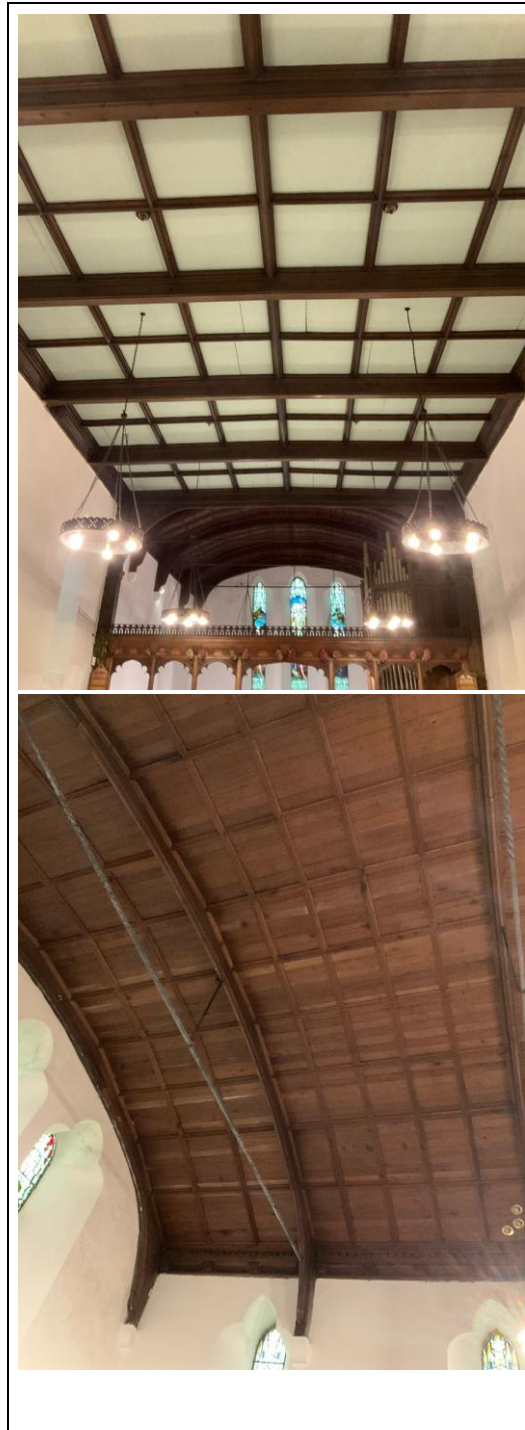
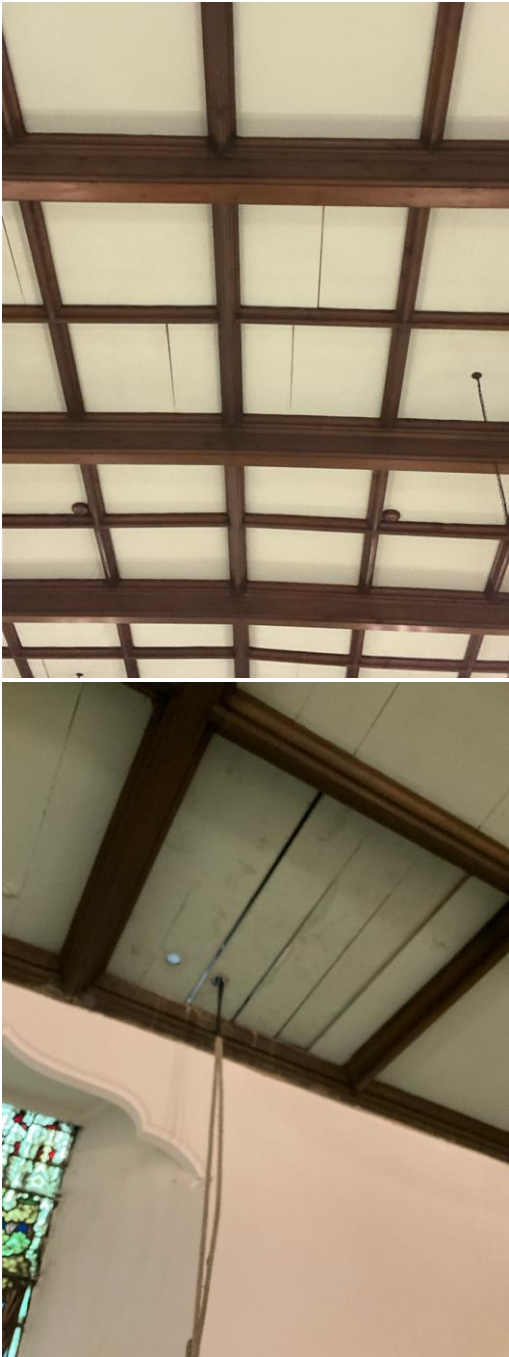
| | <p><b>Condition</b></p> <ul style="list-style-type: none"><li>• In nave some board joints are visible</li><li>• Chancel ceiling is sound.</li><li>• Vestry ceiling appears sound.</li></ul> | |

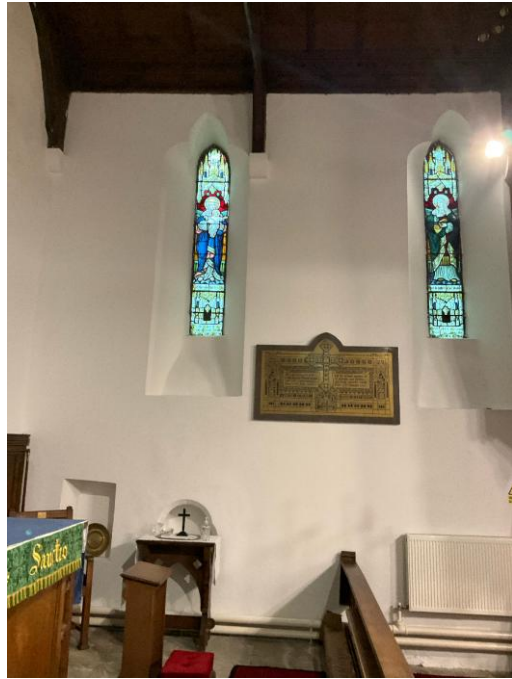
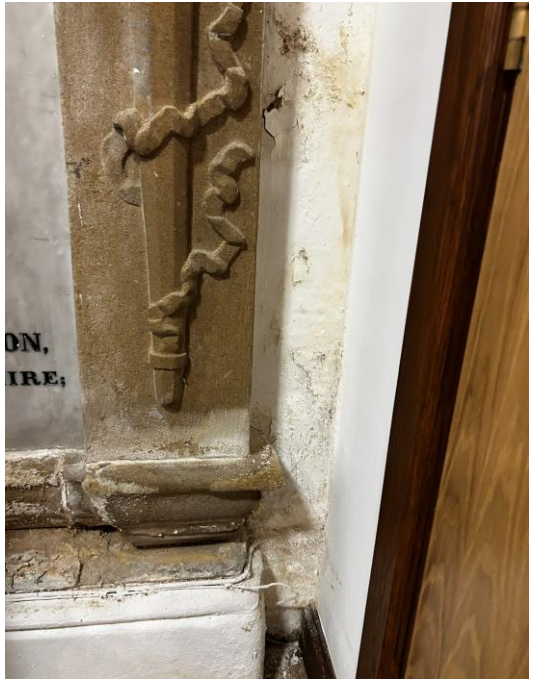
- Nave walls have been repainted recently, but efflorescence is beginning to show through and peeling paint on north side. This is possibly linked to a high water table externally noted in last QOI.

- Some staining on south appears to be water streaks. Following a storm last year. PCC noted no further issues.
- An area of efflorescence and dampness to the west of entrance door beside base of stair at low level. Potentially linked to external downpipe discharging onto the ground rather than a gully.

- Some efflorescence either side of stone & marble memorial underneath stair.
- There is efflorescence and dampness on the plaster walls to the west wall within WC above the tiles.

| | <b>Repair Needs</b> <ul style="list-style-type: none"><li>• Brush off worst of the efflorescence and monitor the area for reappearance. (Refer to the below ground drainage section for recommendation on resolving moisture.)</li><li>• Monitor staining from high level, particularly after heavy rainfall.</li><li>• Check if there is ventilation in WC.</li><li>• Consider planting shrubs along north boundary and install a land drain to reduce water table.</li></ul> | <div>M</div> <div>M</div> <div>M</div> <div>D</div> |

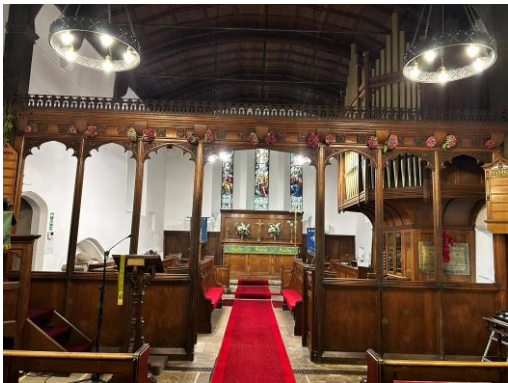
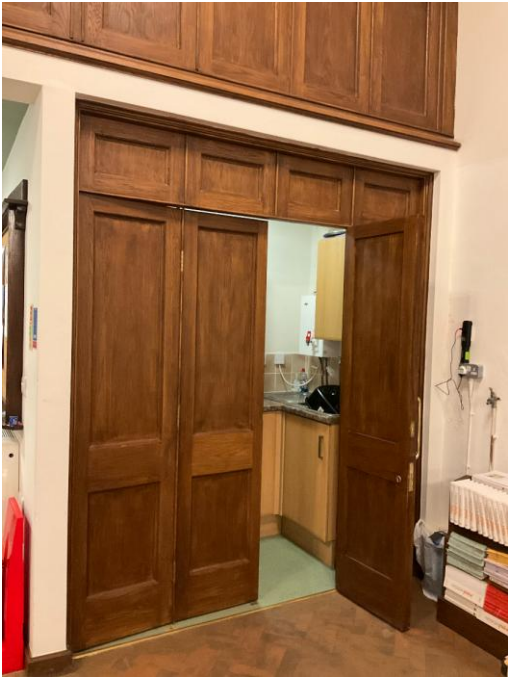
| | <b>Condition</b> <ul style="list-style-type: none"> <li>• Screen between nave and chancel appears sound</li> <li>• Served panelling is sound.</li> <li>• A piece of edging is missing at top of vestry panelling, otherwise panelling is sound.</li> <li>• Gallery and stair balustrade and metal rail appear sound.</li> </ul> | |

| | <b>Repair Needs</b> <ul style="list-style-type: none"> <li>• Replace missing edge piece on vestry panelling</li> </ul> | E |

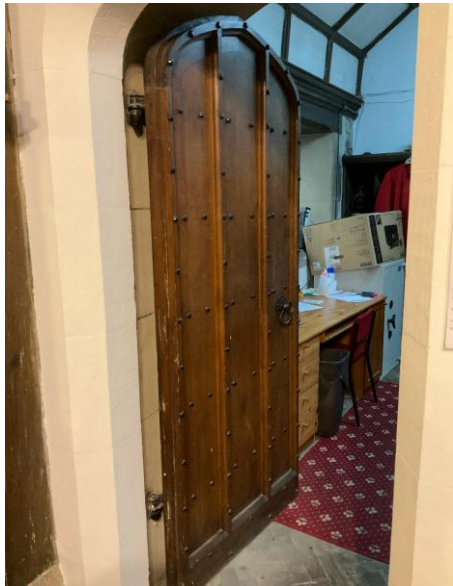
| | <b>Condition</b><br>All doors appear sound. | |

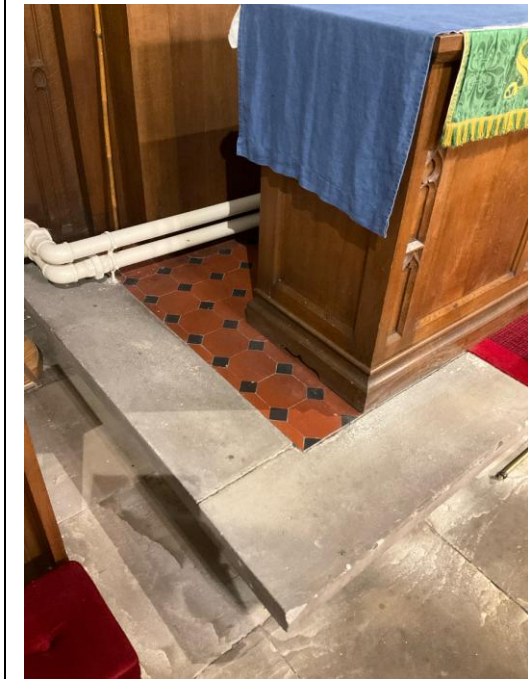
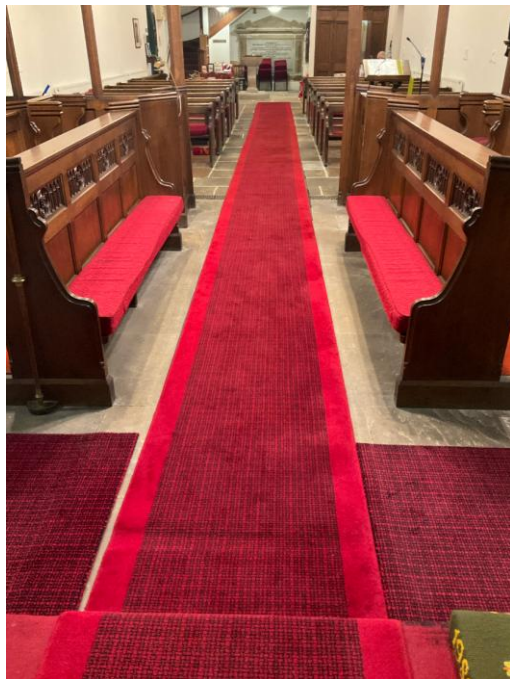
| | <p><b>Condition</b></p> <ul style="list-style-type: none"><li>• Flooring throughout is generally in good condition.</li><li>• Steps have some chips</li><li>• Carpets are good condition.</li></ul> | |

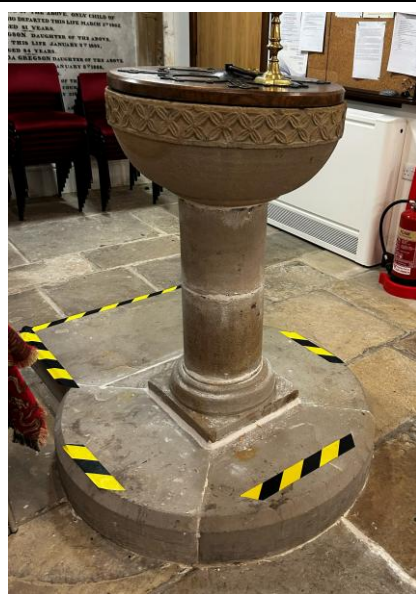
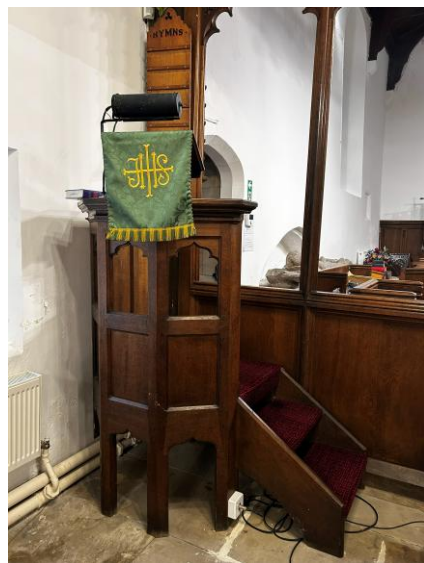
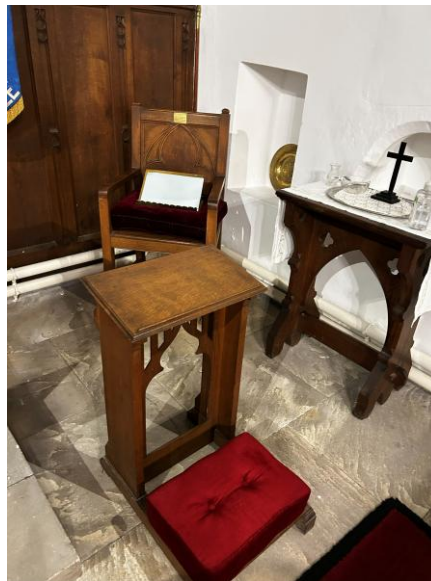
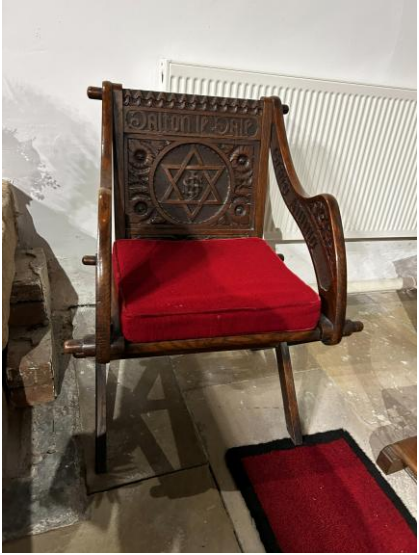
| | <p><b>Condition</b></p> <p>All appear stable and sound.</p> | |

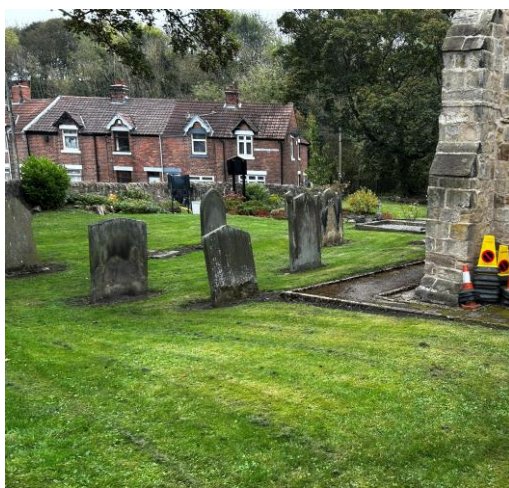
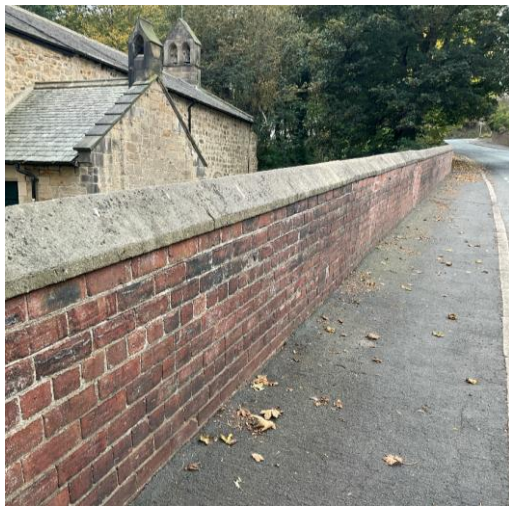
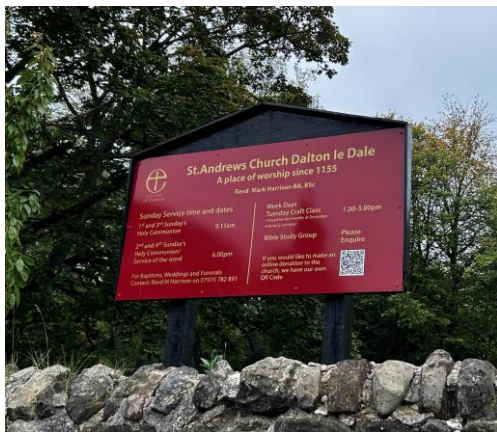
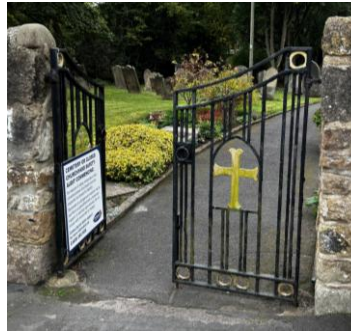
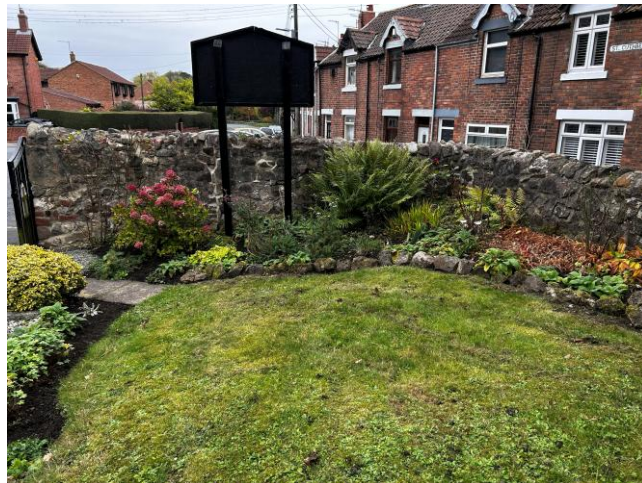
| | <p><b>Condition</b></p> <ul style="list-style-type: none"> <li>• Small area of pointing missing to curved stone wall at front.</li> <li>• Render to inside face of north walls missing in places, exposing brick behind.</li> <li>• Large crack in part of render to base of north wall.</li> <li>• Railings appear sound.</li> <li>• Some moss growth on front gates.</li> <li>• Moss growth to footpaths, particularly extensive outside vestry door.</li> </ul> | |

| | <p><b>Repair Needs</b></p> <ul style="list-style-type: none"> <li>• Small area of repointing required to curved stone wall at front.</li> <li>• Clean down front gates.</li> <li>• Clean moss growth off footpaths.</li> </ul> | <p>D</p> <p>M</p> <p>M</p> |

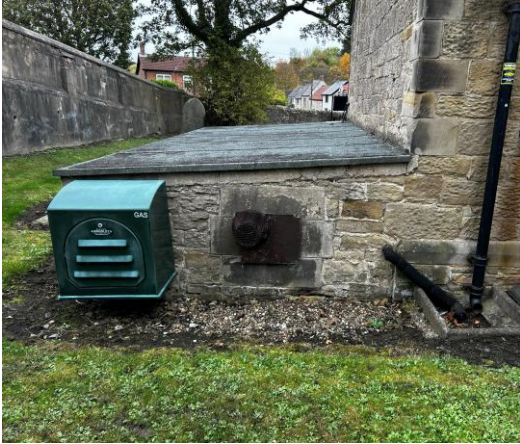
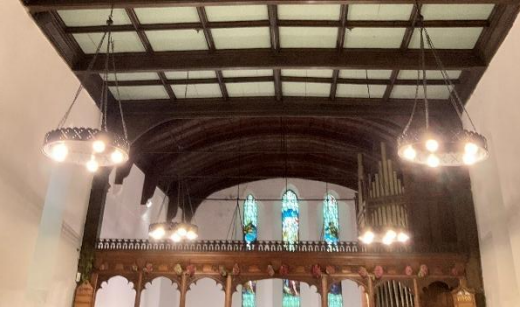
| | <p><b>Condition</b></p> <ul style="list-style-type: none"> <li>• Redundant oil tank is still present in grounds.</li> <li>• Fire extinguishers have been tested and checked recently.</li> <li>• Lightning conductor has been checked recently.</li> <li>• Gas boiler has been serviced recently and no noted issues.</li> </ul> | |

| | <p><b>Repair Needs</b></p> <p>Remove redundant oil tank</p> | <p>C</p> |
