ST CUTHBERT'S CHURCH

Darlington

Report on Quinquennial Inspection 2019

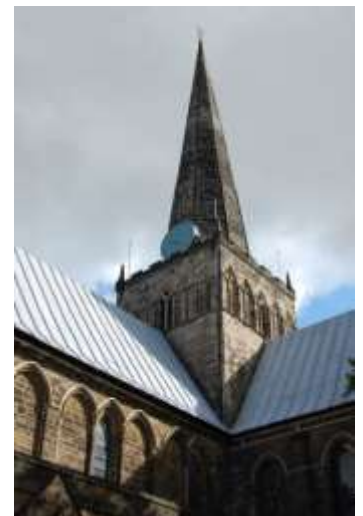
South Elevation:

In good condition as before.

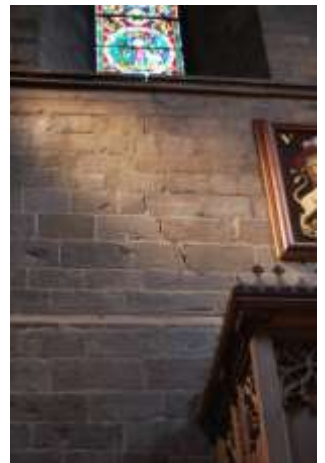
Above and below the southern window, there is evidence of a previous movement crack. This has been pointed externally but it is still visible internally.

Note constant sound of running water, high level heating pipework.

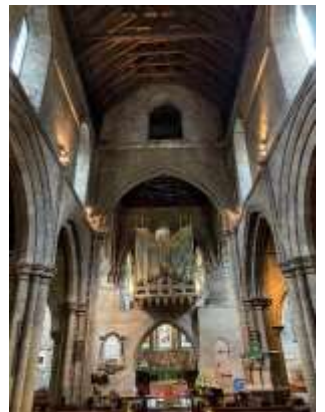
3.1.3. **East Wall / Crossing Arch:**

The arch is a wide, slightly pointed archway with decorated mouldings above which is another opening into the Belfry walkway. Two iron wall ties are visible at high level.

Condition:

All appear to be in good condition.

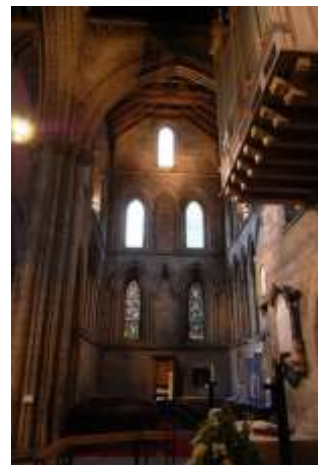
Above the lower eastern window no 6 to the east side of the head, there is a crack which goes up to the string course. This should be pointed and monitored since there is also a crack below the window directly above the niche to the Hogback tombstone.

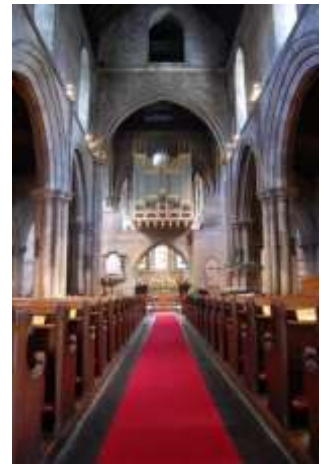
There are a number of ferrous fixings which should be removed and the stone repaired.

There is a large First World War monument to the north side of the arch. In good condition.

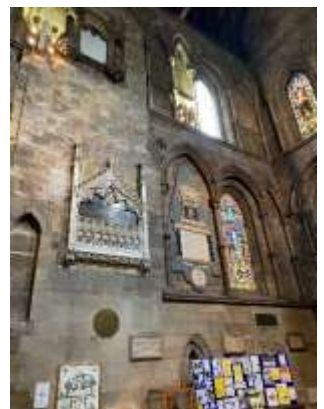
Movement cracks above the windows appear to have been pointed and not moved since.

To the north there is the sound cupboard and lighting fuse board. These could be better disguised.

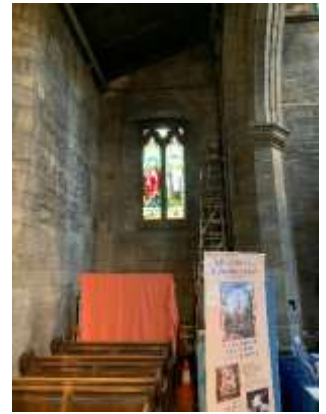
- 3.6.2. **West Elevation:**
In good condition. Unfortunately, a very well used repository for ladders etc.

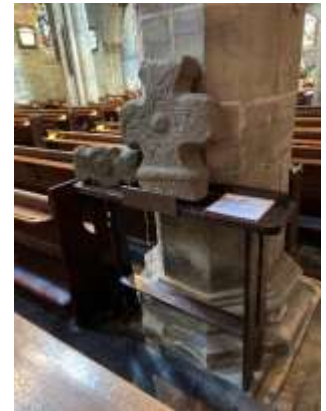
- 3.6.3. **North Elevation / Arcade**
All in good condition. Within the second bay of the Arcade. There are two Saxon stones which are rather precariously balanced on a timber stand and these should be properly displayed and fixed.

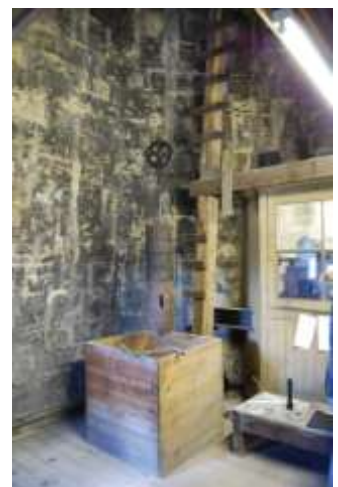
3.7.6. **Condition:**

Evidence of previous insect attack to the timbers forming the access platform and ladders and previous remedial work evident. The Carillon is generally worn out and not in use.

3.7.7.	Recommendations:	Broad Budget Costs
E	• Refurbish carillon.	2
D	• Commission a steeplejack to ascend the inside of the spire and provide an inspection report.	2
E	• Repoint the interior of the spire to prevent leaks.	3
B	• Repair clock mechanism (further repairs required to the faces).	3

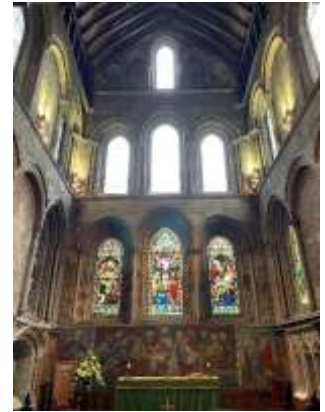
Condition:

This appears to be generally in good condition and relatively clean. The base is of timber panelling. The masonry is in good condition.

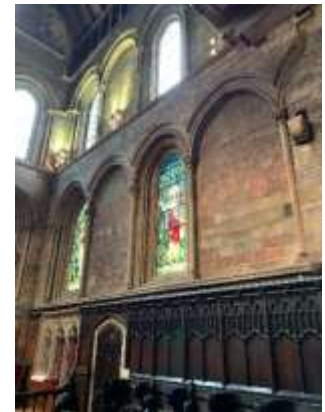
3.11.2. South Elevation

The stonework is generally in good condition, although around the eastern most window 25 the decorative florets around the window have become detached in places and are missing. It would be a good idea to check them for stability.

Above this window are some ferrous fixings which should be removed and the stone repaired. To the left of the head of window 25 is a crack which should be pointed and monitored. Also at high level towards the west there are two ferrous brackets which should be removed.

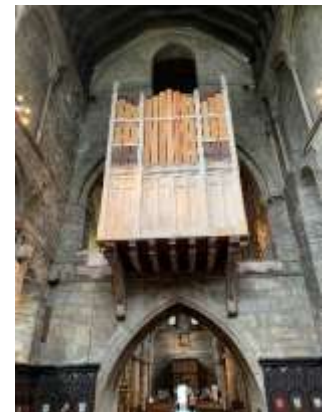
3.11.3. West Elevation:

The masonry is in good condition. As is the Organ casing. It would however be worth considering decorating the Chancel side of the Organ casing when funds allow.

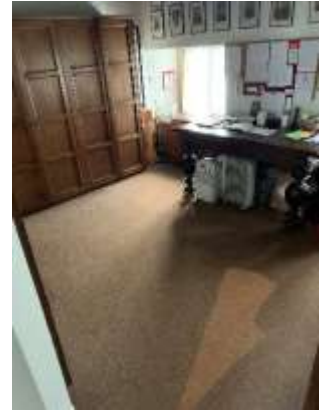
The windows are diamond lattice work with obscured glass in reasonable condition, except for a couple of broken panes.

3.12.2.	Recommendations:	Broad Budget Costs
B	• Carry out external remedial work to flashings and make good decorations.	1
C	• Repair window quarries.	1

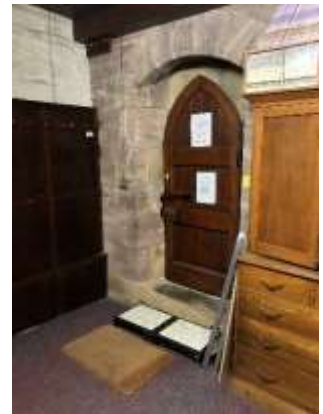
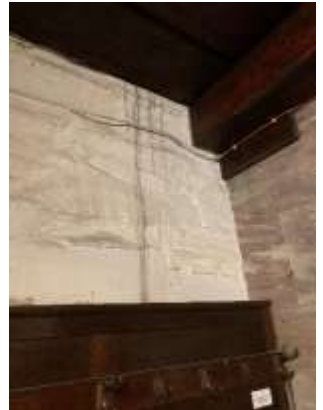
Crack to stone left hand (east) window, reveal to mortar joint vertically leading up to arch.

3.12.4.	Recommendations:	Broad Budget Costs
C	• Make good decorations following leaks.	1
C	• Monitor crack for further deterioration.	1

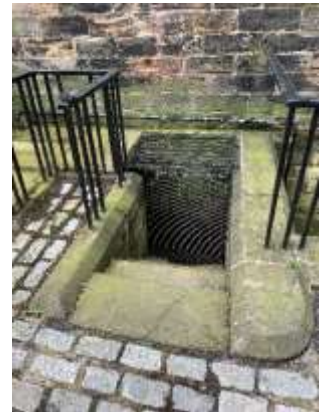
There are two gas fired boilers which are coming to the end of their life. One has failed and the other does not have the capacity to heat the building alone. There appear to be blockages within the system, or problems with the pump, since some pipes are not reaching the temperatures which should be expected.

The flue is directed to a brick built chimney set in the centre of the churchyard to the north side.

3.14.2.	Recommendations:	Broad Budget costs
A	<ul style="list-style-type: none"> • Ensure downpipes and gullies are clear and check underground drainage. 	2

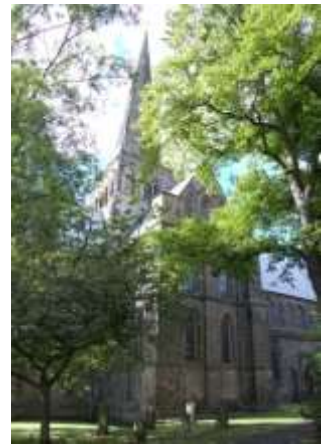
The railings require re-decorating each 5-7 years.

Vegetation around the perimeter should be regularly treated with biocide. There are a number of mature trees in the churchyard and they should be reviewed since the setting of the church could be enhanced with some judicious treatment of the trees.

3.16.3.	Recommendations:	Broad Budget Costs
D	• Maintain masonry in moat.	1
D	• Decorate railings.	2
D	• Review trees and obtain report on condition.	2
