ST CUTHBERT'S CHURCH

Darlington

Inspecting Architect Ulrike Knox RIBA AABC

Quinquennial Inspection Report 2024

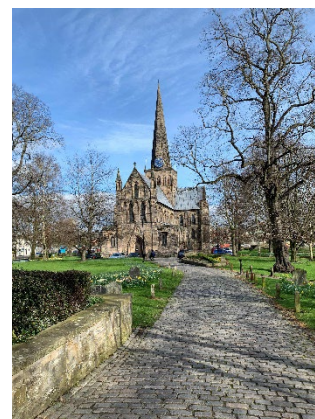
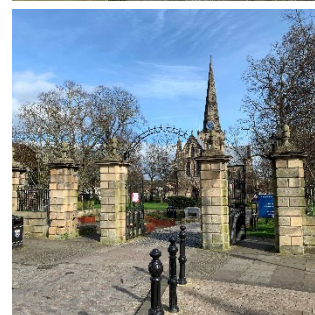
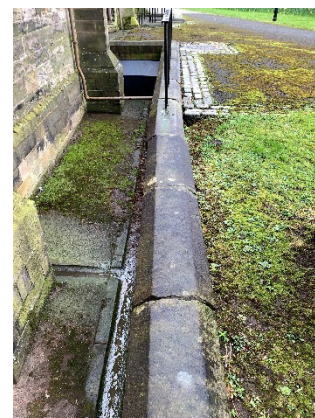
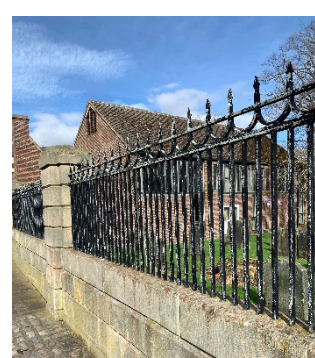
Metal Railings

There is extensive flaking paint to the metal railings to the west to Market Place and to the east at the River Skerne.

2.20.3.		Church Grounds Recommendations:	Broad Budget Costs
	M	Remove weeds, moss and vegetation from the dry moat.	1
	D	Repoint open joints to the dry moat stone walls.	2
	D	Decorate railings.	2

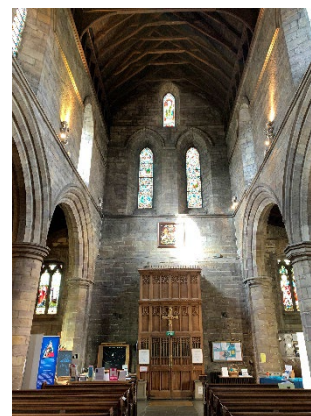
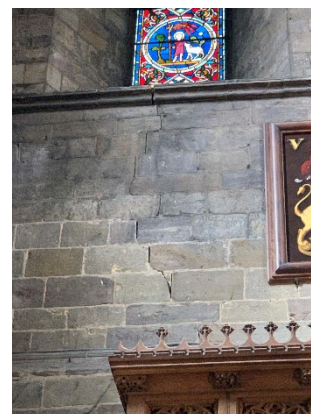
Above and below the south window, there is evidence of a previous movement crack. This has been pointed externally but it is still visible internally. This does not appear to have opened up since the 2019 inspection.

3.1.7.		Nave Recommendations:	Broad Budget Costs
	E	Clean internal masonry throughout.	5
	D	Repair crack to west end wall and monitor for further movement.	1
	E	Monitor open joint to east elevation above the arch	1

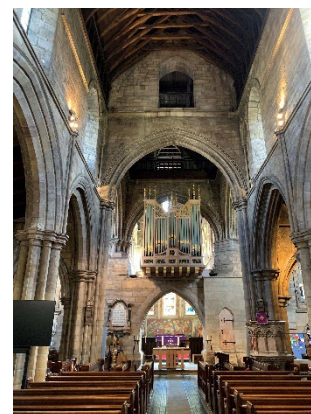
Stonework appears to be in good condition, although a minor open mortar joint was noted running vertically from the north side of the arch upto the string course above. The open joints did not extend through the arch stonework or the string course. Monitor for potential movement.

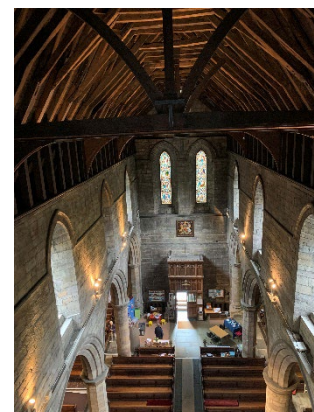
Generally in good condition, the medieval timbers are somewhat gnarled, with evidence of past furniture beetle infestation, however it is understood that the major timbers have been treated in the past.

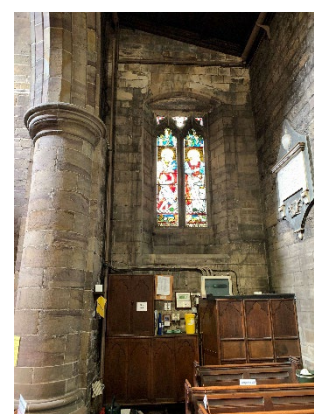
This elevation is particularly dirty and damaged by water marks and other run off. Leaks have been reported in the past but temporary repairs to the roof above appear to have worked for the time being. The Cottier window is of significance and would benefit from cleaning and conservation.

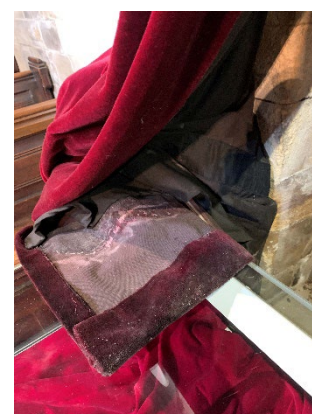
The stone work is generally in fair condition, although there is salting to the stone to both sides of the north door at low level. Some of this has soaked into the curtains. This may relate to the external moisture issues mentioned in the where water may be entering under the north door.

The fixings for the monuments should be checked on a regular basis since they are ferrous and liable to corrode.

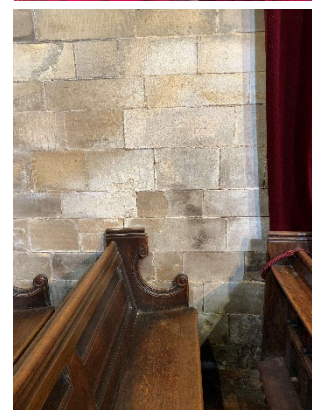
In good condition. Following the inspection, water ingress has been observed to the floor at the column location. This is likely from the north aisle roof which is due to be replaced.

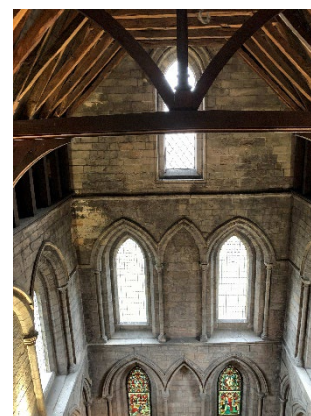
Generally in good condition, the medieval timbers are somewhat gnarled, with evidence of past furniture beetle infestation, however it is understood that the major timbers have been treated in the past.

3.3.7.		North Transept Recommendations:	Broad Budget Costs
	D	Repoint and monitor mortar cracks to the different elevations.	2
	B	Brush salts from low level north west wall behind pews.	1
	M	Regular checks for insect infestation should be undertaken.	1

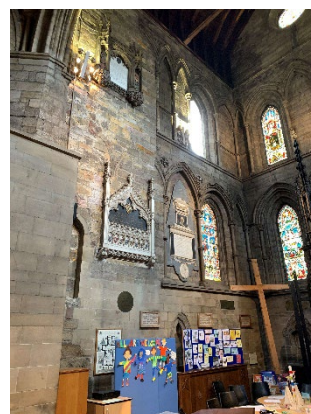
The stonework is generally in good condition although there are areas of salting near the steps to the Pulpitum and also to the flat areas of wall between the monuments. This latter area could be the result of a leaking external downpipe.

3.5.6.		South Transept Recommendations:	Broad Budget Costs
	D	Repoint and monitor mortar cracks to the different elevations.	2
	B	Brush salts from east wall and pulpitum steps.	1
	M	Regular checks for insect infestation should be undertaken.	1

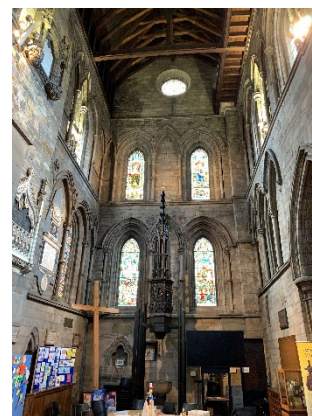
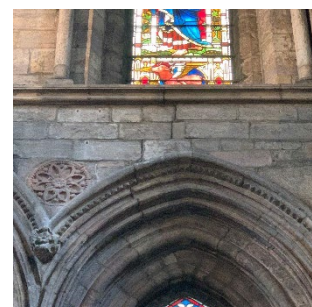
The stonework is generally in good condition. It was noted that there is a movement crack to mortar joints over two windows and these should be pointed up and monitored. These do not appear to have opened up since the 2019 inspection. The staining noted in the 2019 inspection to the roundel window is still present but it does not appear to be letting water in.

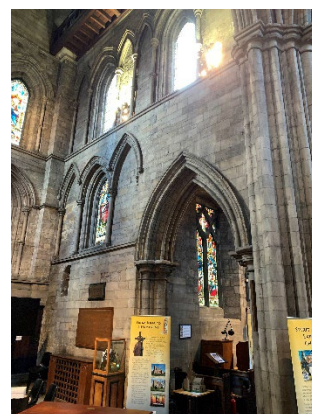
Generally in good condition although there are some cracks to mortar joints at the first stage to the north of the blind arch; and to the upper stage to the south of the uppermost arch. A crudely repointed crack to window 41 was noted. It appears to be of some time ago and does not appear to have opened up.

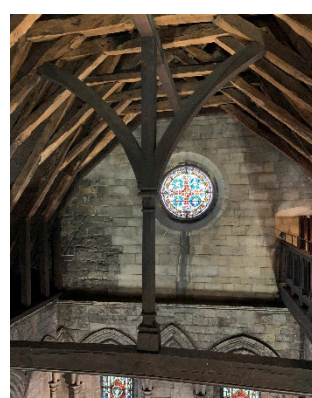
Generally in good condition, the medieval timbers are somewhat gnarled, with evidence of past furniture beetle infestation, however it is understood that the major timbers have been treated in the past.

There appears to be evidence of previous water ingress with staining to the timber penny boarding in places. Any leaks will likely have been resolved by the replacement of the south transept west slope roof in 2017 so the staining may be historic.

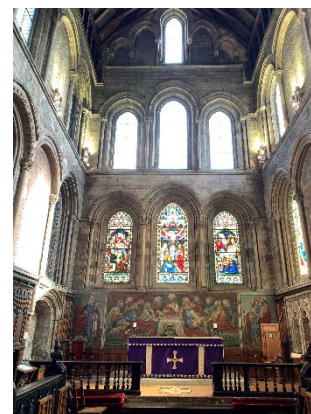
This appears to be generally in good condition. There is an area of stonework of a lighter colour to the south east corner at high level. It was not possible to determine if this is due water ingress. There are some open mortar joints to stonework above window 12c – the eastern stained glass window.

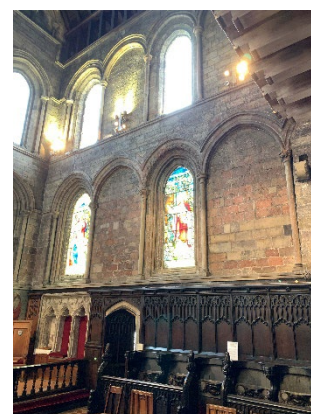
The stonework is generally in good condition, although above the eastern most window 25 at the 2nd stage, there is a cracked mortar joint. It does not appear to have opened up since the 2019 inspection.

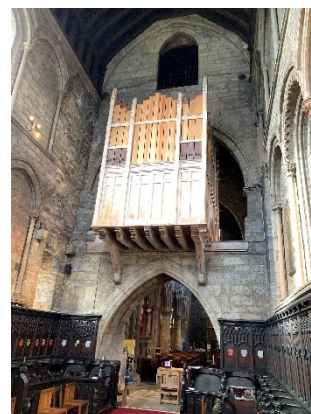
Generally good although some minor cracks to mortar were noted at the north high level corner.

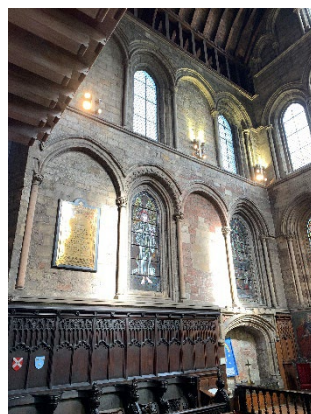
Generally good although there are some open mortar joints in the string course directly in the sill of the upper western most window (35) and above the eastern most window (11) to the 2nd stage.

To the east there is the Easter Sepulchre. Within the arch of the niche, cement pointing has been used and this is very unsightly. Consideration should be made to completely remove the cement and repoint with lime pointing.

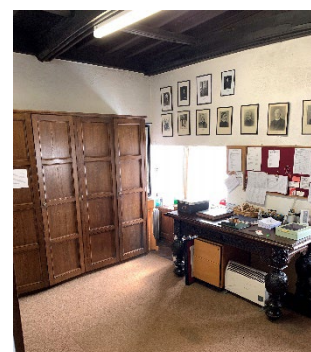
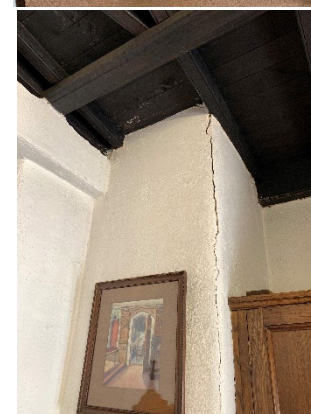
The water stains to the timber boarded ceiling noted in the 2019 inspection are still present, but there are no reports of water ingress and it is thought these relate to a previous leak from the roof above which was resolved some time ago.

There are a two broken quarries to one of the windows.

3.8.2.		Clergy Vestry Recommendations:	Broad Budget Costs
	M	Continue to monitor the crack to the plaster.	1
	M	Continue to monitor for water ingress from the roof.	1
	D	Repair window quarries.	1

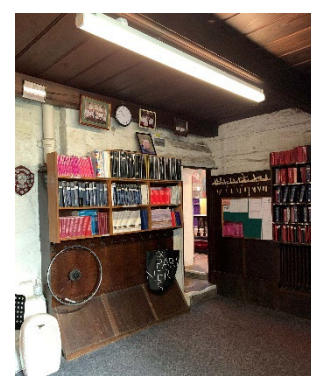
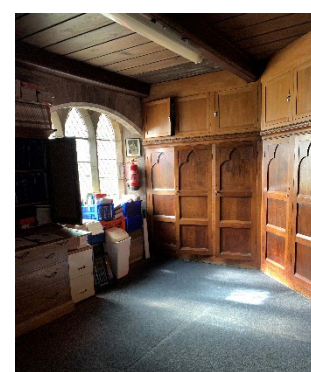
Similarly the water stains to the timber boarded ceiling noted in the 2019 inspection are still present, but there are no reports of water ingress and it is thought these relate to a previous leak from the roof above which was resolved some time ago.

There are water stains to the timber ceiling around the downpipe penetration and the pipe flashing should be checked at roof level.

3.8.4.		Choir Vestry Recommendations:	Broad Budget Costs
	M	Continue to monitor for water ingress from the roof.	1
	A	Check pipe flashing at roof level for potential defects.	1

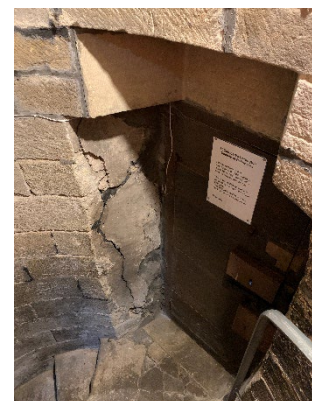
There is some cracking to a crude mortar repair adjacent the access door to the balcony walkway.

3.9.2.		Turret Staircase Recommendations:	Broad Budget Costs
	D	Repair damaged mortar/rendering adjacent to the turret door.	1

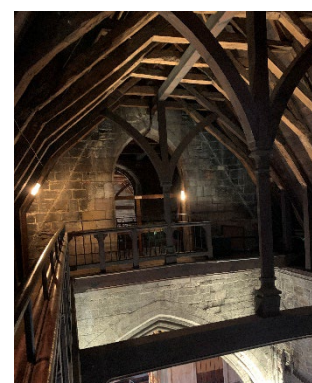
Fair condition. The timber balcony has had steel balustrading added at some point in the past to bring the height of the guarding upto the required height for safety.

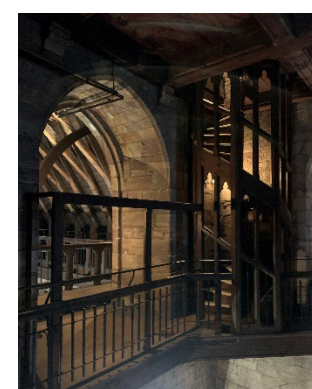
The timber structure to the stair has large open gaps in between the vertical struts and these should be closed up with additional balusters to mesh infill.

3.9.5.		Balcony Walkway and Staircase Recommendations:	Broad Budget Costs
	B	Add balusters to the timber staircase to close the gaps.	2

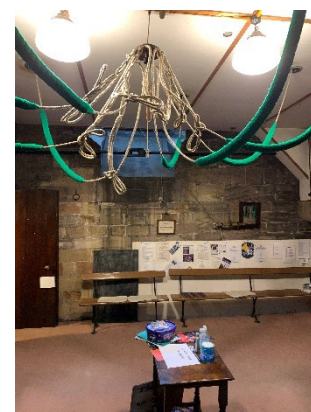
There are water stains to the ceiling in places, in particular around the bell rope penetrations. It is possible that wind driven rain is entering the belfry openings above and onto the Belfry floor.

3.10.2.		Bell Ringing Chamber Recommendations:	Broad Budget Costs
	M	Monitor for water ingress above.	1

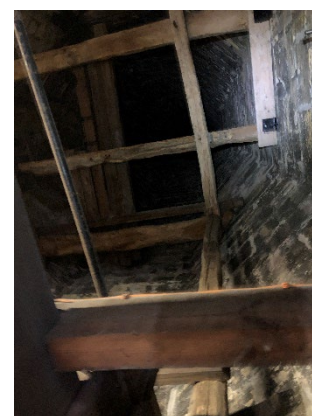
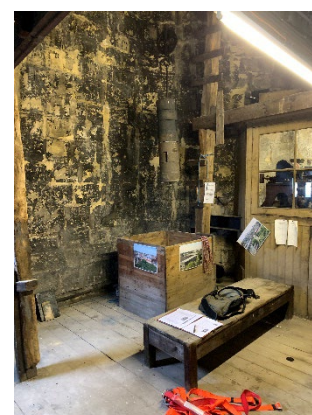
Condition: Fair generally but several areas have water staining which may indicate water ingress from the spire above.

3.12.7.		Spire Recommendations:	Broad Budget Costs
	E	Refurbish carillon.	2
	D	Commission a steeplejack to ascend the inside of the spire and provide an inspection report.	2

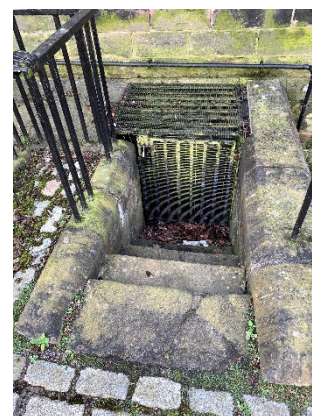
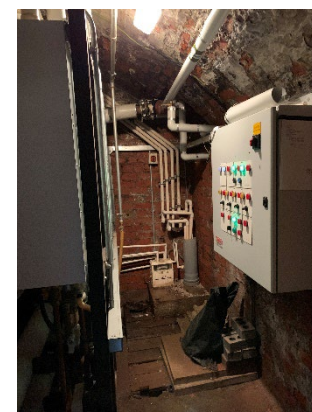
Some of the metal pipework is rusting.

Lighting is inadequate with poor illumination.

The floor is uneven in places and the timber duck boards are decaying in the wet conditions.

3.13.2.		Boiler Room Recommendations:	Broad Budget costs
	B	Repoint open joints to external stonework.	1
	C	Consider improvements to minimise water ingress down the steps entering into the boiler room, and also via other openings.	2
	C	Remove decayed timber duck boards and assess the flooring to remove potential trip hazards.	1
	C	Enhance the lighting to improve light levels.	1
	B	Commission and services engineering consultant to advise on repairs to pipework.	1
	M	Regularly remove leaf build-up from steps.	1

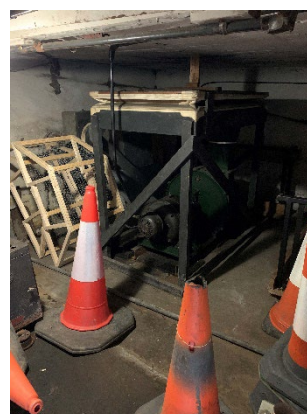
The roof is a painted concrete soffit with painted steel members.

The floor is concrete.

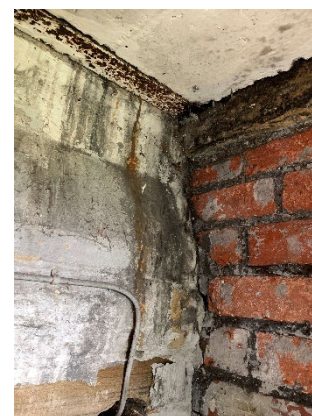
Internally the painted masonry and rendered surfaces are flaking. The steps would benefit from a hand rail.

Steel roof members are rusting.

3.14.3.		Blower Room Recommendations:	Broad Budget costs
	C	De-rust steel members and redecorate.	1
	C	Replace the felt roof coverings to the external stone enclosure.	2
	E	Provide handrail to the steep steps.	1

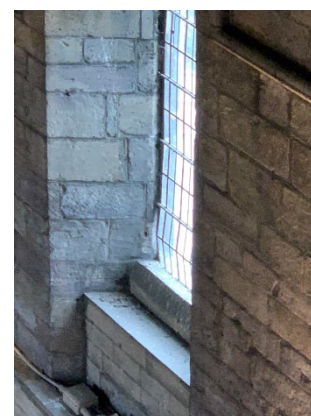
3.15.2. The windows are in various states of repair, some of the defects dating back some time. A window report was carried out by Josie Kyme in 2015. Repairs were carried out to several windows in the Chancel by Jonathon Cooke in 2019.

Other windows are showing signs of deformation and buckling, in particular some clerestory windows to the north and south nave clerestories and also in the north transept. Other have fractured glazing.

Discussion was held in 2019 about access to the south clerestory windows to gain a closer inspection and some guidance and budgets were provided by the Cooke's. This work did not proceed due to lack of funds, but this areas should be revisited.

3.15.3.		Windows Recommendations:	Broad Budget Costs
	B	Consider how high level access can be provided to closer inspect the high level window defects.	2
