Diocese of Durham

**DENESIDE ALL SAINTS
SEAHAM**
(94)

QUINQUENNIAL REPORT
on the architect's inspection on

14 June 2017

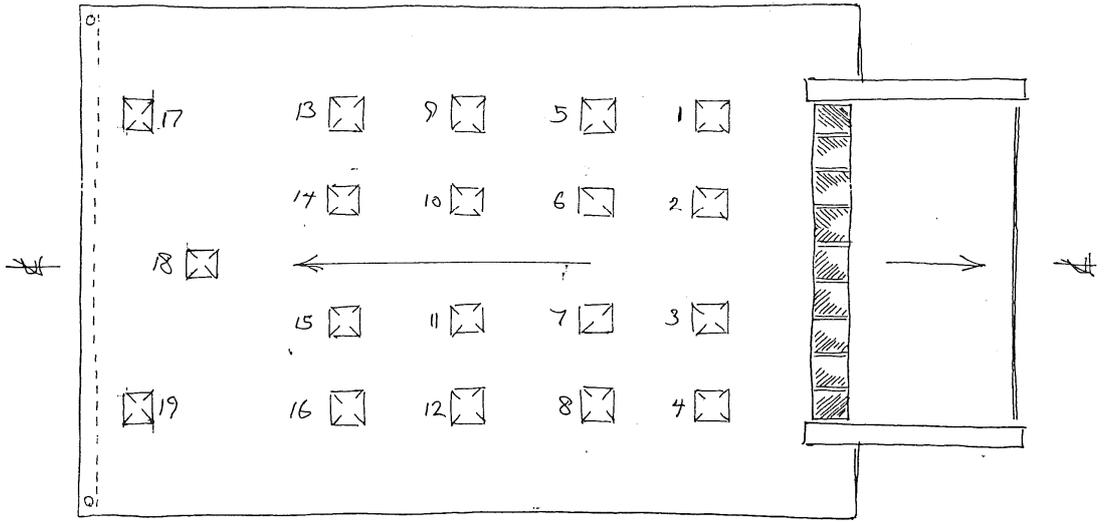
ROOF PLAN

6. The building is stable and in good general condition. The inside is well maintained and attractive.
7. One of the nineteen rooflights leaks on occasion (no. 10 on plan).

1, 14	single skin, sound except broken corners
2, 7, 8, 9, 10, 17, 18	sound but 9 lacks most of its fixings, 10 has water trapped on the kerb Recent drips are reported under 10.

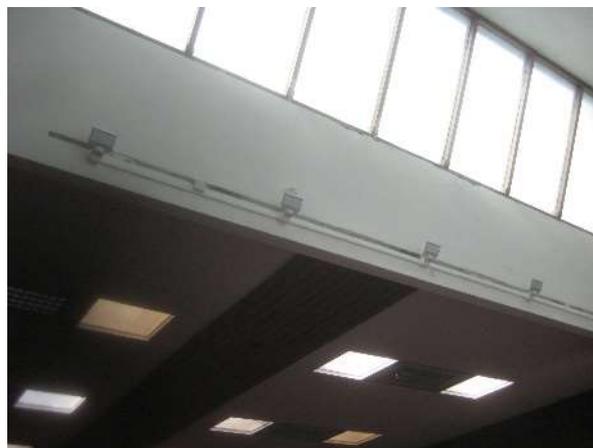
54. Rising main to main fuse and meter in Vestry where renewed distribution board with 30mA residual current device (RCD) protection. Wiring mainly concealed. Some surface wiring in orange pyro painted out in parts. The installation is estimated 35 years old with more modern distribution board.
55. Serious defects reported in the May 2013 Periodic Inspection Reports appear to have been rectified.
56. At Nave recessed ceiling fluorescent lights. On blind side of Sanctuary beam five recent LED flood lights on conduit. Concealed fluorescent tubes over NE and SE escape doors. A domestic white wall light over Our Lady of Walsingham mounted on wall with black surface cable to socket.
57. In Lobby recessed fluorescent lights with wall lights renewed 15 years ago when the Vestry and Kitchen are reported rewired. Single pendant in kitchen. Bare pendant GLS lamps in wcs. Outside light.

58. In Vestry two pendants, plastic recessed and surface 13A sockets. In Kitchen twin 13A sockets at low level, cooker outlet and 13A socket used for organ blower. Disused fused spurs for former water heaters in Kitchen and wcs.

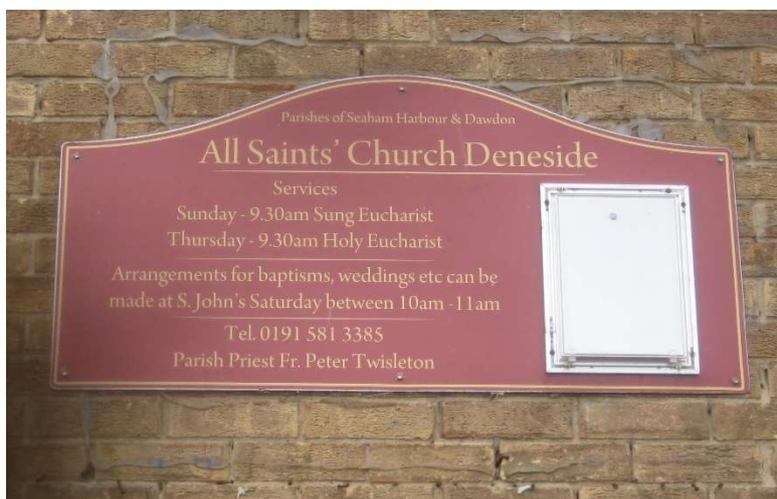
68. An unfenced rectangle of sloping grass without trees, surrounded by footpaths and houses. Access from E across a tarmac car park and wide paths both sides to the W entrance at the blank side. Two streetlights on site.
69. Many pedestrians use a footpath along the site's W edge, not connected to the entrance. An improvement might be diagonal paths from the W corners to the church.
70. A small neat sign on the church E wall needs updating. An opening notice case is too high for easy use.
