QUINQUENNIAL INSPECTION REPORT

CHURCH OF THE ASCENSION

SEASIDE LANE, EASINGTON COLLIERY, COUNTY DURHAM, SR8 3PG

v.2 | APRIL 2022

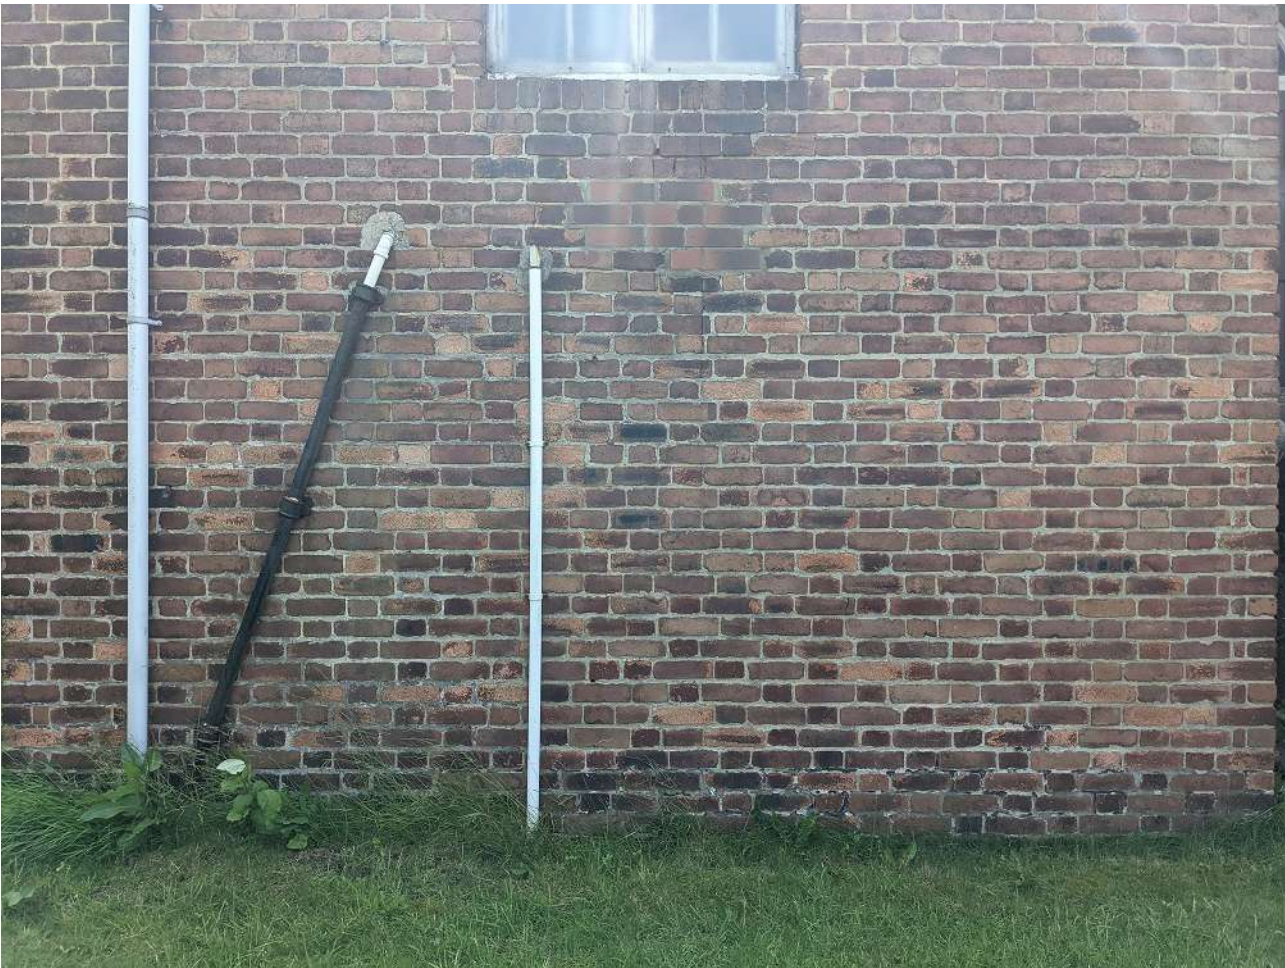
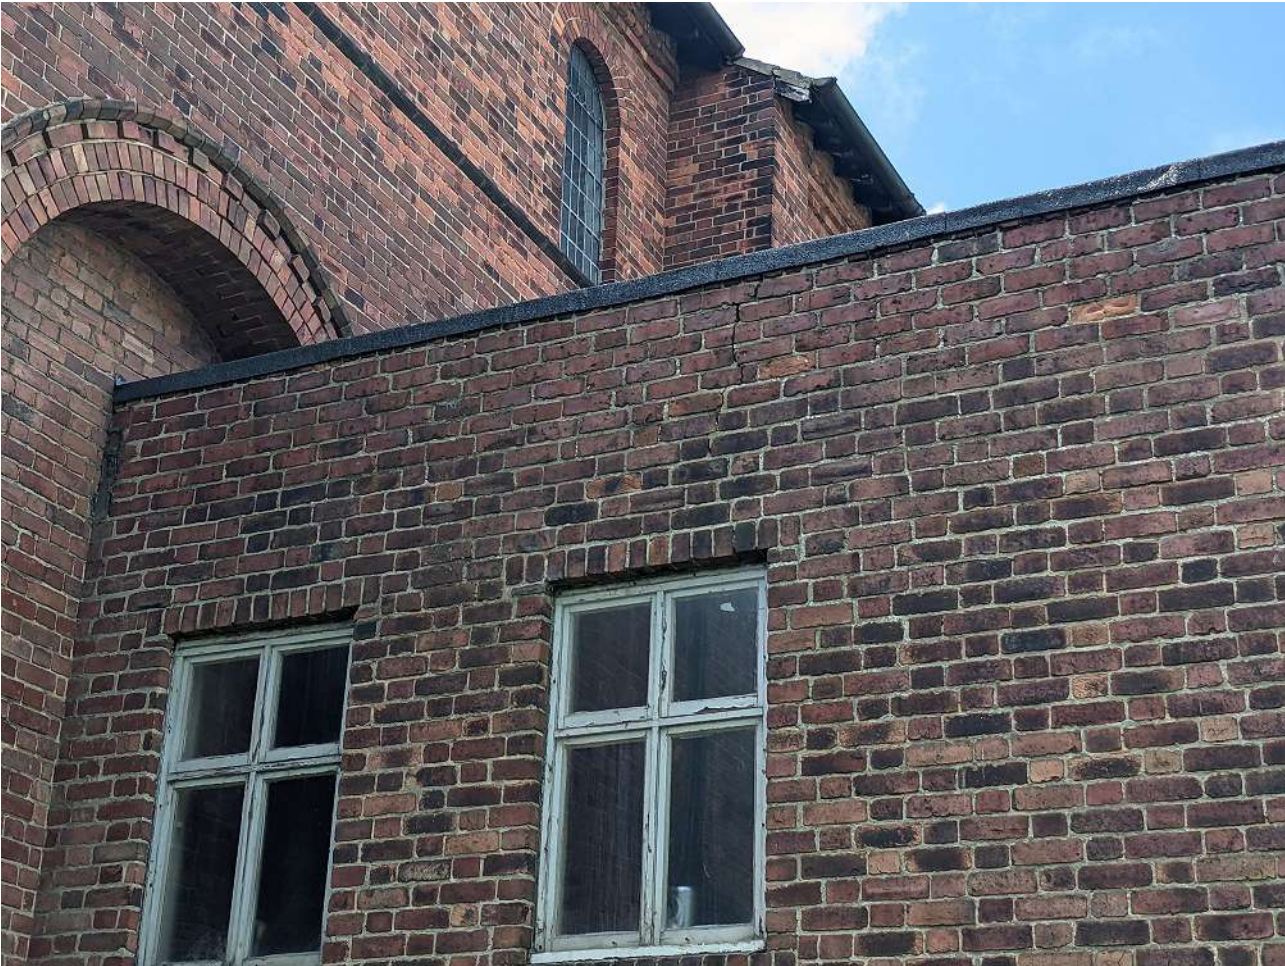
7.4 SOUTH ORGAN BLOWER CHAMBER

7.4.1 Brickwork and pointing in sound, satisfactory condition. Full inspection not permitted due to plant growth locally.

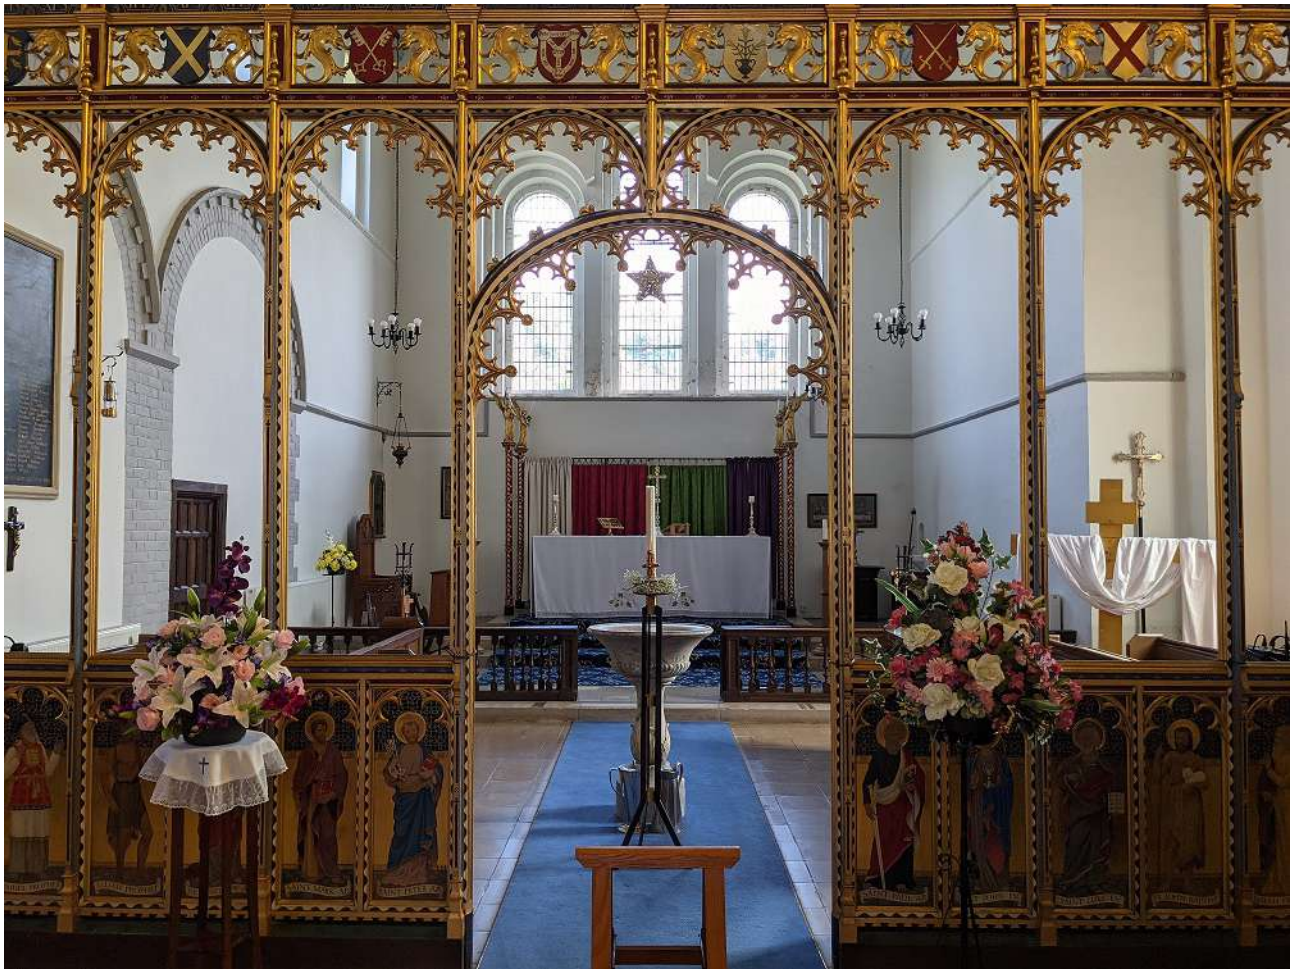
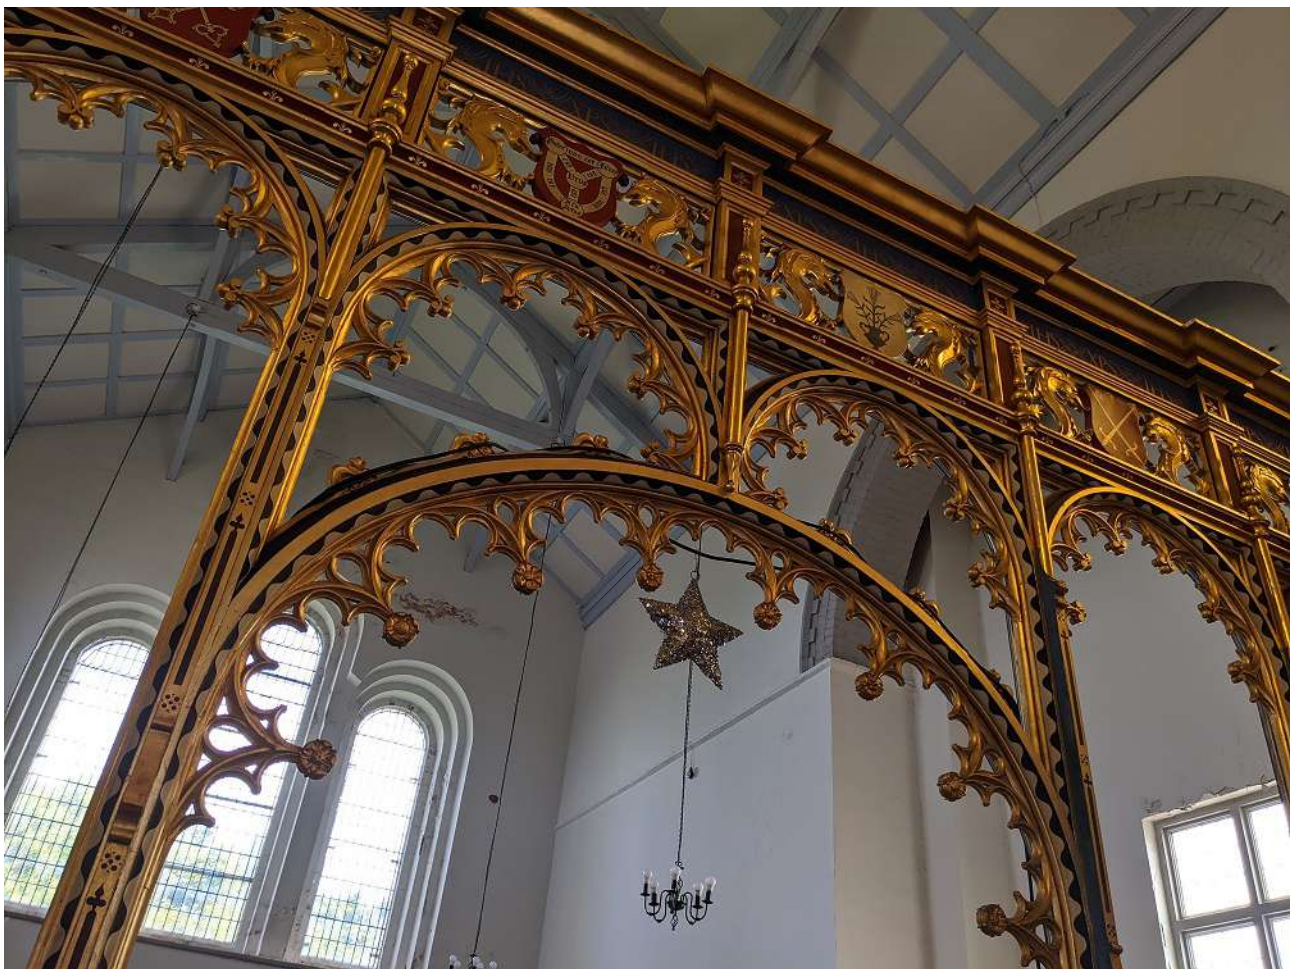
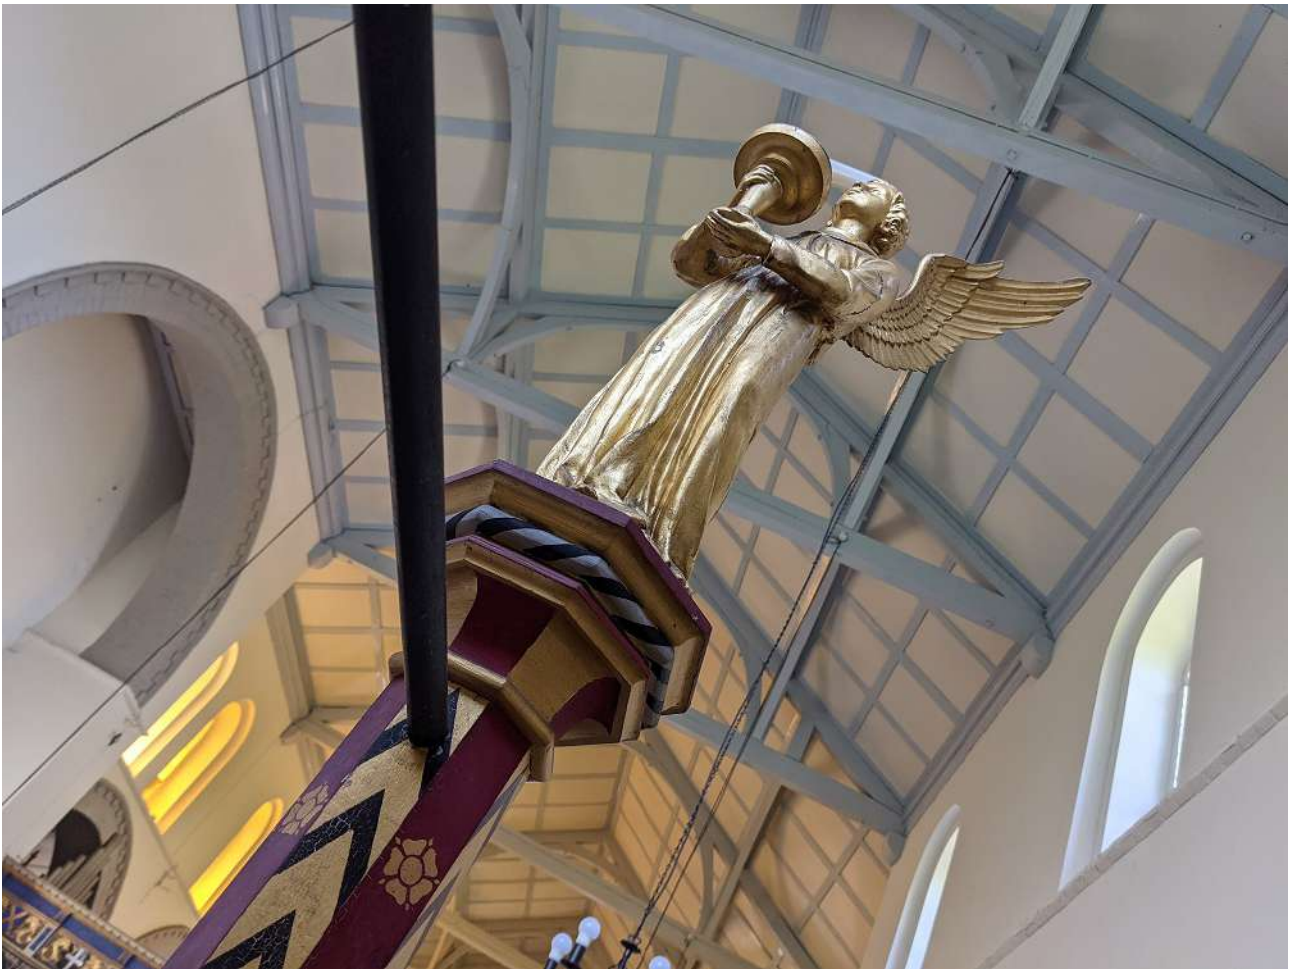
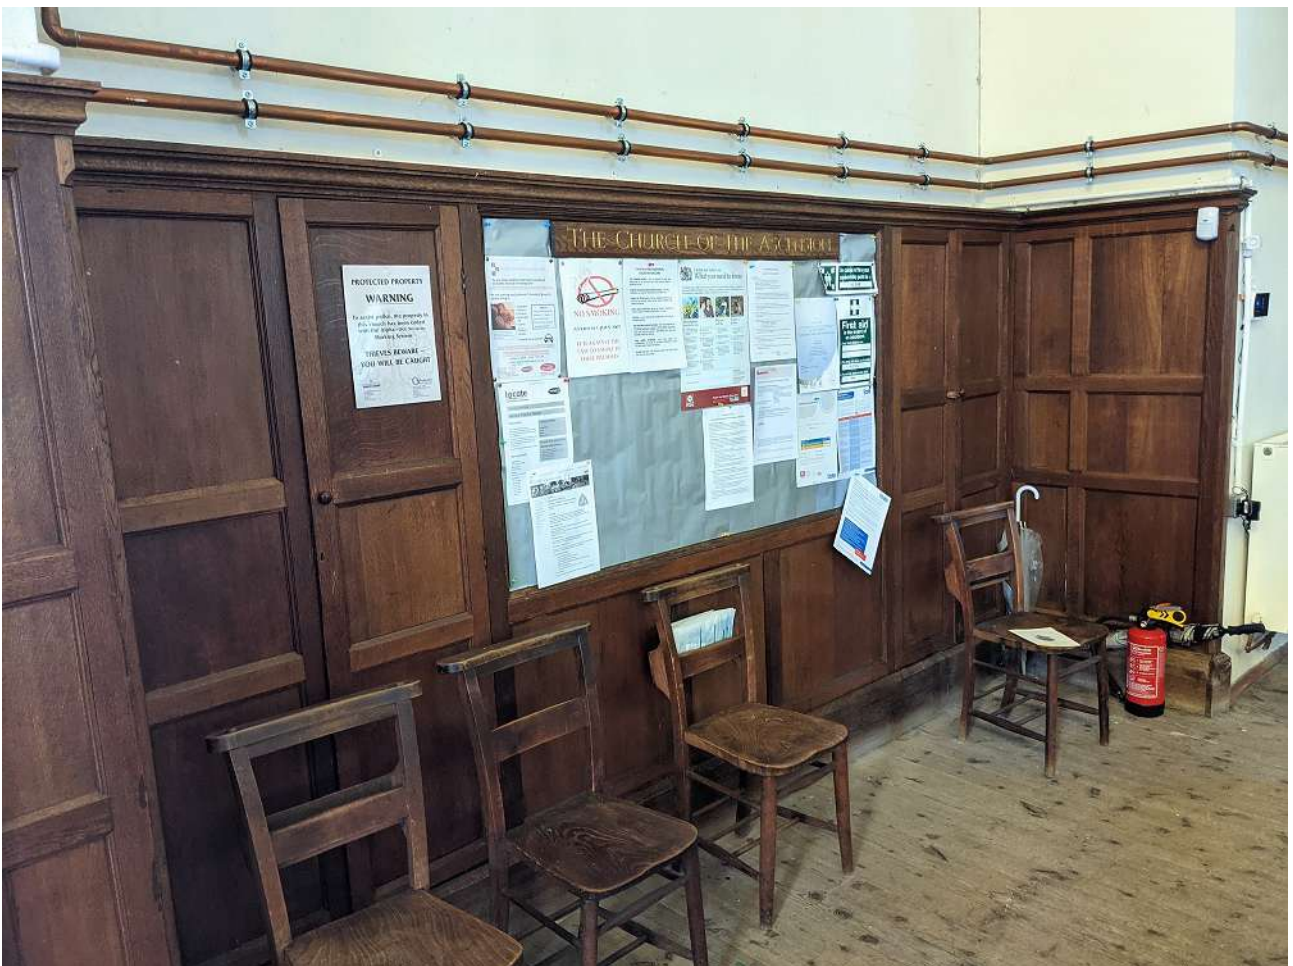
15.3 CHANCEL – VESTRY OAK PANELLED DOOR

15.3.1 The oak panelled door appears in a sound, good condition.

M Although there are no signs at present of any insect or beetle infestation it is sensible to be mindful and regularly check for any signs of activity in this area.

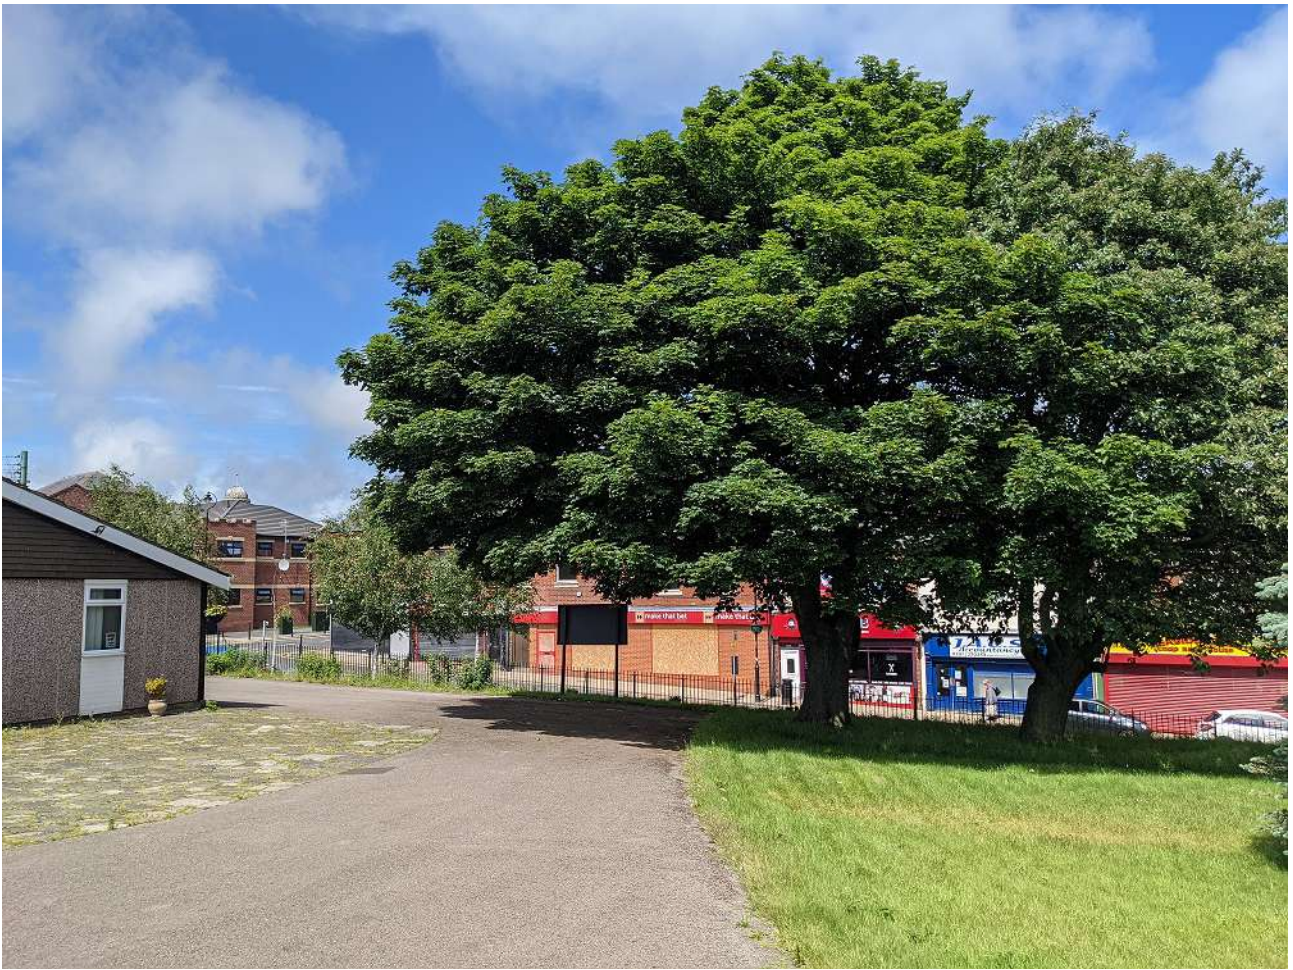
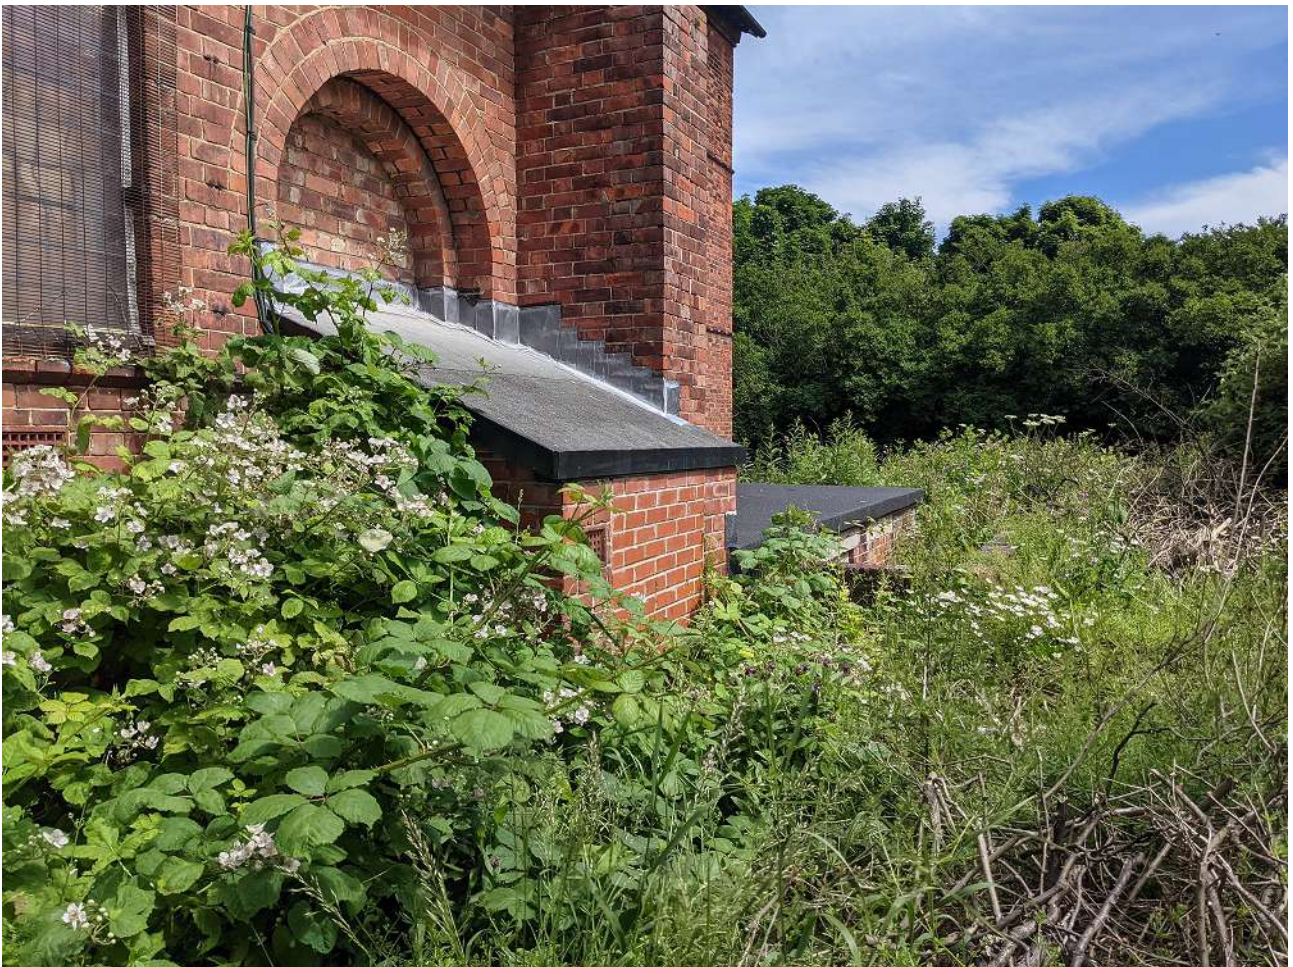
Boundary wall in a sound, satisfactory condition.
