**QUINQUENNIAL INSPECTION REPORT
OF
EASINGTON, ST. MARY**

**DIOCESE OF DURHAM
ARCHDEACONRY OF DURHAM
DEANERY OF EASINGTON**

QUINQUENNIAL INSPECTION AND REPORT

January 2021

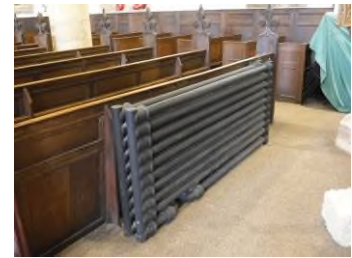
D Heating: Twin gas boilers, over thirty years old, below the tower floor serves cast iron radiators formed of pipes with a large pipe distribution system. It is reported to have about four to five years left in it and the church will be considering a new heating system within the quinquennial.

Last inspection was February 2016 and there have been repairs to leaks in November 2018 and June 2019.

Recommendation: plan for improving the heating system

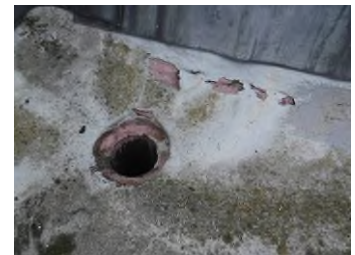
C Tower Roof:

Concrete flat roof with c. 15 year old liquid membrane covering which has holes and tears. It has been patched and may take one last round of patching but full replacement is recommended. One of the flashings are loose on the W side where the flagpole stay is, the flagpole stays look ok as does the glass fibre flagpole, though there is some rust of the bolts showing on the soffit of the roof. The parapets are single stones and look a little bit worn at some of the pointing. The pointing is a heavy grit that is generally alright, and there is just one small area on the E guy rope that is buckling slightly but doesn't need any attention.

The lighting conductor has four air terminals and it is connected to the flagpole but there isn't one all the way up the flagpole. The roof seems to keep itself clean but there is no balloons over the outlet, there are downpipes in two positions on the E side going down on the N and S sides.

Recommendation: replace roof covering, repoint loose flashing

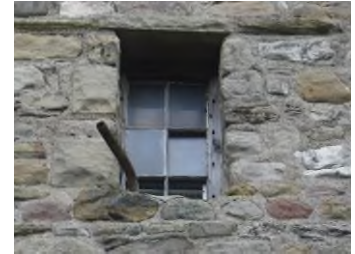
Ringling Room:

- **Ceiling** – The ceiling is over boarded with pine boarding.
- **Walls** – The walls look ok. There is an aluminium flue running up but it also looks like an old brick flue close to it which is showing signs of salting, is that the downpipe route out?
- **Floor** – Timber floor with carpet.
- **General** - The room could do with a bit of a clean-up it is a bit scruffy with paint breaking down. The W window looks a little poor it has been broken in the past and birds will get in here, this houses the security alarm system. The door catches the carpet, the key is kept up here on a string and is a little awkward to open because you are twisting at the top of the stair.

The room contains the clock by W Potts and Sons, Leeds 1895, this has got weights and chimes on it, it looks like the clock is maintained by Smiths of Derby and the last inspection was March 2019. The room has two electric convector heaters and the heating expansion tank is in the room. The ladder to the belfry is frightening (it is long and has little rungs). It should be replaced with an aluminium ladder.

Recommendation: repair window, ease door, tidy up, replace ladder

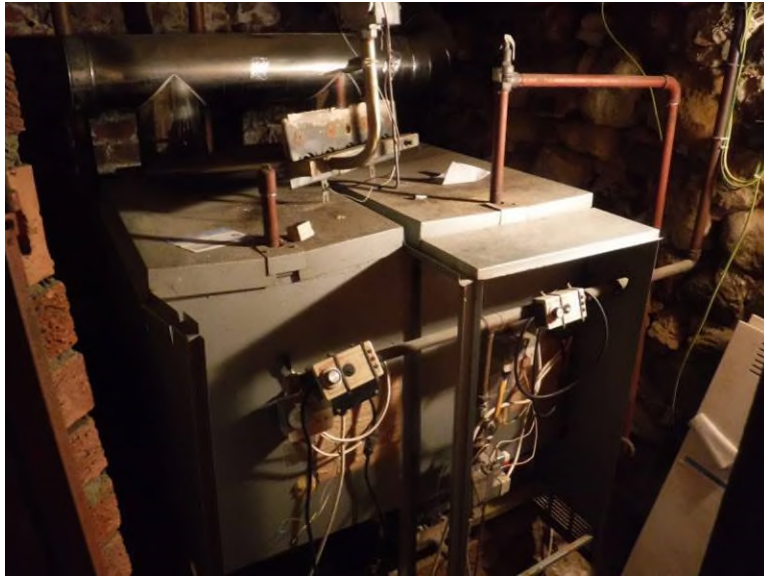
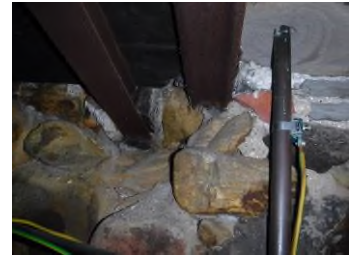
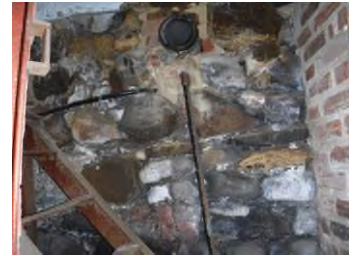
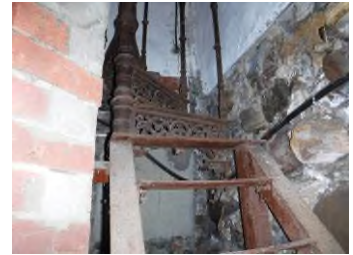
Boiler Room:

Under the tower, entrance at the foot of the spiral staircase.

- Ceiling- see above
- Walls – The walls are rubble stonework. There is a brick enclosure within the space to provide possibly a fire box for the boiler but it's not effective. There is a metal door for the box but that is no longer on and there is a smell of gas.
- Floor – The floor seems to be nothing more than beaten earth or concrete- it is not very clear.
- General – The rooms contains the boilers which are ancient now, there is some combustion air that comes from a pipe to the space, I guess that is why the door is taken off because it would choke it and there is a large grille above that combustion air. The whole place is a bit poky.

Recommendation: assess fire risk

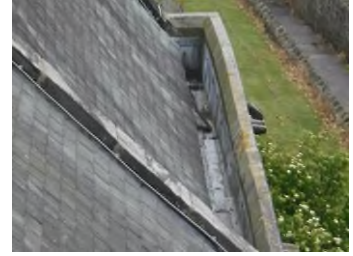
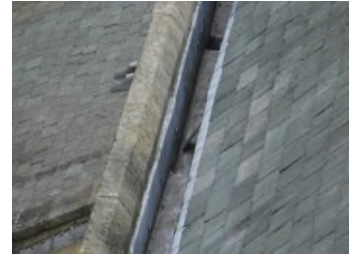
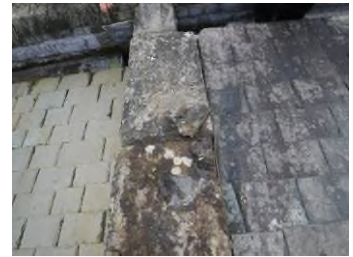
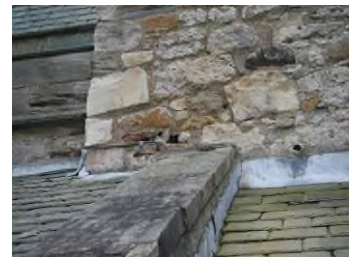
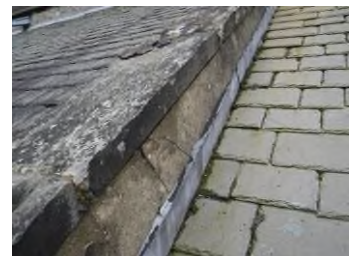
But there is a problem at the junction of the N aisle to vestry.

The water table stone is laminating, the side render at the flashing is cracked and the slate junction flashing is leaking. This is causing damp inside and the loss of plaster.

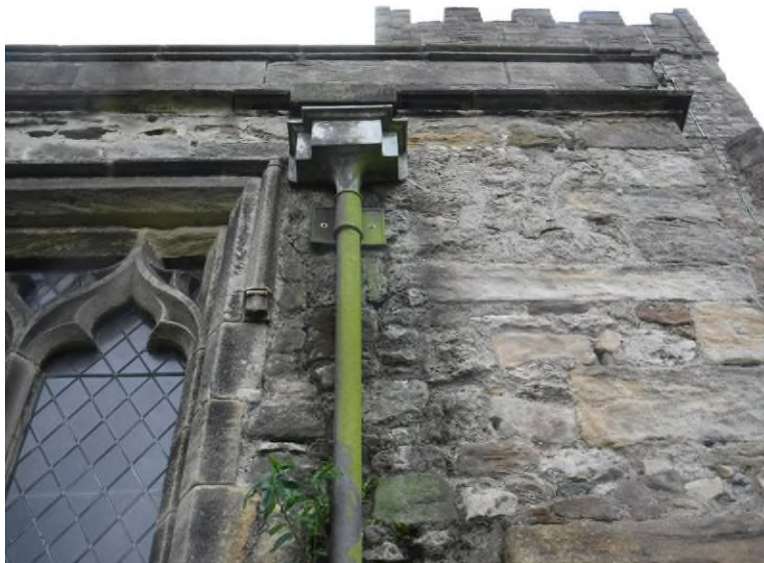
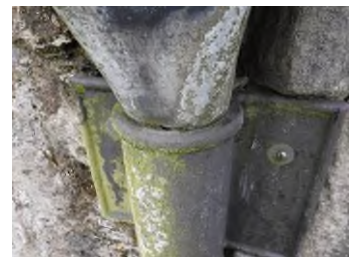
The roofs have deep parapets and they are all lead lined, the lead lining is sound. But there is a significant problem of blocking of the parapet sumps and outlets that comes as a result of lack of maintenance and an element of design. The lead hopper design is fair but does choke as it goes into the downpipe. About seventy percent of the downpipes are blocked including the

tower. The fixing back of down pipes is loose in some positions. The gullies and channels are blocked with leaves.

Recommendation: carry out gutter clearing maintenance. Enter into an annual maintenance agreement with a suitably qualified ecclesiastical roofing contractor. Remodel hoppers

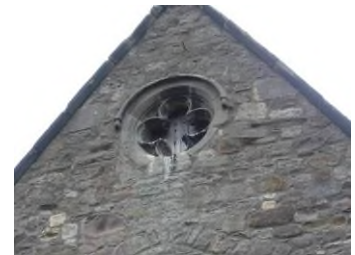
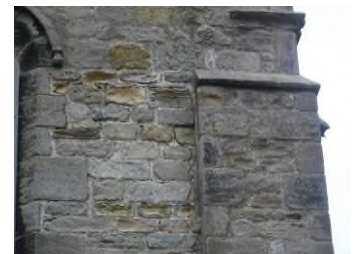
M East Gable of Chancel:

Water table is very steep, open joints at the apex but appear sound. General walling is good as are the buttresses. The quatrefoil light at the apex has bird marking and timber board behind it may have a split.

Stepped five light lancets look ok, covering of grey polycarbonate can't really see the joint of the glass. Above them a relieving arch in the stonework, one stone beginning to dish out but not a problem. Below that there is a relieving buttress underneath the

middle lancet that is ok, as is the plinth below it. There is a down tape coming in the S corner.

There is some movement to the outside edges of the wall plate suggesting there is a bit of wall head movement which is more exaggerated on the S side and this was picked up in the last QI. It looks a bit more active to my liking so needs monitoring.

Recommendation: monitor kneeler

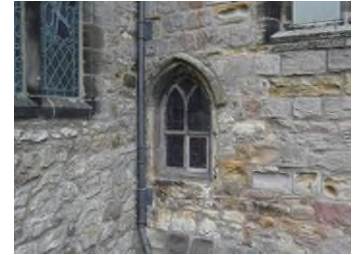
- **South Chancel:**

Slight lamination to one of the parapet stones but no need for action. The general walling is sound though there is some erosion. There is a run of four at the W end that might want some attention sometime in the next ten years or so.

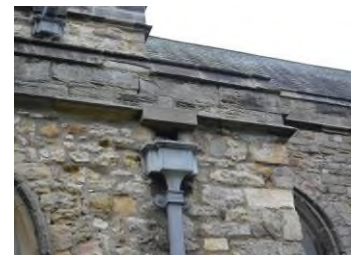
- **South Aisle:**

This has been heavily cement repaired in the past and there are quite significant pockets of erosion to it, some of these were attended to as part of the GPOW works. The parapet is quite laminated in places, there are a couple of apex stones that look as though they might want replacing and some open joints to the pointing, a panel of stonework below the western most window looks in most need. The moulded string under the parapet is decayed in about twenty five percent of the places. This can all stand for 5- 10 years.

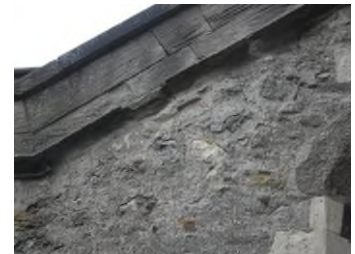
D **North Aisle:**

W end has a massive buttress to the nave that looks ok. There is some slight cracking to it and it also looks a bit wet but I think it is ok. The raking moulding supporting the parapet is quite decayed. The stonework is heavily covered with cement a bit like the S aisle and some eroded stonework possibly a damp corner.

The N side has a significant amount of cement pointing over it and quite a few open joints particularly at low level and the buttresses. Leakage from rainwater pipes has wetted the walls at both ends. The parapet looks ok and the cornice moulding is eroded in some parts but generally ok.

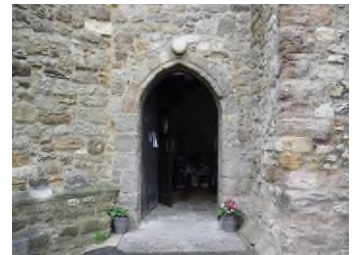
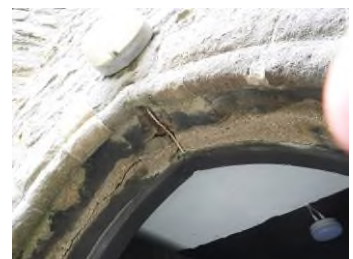
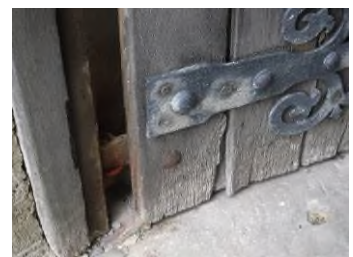
D Tower Door:

Surround much eroded, a mixture of grit stone and magnesian limestone and sandstone, also with some slate packing. The pointing to the doorframe is coming apart and there is a big gap at the bottom of the door. Within the inside of the arch the pointing is breaking up too.

Recommendation: repair door and repair pointing

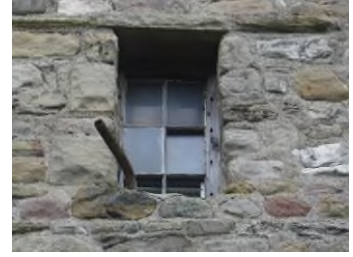
C Tower West:

- 1) Belfry louvre, can't see from the ground very well.
- 2) Ringing room window, timber, four panes, one pane dislodged and joinery has no decoration, it has a pipe coming out of it and a bit of mesh, a bit of a mess all round.
- 3) Pictorial glass which has been over glazed with glass and pointing in the opening is broken.

Recommendation: repair ringing room window

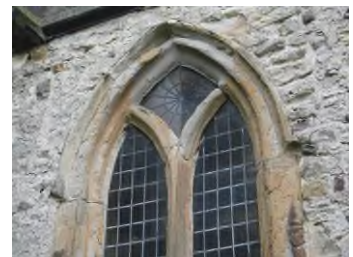
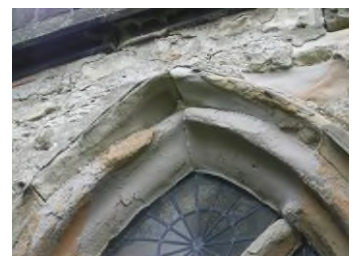
- Organ and Vestry:

Arched twin light with wide tracery and hood mould. Worn but will last for 5- 10 years. The mullions are laminating as well. The cills are reasonably sound. Vestry door is ok, the iron work is rusting a little.

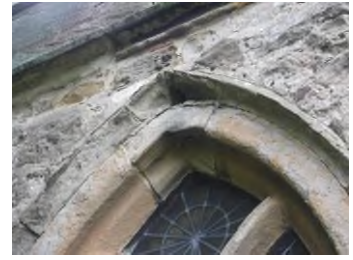
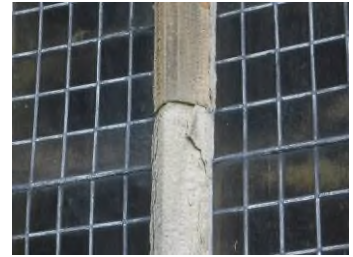
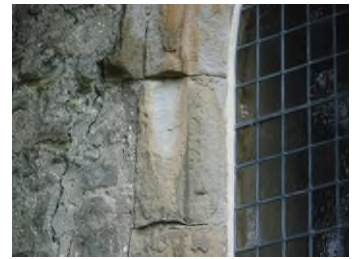
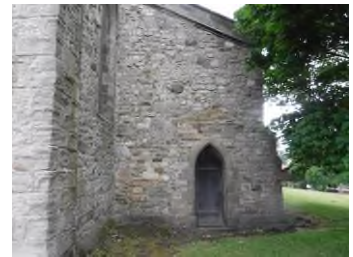
North Chancel:

Arched twin light with wide tracery and good hood mould in good condition. Has dirty polycarbonate.

Recommendation: none

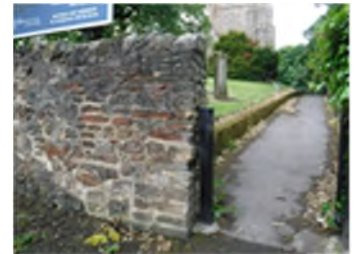
D **West Boundary:**

Onto houses and this has quite a lot of Sycamore on the boundary here, it is quite a strong buttressed wall, looks like it has had a cement face to help it retain better. Probably the Sycamores are bursting the wall a bit, I think the wall is actually built in-between it. Good handrail leading down to good metal gate at the north but the post is loose, slight undulation to the tarmac on the verge down to the highway.

Recommendation: fix post

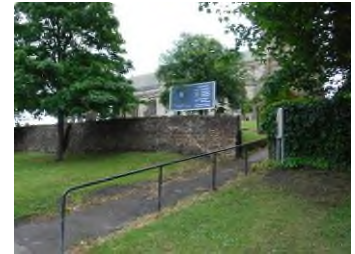
- **North Boundary:**

Fairly substantial battered stone wall retaining the churchyard approximately five feet high. It has been cement repaired.

Recommendation: none

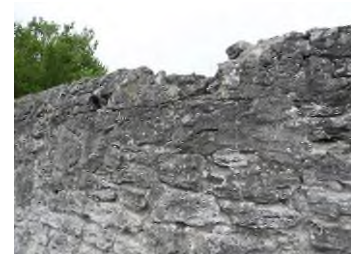
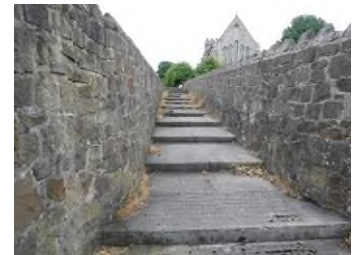
D East Boundary:

The boundary turns round to the E, part of the coping is lost just at the junction, over all it is sound. There are two or three places where the coping has gone. A pair of good iron gates currently locked, so those haven't been tested. There is a seating area dated 1897 up against one part of the wall.

Recommendation: repair coping

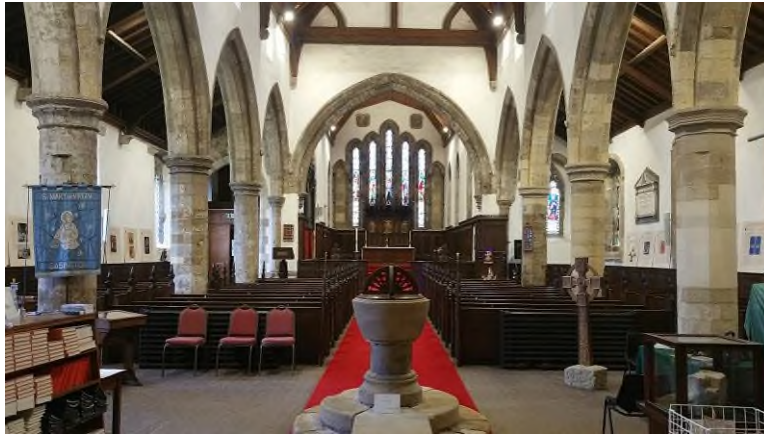
Tower arch – this is flattened now and the pilasters are leaning outwards. The capitals are broken on the nave side, very dark cement pointing to it in all areas apart from the S side impost.

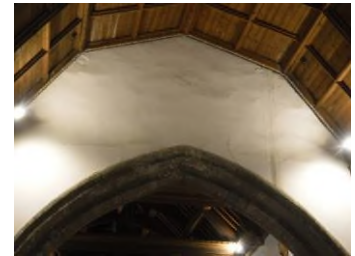
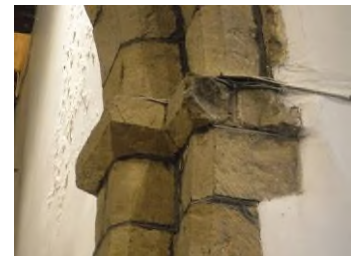
South arcade - has been restored as part of the 2016 GPOW works and a few replacement arch stones. The W most column has had fifty percent of its stones replaced. The capitals were replaced in sandstone rather than magnesium limestone. The E column is the next for repair because as the third course down is beginning to break, the central column was repointed as part of the GPOW works.

North arcade - Is good with old lime wash showing and some decay of stonework to the W column and mid height in the central column, it is recognised that the columns might have been repaired with cramps (none seen on the S) and that is why the W most is spalling.

Recommendation: S arcade W column monitor stone decay

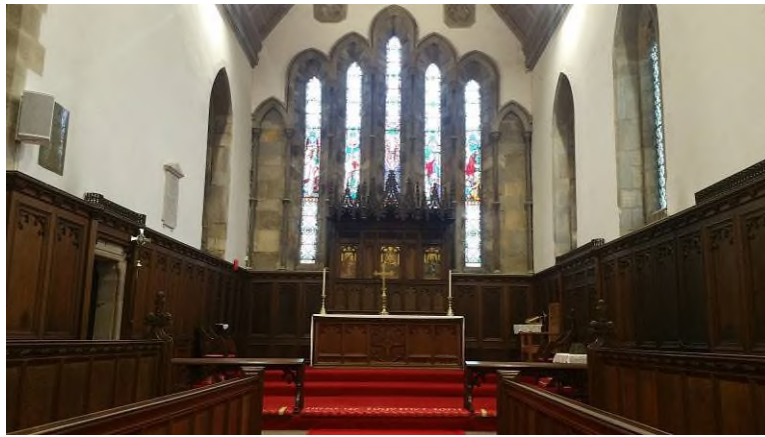
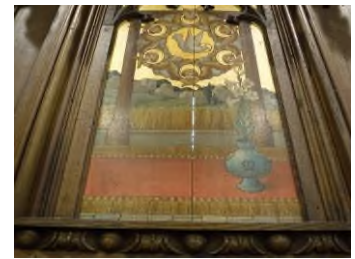
Chancel – has nice fitted out dado panelling in oak with good reredos with figurative art, the tracery panelling is mid-17th century. The vestry door is in oak and ok.

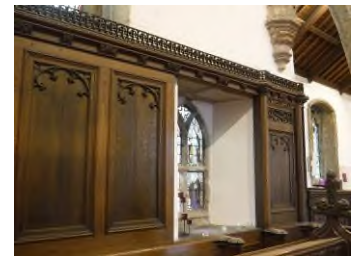
Vestry arch – infilled with 1930's oak panelling.

The vestry partition is formed by boarded soft wood painted brown there is some decoration upkeep required where the former cupboard has been removed, door is ok though it squeaks.

Recommendation: redecorate vestry partition, ease door

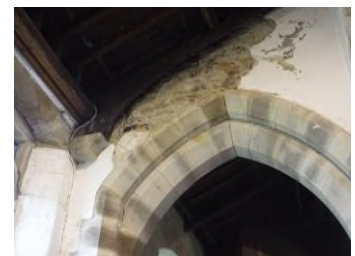
Vestry – The vestry has a large area of damp against the window reveal it looks as though it has been repaired in gypsum plaster in the past. There are cracks in the adjoining wall and is decay in the masonry. The loose plaster has been removed and is drying out before repair. The vestry outside door has some rusting ironmongery and cracking at the lintel.

Recommendation: replaster and decorate vestry/organ high level wall after roof repairs.

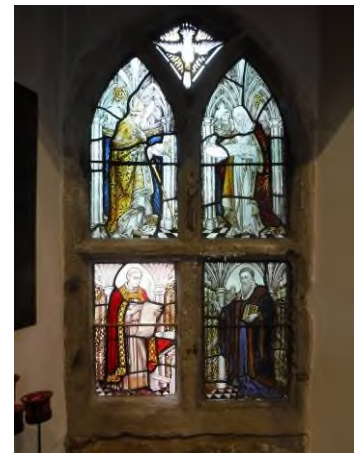
South – Three two light windows geometric leaded diamond with some reuse of older painted glass at the W end, some modifications to the saddle bars in the past, glass looks stable but is dirty.

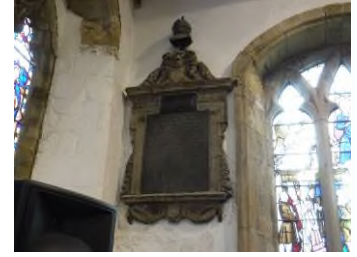
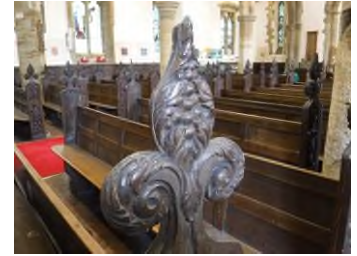
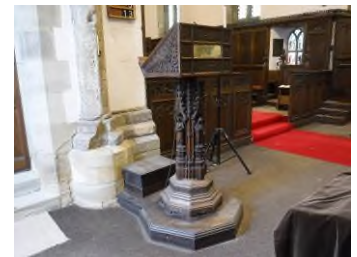
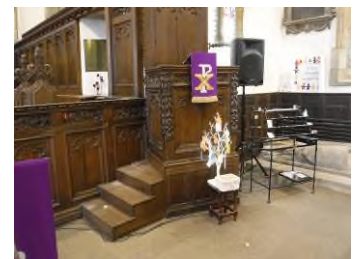
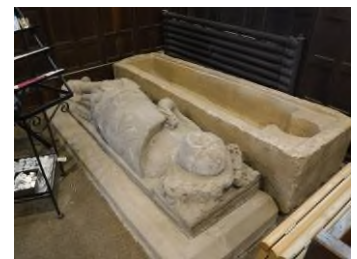
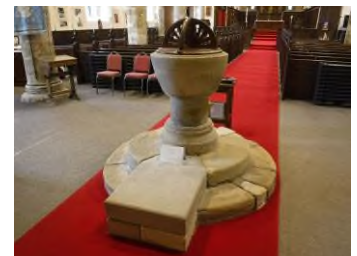
South Aisle – There is a monument to Conyers which has a cracked head to it and some damp to the wall beneath it, to the right is a classical marble monument just dirty.

East End of North Aisle – Female effigy in Frosterley marble dated 14th century in very good condition. Kept toasty by the large radiator- is its proximity causing any damage?

Mirrored at the S E with a 13th century sandstone effigy of a Knight alongside a stone coffin- also close to the radiator.

Recommendation: none
