## QUINQUENNIAL INSPECTION REPORT

**St. GEORGE'S CHURCH**  
FRONT STREET, EAST BOLDON, NE36 0SW

APRIL 2021

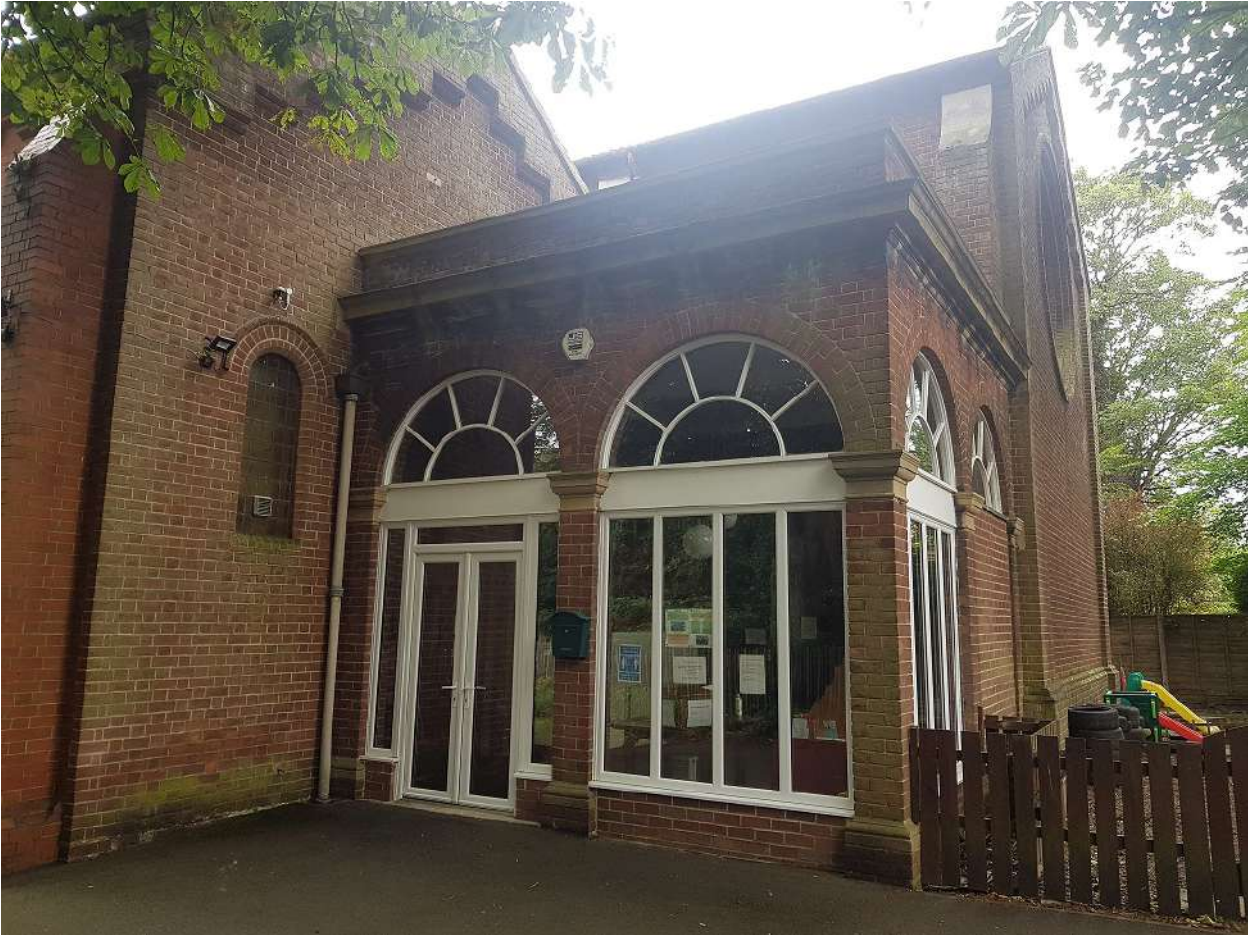
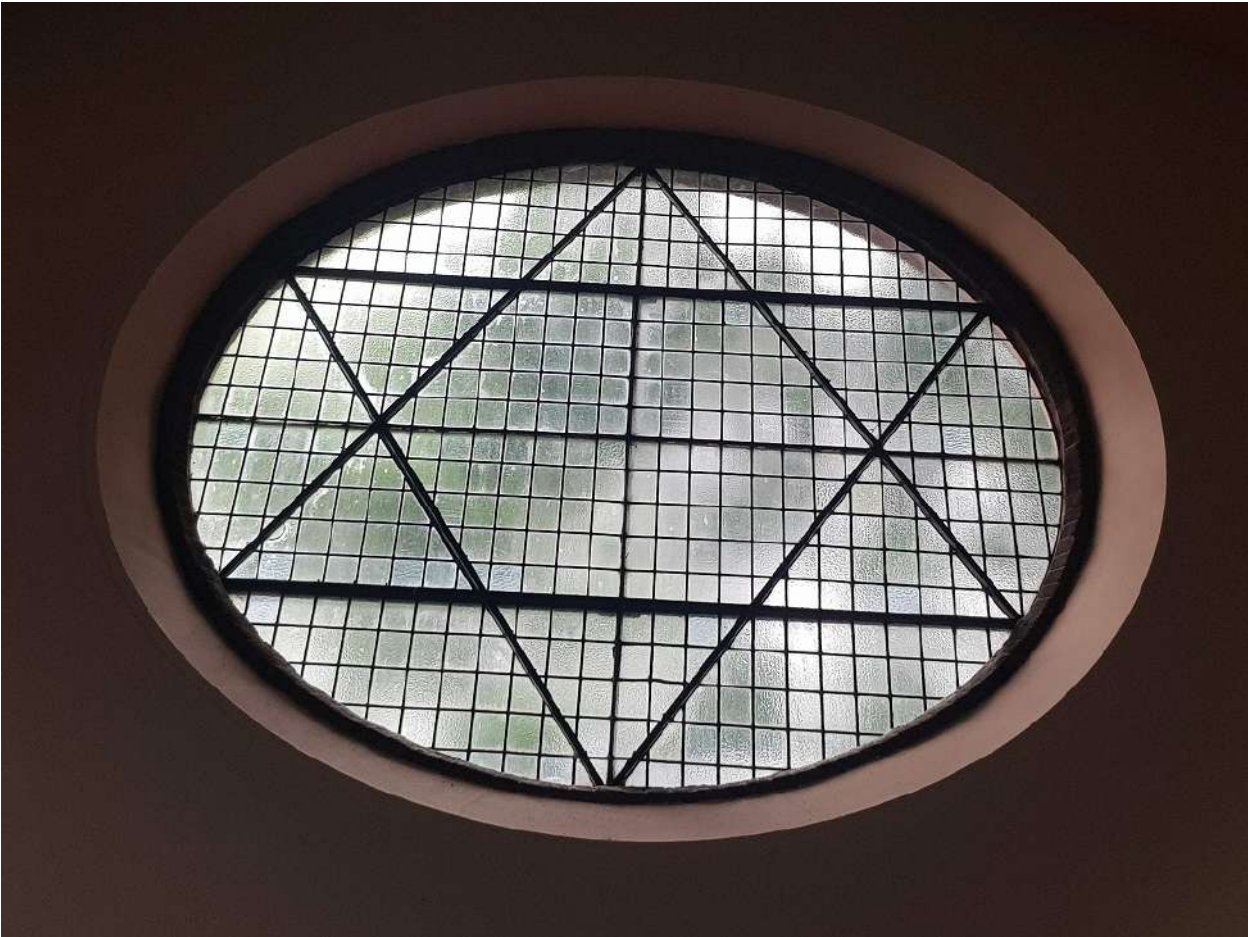
Timber infill panels to the entrance porch have been recently replaced with white UPVC frames and double glazing.

9.1.1 Generally the windows remain in a sound, satisfactory condition.

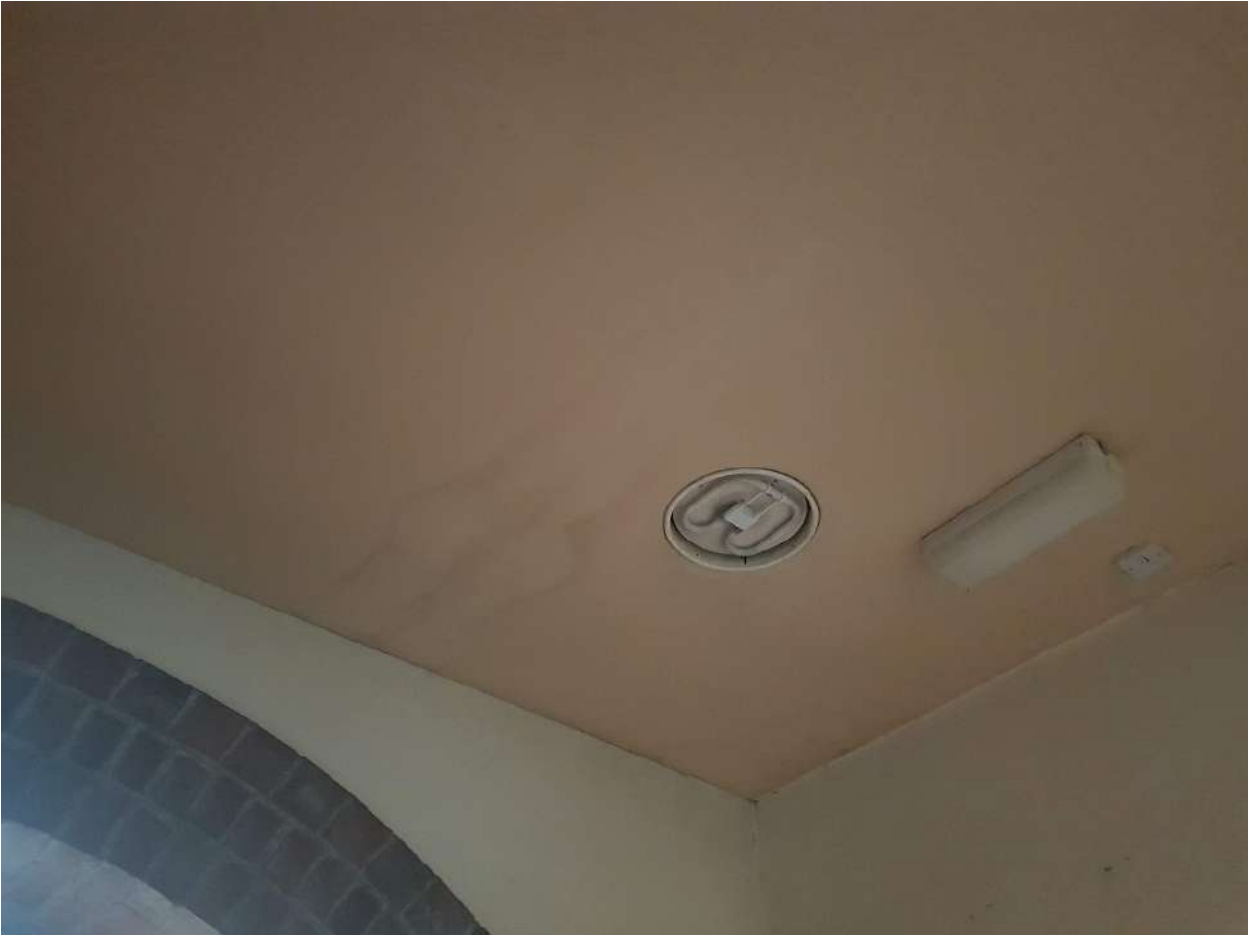
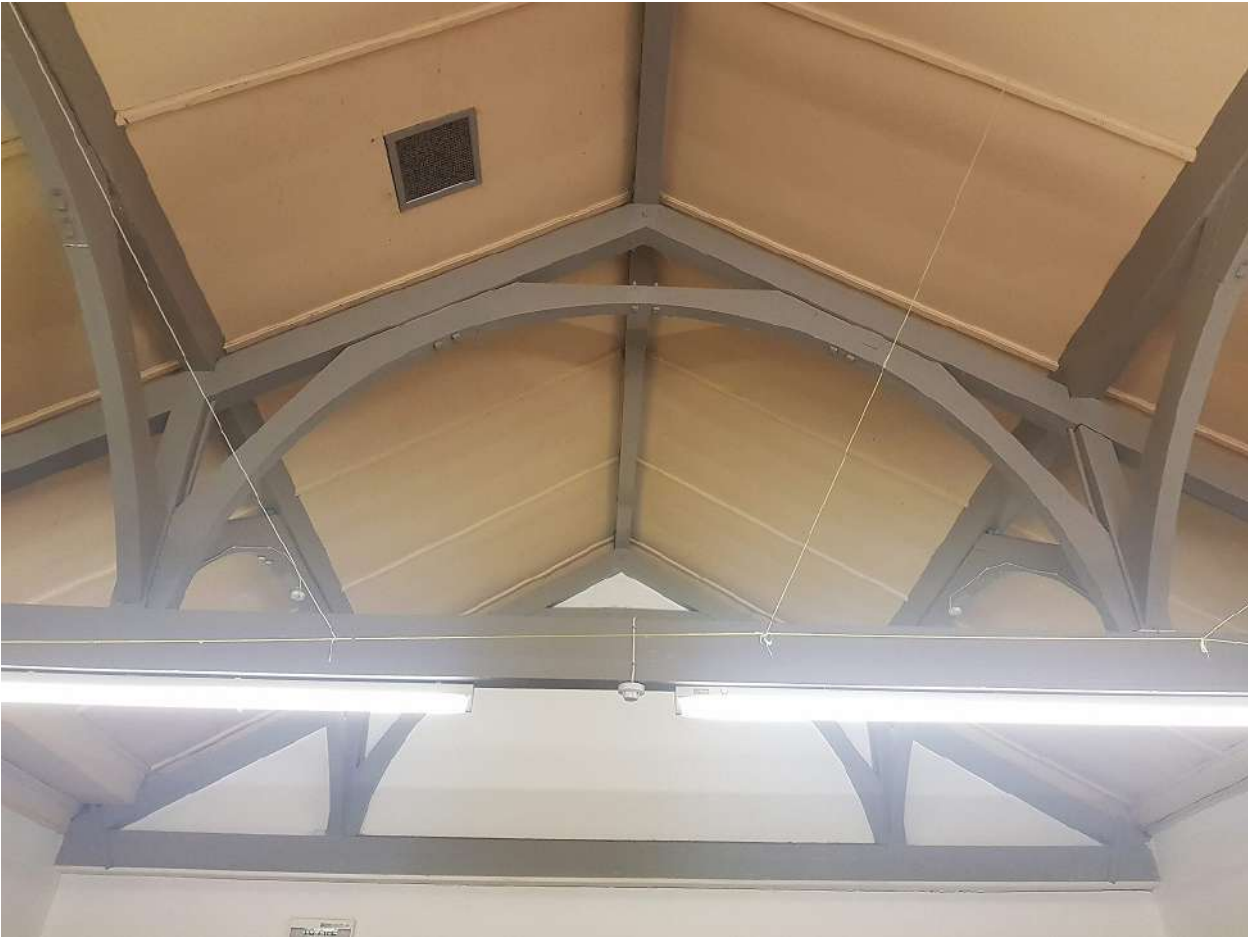
The ceiling shows water staining understood to be historic damp penetration.

**R2** Carry out minor ceiling repairs, cleaning and redecoration.

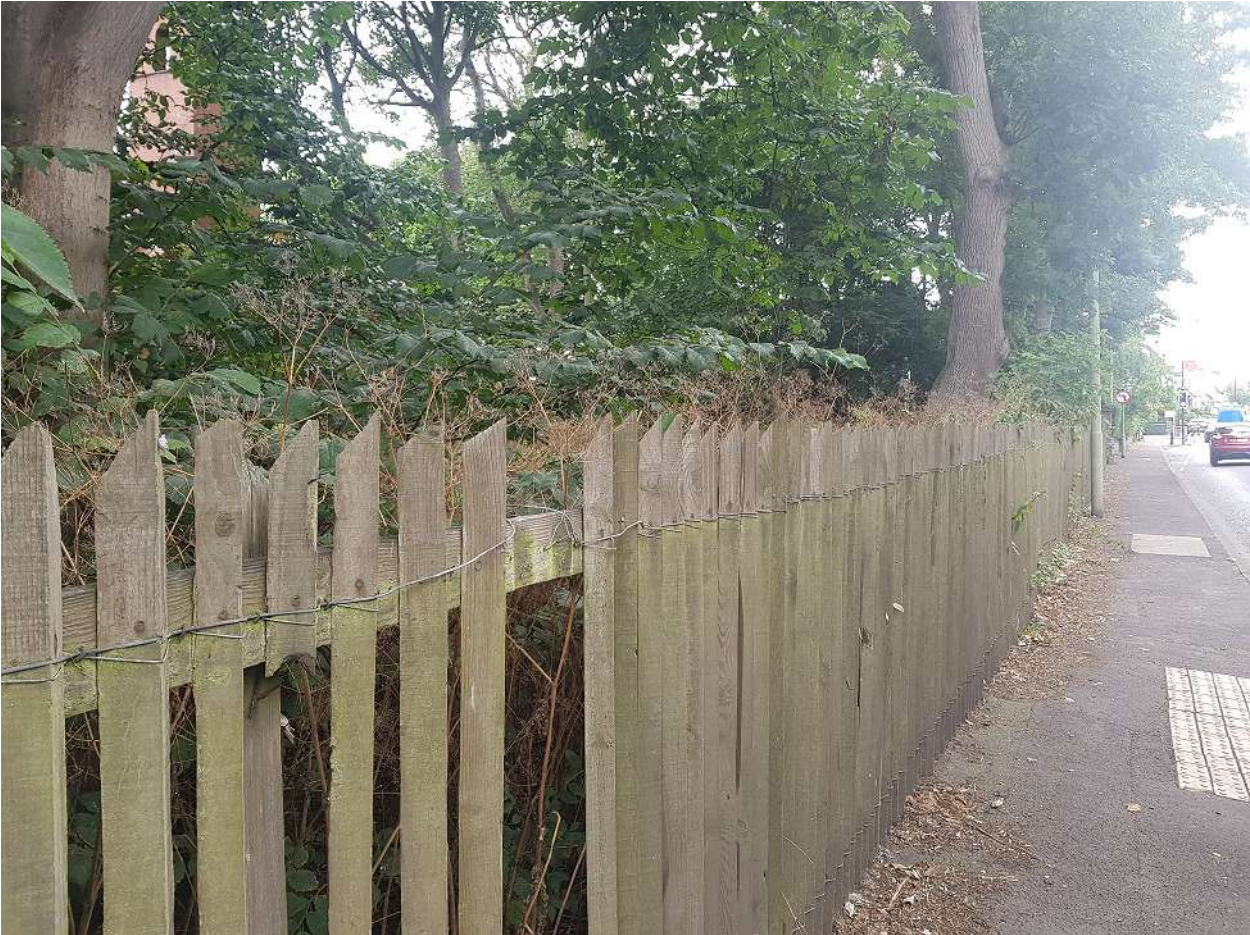
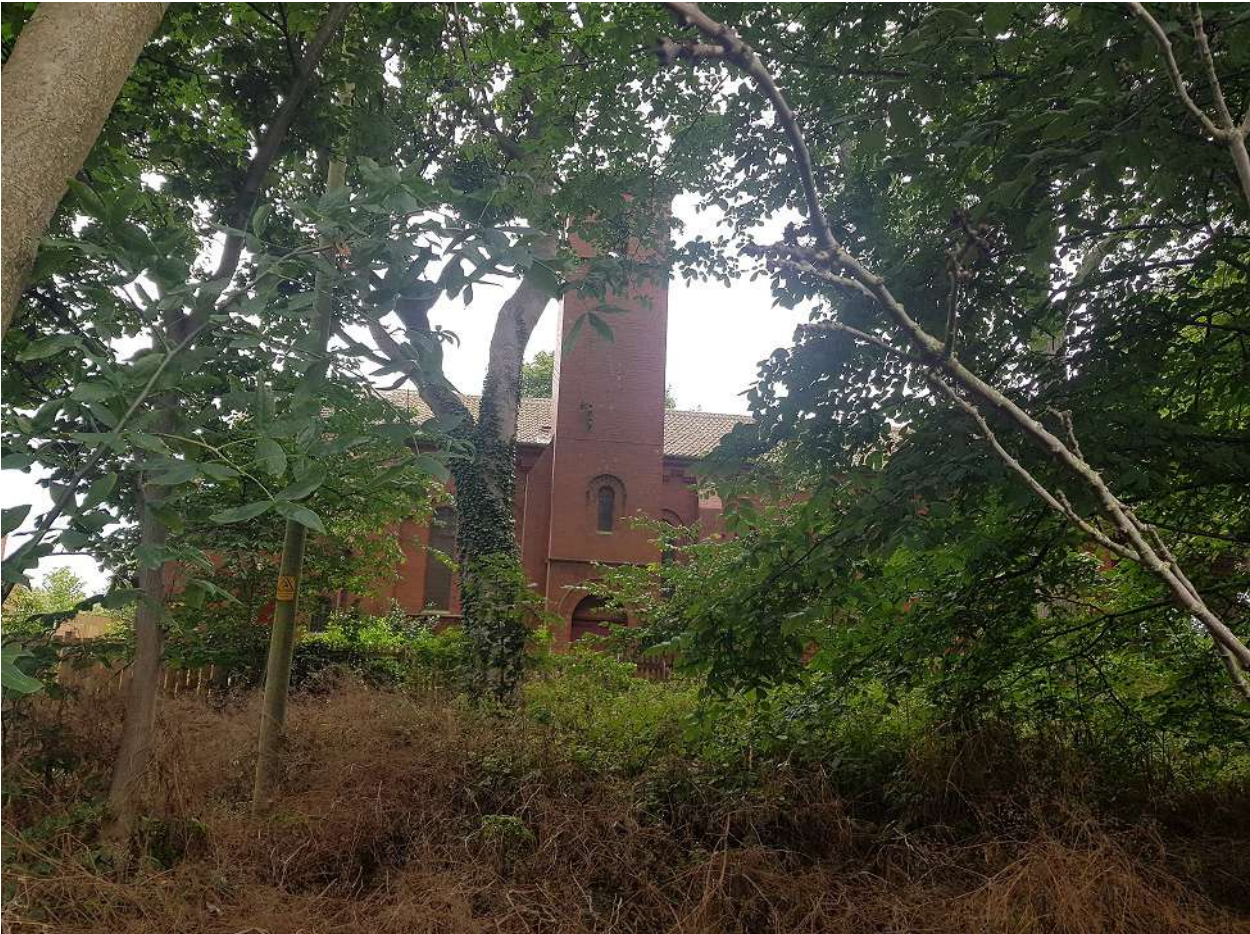
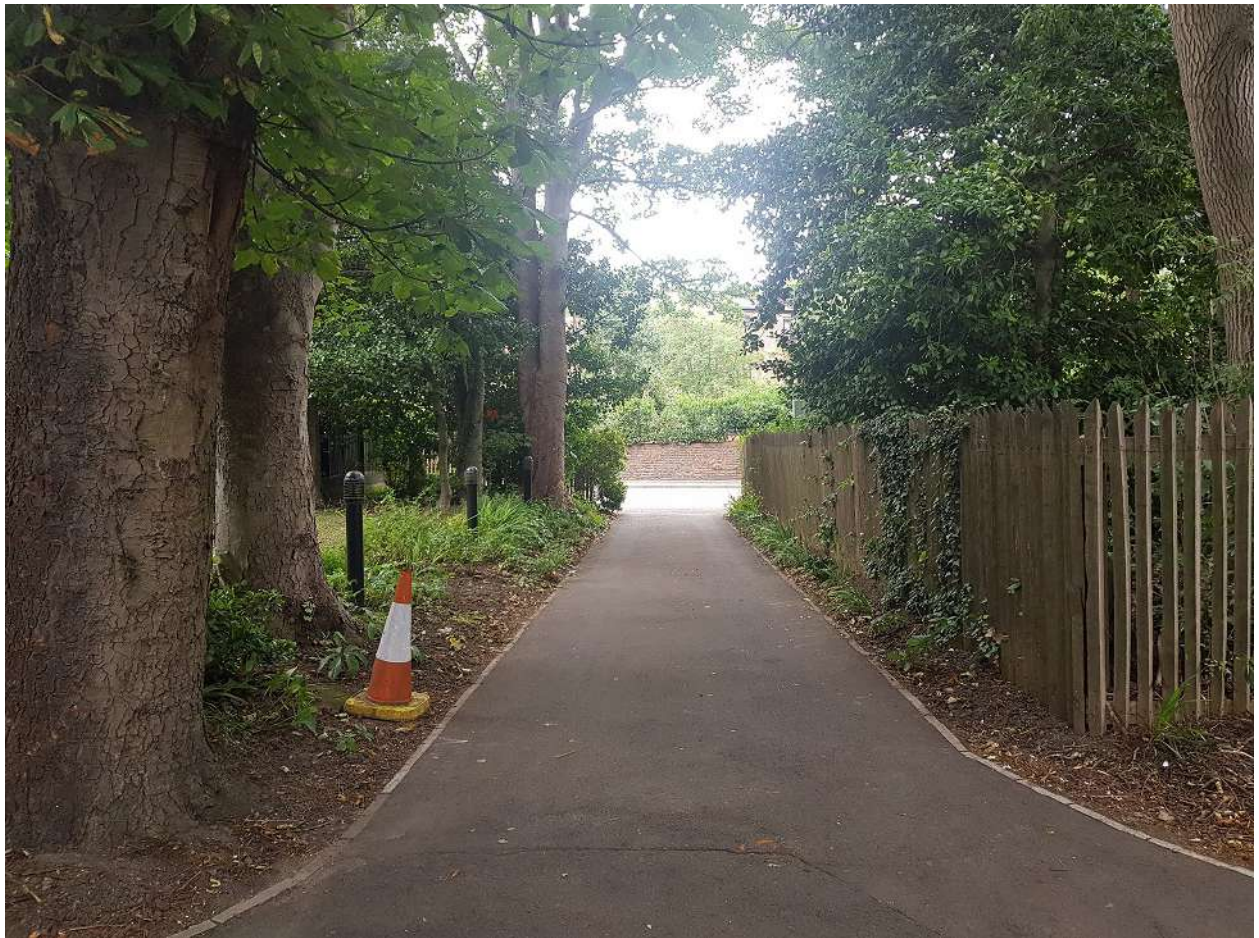
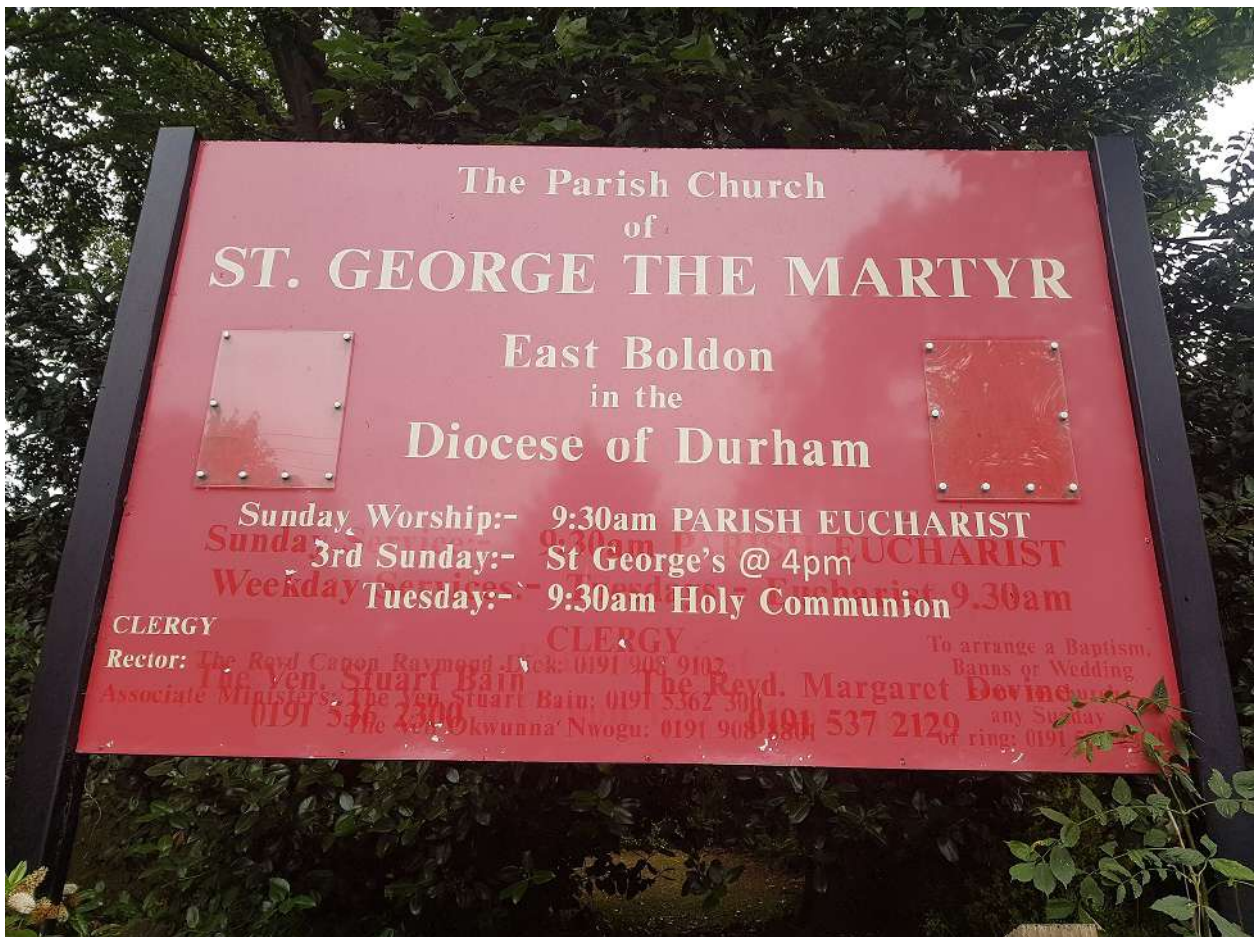
- 38.2 The section of land separating the north side of the church and the main road is owned by the South Tyneside Council.

It is recommended that enquiries are made with the Council regarding when these trees were last examined by an arborist and their current condition.
