**Quinquennial Inspection Report
St George's Church, Hatfield, Washington
Deanery of Chester le Street
Archdeaconry of Sunderland
Diocese of Durham**

David Jowett - Architect, BA, DipArch, RIBA
25 Roseworth Avenue
Gosforth
Newcastle upon Tyne
NE3 1NB
Tel: 07788 710 204
email: david@davidjowett-architect.co.uk

30 June 2019

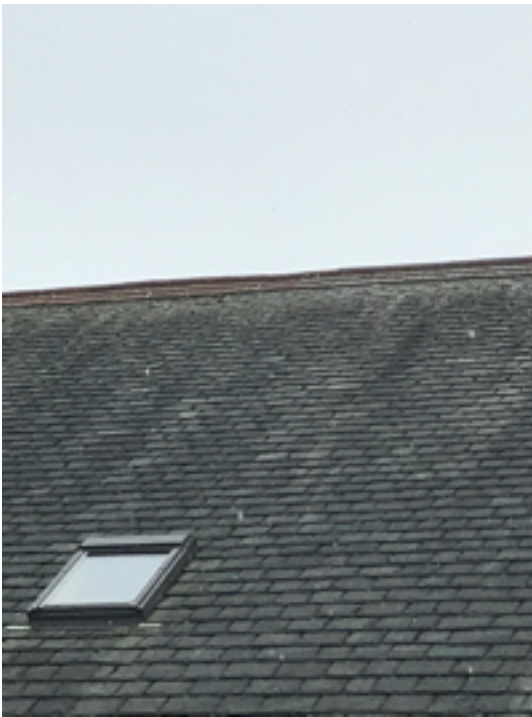
North Elevation Roof

Several chipped slates and a few missing and slipped slates to all areas. Not all areas are visible from ground level and should be inspected on a yearly basis by a reputable roofing company. The ridge to Porch appears to be have been overclad with flashband. The ridge tiles are generally uneven.

Replace all loose and missing slates. £750.00.

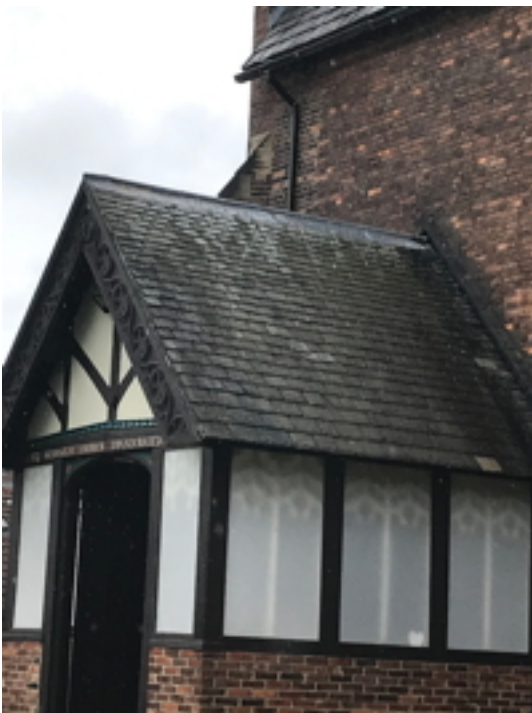
Slipped slate to Porch Roof

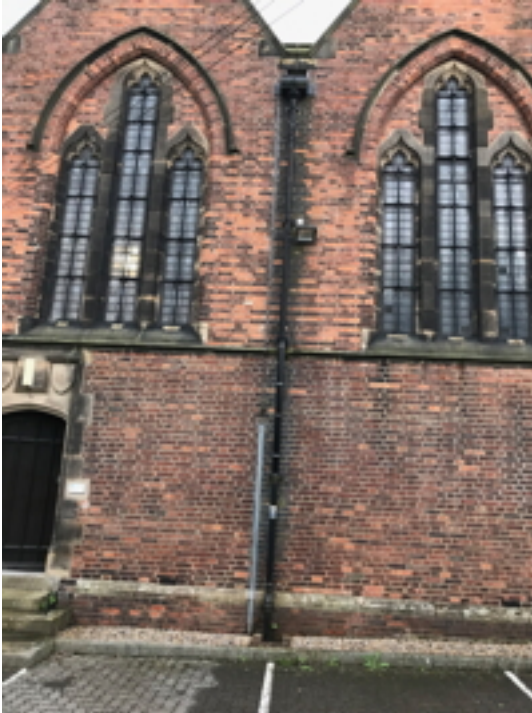
North Aisle Rainwater Pipe

The North Aisle rainwater pipe middle section has been over clad with UPVC as a temporary repair.

Replace split rainwater pipe to North Aisle. £150.00

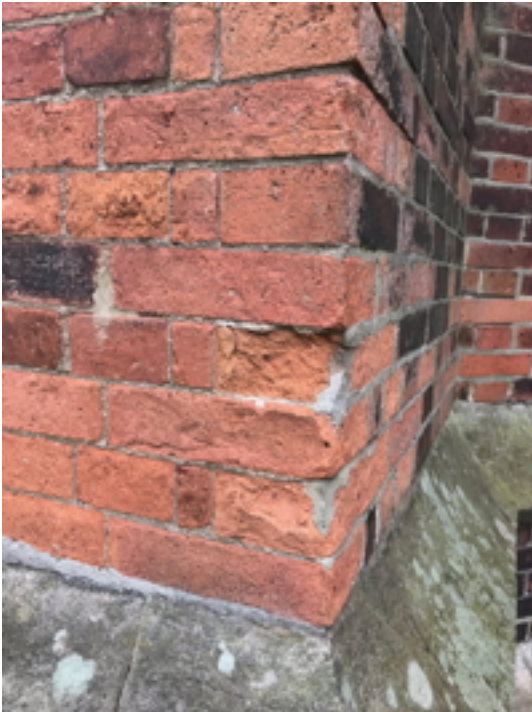
Erosion of brick faces to buttress

Some erosion of brick faces is visible. This is largely due to the brick being softer than the mortar, hence water is trapped in the bricks and frost action gradually destroys the brick. This will be an ongoing issue but careful attention to pointing and repairs will slow the deterioration. Similarly to stone string courses some of which have had unsightly mortar repairs and an area of staining indicating a leaking gutter above.

Monitor brickwork and stonework deterioration.

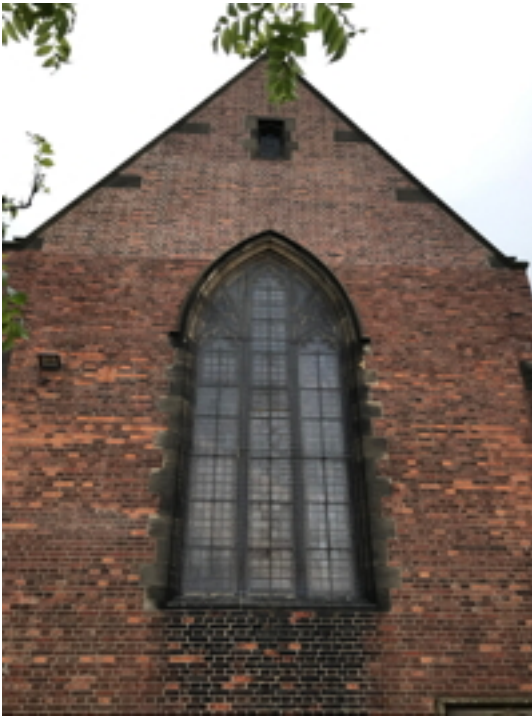
West Window

Run-off from the grille to west window is staining the brickwork below.

Replace wire mesh grills with polycarbonate. £2000.00

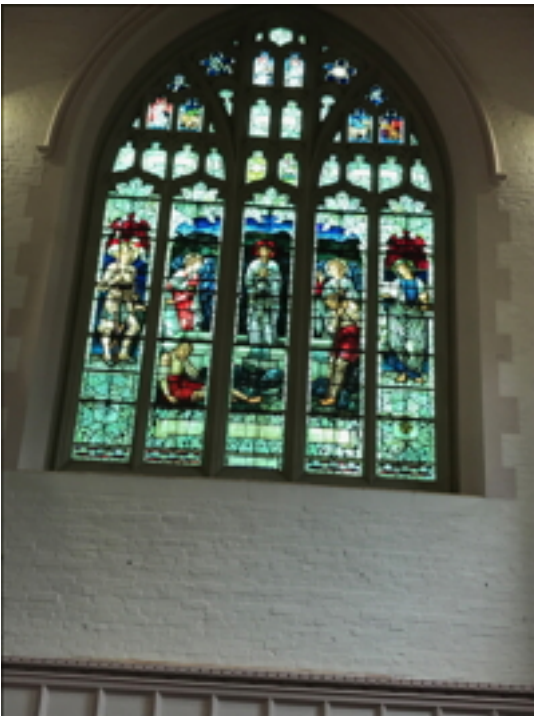
East Window

Grille to east window is badly fitted and distorted. Both Grilles should preferably be replaced in polycarbonate.

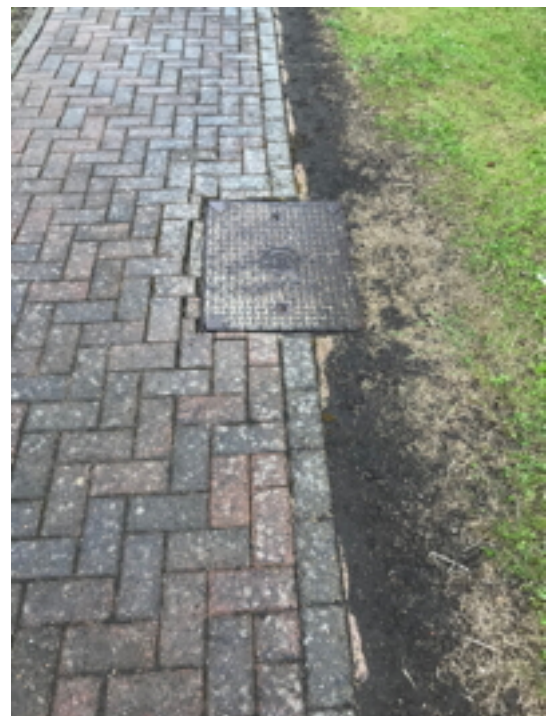
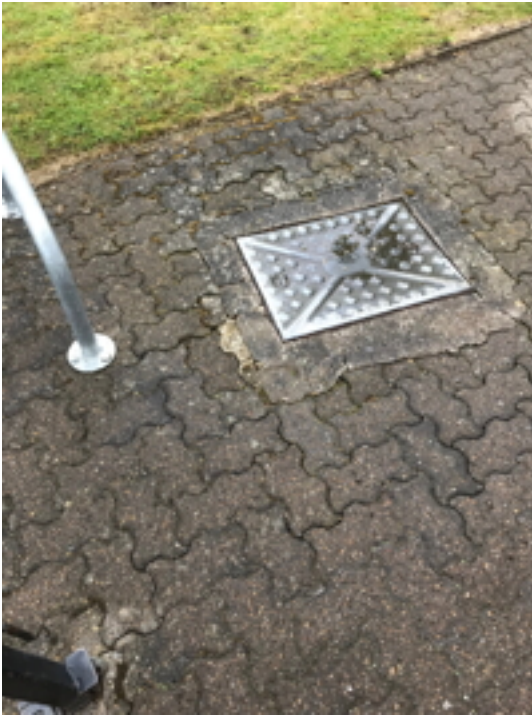
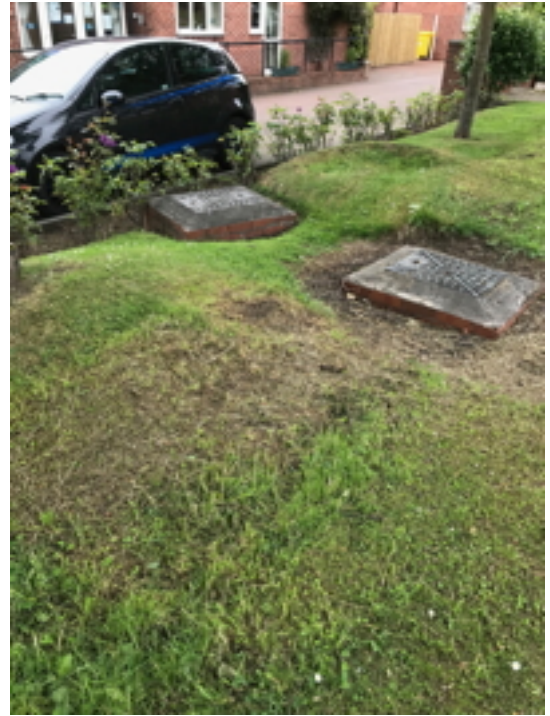
Gullies are mostly blocked and surrounds are damaged.
Inspection chamber covers are satisfactory

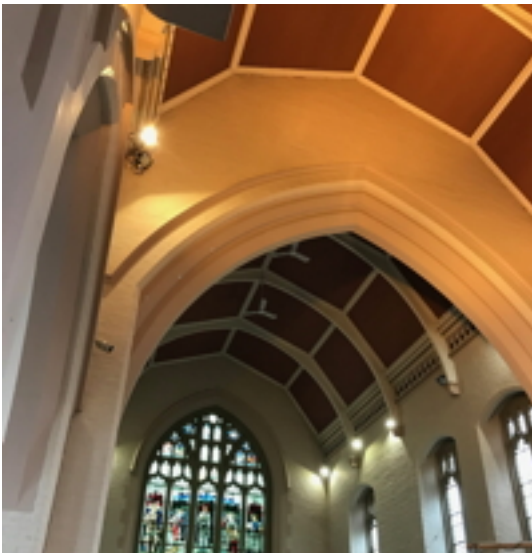
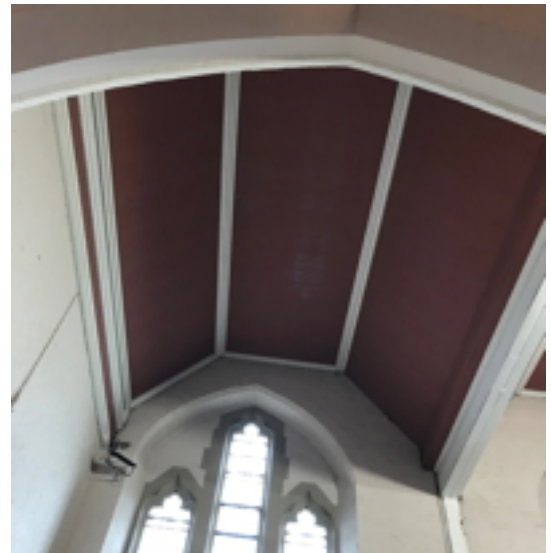
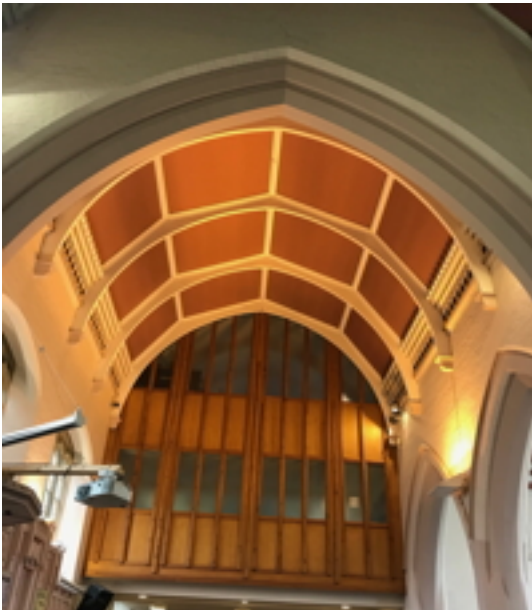
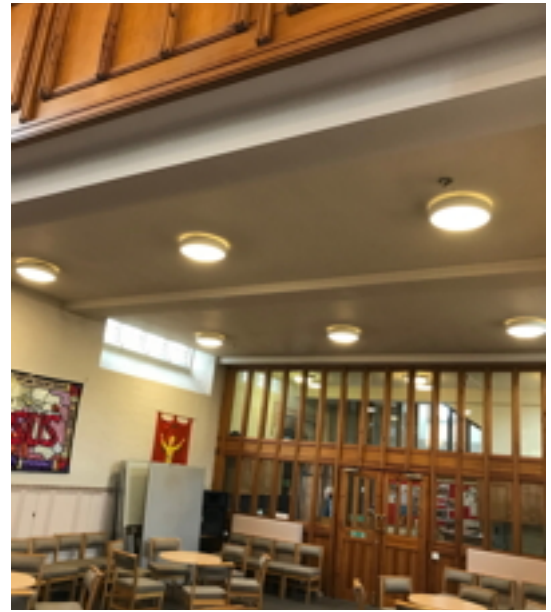
All appear in good condition.

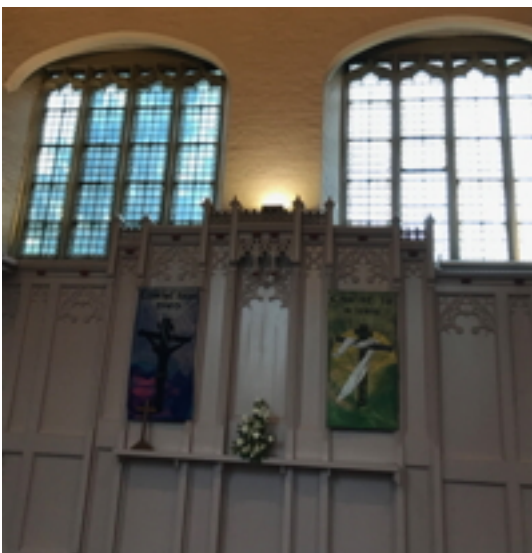
South Wall Panelling

Doors and screens are all in satisfactory condition. The panelling shows signs of shrinkage cracking as mentioned the last report.

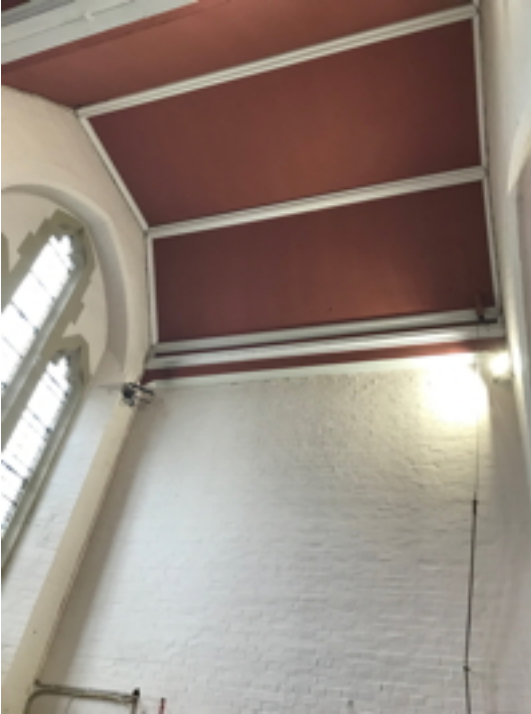
North Aisle Brickwork Wall

All is in satisfactory condition.

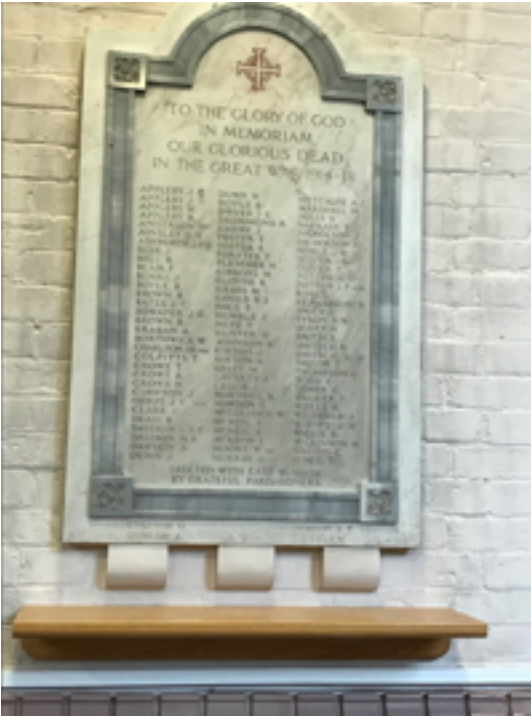
1914-1918 Memorial

All memorials are in good condition and well cared for.

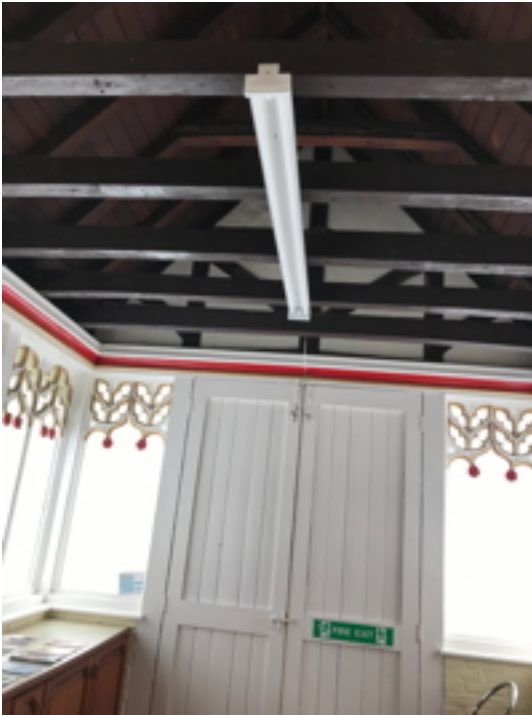
South Porch South Wall

The South Porch is all in satisfactory condition.

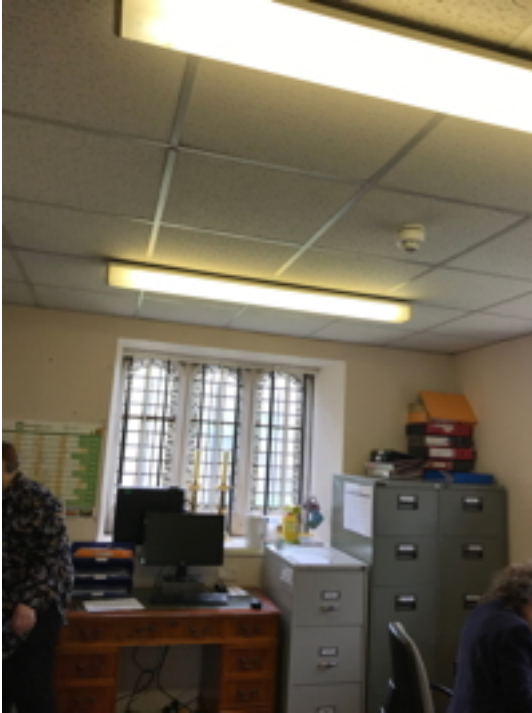
Vestry North Wall

There are signs of staining to the ceiling but it was reported to me that the was due to a recent leak that has since been fixed. This is an area below a valley gutter that is always vulnerable. The Vestry is all in satisfactory condition.

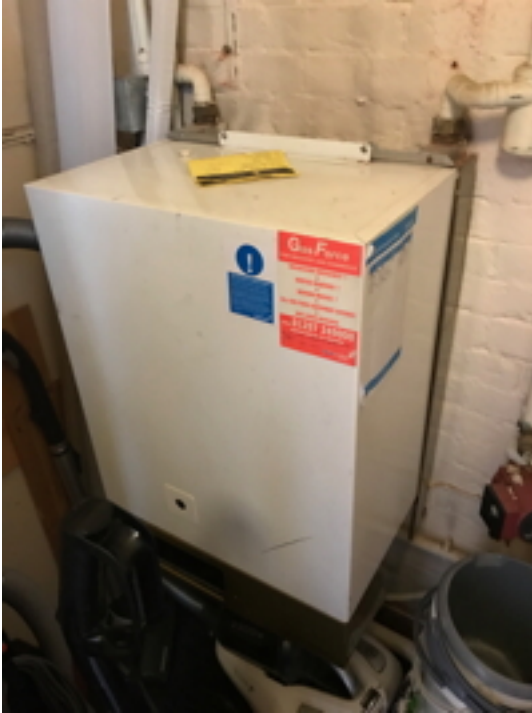
The Office is all generally in satisfactory condition. However the boiler room has a fire door but the air grilles cut into it are not fire resistant, defeating its purpose. They should be replaced with intumescent grilles of half-hour fire resistant standard.

Replace grills to First Floor Boiler Room Door with intumescent grilles of half-hour fire resistant standard. £75.00

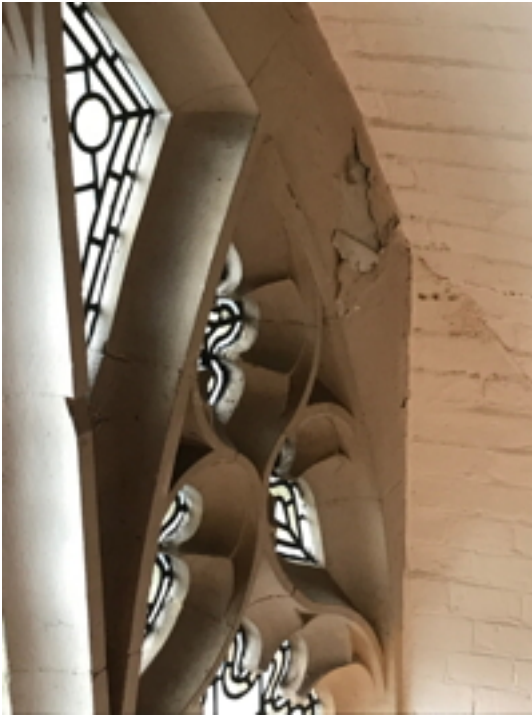
The Second Floor Landing is generally in satisfactory condition. However there paint peeling from the top of the west window.

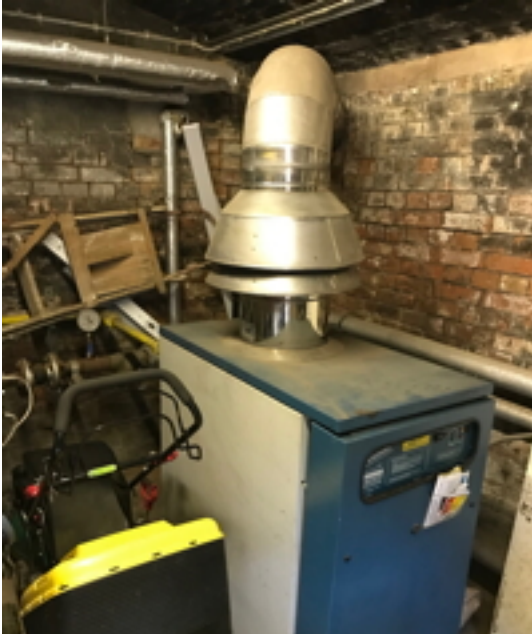
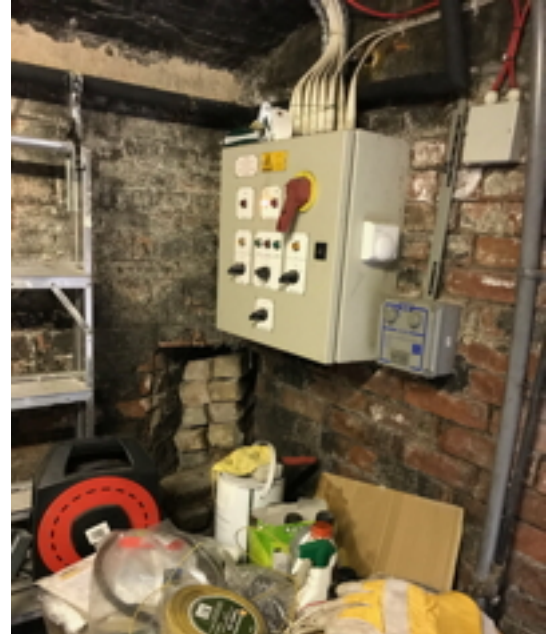
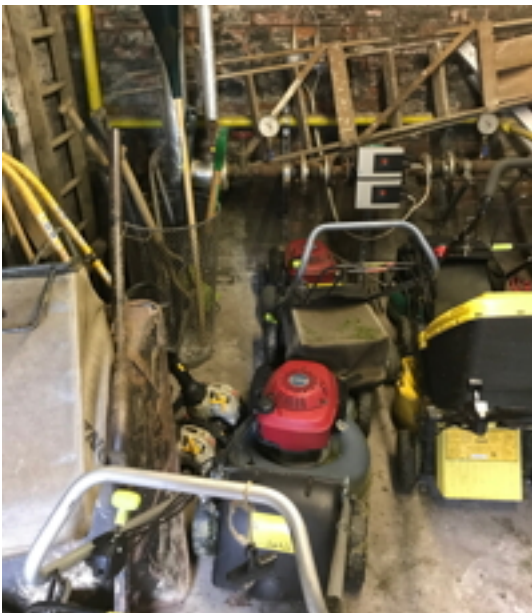
The Boiler House is generally in satisfactory condition. It is however also used as a store for petrol driven lawnmowers and strimmers.

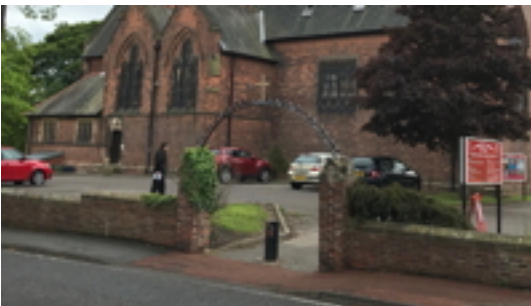
North Boundary West End

The brick and stonework walls are in satisfactory condition. As noted in the last quinquennial the timber fencing is partial and collapsing and could best be removed and a hedge established along this boundary.

Replace timber fencing with hedging. £1,000.00.

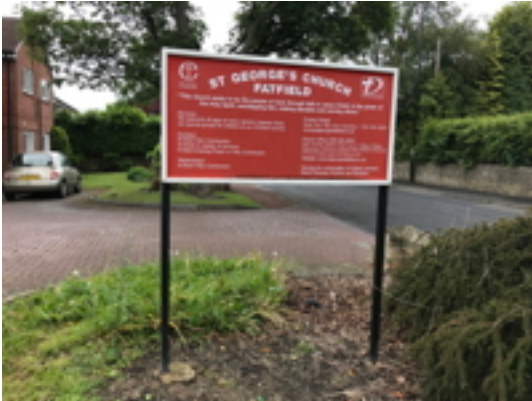
North Entrance Notice Board

The Noticeboards are in satisfactory condition.

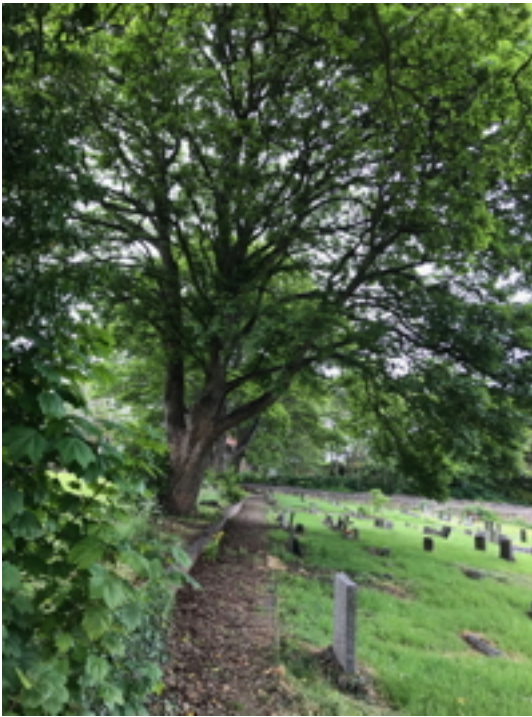
Pathway Separating Open and Closed Graveyards

All is generally in satisfactory condition and well maintained. The separating pathway between the open and closed graveyards should be cleared of fallen leaves.

Repair Needs, Category M, Routine maintenance

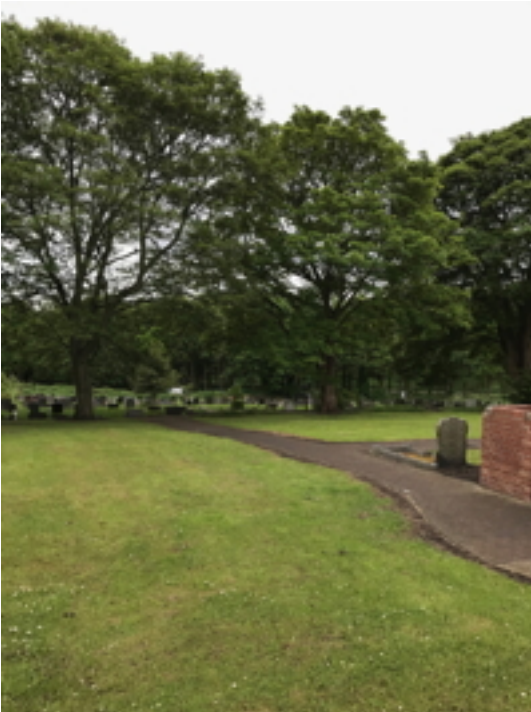
Typical Mature Trees to the East

The trees generally all appear is satisfactory condition. However the sycamore seeding should certainly be fully removed before it causes damage to the church structure which could be significant if left. The trees should all be inspected by a qualified tree surgeon every five years and pruned in accordance with their recommendations. They should specifically advise on the conifer to the south elevation.

Repair Needs, Category M, Routine Maintenance

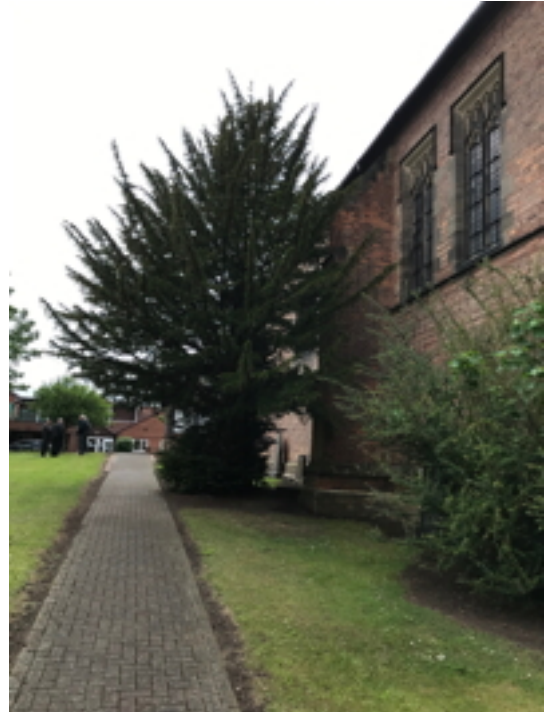
Coniferous Tree and Shrub to the South Elevation

There is coniferous tree, possibly a yew, immediately to the south elevation of the church and adjacent to this large shrub with a sycamore seeding growing through it.

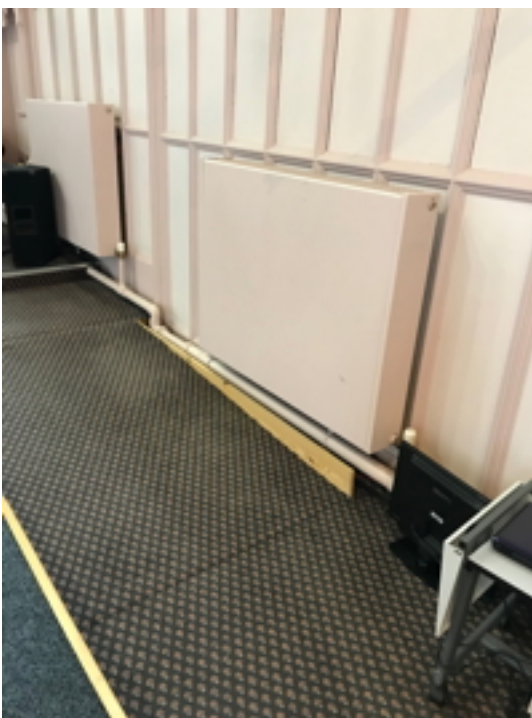
Typical Nave Radiator

All appears to be in satisfactory order but it is noted that the main boiler is old and will require replacement in the not to distant future.

Repair Needs, Category M, Routine Maintenance

Plan for future replacement of boiler. £0.00
