**QUINQUENNIAL INSPECTION REPORT
OF
ST. JAMES AND ST. BEDE, GATESHEAD**

**DIOCESE OF DURHAM
ARCHDEACONRY OF SUNDERLAND
DEANERY OF GATESHEAD**

**QUINQUENNIAL INSPECTION AND REPORT
2019 report on the 2018 Inspection
DATE David Beaumont BA (Hons) Grad Dip, RIBA, AABC**

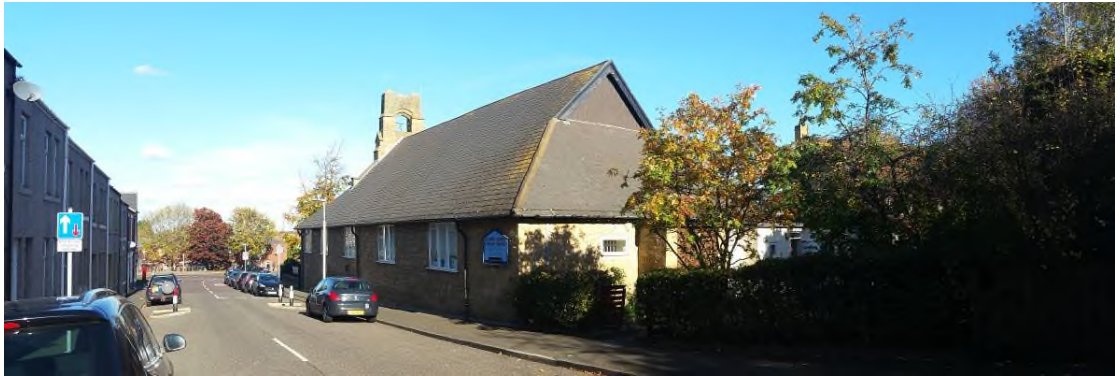
Externals:

The site is bounded by highways on the west. Housing development parking on the east. The west paving has a fillet up against the wall and this is breaking down in places, is this the responsibility of Highways or the church? At the south end is a small paved area with shrubs, all satisfactory apart from a rusting ramp handrail. The west garden is mostly gravel retained by brickwork and this is in good condition. There is tree within the boundary fencing and it would be wise to keep this in check.

Recommendation: Keep the tree in check.

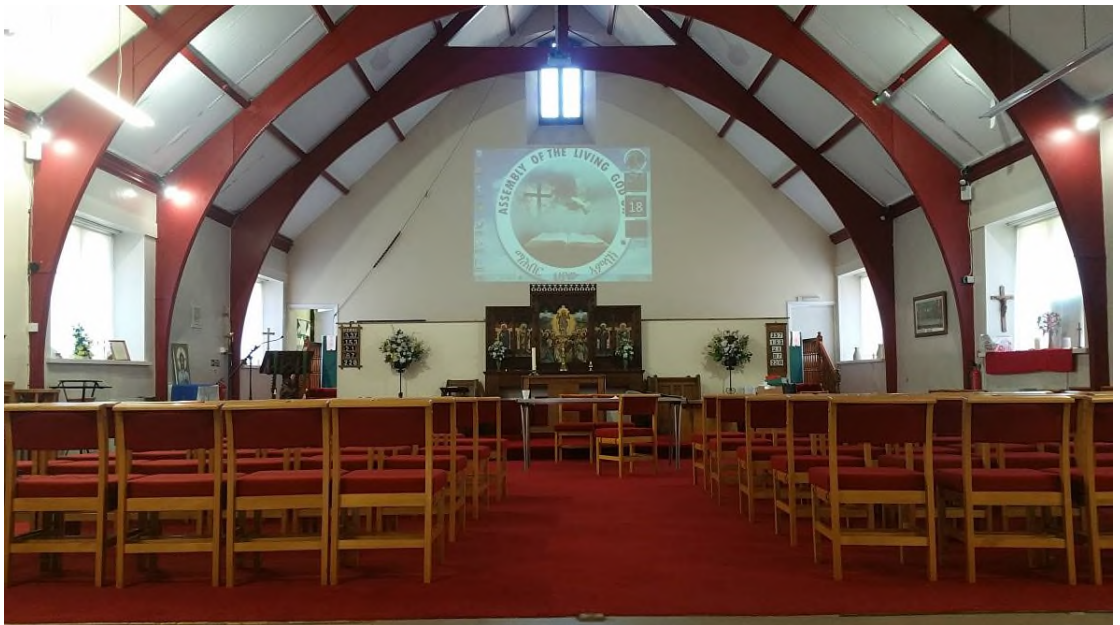
Inside:

Generally the interiors are of fair to good condition and the PCC are doing their best to keep on top of the decoration and quality of the finishes. The only significant item is the Nave boarding to the ceiling whose taped joints are coming away but it is recognised that this is a considerable expense to remedy.

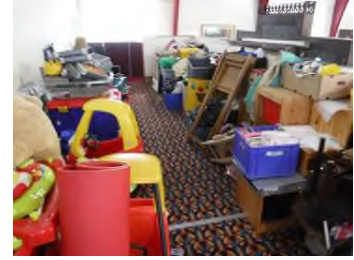
M **Storage area behind the Altar:** 6ltr foam spray extinguisher and a 2kg Co2 extinguisher. Full of toys and boxes.

Recommendation: tidy up?

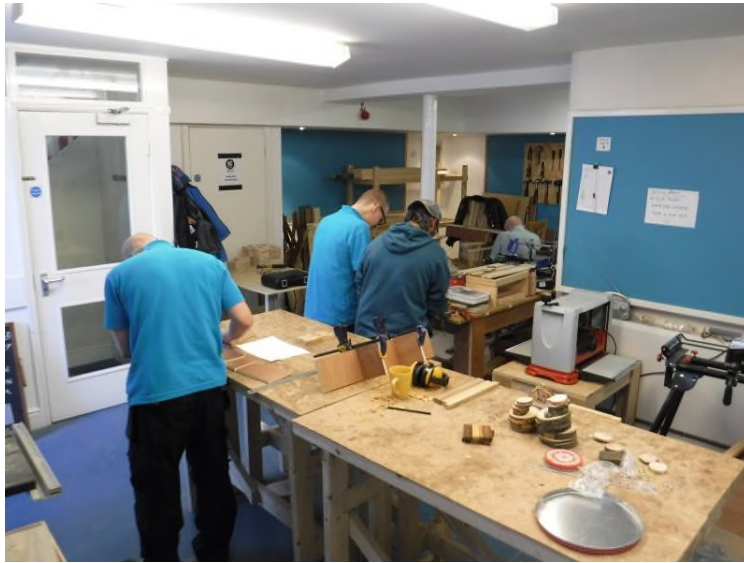
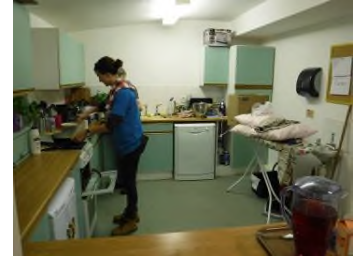
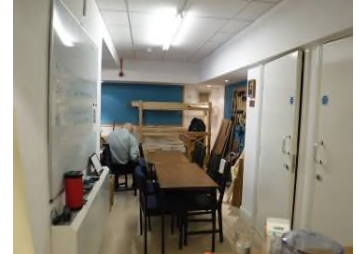
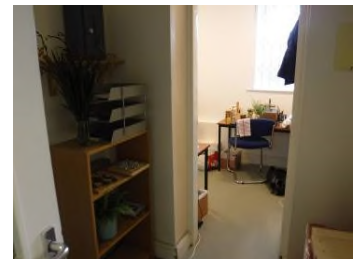
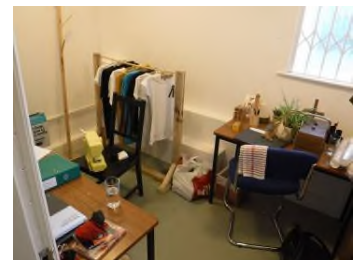
- **Workshop, Kitchen & Storage areas:**

- Ceiling – Some suspended.
- Walls – Plaster and painted.
- Floor- Solid with vinyl. Generally all in good condition.
- General –The rooms are being used for a workshop and contains is joinery equipment in.
- In the workshop there is a break glass fire point.

Small kitchen servery which is now nicely fitted out with modern units and contains an oven, fridge and wash hand basin. Small office area to the side of it, is full of things but itself is generally ok. There is a w.c. for disabled users, all in good order. The doors are ok. There is a Fire blanket in the kitchen and a 6ltr floor mounted foam.
