Diocese of Durham

HARLOW GREEN St NINIAN
(296)

QUINQUENNIAL REPORT
on the architect's inspection on

4 November 2022

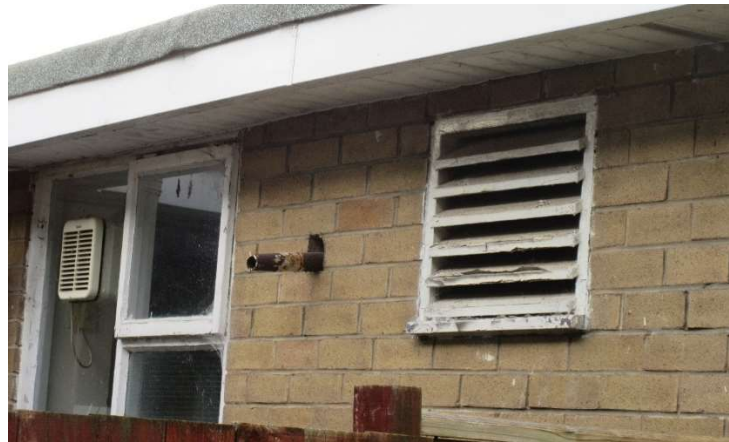
55. Gas central heating throughout except the Store. Ideal Evomax wall balanced flue boiler installed 2020. Meter, pressure vessel and frostat in the Boiler room. Thermostat in Vestibule.
56. The Boiler Room no longer needs combustion air because the boiler has a balanced flue through the wall. In fact it is now excessively ventilated by both original louvres through the wall and the parting above roof level of the redundant metal twin wall flue through the flat roof (photo below). This damaged flue now opens the room to the sky so wind and rain get in. The whole flue should be removed and the roof sealed over, perhaps as part of a reroofing of the whole link roof (para 18).

disused flue
