**QUINQUENNIAL INSPECTION REPORT
OF
HART, ST. MARY MAGDELENE**

**DIOCESE OF DURHAM
ARCHDEACONRY OF DURHAM
DEANERY OF HARTLEPOOL**

QUINQUENNIAL INSPECTION AND REPORT

June 2021

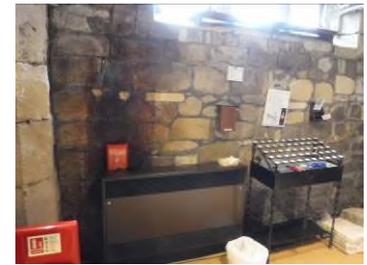
The system is reported to be ok and is producing adequate heat though there is some noise from the chancel radiator fan.

Recommendation: Carry out annual inspection and put certificate in file. Consider replacing chancel heater.

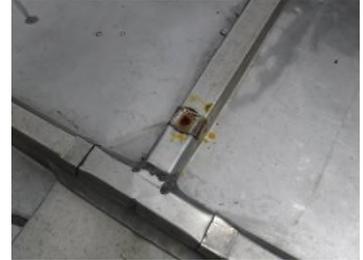
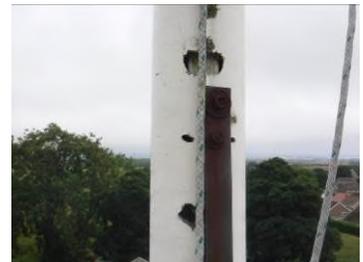
B Tower Roof:

Terne coated stainless steel showing some slight oxidation but satisfactory, the parapet gutters at the high points have got a collection of tree twigs and leaves. The hatch is copper, it catches the trimmed opening edges and is rather hard to use.

There is a couple of areas where the solder dots covering fixings has come away but no repair needed yet.

The flagpole looks a little worn at the fixing point, not wobbling. The lightning conductor is broken there and also the spikes are missing from the two W most pinnacles.

At the S W corner there is some cable that is loose, I don't know what that is doing there.

The W tree is starting to brush against the parapet top and needs to be cut back. There is only one finial left and that seems to be cracked in the corner.

Recommendation: improve operation of hatch, tidy metal edges on opening, check finial, repair lightning conductor arrangement,

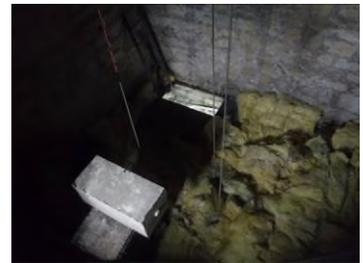
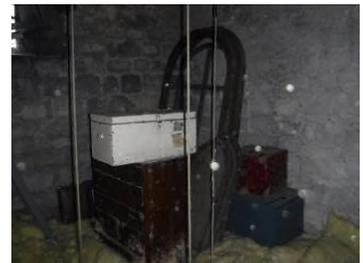
E Deafening Chamber:

The ceiling is supported by modern steel beams and that looks satisfactory. The walls are pointed some with cement, bit of shailing but looks generally sound, the floor has insulation on top

of boarding so it can't be inspected. The roof hatch is a little awkward to pull closed.

Recommendation: improve hatch operation

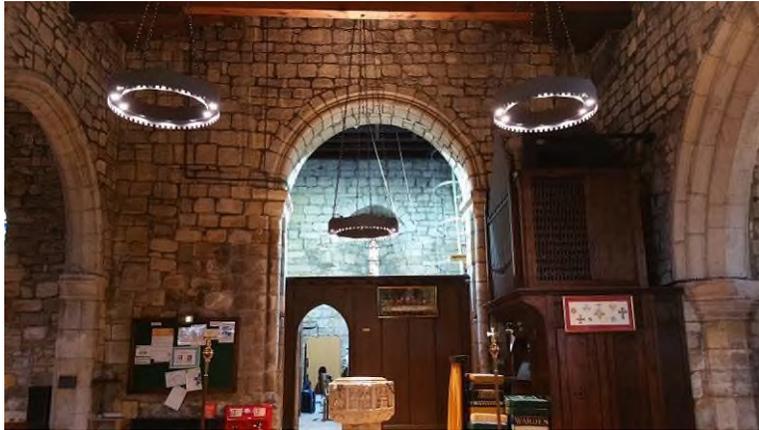
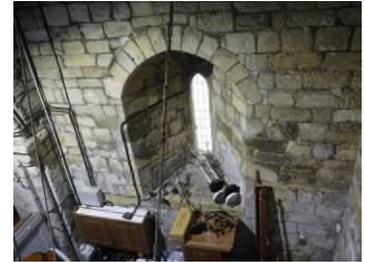
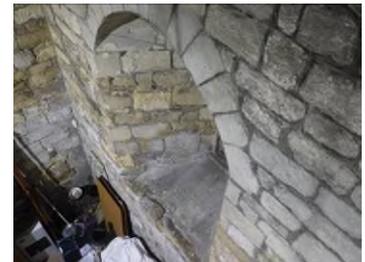
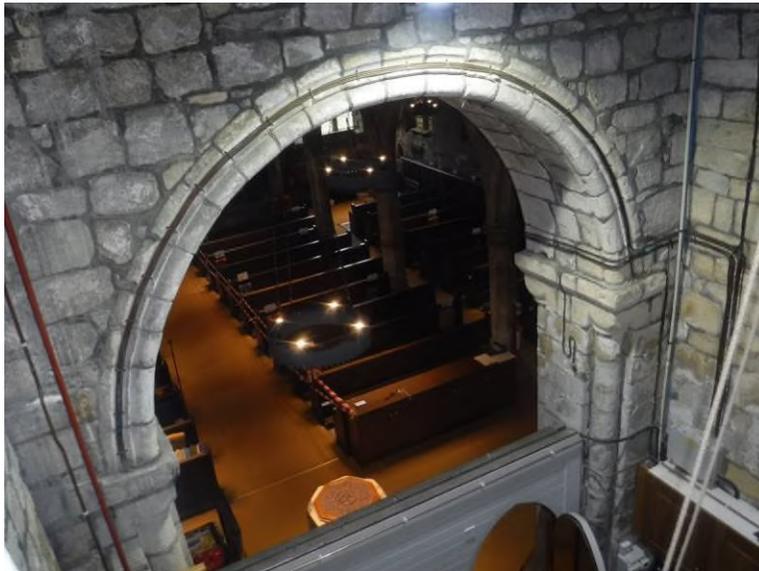
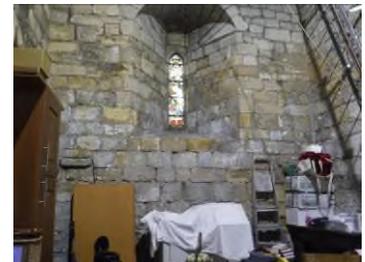
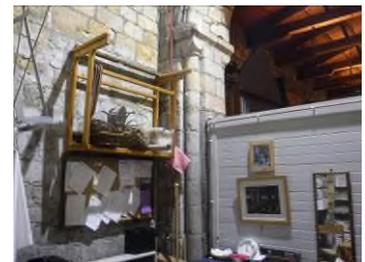
Base of Tower:

Tall space with windows on S and W sides and Norman arch, used as a vestry, office and meeting room. The ceiling is supported off stone corbels and the boarding all looks ok, through it comes three bell ropes.

The walls have been repointed in cement, showing signs of efflorescence confusingly at about three metres high at around about the level of the window cills and parts of the column shafts and the capitals of the Norman arch.

The base of the tower is below raised ground to the W and whilst that might explain some damp on the W side up to a metre above the external ground level, it doesn't explain why on the opposite side of the tower there is so much damp at high level close to the springing arch of the tower and the whole thing remains a puzzle.

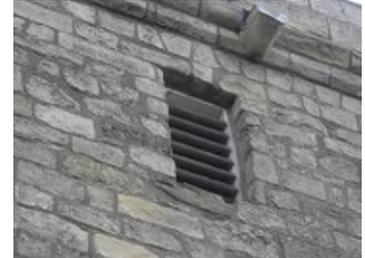
M **South side**

All the walling looks ok, there is some wear just on one stone on the bottom stage on the corner, no apparent movement. The louvre oak frame could do with painting, as could the window frame below it when there is next scaffolding. Beneath that the electrical supply comes in and below that is the ground floor window which has polycarbonate screw fixings that are rusting a bit, there is also a datum point this looks to be where there is an earth cable coming down. The tower is two stages.

Recommendation: decorate louvres and window

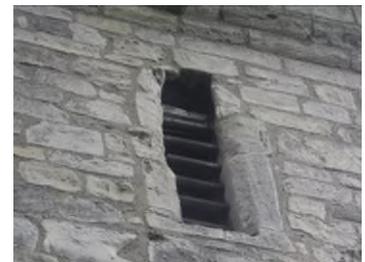
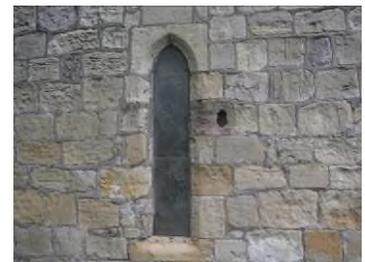
C **West side**

The adjacent Ash tree is brushing against the top of the parapets, the upper stage louvre opening head looks a bit mangled and the wood louvre is undecorated. The upper stage walling looks ok. The lower stage walling has a bit of a crack just below the window through the joints, it has been cement pointed badly and heavily, a different look of pointing on the lower stage of the upper, probably more recent.

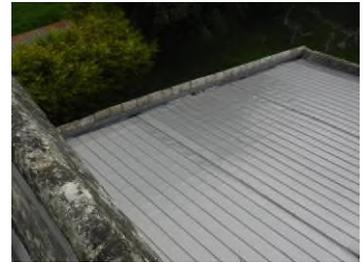
B Nave:

Nave is covered completely along with the outer aisles with a single span stainless steel into parapet gutters, the N side steel towards the E end seems to have some pock marks and perhaps a patch but generally ok. On the S side in the middle along the way there is a high point, either side of that is two gulleys, there has been rainwater inside the building showing at this point. There is some build-up of debris in the parapet gutters, unable to check the flashings against the tower.

Recommendation: clean out gutters, check all sumps are free running- particularly S sump.

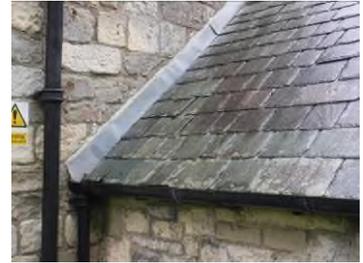
- **South Porch:**

Ridge capping in angled clay is ok with diminishing courses in variable widths Westmoreland and a little chipped in places but sound enough. The abutment flashings are in lead replacement. The S side is a little more worn where a couple of areas where slates could be refixed or new ones patched in but they could go 5 years. The cement pointing to the replacement flashings is coming away a little bit in places but it is generally sound, the water table appears ok.

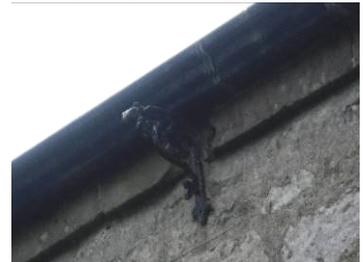
Chancel:

The chancel has a more ornamental ogee cast-iron gutter on rather fancy brackets that look a little bit incongruous. On the N side there is grass in the gutter at the E end downpipe looks ok, in fact the downpipes are four inch and quite oversized.

Same detail on the S side looking a little rusty on the bottom of the gutter.

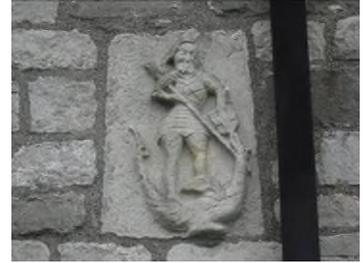
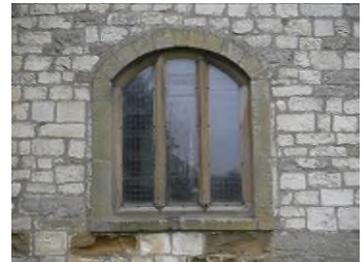
Chancel:

South – eaves corbel looks ok, as does the walling apart from c. nine stones in a softer sandstone, mixed in amongst the lime stone units. They have eroded particularly around the window and the abutment to the nave.

This wall also features the George and Dragon plaque. Window surround is Romanesque arch with three light window, mullions look ok with slight open joint to one of the tops of the mullions at the arch but otherwise sound.

Recommendation: replace eroded stonework

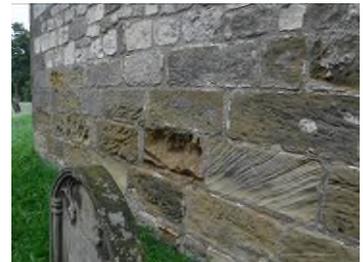
East

Quite a thin looking water table, just slabs though the kneeler looks integral to the slab, it doesn't look its age. The lower part of the walling is the large format sandstone blocks and there is erosion to those, one in particular another below that. Honeycombing in the middle below the window. The general

walling otherwise is ok and the pointing is holding up as it is everywhere, albeit that it's a little hard. Slight cracking showing on the N kneeler into the walling but I don't think this is anything to speak of.

Recommendation: replace eroded stonework

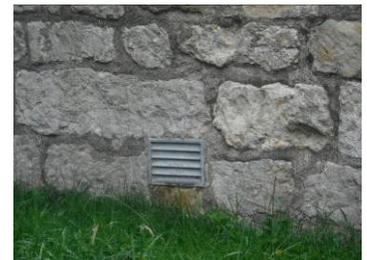
C South side

This is a three bay elevation with three downpipes on it, this has a better parapet which all looks in good condition, the walling as well is good, there is some low level wall ventilators, what is their purpose? There doesn't seem to be any evidence of it on the inside.

Diagonal buttress on the E end with slight cracking up at the top because it is wanting to separate but it is ok, the wall has two plain mullion windows, central window mullion has been replaced and has new polycarbonate and the E most has a crack to the centre of it but I think it could survive another five years, there are various rust marks and some slight breaking up of the limestone dressing but ok otherwise.

At the W end the walls start to have open joints just about where the downpipes are as it comes to the ground of the raised ground.

Recommendation: point open joints

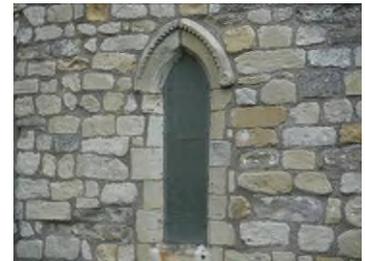
West side

– Same slightly poor quality of the water table and there is some run off as it joins the better parapet on the long elevation. Walling looks ok, some ivy starting to grow. Single lancet window with nutmeg decoration, much eroded and loss of label stop detail. The polycarbonate within is rather obscure now and the glazing support bar behind is rusting on to it.

Recommendation: remove ivy

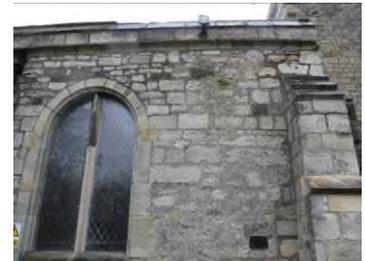
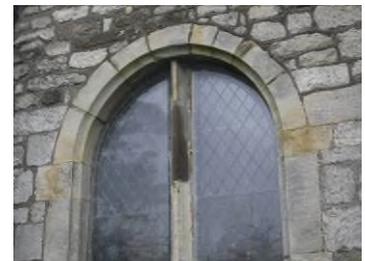
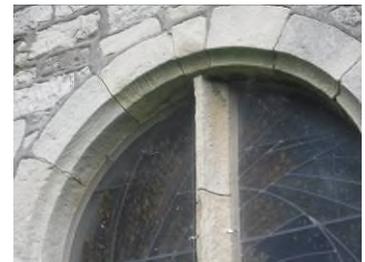
North side

The parapet has lost its roll top moulding. At the W end, there is a security light here and the curved cornice is ok. The walling below it has had a couple of goes of different cement types, the more bulbous type features towards the middle and E end and is just horrible. The wall bellies out and it is interesting to note that the E most buttress is actually built vertical so it must have been attached to that wall after the wall had moved out, whereas the middle buttress seems to have grown outwards with the wall.

There is a middle panel to the right of that central buttress that is projecting forward of the rest of the wall, was there a window here in the past? This wall also features three air grilles.

Recommendation: none

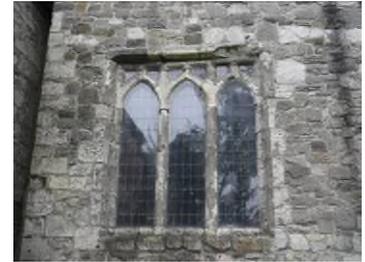
- **East side**

Water marks to gaps in watertable. Stonework ok. Three light leded light with tracery. Has cement facing breaking down. Broken horizontal hood moulding to the N side.

Recommendation: none

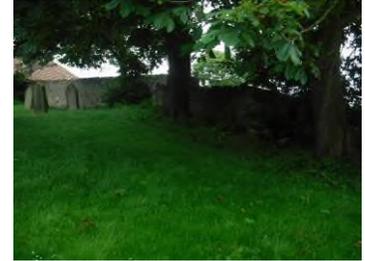
M East Side-

Listed and Scheduled Monument stone wall which has been badly repaired in cement in the recent past by the LA. There are some holes in it that can survive another 5 years. Vegetation growing on the top

Recommendation: keep vegetation in check

M	Tower : decorate louvres and timber window	-
M	North Aisle: clean up glazing protection	-
M	External East Side: keep vegetation in check	-
M	North Boundary: keep container conifers in check	-
M	Chancel Arch: monitor cracking above chancel arch	-

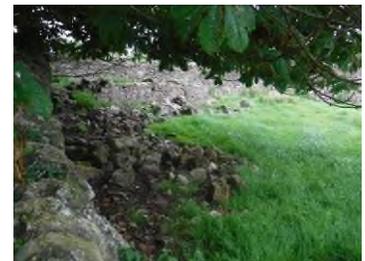
M North Boundary:

This retains the churchyard, at the W end it is leaning out a lot but is stable. It doesn't look to have moved in the ten years we have known the building. Just here is the concrete base and the sea container which is used for pew storage garden items. It is shielded by some conifer trees that need to be kept in check. The

Recommendation: keep container conifers in check

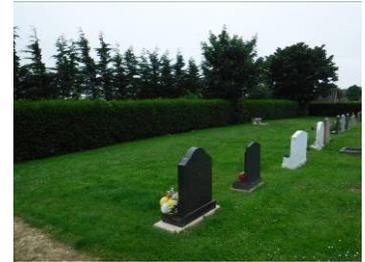
- **East Boundary:**

There is an area for ashes with a formal planting area which is beginning to look a bit full now.

The next parcel of land is the S E corner of the site, this is surrounded by privet hedging and all of that looks ok, there are some mature trees in the background and a large range of conifers coming up that look to be outside the boundary, I wonder what impact they might have in twenty years' time so they need to be kept in check.. The graveyard here is really quite nice, it is laid over as a meadow really, and it is quite charming.

Recommendation: none

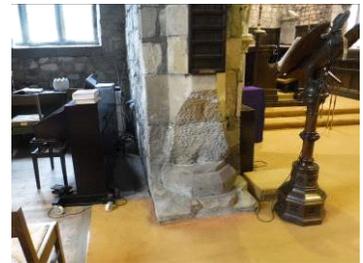
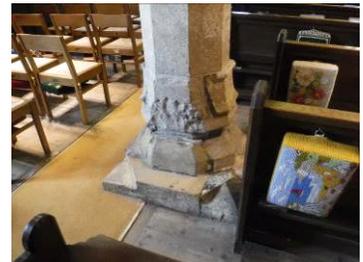
Has had some slight cracking in the past but it is negligible, it has a very low springing point but it is quite commanding. Remnants of a former arch above it with triangular headed window above there is a bit of a crack running up to the window cill but I think that is just exacerbated by brittle cement. The impostes are good to the ground with no damp showing, on the chancel side of the arch just on the N side of the centre, there is some action of shearing happening to one of the outer chamfer stones and I wonder if that is the pressure of the remnant arch above it looking to crack it, there is something going on there, but it is modest nothing really much happening. On the chancel side we can see that at around about two metres high there are salts occurring, and worst on the S side, salts appear to be coming through into the nave side as well.

Recommendation: monitor cracking above chancel arch

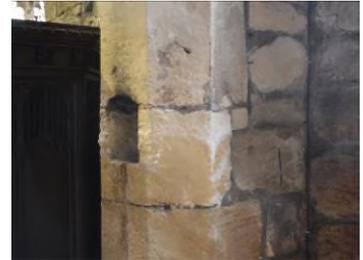
Walls:

Chancel - Walling has bulbous cement pointing on it with water marking at the eaves, particularly on the S side which is said to be historic. There is a timber dado covering the bottom third of the wall. There looks to be a crack on the S wall running through the window arch close to the apex but it doesn't seem to run up the wall, it is on both sides of the centre of the arch, there is a little bit of movement to the right hand side of the window jamb where the cement is coming away a bit but I don't think there is anything troublesome here.

The N wall has a broken glass telltale and a hairline cracking running up through the joint in the cracked cement pointing that has been picked up in the last two QI's so there is nothing changing here.

To the W end there is some chalked on graffiti 'Maple 1965' in chalk it's not very clear. The walling above the chancel arch showing quite significant amount of water staining but this is said to be historic.

Nave - Equally has water staining against the tower and said to be historic.

South Aisle - Whilst it is leaning out from the nave, it appears to be stable, there is cracking to the stonework above the porch arch in between the outboard tie rods and that it probably induced by the tie rods, plenty of water staining on the S elevation and an attempt to patch the gap up to the eaves and has failed as the mortar is dropping out.

There is some quite significant salting by the middle window again this is three metres up, very odd. The bottom fifth of the wall is in dado panelling, this was installed about the time of the complete renovation of the chancel I think. The E wall at the

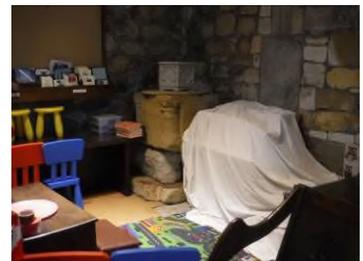
window has a rusty looking markings to it, is that from heat from the radiator or has there been a little fire here in the past? There is efflorescence showing two metres up by the security detector and the impost of the arcade around about 1.5 up where there is a pocket out.

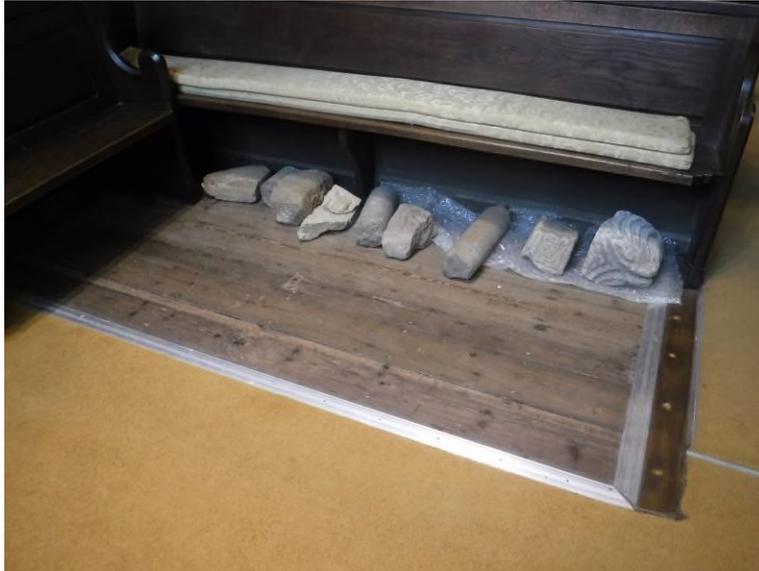
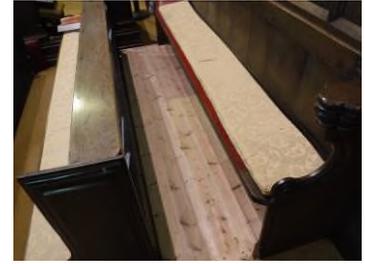
The whole floor has been reduced by approximately two feet in late Georgian times apparently, though the 15th century columns appear to be at the level of the original ground, they can't hardly have been extended downwards could they or changed?

The circulation areas are solid and covered with carpet, the carpet looks a little old and tired now and that could actually be easily cleaned for not very much money.

The N aisle E end floor has had one joist repaired recently by the repositioned radiator, there is also a loose area on the corresponding side on the N aisle, just under the carpet.

Recommendation: repair loose floorboards

C	Floors: repair loose floorboards	100
C	Boiler Room: remove sapling to boiler compound	-

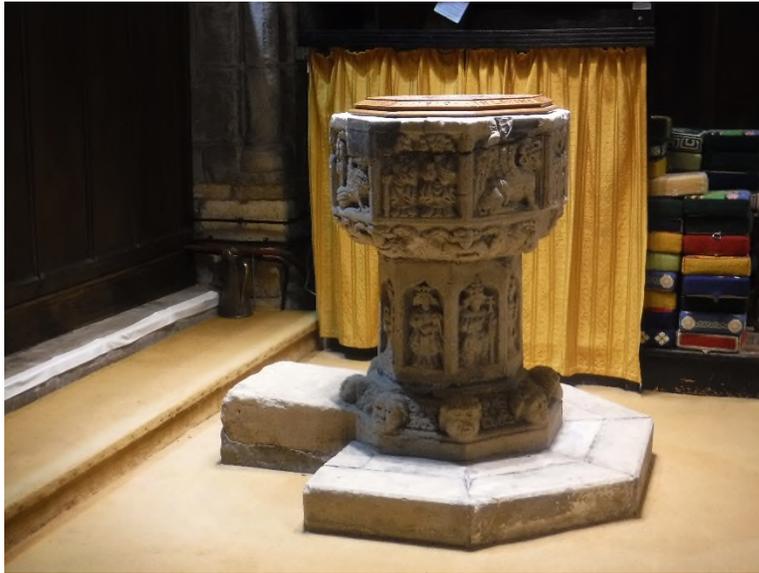
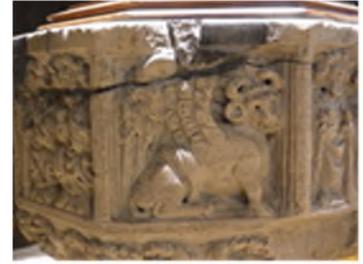
Octagonal stone font with decorative carvings poorly restored with cement with a 1910 oak cover, lead lined bowl with glass bowl within it.

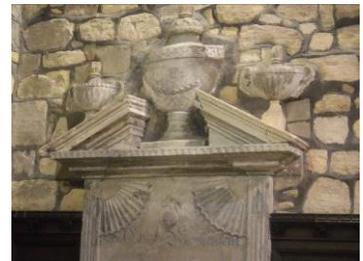
Chancel- A large classical broken pedimented tablet celebrating the memory of the Ellerker family whose descendants died in the late 18th century. There is a bit of damp showing to the bottom of it and it has been rather buried by the upper altar step suggesting that it is clearly an addition to honour and beautify the church and regrettably it has received rather a lot of cement pointing around it. The bottom of the pediment is broken though it remains in place.

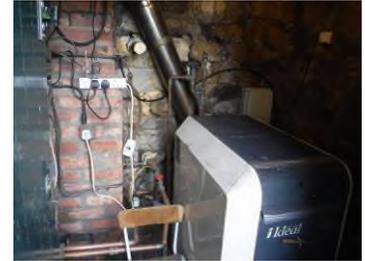
C **Boiler Room:**

Open boarded ceiling of recent construction, it is covered with mineral felt and has lead alternative flashings- generally fair. The walls are an amalgamation of the church walls and new walls forming the enclosure of brickwork, generally sound. There are some open joints but they will do. The floor is concrete and there has been some oil spilt in the past. The room contains the CCTV recording and a monitor and there is also quite a bit of loose wiring about the place, the boiler is a Falcon GTE.
