**HAWTHORN**  
**St MICHAEL & ALL ANGELS**  
(49)

**QUINQUENNIAL REPORT**  
on the architect's inspection on

**29 September 2022**

IAN NESS  
ARCHITECT  
26 GROSVENOR PLACE NEWCASTLE upon TYNE NE2 2RE  
tel & fax  
0191 281 2559  
i.ness@btinternet.com

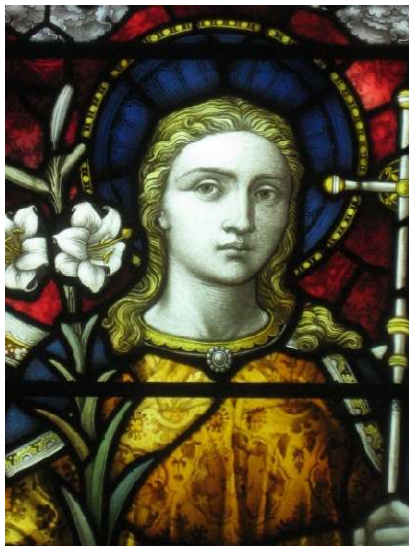
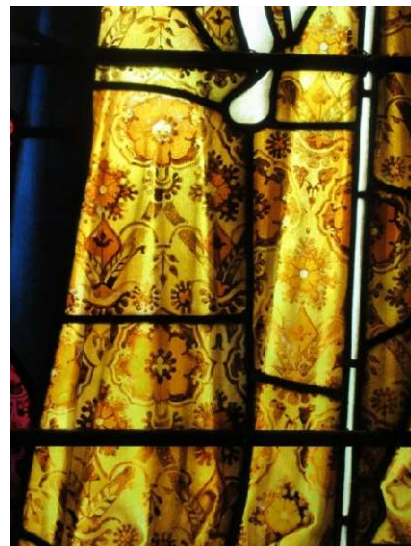
66. W gable pair Faith and Hope memorials 1896 and 1900 to Pemberton daughters, Clayton and Bell of London very good colourful painting and condition.

67. Black wire grills at E quatrefoil and N and S Chancel. Grills and protective sheet glass at E lancets with two minor cracks.  
No protection at Nave or W gable. Perhaps protection should be added at the Bacon and W glass.

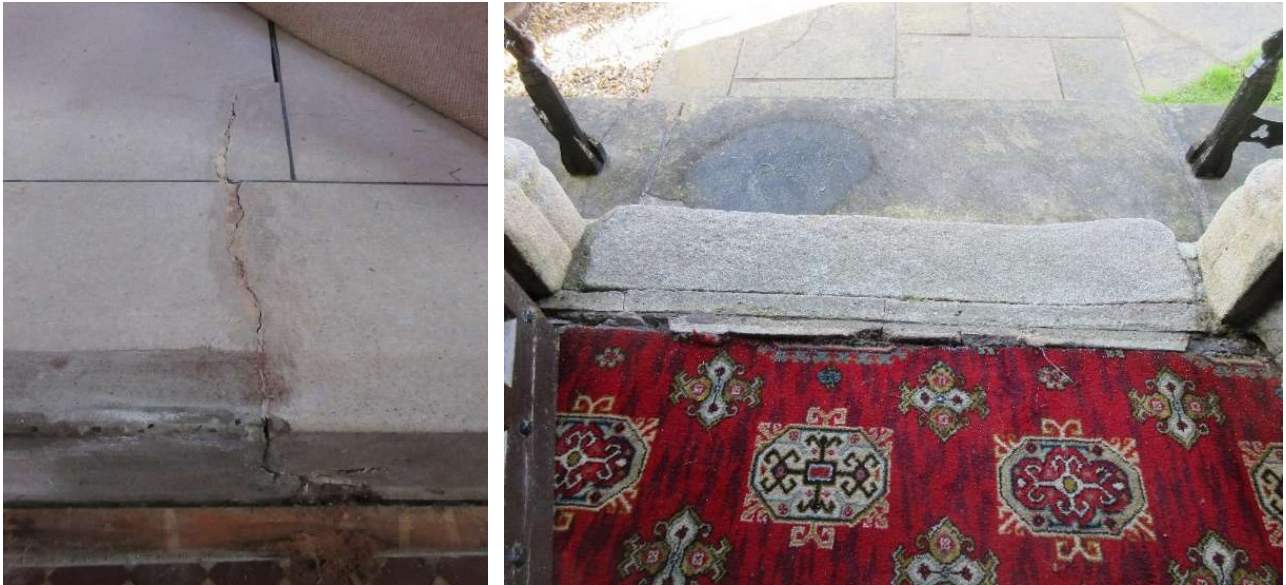
68. Chancel loose carpet on granolithic topped solid floor which is not original (blocked air bricks para. 59). Grano divided into square bays by black strip movement joints to prevent shrinkage cracking. Some damage to grano L of altar. Middle of floor slightly humped up and cracked, making parts of the rigid black strips stand proud under the carpet. This may be a mild form of the heave or subsidence often found in solid chancel floors due to poor base material.  
The front edge (the Chancel step) is patched with makeshift concrete now cracked.  
The time may have come to renew the whole Chancel floor with ventilation which may reduce decay at the Chancel arch.

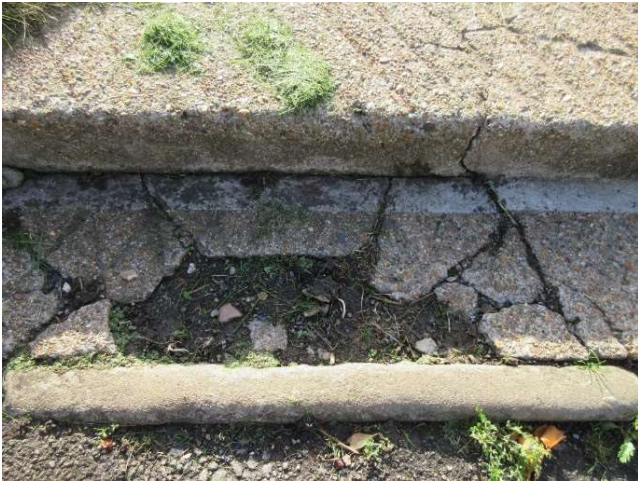
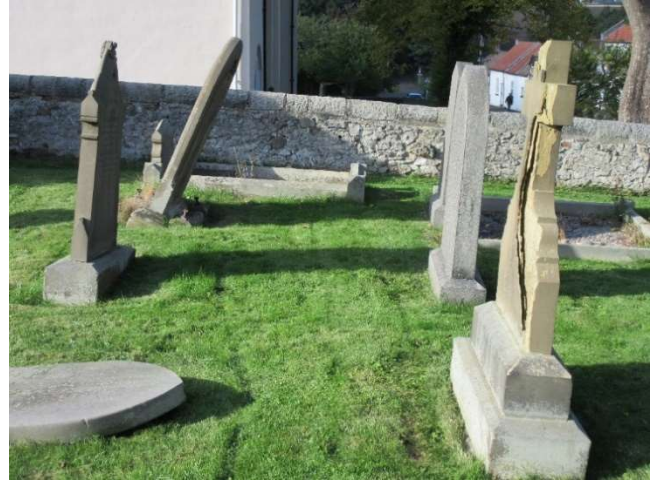
90. The churchyard remains open for burials. Limited space at W end.
91. A simple rectangle between the main road to the E, a garden at W and between houses at N and S. Stone boundary walls all sides with good round copings. The pointing of the pavement wall is poor enough for some small rubble at SE to become loose. N wall similar. Its W end retains the churchyard above the neighbouring garden, over which it may lean slightly. The W wall also retains the yard. Slightly cracked and bowed where it is pushed out by an ash tree. S wall fair but small patches are becoming loose.
92. Recent gates. Chamfered tops. Stained softwood gate posts installed 2016. Concrete step very poor. Good varnished oak sign with hinged front. Both need to be kept well decorated

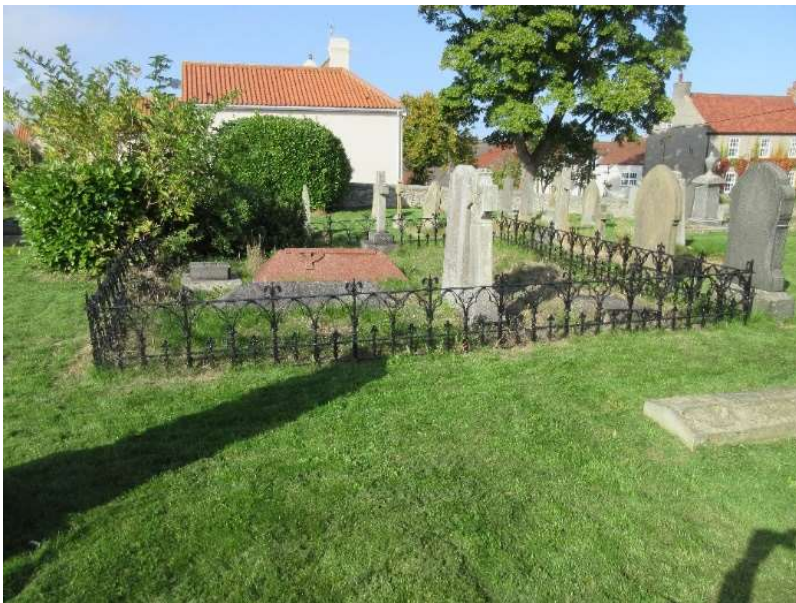
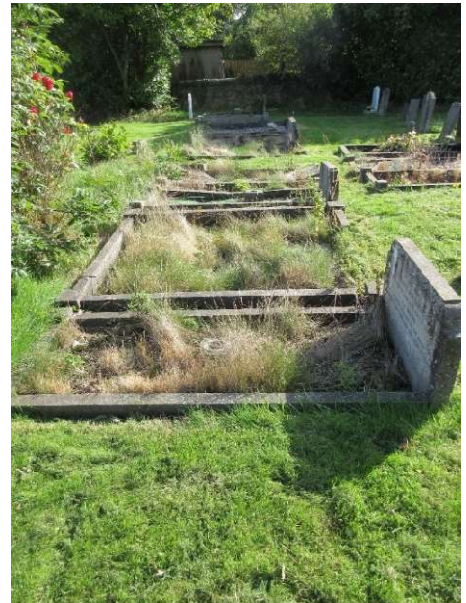
94. A cast iron filigree fence around a group of Pemberton graves with gates wired in place. Part painted since last inspection.

In contrast near the S wall a small grave with oak cross and kerb now decays.
