Quinquennial Inspection Report

Church of St Oswald

Hebburn

Date of inspection: 18 September 2020

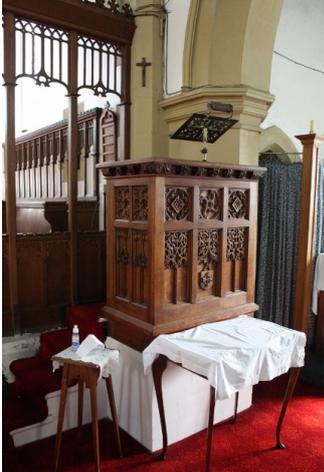
2.8 Fittings, fixtures, furniture and moveable articles		
<p>Condition</p>

<p><u>Chancel:</u></p> <ul style="list-style-type: none"> - Carved oak reredos and adjacent panelling - Choir stalls with carved oak front panel - Carved oak rood screen and fretwork behind choir stalls <p>All are in good condition.</p> <p><u>Nave:</u></p> <ul style="list-style-type: none"> - Carved oak pulpit – there is no handrail to the steps (see photo). One should be fitted for safety reasons. - Stone font and base – (painted with masonry paint). The paint work to the base is blistering. Removal of the paint to allow the stone to breathe is recommended. - Stained pine pews – decoration is poor. Re-staining is recommended. 	<p>B</p> <p>C</p> <p>E</p>
