St MARY HEWORTH

QUINQUENNIAL REPORT

12 July 2022

IAN NESS
ARCHITECT

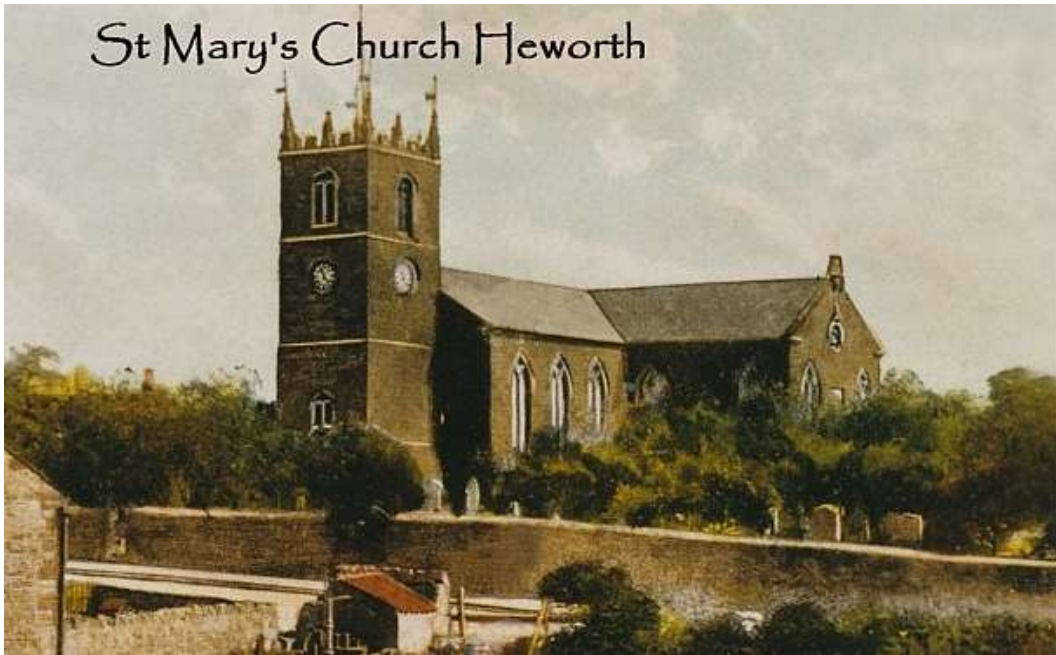
postcard before the roof altered to flat at Transepts with lower gables

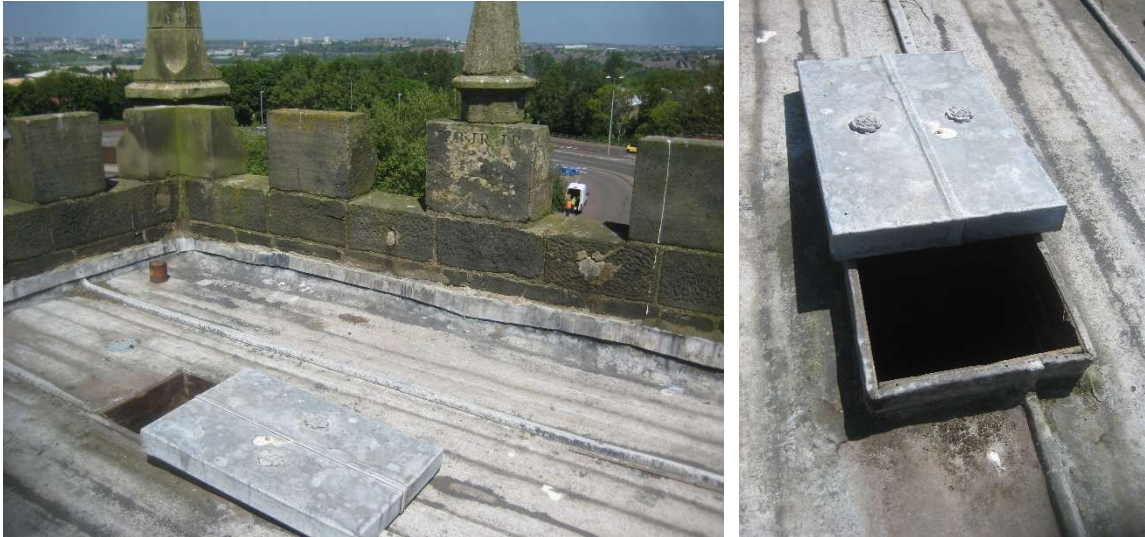
17. The **Tower** roof is aged lead in four overlarge pieces with wood roll joints and a lead box gutter at E. Bays 4.4m long, 0.95m wide which is well over the recommended maximum. Since the first report in 1959 the lead has been described as needing repair. Lead burned repairs appear sound. Another NW of the hatch appears to be an asphalt patch with silicon rubber around the edges, part loose but apparently sound. The cover flashings are sound.

20. The hatch upstand near the middle causes a pond and prevents free movement of the lead as it expands and contracts with temperature. Free movement is needed for long life. A cracked hatch corner has been patched with silicon rubber which seems to have stopped a former leak.

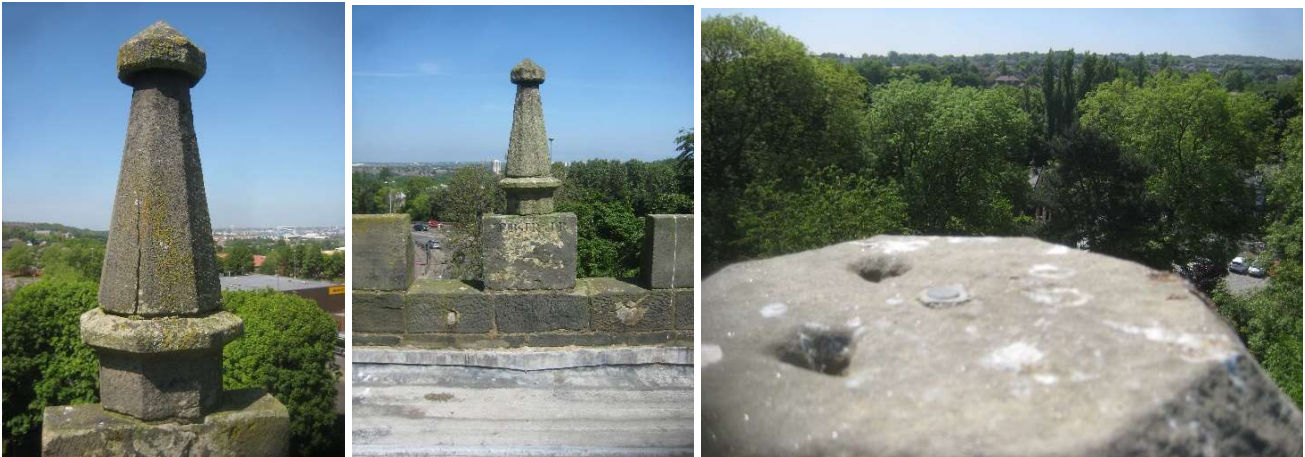
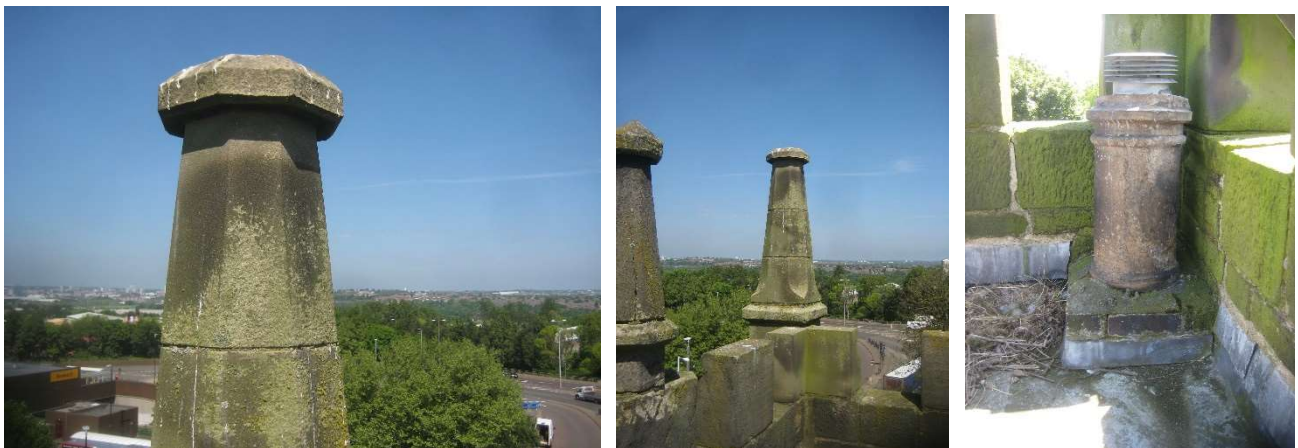
35. *The corner pinnacles and merlons are modern. The mid W pinnacle and the mid S pinnacle and its base have old splits but are stable.*
36. Internally damp masonry each side of the brick flue in the SE corner of all stages including damaged painted plaster in the Ringing Chamber and on the Nave W wall suggests a past or present leak. The 2016 photo of the parapet SE corner shows

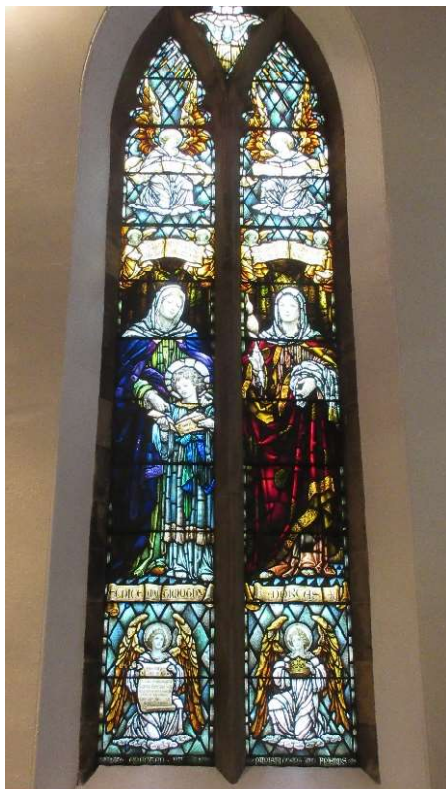
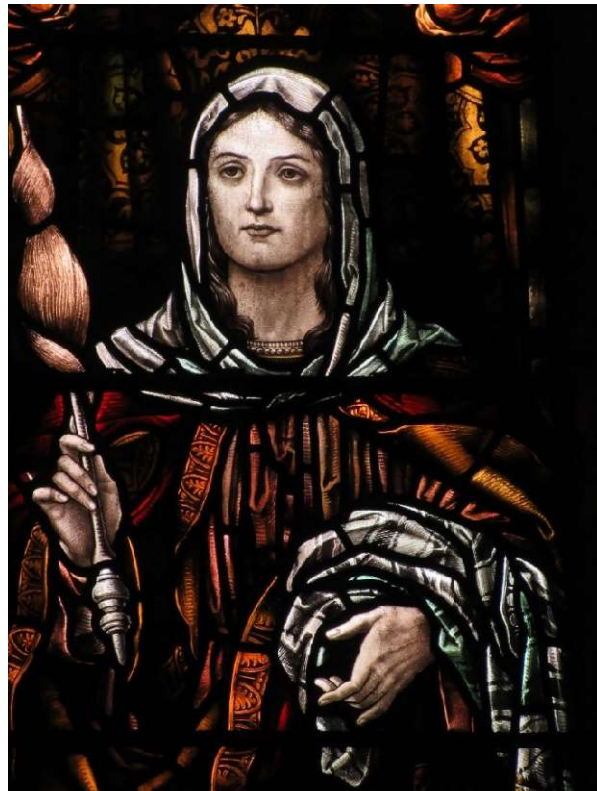
64. E triple light Crucifixion. Good except paint loss from flesh and some borders.
65. Five Victorian and Edwardian memorial stained glass windows.
At N Choir 'Plummer' 1870 is intact but slightly distorted by the weak lead pattern including roundels and triangles.
66. At S Transept W side by the font a matching pair of floral geometric pattern with roundels. Drewett 1870 and Revd Plummer 1877. Minor distortion and dirty.
The S Transept E window (hidden by organ) is clear diaper leaded, sound but the bottom is boarded over inside. Very dirty.
67. In N Transept E side the bottom of the Steel 1903 window was well repaired after malicious damage.
Good except minor paint loss and slightly dirty.
68. The opposite W window in the Chapel is a particularly beautiful subtle colour Steel 1911 memorial, Eunice, Timothy and Dorcas, said to be by Ballantyne of Edinburgh. Slight dirt.

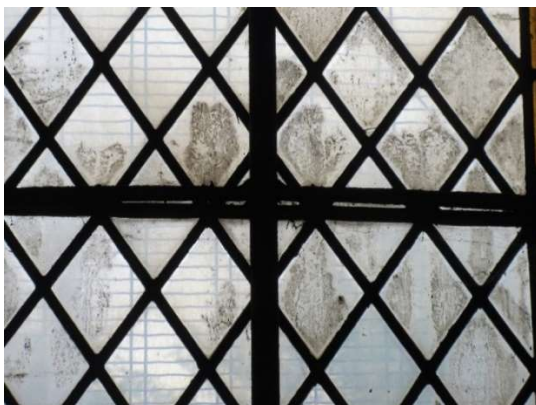
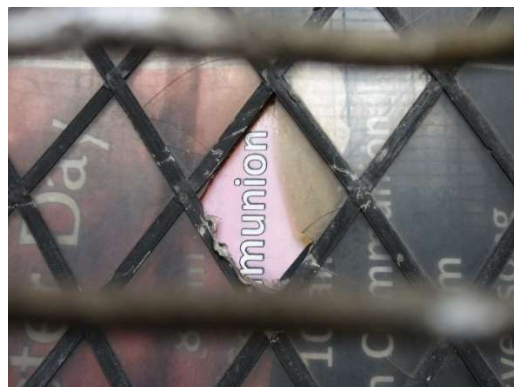
69. Both N windows in the N Transept sides have clear diapers with yellow borders and heavy internal ferramenta. Both dirty, especially the W where two broken pieces are covered by card inside.
The other N Transept windows sound clear diaper leaded with yellow borders, dirty.

Clean glass	66 - 72
Repair plain glass	69 - 71
At Lychgate remove or derust and paint gates	112
Repair and repaint signs at N and W	113, 114

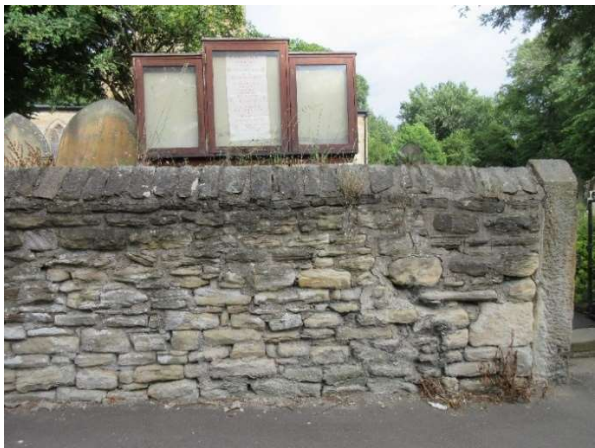
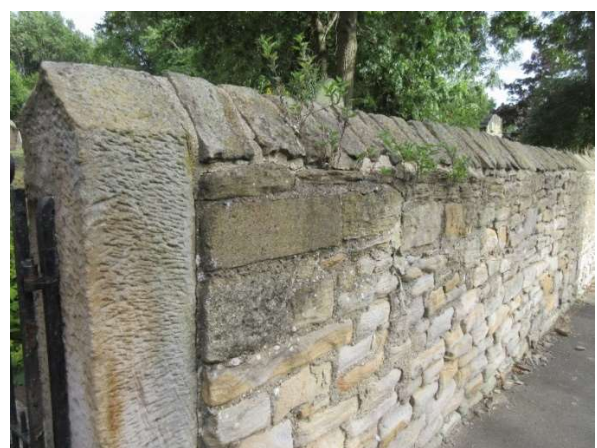
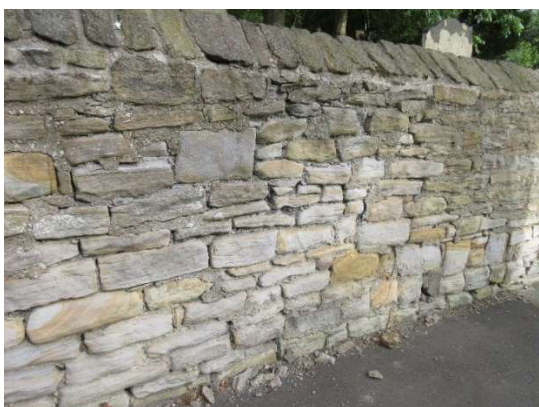
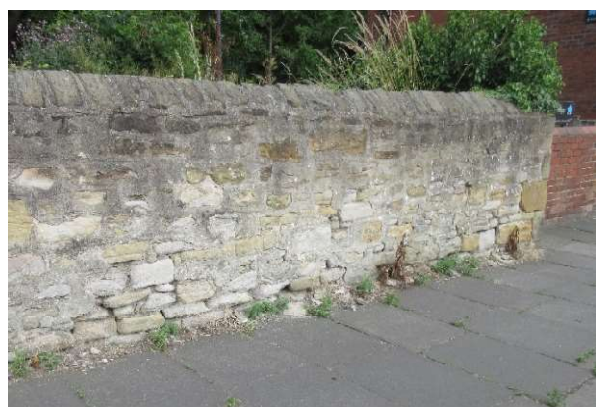
Ceilings

trees disrupting graves

Remove whole flue terminal above roof level, clear nests, extend gutter, add flashings, point parapet	36 – 38, 44, 58, 85
Continue to remove self seeds in graves	106
Repair boundary walls at W	109

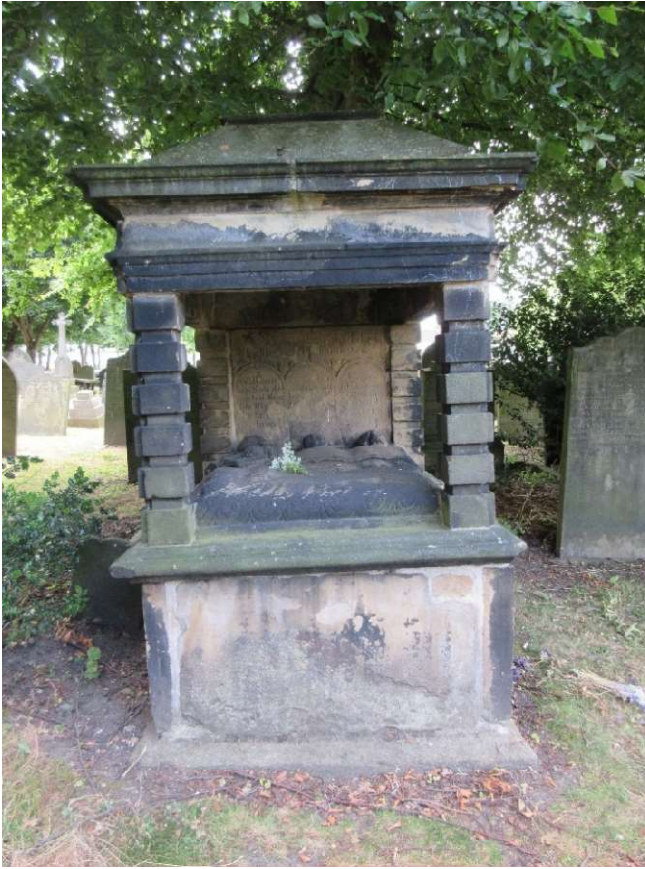
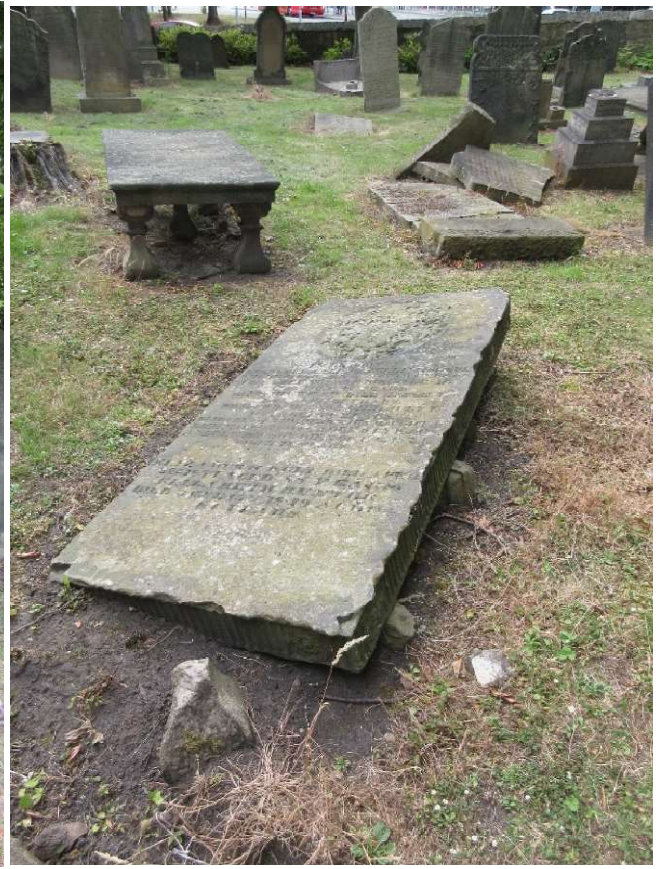
107. Seven tombs or monuments and two groups of marker stones in the churchyard are separately listed. Among them the famous Haddon 'bed' tomb N of the church has been repaired but remains tilted. The rest are in fair condition except the Kell table tomb N of the Nave which has collapsed. The table top remains in one piece and the five legs may still be intact.

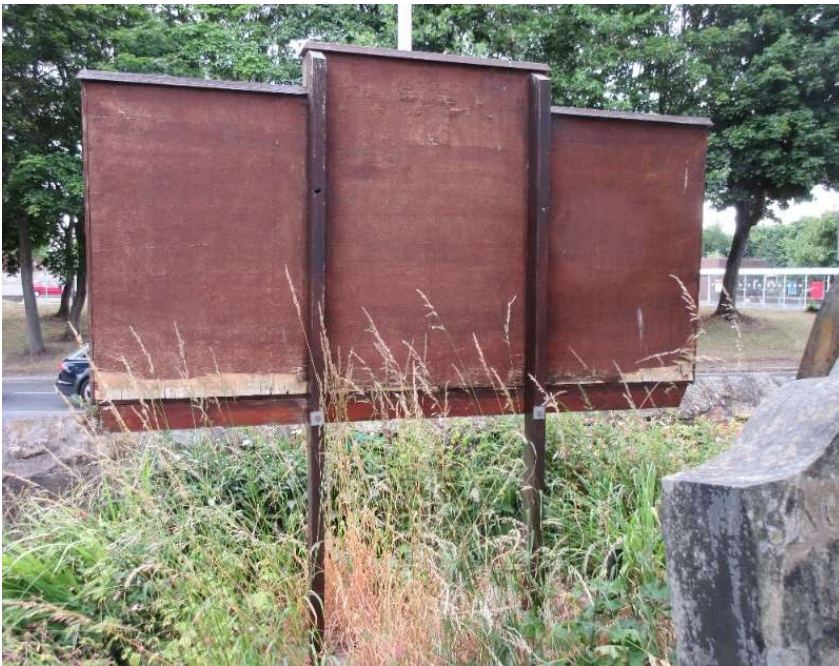
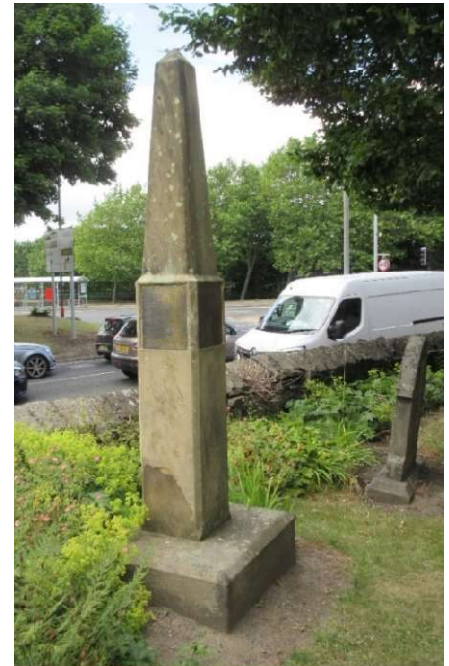
108. Among the separately listed monuments, the small 1812 Colliery disaster (a stone needle with inset bronze name plates) is mostly sound but the lower stone has a cement mortar skim which is part loose.

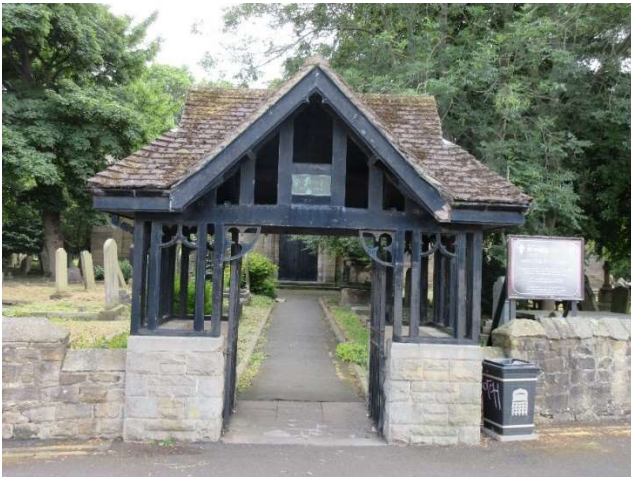
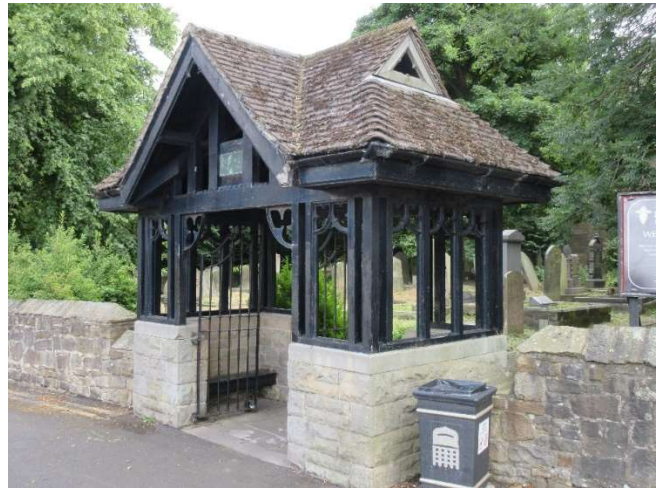
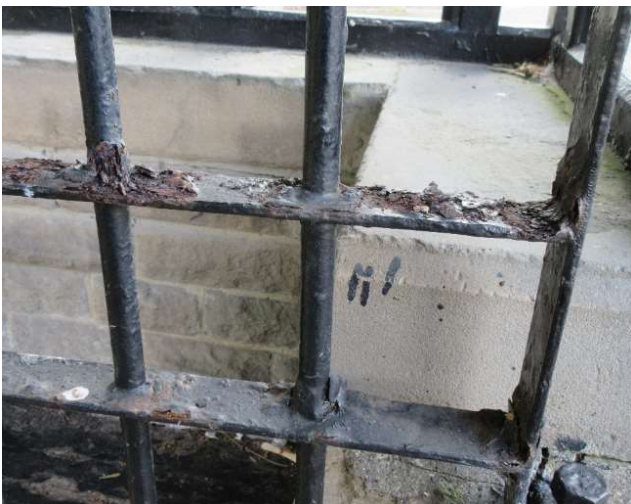
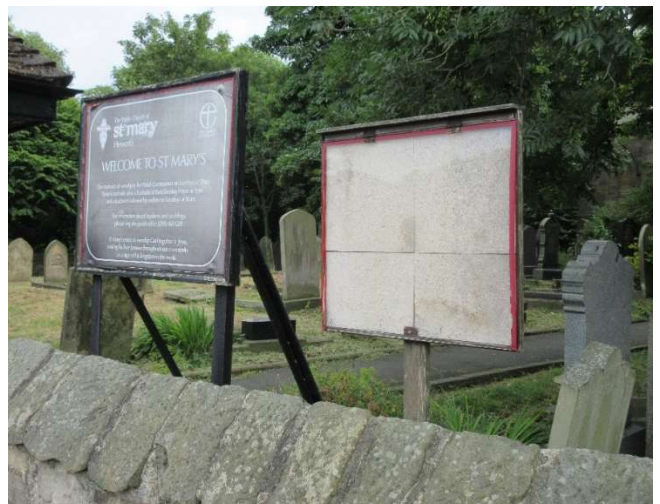
111. The S gates are rusting modern mild steel hinged on steel posts.
Fine old stone piers with an iron bar overthrow and holder for a former oil lamp. The stone is sound and the W cap and top two courses have been realigned and pointed since the last inspection.
112. The 1937 Lychgate tiled on oak and stone is in fair condition. Rusting steel gates are locked open.
Aluminium guttering and brackets with one corner loose. A plastic downpipe at E side. The guttering could be removed as it is a maintenance burden and mainly stops drips onto users passing through.
