**St PATRICK  
HIGH SPEN**  
(22A)

**QUINQUENNIAL REPORT**  
on the architect's inspection on

**8 May 2018**

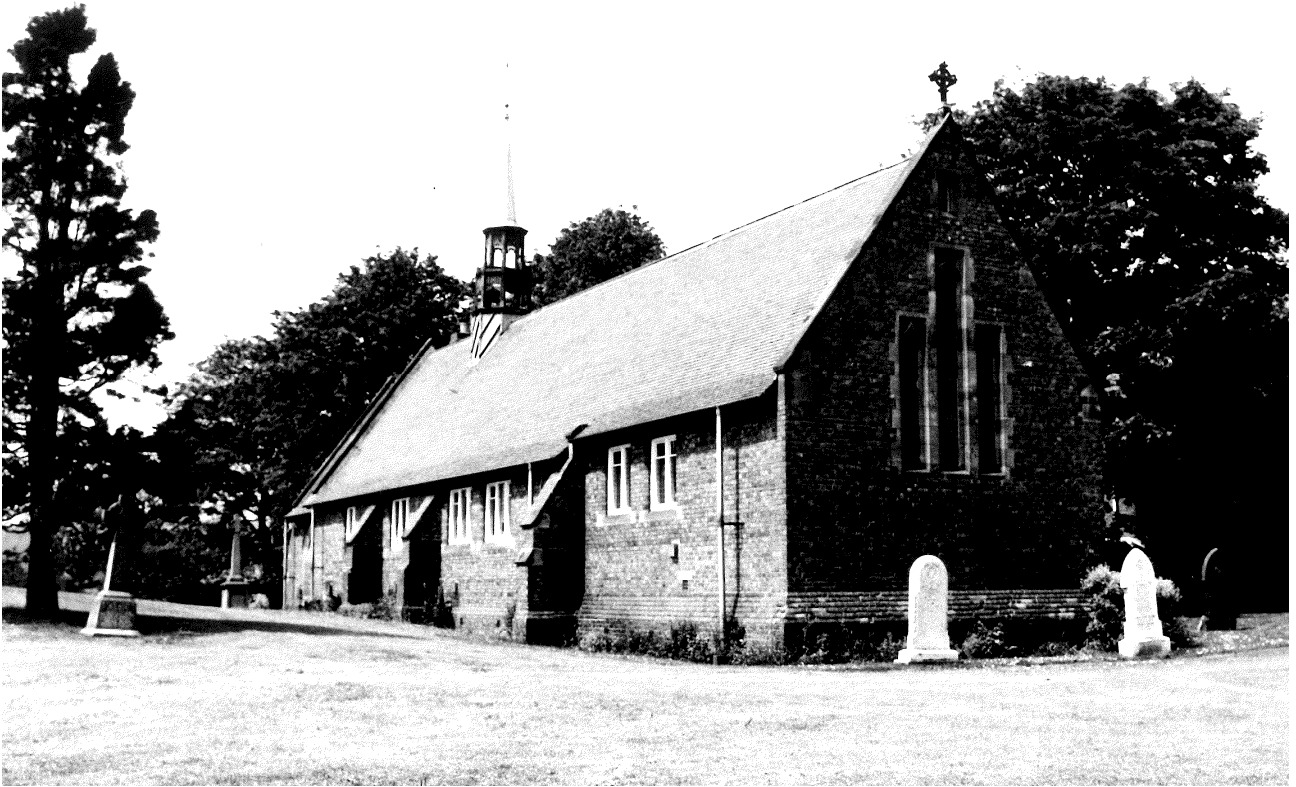
16. **Vestry/porch** N side good. S tiles good except scattered broken corners and one broken near ridge.
17. Lead soakers and cover flashings at the gable upstands. Stepped flashings abutting the Vestry to the Nave.  
All seem sound.

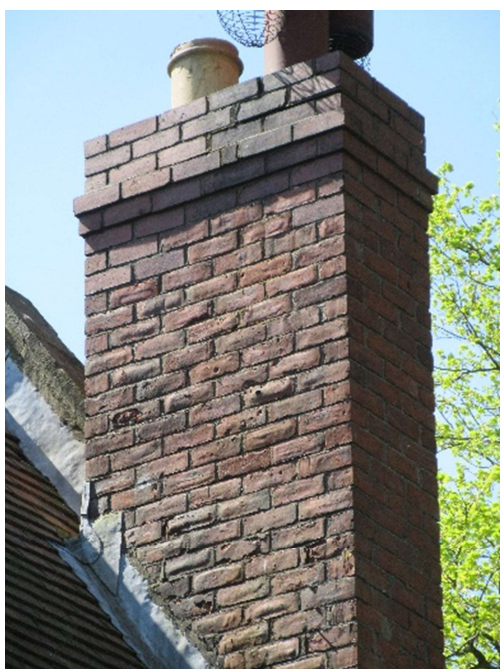
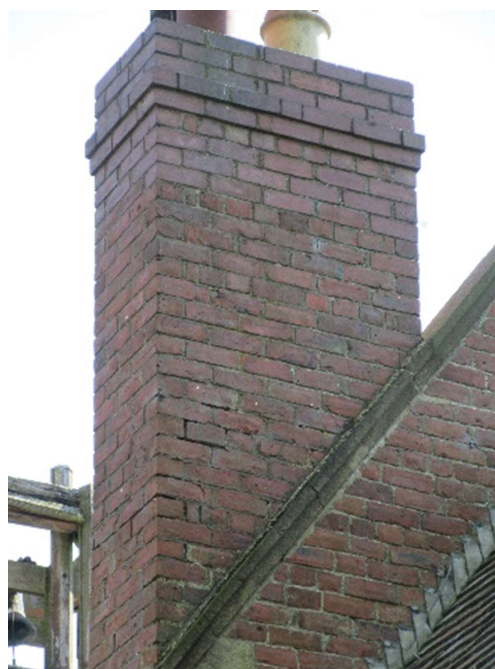
28. Solid red brick with double course of plinth bricks except six plinth courses around the Chancel. At the buttresses, sandstone setbacks with drips and brick plinth setbacks. The tops of the wide buttresses are tumble-in brickwork leaving large areas of exposed sloping brick on edge which needs to be kept well pointed and as waterproof as possible.
29. Where the narrower Chancel meets the Nave the different sprocket levels are accommodated by stone blocks protruded through the tiles and flashed with lead. This complication has the added weakness of letting a little roof water run over the buttress brick tops instead of into a gutter.
30. Disused brick chimney, two pots and mortar cap seem sound except  
- top two courses at NE have lifted. Perhaps a flue liner fixing is rusting and lifting bricks.  
- minor open joints at the W side

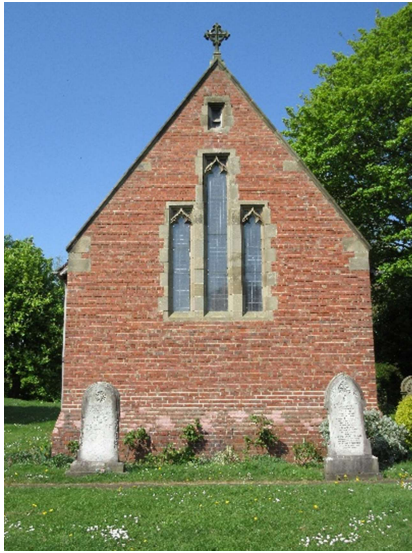
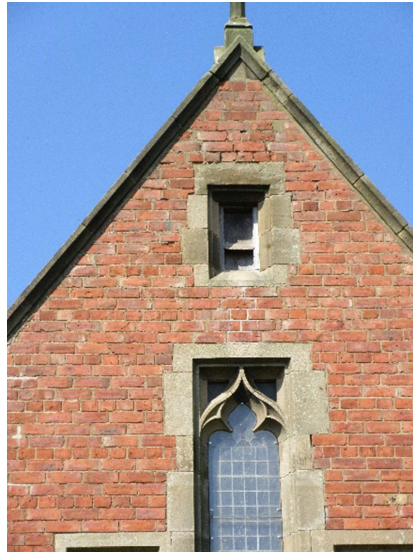
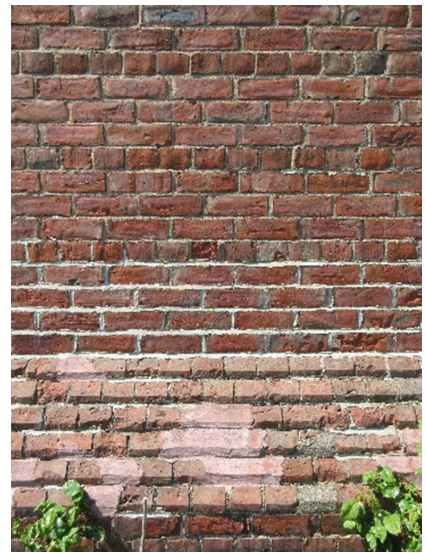
31. Sandstone watertables and kneelers on the three gable upstands with a carved cross at E. Minor spalling of stone on the watertable tops. Some very narrow joints are open.

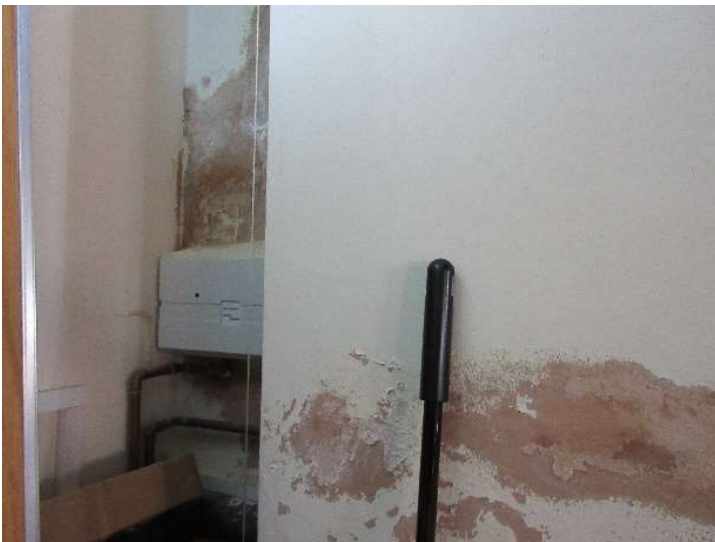
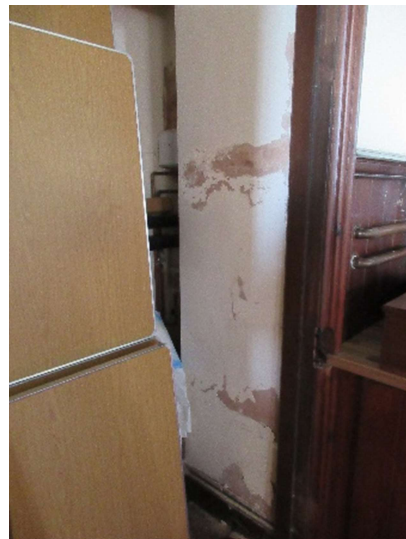
47. Nave fair after plaster repairs at pulpit and kitchen. Plaster and paint damage remains in the Store next to the kitchen, including behind the instantaneous water heater which may become damaged if damp persists. Outside the buttress pointing and gutter need to be kept in good condition and clear.

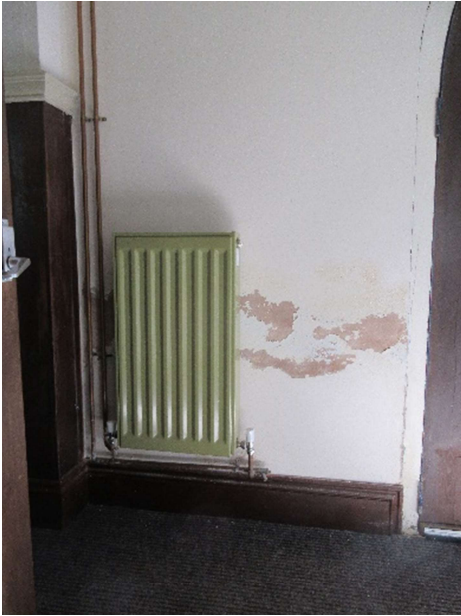
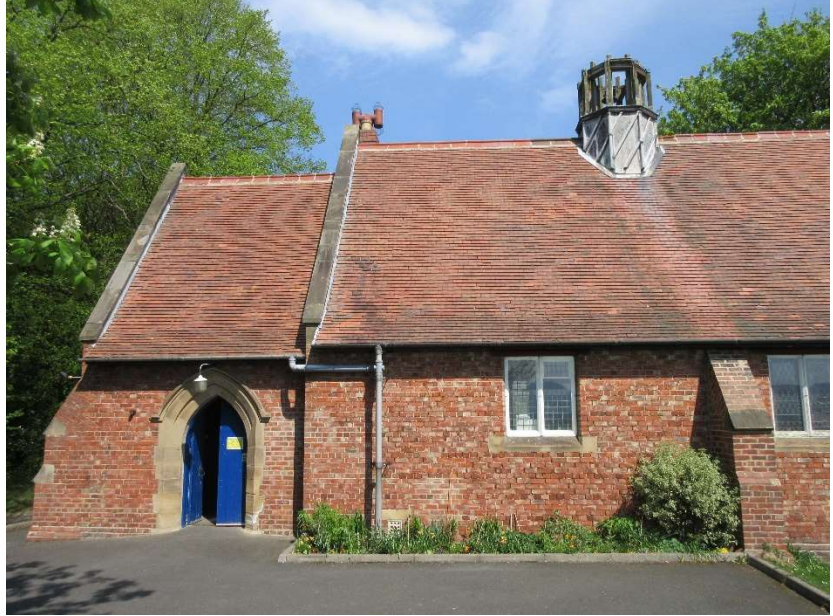
49. Porch fair but slight rising damp damage persists at the S wall E of the outer doors. The causes could be a combination of:
- the raised tarmac level outside, needed for level access
  - damp from the nearly adjacent high soil level in the planting bed against the W bay of the Nave
  - poor drainage from the nearest rainwater pipe which goes directly into the planting bed
- If plaster damage persists and cannot be solved by reducing soil level or clearing a blocked soakaway there could be an argument to cover the lower wall with simple dado panelling and capping on the same principle as the dado in the church, which was a precaution against similar damp damage

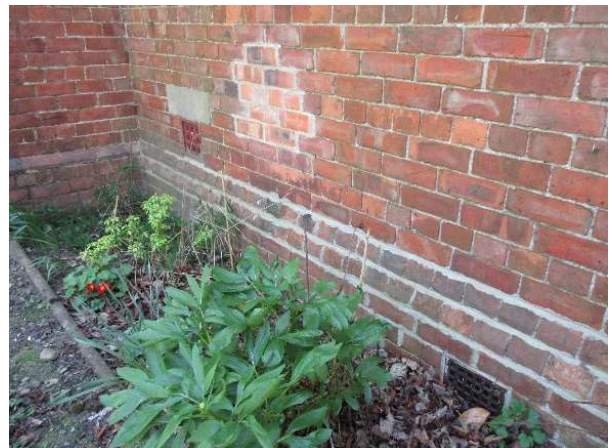
56. As usual in Victorian public buildings the interior is excessively ventilated by modern standards and loses heat especially when windy. As well as the ridge vent which may be sealed, vertical ducts on the Nave walls bring air from further large air bricks above floor level to top of dado level where hinged wooden flaps do not control the winter winds well.

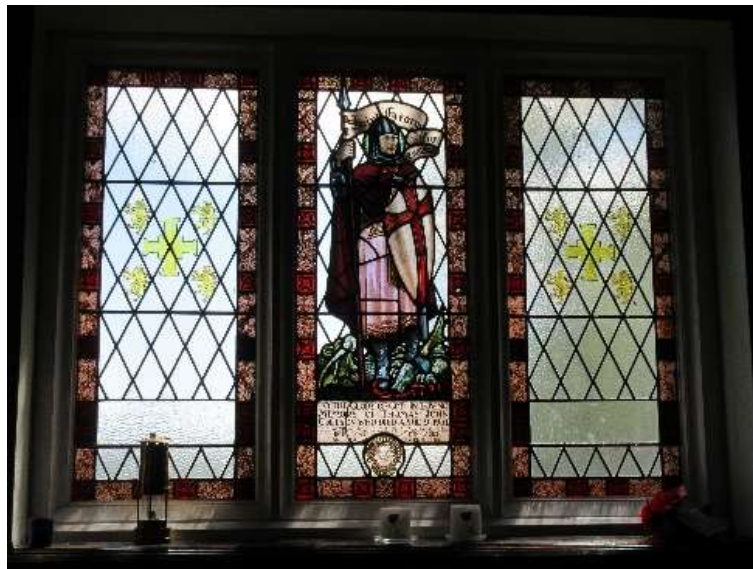
59. E lights plain clear leaded glass with minor coloured glass in the cusped heads.  
Dirty inside glass and inside polycarbonate.
60. One S Nave window is stained S George between painted cast diaper glass, 1931 Coulson memorial, sound.

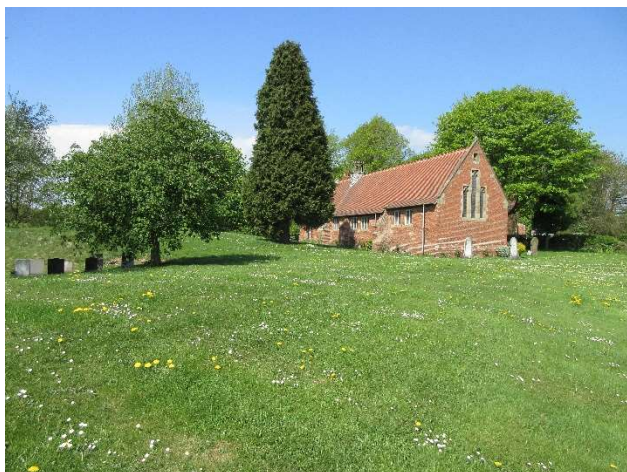
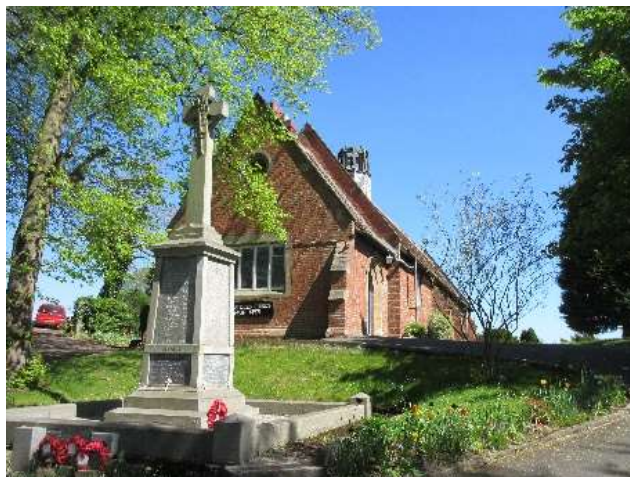
91. A closed hilltop churchyard continuous with the adjoining municipal cemetery with which it seems to share maintenance. Cleared of most stones, grassed and well maintained.  
At the road hedges and cast iron gate posts without gates.
92. The main feature is a granite war memorial obelisk and cross between the road and church. It appears to have been heightened by adding a base for 2<sup>nd</sup> war names. Cleaned and repaired by the local authority some 15 years ago. Good condition. Round it loops the short steep tarmac access.

93. Painted timber notice board is now decaying. Might be replaced with new timber on the existing aluminium legs or with a new longer lasting printed metal sign.
94. Large sycamore between the N side of the church and the former vicarage garden, overhanging the church a little. A horse chestnut by the access and tall limes by the war memorial.
95. The few headstones, mainly at E and N are in fair condition.  
 An isolated 'Stewart' stone S of the church entrance will eventually be overturned by a tree growing tight against it.  
 A tall 'Wilson' celtic cross S of the Chancel leaned at the last inspection, perhaps due to the roots of a fir tree close by. Now lying flat. Not known whether it was laid down deliberately. It now impedes grass cutting and is a loss to the quality of the churchyard.
