**JARROW GRANGE
CHRIST CHURCH**
(109)

QUINQUENNIAL REPORT
on the architect's inspection on

11 August and 14 October **2017**

IAN NESS
ARCHITECT

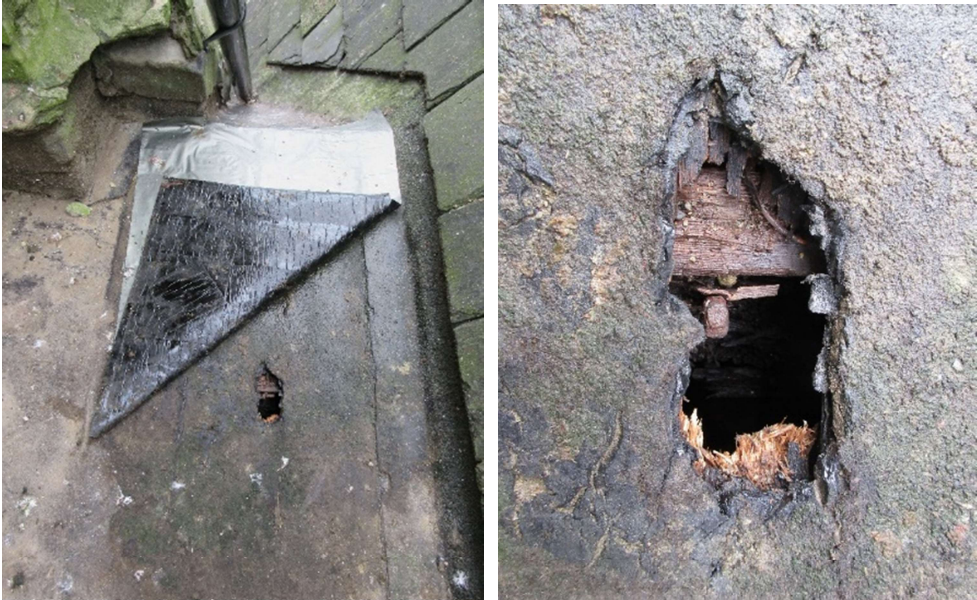
14 October 2017 after clearance

28. The gutter discharges by a series of complicated flashings and back gutters around the Tower SE buttresses, also just cleaned of silted and plants which prevented good drainage into the Chancel eave gutter.

The back gutters SW of the Tower remain full of plants (para 19).

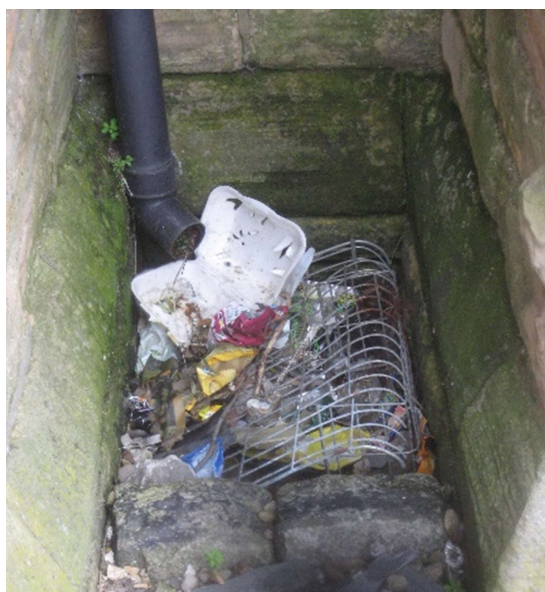
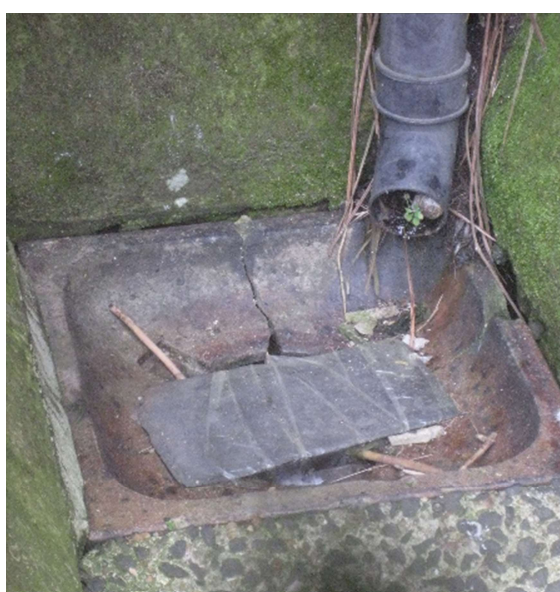
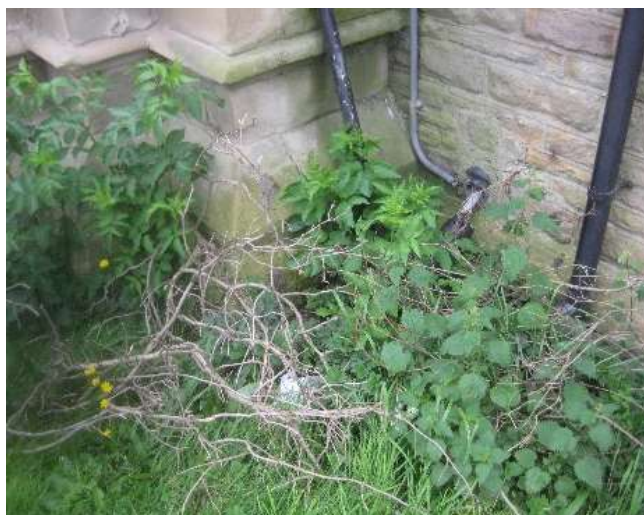
31. The Nave pipes crossing the Aisle roofs have pipe clips steel screwed down through slates. Rust will crack the slates eventually. The top joint of the NE Nave pipe is loose and must spill water onto the Aisle slates.

32. The down pipe W of the Porch is blocked. Spilling water wets the wall which grows ferns and damages the paint inside.

33. N gullies and the gully E of the Porch are blocked. All gullies should be cleaned say twice a year to prevent overflow saturating the ground under the building.

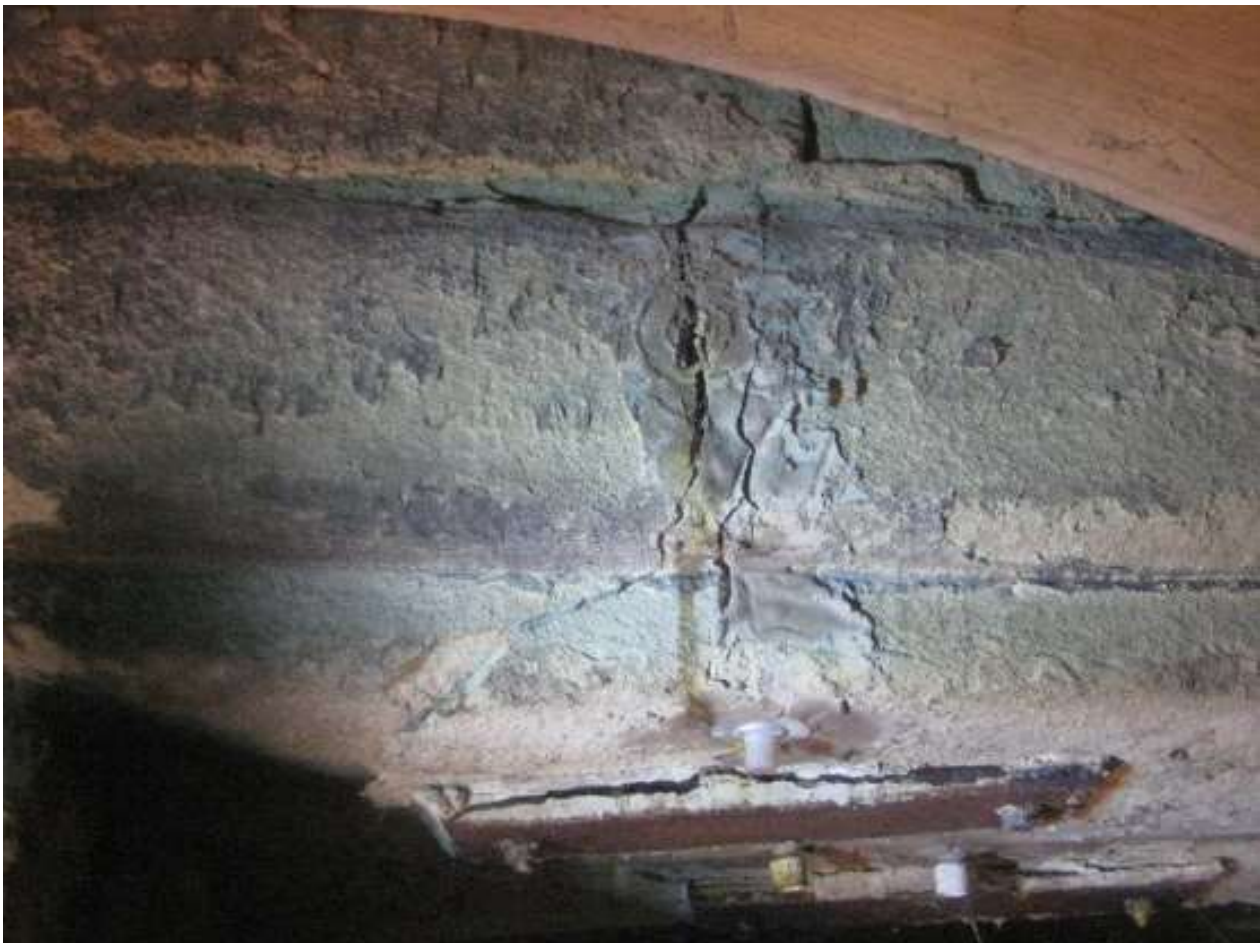
37. Top Chamber sound except a vertical crack through the E door lintel widest about 5mm at top. Resin filling in the vertical crack is cracked. Now also a minor vertical crack on the lintel's stair side. Lintel reinforced in 1992 by two rusting steel plates pinned underneath into resin. The plates are coming away from the lintel. Without accurate telltale comparison with my 2012 photos is not exact but it appears very slight movement over the door continues, complicated by rust behind the mild steel plates which may be forcing them off.

2017 – cracks wider than 2012?

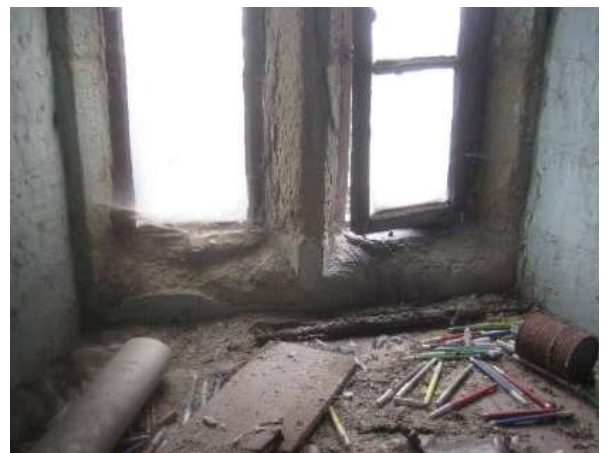
47. **E of Tower** least decayed but parts of the string courses and the low reveals each side of the louvres are missing and the ashlar surface is spalling at most of the stair turret and at three wall panels below the louvres. At the Ringing stage the double window is decayed inside and out and the opening light no longer closes, so wind passes through, increasing scour.

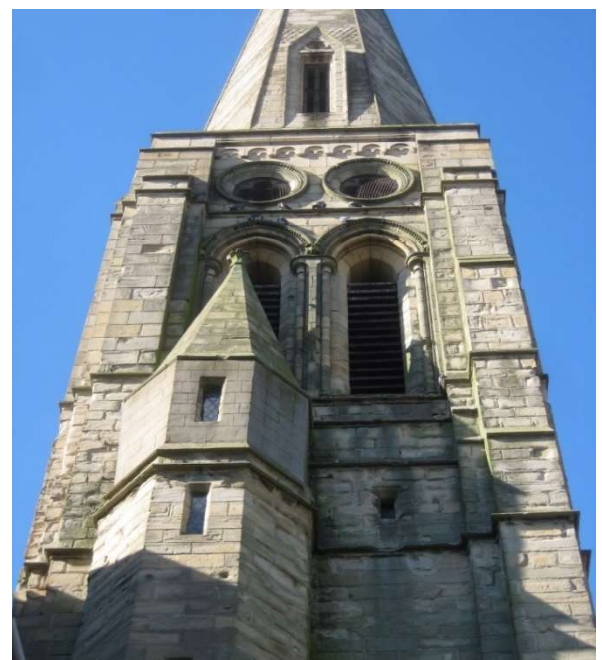
48. Erosion is deepest under the Belfry openings and at the SE buttresses facing the Chancel roof. The rendered repair of the top stage of the spiral stair turret looks sound though not well matched in colour. A tree grows again where silt is trapped between the turret and buttress.

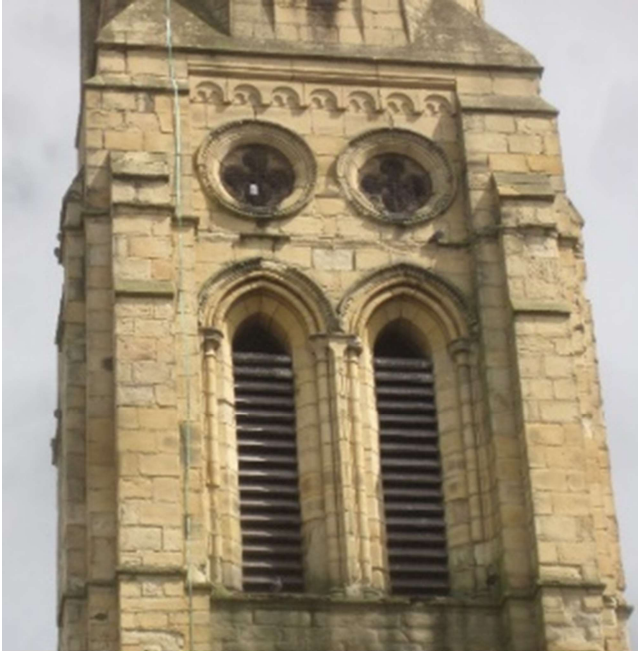
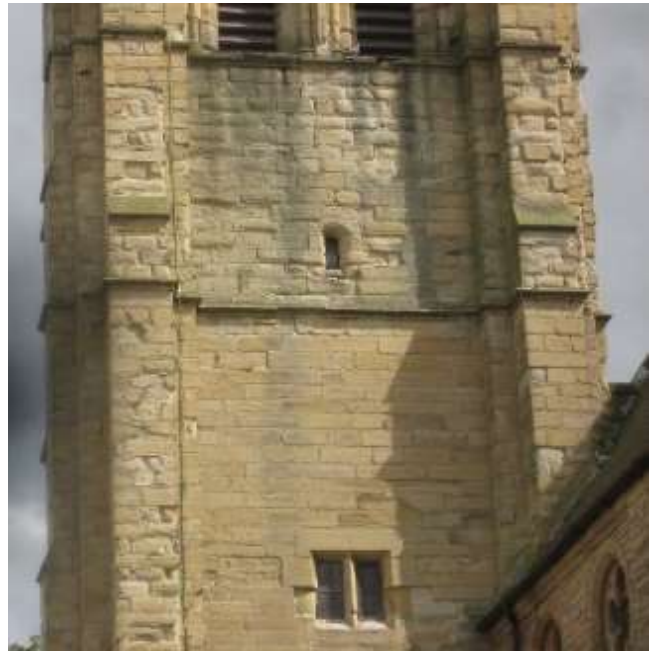
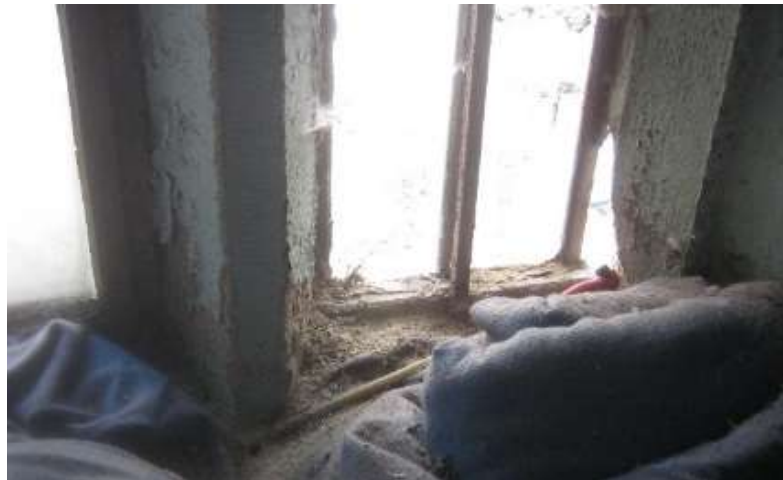
50. **W of Tower** Mouldings framing the round bell openings are about 30% deep decayed. The moulded string above the louvres is almost all destroyed. Several decayed reveals at the bottom of both louvres. Below the louvres almost all stones in the plain panel and its buttresses have lost their surfaces and are deeply decayed from the joints. About 50% decay in the rest of the NW buttress. At the Ringing chamber left window a reveal stone is so eroded that over an inch gap has opened between stone and iron window frame. Wind scour increases stone erosion here. Otherwise fair except random surface or edge decay.

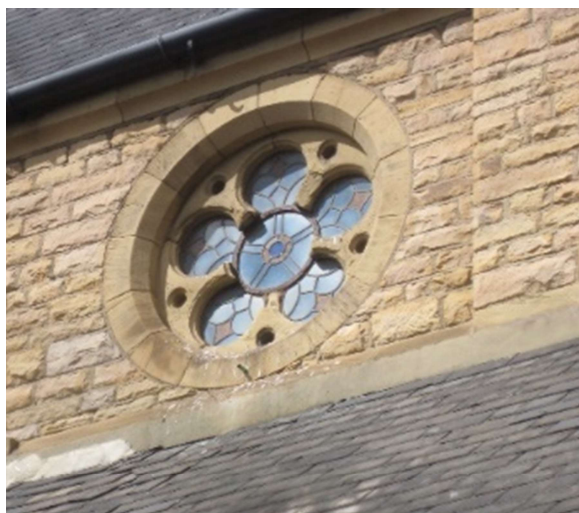
62. **E Chancel** 3 lancets and round multifoil window good except one cusp at L of round window has decayed back to the glass line where the tracery tip meets the iron hoop armature.
63. **S Chancel** 2 lancets good except two pieces of hoodmould are decayed, one missing.
N Chancel 2 lancets good except erosion from open joints in the hood moulds.
64. Small door opening at base of **Tower** and pairs of small lancets without hoodmoulds in **N and S Aisles** in good condition but soft beds in the arches of the Aisle end lancets.
65. At the **Vestry** door 2 pieces of hoodmould are deeply decayed.
66. **N and S clerestoreys** 8 cinquefoil windows in each.
Fair but eroding from many cusp tips like E Chancel.
Some old mortar patching of the tips. At S second window from W part of the bottom cusp is missing.

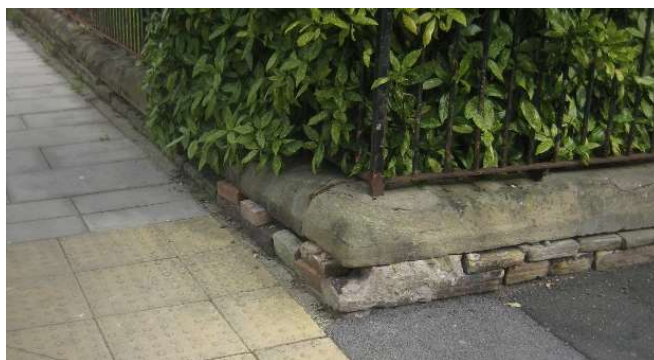
126. The low stone boundary walls, piers, railings and gates are in worsening condition. Rust gives a poor impression and damages the metal. Chipping, derusting and painting of railings and gates is needed. Plants growing in the walls should be removed and the joints raked and pointed. The NW corner is derelict and propped on bricks to stop the railing breaking.

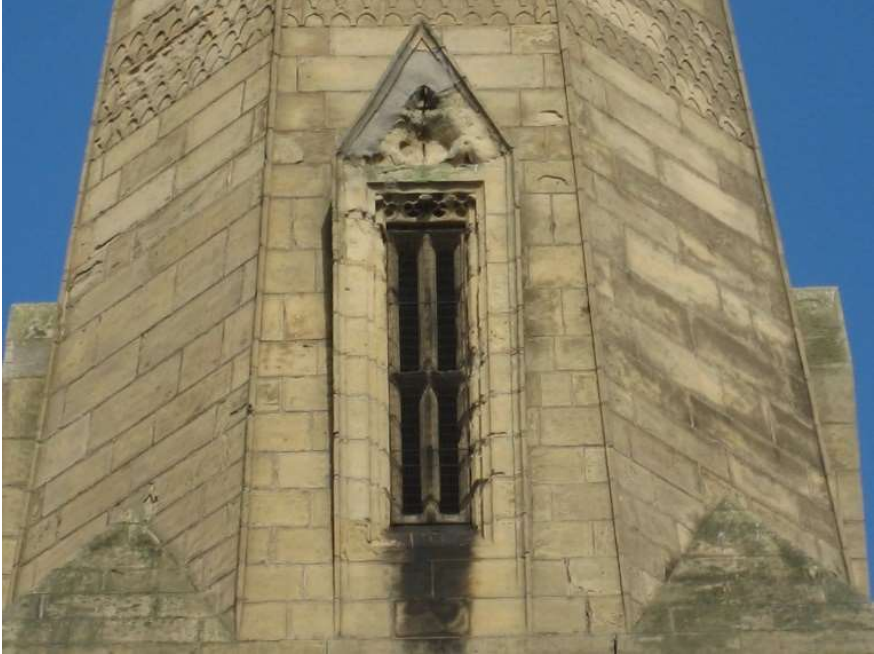
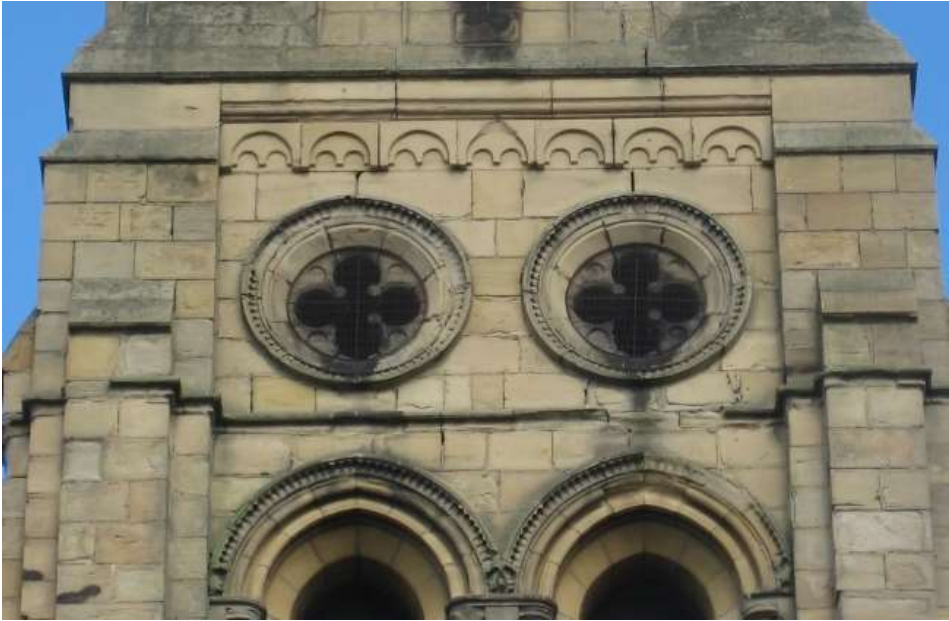
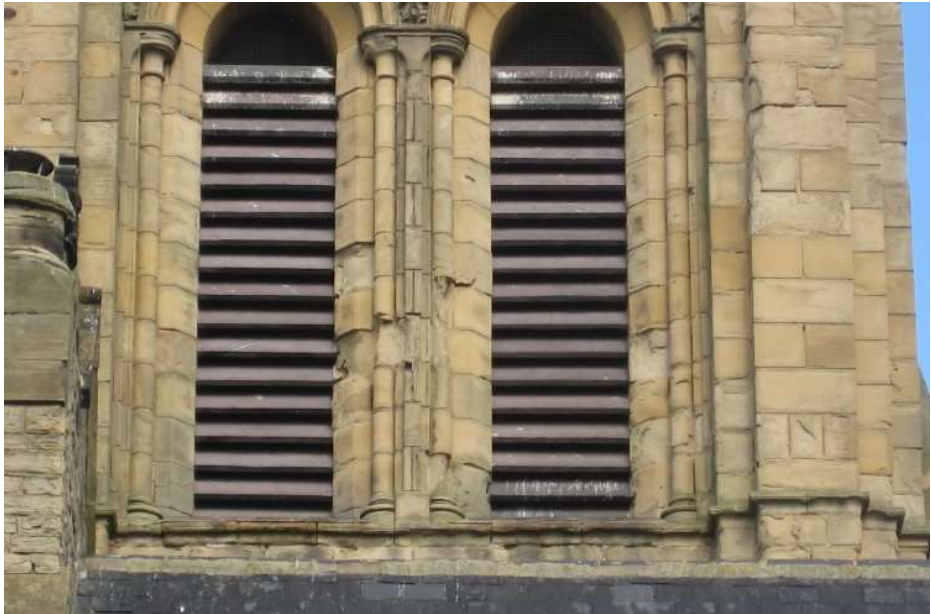
South

APPENDIX Spire and Tower Photographs before and during the 2010 repairs from N side scaffolding typical of decay all sides
