**St JOHN the Baptist JARROW**  
(106)

**QUINQUENNIAL REPORT**  
on the architect's inspection on

**2 July 2018**

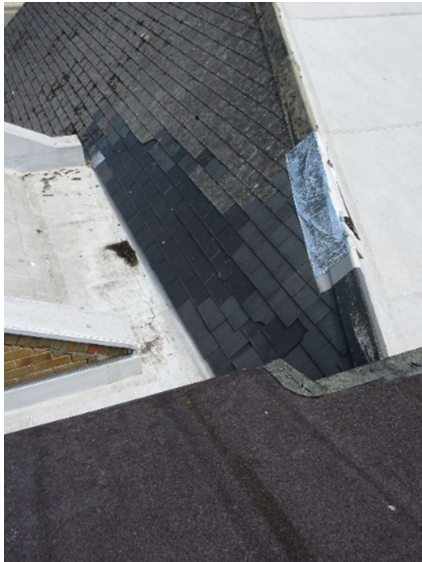
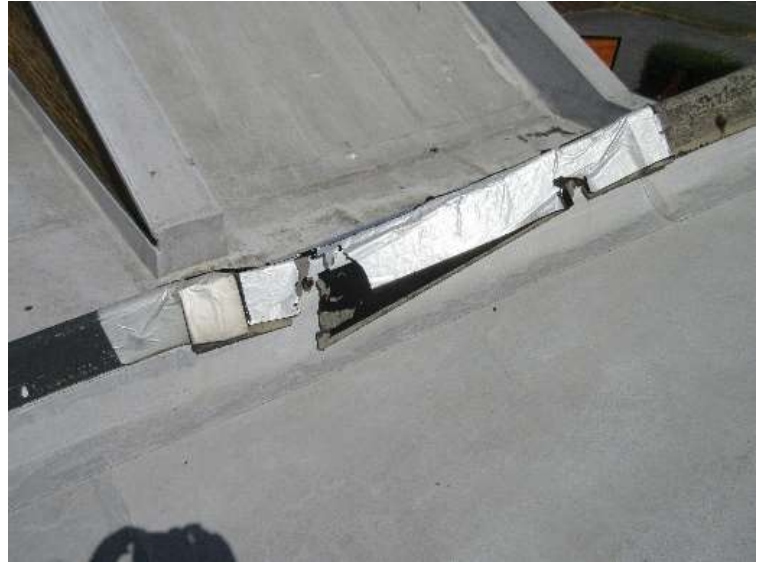
12. From a short E ridge fall two visible side slopes and a shallower hidden hip. Rather crude ridge tiles meant for monopitch roofs cover the hip angles, joined to the ridge with a Sarnafil patch. One hip tile has a broken end. Another broken hip is patched over with flashband, itself repatched and now split.

Internal gutter between Church and Hall  
Broken tiles at both hips, one patched with flashband

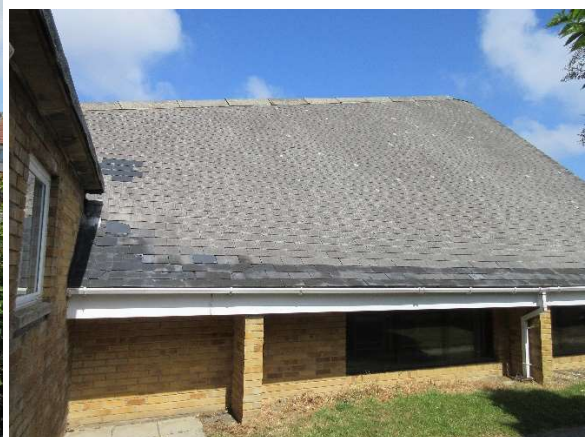
Narrow hidden gutter where the Church S slates butt to the flat roofed SE entry (para 16)

16. The S slates have a narrow gutter butted against the SE lobby, under its felt overhang. It appears sound though neglected and again contains debris.
17. Where the N slates meet the side of the Porch a thin substitute cover flashing is stuck to the slate and brick surfaces instead of being turned into joints. Its open top edge has been sealed with mastic, part missing.

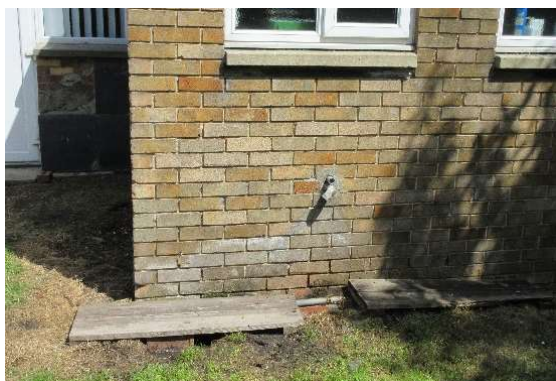
para 28

28. The downpipe in the garden S of the Kitchen has been renewed but not connected to the gutter felt so water must spill down the wall and around the outside of the pipe. The corner brickwork remains soaked. Very poor work.
29. The Kitchen sink waste pipe is missing so more soaking of bricks.

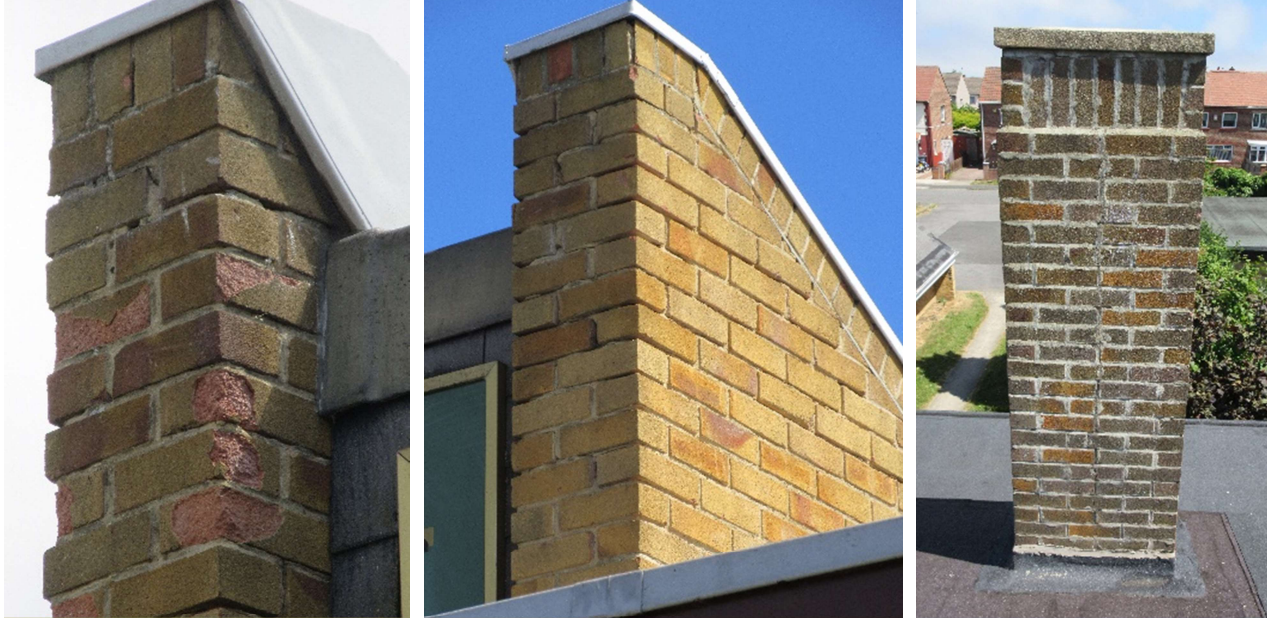
31. Cavity facing bricks in mostly good condition. The small amount of Church brickwork is in good condition except at Porch
- W wall and parapet over the Vestry roof has many open joints
  - the exposed peak of its E wall including its N return has open joints and several spalled bricks (usually caused by frost damage at soaked bricks), have appeared despite the caps being protected with Sarnafil. The added Sarnafil caps have not protected the E bricks enough to stop spalling. Repointing both walls could help to delay brick replacement becoming necessary.

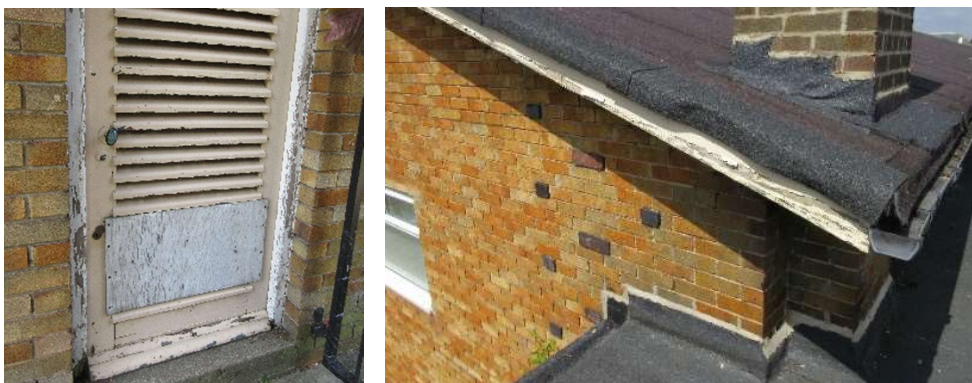
38. The Church Porch and Hall N entrance hardwood doors have recent stain and are sound. The Boiler and SE entry door paint is good but the entry door aluminium handle is loose. Both feet of the Boiler door frame remain decayed. The remaining doors are sound and well decorated. Draught stripping at Kitchen door.

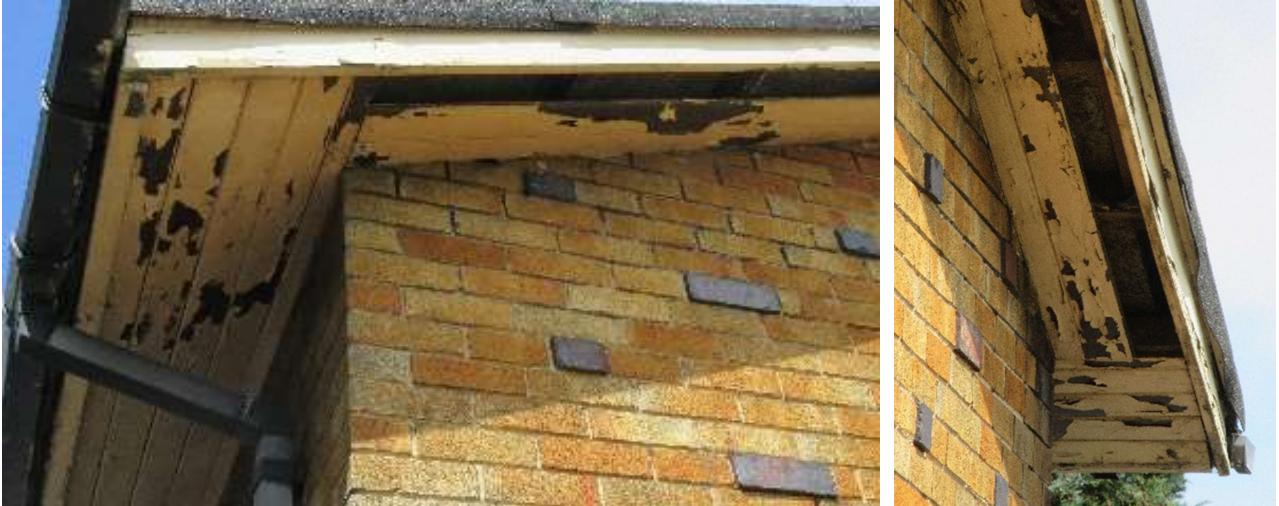
39. The top bolt at the Hall N doors works well but the bottom has been bent out of its socket.  
The W hold open door closer works. The E is disconnected and the loose arm damages the wall plaster.
40. The upvc Church eave and gable fascias look smart.  
The Hall fascias and soffit boards at the gables are painted timber. At the S gable two boards are missing.  
Otherwise sound but paint poor.  
At Hall N entry bargeboard some loss of paint.

Replace missing soffit boards at S end of Hall	40
Repaint Hall fascias and soffits	40

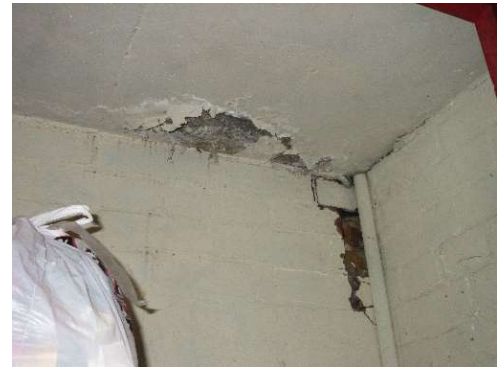
51. The Kitchen roof slab is lined with sound interlocking white upvc slats, silicon sealed to the wall tiles.
52. The exposed concrete roof slab over the SE Lobby and Store is painted. Some paint and concrete damage at the top of the SW cupboard wall next to the Boiler room suggests either an old roof leak or blockage of the gutter outlet (para 27).

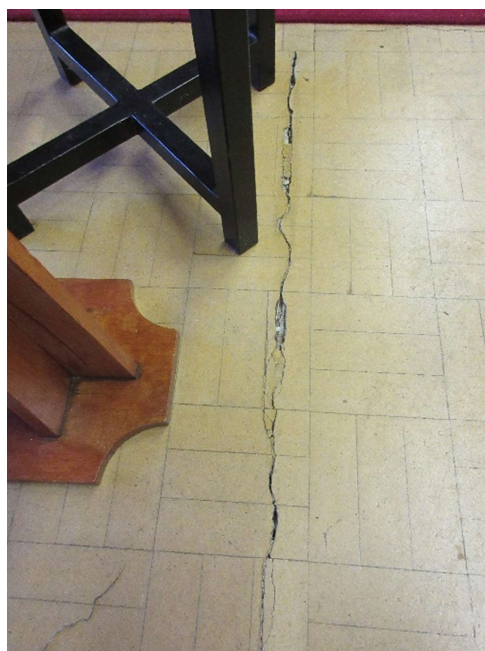
72. Since 1994 the cracking has steadily returned around all of the N, W and S sides of the Church and towards some of the convector heaters. Some edges at open cracks are broken, especially in the middle of the W side where people enter. Generally the cracking is merely unsightly but the open edges will worsen.

73. Cutting new movement joints carefully positioned over each side of the ducts in strips of replacement blocks may prevent future cracking. This will need removal of areas of blocks to trace the ducts fully.
