**QUINQUENNIAL INSPECTION REPORT
OF
JARROW, ST. PAUL**

**DIOCESE OF DURHAM
ARCHDEACONRY OF SUNDERLAND
DEANERY OF JARROW**

QUINQUENNIAL INSPECTION AND REPORT

December 2020

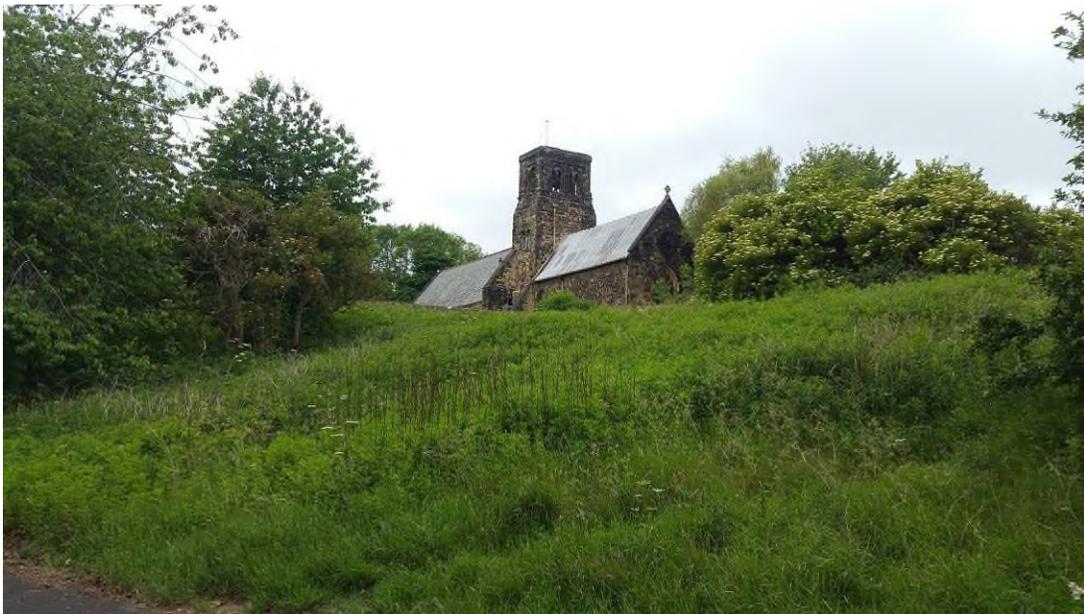
The churchyard is closed and under the care of the Local Authority, the boundary walls to the N are suffering from three trees close to the boundary which are bursting the walls and this has been advised to the LA. There

are quite a significant amount of mature trees on the site, it would be interesting to know if these are covered by tree preservation orders and if the Local Authority are managing them well. There must be a shared responsibility between English Heritage and the Local Authority, as the walls wrap around the southern part of the site, enclosing the monastery area, these are breaking up in places, it will be worthwhile the PCC understanding if the repair obligations are English Heritage's or the Local Authority.

Entrance gates on the W side are good but the piers are cracking because of iron expansion of the hinges and this should be attended to, as this is the public entrance to the site, and it is important that it doesn't appear run down. The sign board adjacent to it looks a little tired now. The east boundary is overgrown and part of the cottage property and this is beginning to look run down. BBA have independently reported on the cottage in the recent past.

The north entrance piers are in need of attention as the top courses have moved. It would be wise for the LA to use quality stonemasons for the gateway repairs.

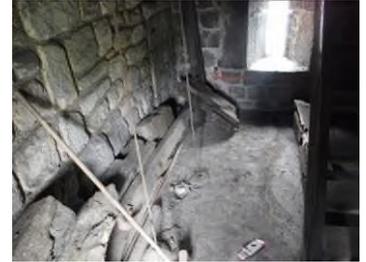
- D Bells:** There are two bells hung in a steel frame in the tower, they have been previously identified as of an early date, one with medieval inscriptions and the other of a metal shape. The metal parts of the frame and fittings are rusting, guessing that these are at the date of the Victorian re-build by Scott. There is evidence that there is still a bit of primer on parts of the iron work suggesting that the parts that are built in to the wall which are surround by concrete are still primed, there doesn't appear to be an expansion of rust.

Recommendation: Clean down rust and paint with inhibiting paint.

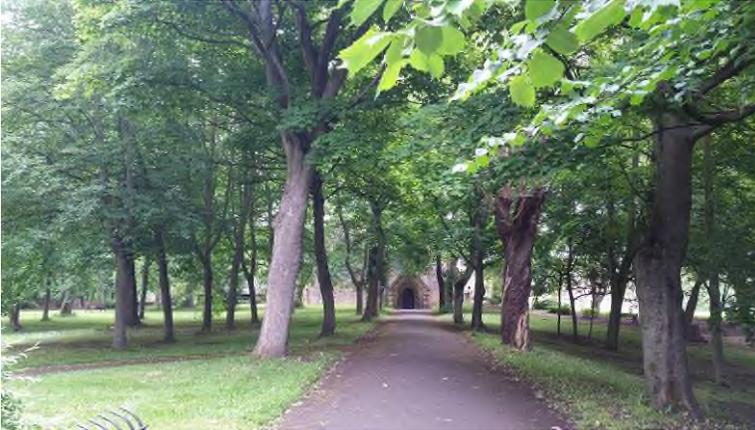
It is closed and the responsibility lies with Sunderland City Council. There are no standing gravestones, they have all been laid flat. Within the site are mature trees and it is unsure if these are covered by a tree preservation order.

There are three trees threatening the N boundary wall as the graveyard is higher than the external ground levels, those three trees were inspected by the Local Authority in January 2020 and the PCC have yet to be advised what their fate is.

There are repairs needed to the N boundary wall where the trees are pushing the wall, and the gate piers that have moved tops, the W is in good condition apart from one of the gate piers which has rusting iron breaking the stonework. The junction down to the S wall where it turns into brickwork is breaking up a bit and is this the responsibility of Historic England? The W wall is mostly covered with ivy and no easy to inspect but it looks ok.

Recommendation: see inspection section

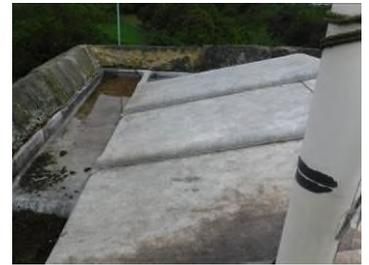
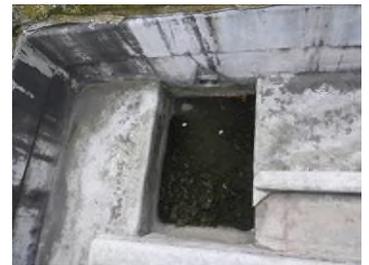
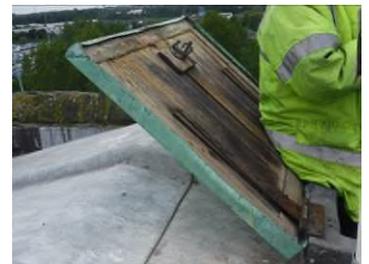
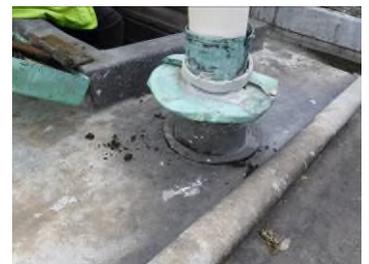
The lead covering is sound, solid timber battens and lead rolls. There is a ridge fixing nail showing and that could do with a patch over it. The hatch is copper but on rather rusty hinges these need attending to. Glass fibre pole that is rocking and it has a poor copper apron flashing trying to shield the lower lead welded joint and that is cracked and will be leaking. There needs to be a grab handle at the hatch exit.

It has a very low coping, perilously dangerous in fact. The stones look alright but they have been silconed in that past that is beginning to wear away, as reported last time. The flashings are ok but interestingly it looks as if the plastic pointing has shrunk back and so it doesn't need attention now but it's not perfect but it will do for the moment. Really it all needs redoing in lime if there are other repair works to the tower that come in the future.

There is one cracked flashing on the W side but it doesn't really need anything doing at the moment.

Recommendation: remove silt from outlets, patch ridge nail, ease hatch hinges, provide grab rail, repair pole flashing and pole fixing down, repoint flashings. Reset fall of gutter when next carrying out significant repair works to the tower.

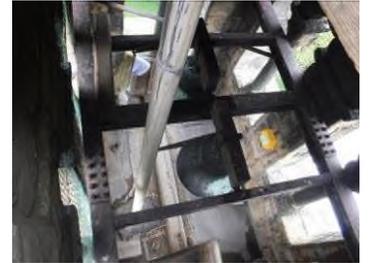
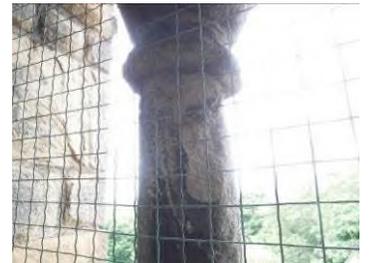
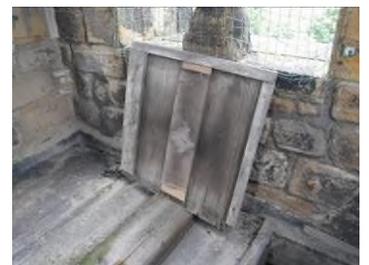
There is a large central floor beam with rusting bolt fixings some of the nuts have gone on it so we need to know what job it is doing on the ceiling below, it is beginning to break-up now and is a bit green in places with some rot on it.

The belfry openings are covered by mesh and that is clearly not effective as there have been birds getting in here, they seem to be broken mostly at the bottom part and they all need fixing back.

Recommendation: sweep up floor, investigate if the floor drains water out, check light works, replace hatch, provide grab rail, ensure bird mesh is effective, prime the bell frame, check bell operation, unblock the downpipe, check stair foot is ok

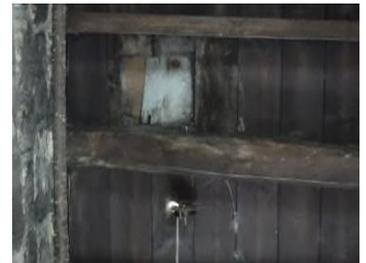
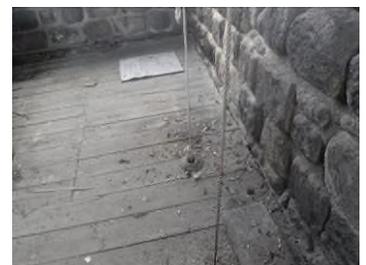
- **Ceiling** – There is no explanation for that central beam that is in the floor above. The ceiling is beamed with boarding and the S E corner beam is effected by water, there is also water on the floor directly below it, that is where it is ponding on the lead above, that beam plus the central beam looks as if it has got poor joist bearing.

- **Walls** – The walls are all ok, the same as the last inspection. This room has the two levels of tie rodding in it- up at ceiling and at floor level and it's all as before.

- **Floor** – The floor has a bell hatch with loose floorboards in, there is also a piece of plywood that is screwed over part of the floor but you can't tell what that is, maybe we will know underneath it. The wall cracking is unchanged since the last inspection.

- **Windows** – The windows have diamond leaded glazing. Is this a more modern edition because there is what looks like old bird droppings on the tie bars, so perhaps these were infilled in later years? It has polycarbonate and this is breaking down, the joints are breaking down on the S side they are very cobwebby and they really need a clean down to be inspected further. There is something odd about the position and design of the central baluster in the arch- it isn't in the middle of the wall- it's towards the inside, and the capital outside is cantilevered to catch the arch.

Recommendation: clean down the glass and inspect, review repair options to the cracked corner

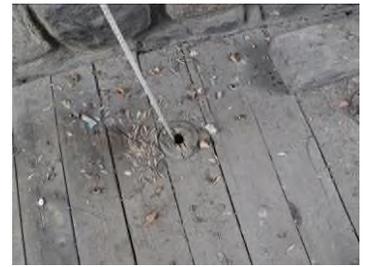
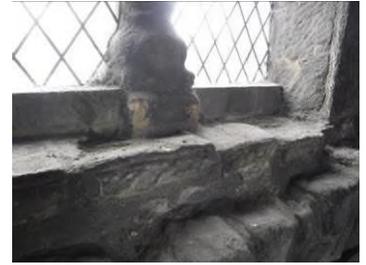
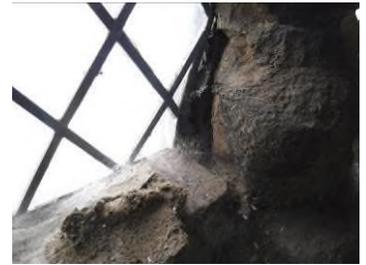
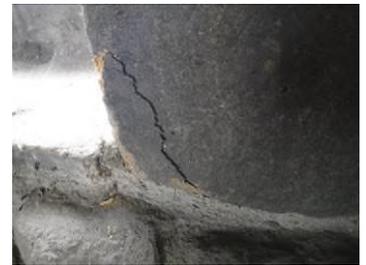
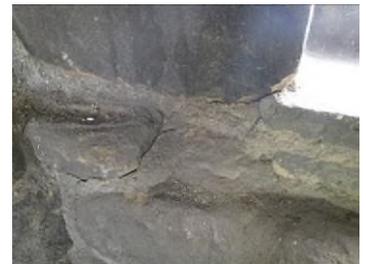
- **General** – In the S W corner just below the window cill we have got a crack running through the joint just above the tie rod this is reflected on the masonry on the outside, there is also a shear crack on the corner of the S W window jamb as it joins on to the cill. Also on the N as well as the S. The S cill seems to be the most affected. It's obvious that this is the weak corner on the tower and that this needs repair. The structural engineer report recommends this as well and makes further recommendations for additional measures. The scope of the repair requires review.

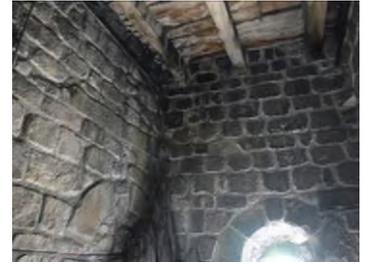
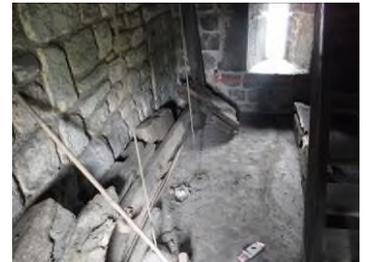
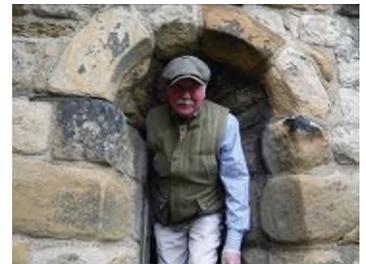
- **Ceiling** – The ceiling is beamed and boarded and is structurally sound. It has had water penetration in the past thus reinforcing the fact that the windows in the stage above used to be open. There is a pair of high level tie rods running N to S, these are painted, unlike the ones above it which are not. There is a lower tie rod of a bigger section and different pattern, unpainted on the E side running N to S. So does that suggest that there were two phases of tie rodding?

- **Walls** – The walls are in good condition, arches are all sound.
- **Floor** – The floor has quite a slope to it running high at the south and low to the N.
I see that the floor has a drainage hole on the N side I wonder therefore if the ceiling is a later introduction and that this actually used to be a double height space?

Recommendation: provide grab handle, review what to do with the bell frame timbers.

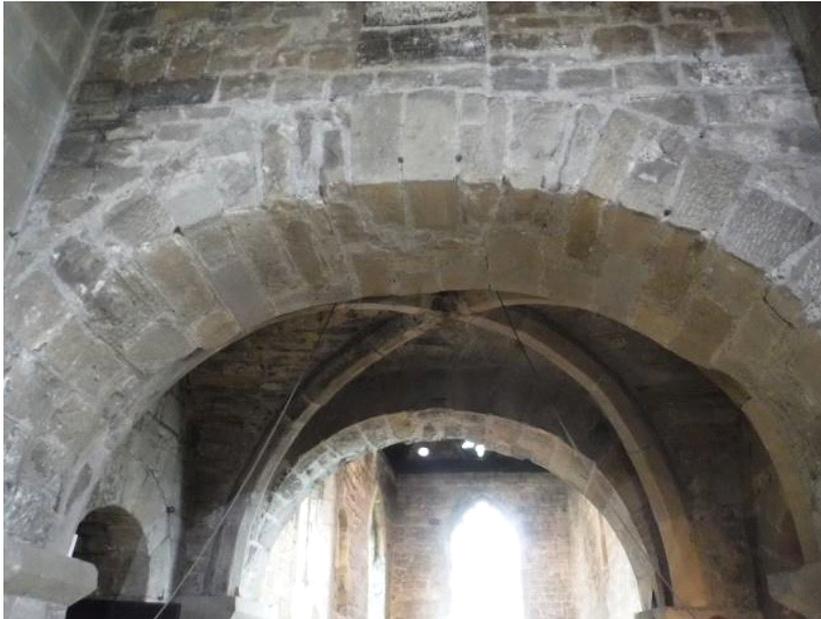
West arch

- **Walls** – Arch looks ok, there is one diagonal crack coming from the S buttress radiating upwards which we know of in the past. Suggesting of a crack in the arch on the nave side but not in the stone only in the joints. Hard pointing doesn't help.
- When weighed up with the observations outside it suggests that the S E corner of the tower has had differential settlement. Or other reasons, as there are competing forces acting on the structure due to tie rods

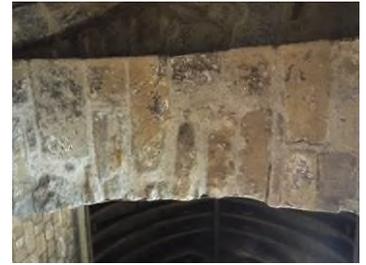
east

and the massive buttresses may be dragging the tower a little but it's not going anywhere.

- East has different masonry in the middle- rebuild to the inner or outer edges?
- **Floor** – ok

Recommendation: none

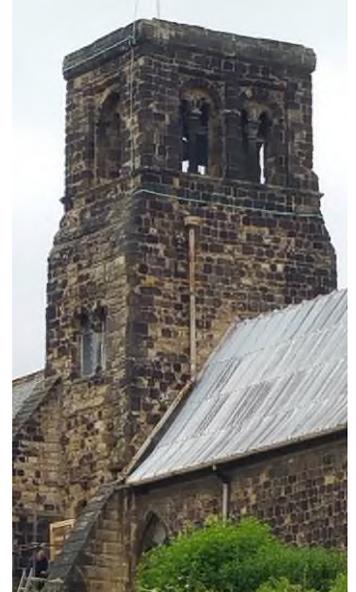
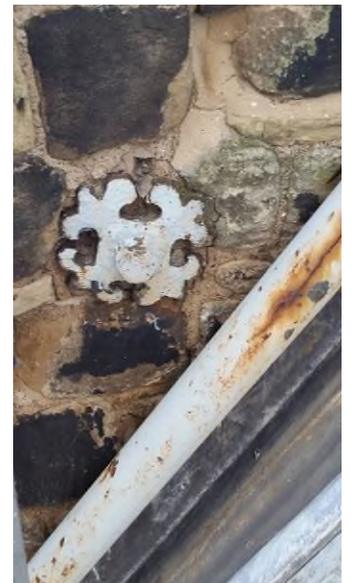
East Elevation – The buttress back is rusting and pushing the stone inwards. There doesn't even seem to be any metal in the stone beds, that is seen on the south and west elevations.

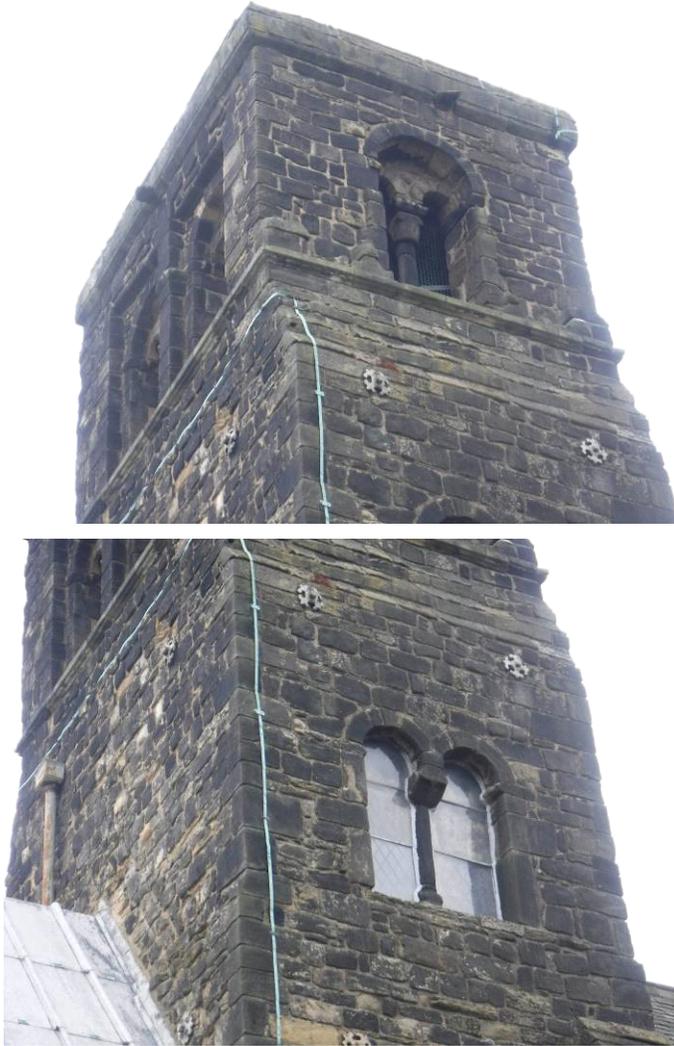
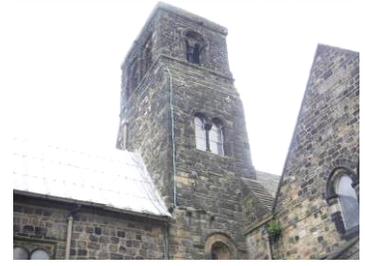
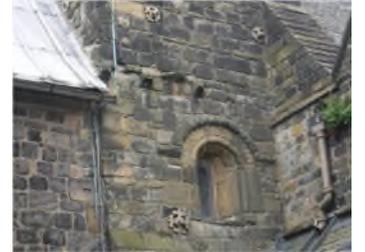
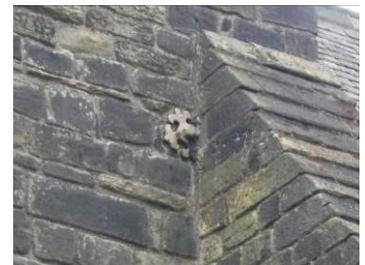
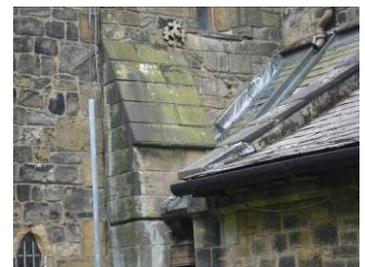
- **North Elevation** – The down tape comes down on this side, albeit crosses over on the E and comes from the S E corner, there is also another terminal on the N W corner.

This elevation has tie rods showing at two stages, they seem ok, this doesn't really have much in the way of cracking on this side,

There is something odd about the position and design of the central baluster in the twin arch- it isn't in the middle of the wall- it's towards the inside, and the capital outside is cantilevered to catch the arch. The pointing in of the polycarbonate to the windows looks rather ham-fisted.

The bottom patress next to the buttress top is rusting badly.

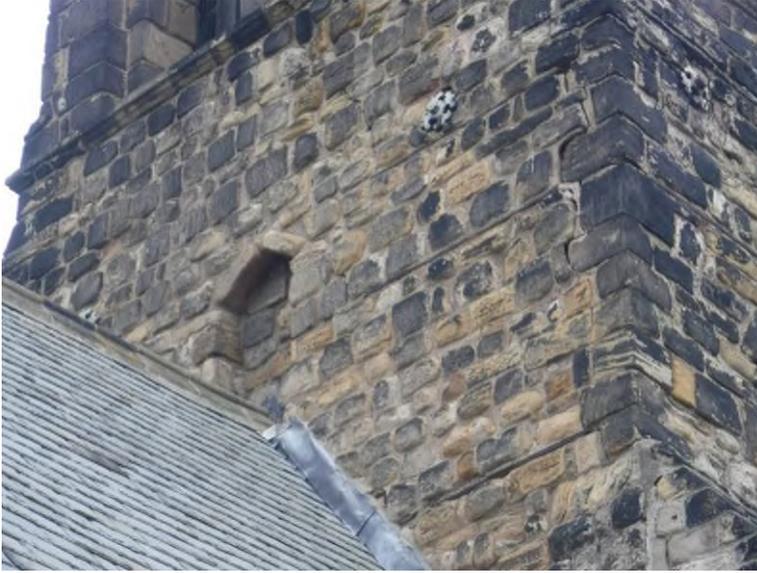
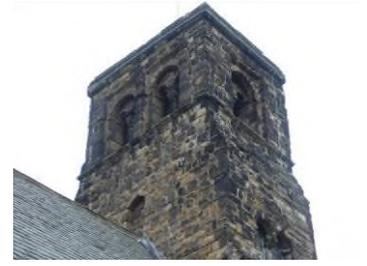
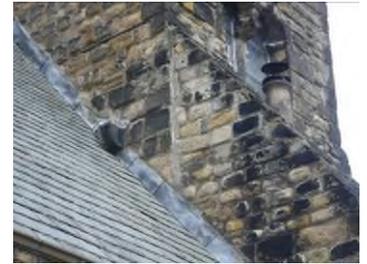
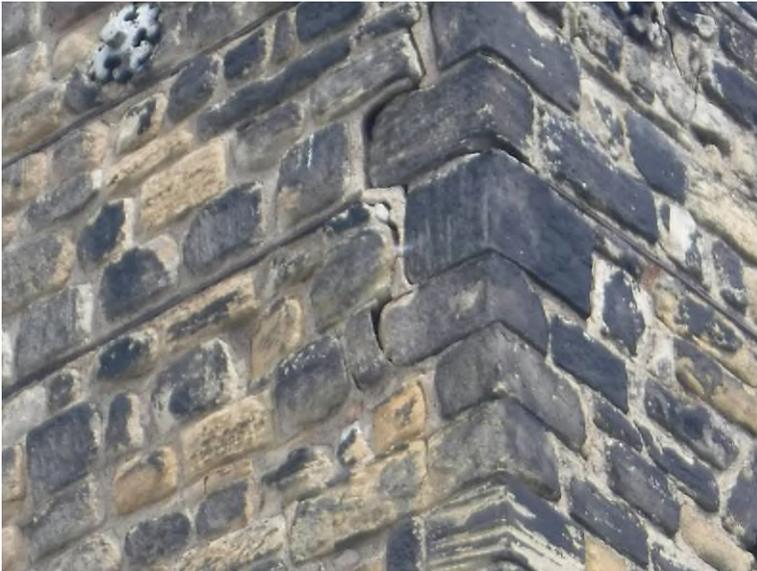
- **West Elevation** – This has the most serious cracking at the S W corner at the deafening chamber level and in-between the tie rods, the corner is coming apart.

There is also four noticeable bands of bedded metalwork in the stonework that starts from the corbel projection and there are four levels above that, there is also a further crack forming more towards the centre above the apex at the stonework above the top pattern, the belfry stonework and balusters all looks ok above it.

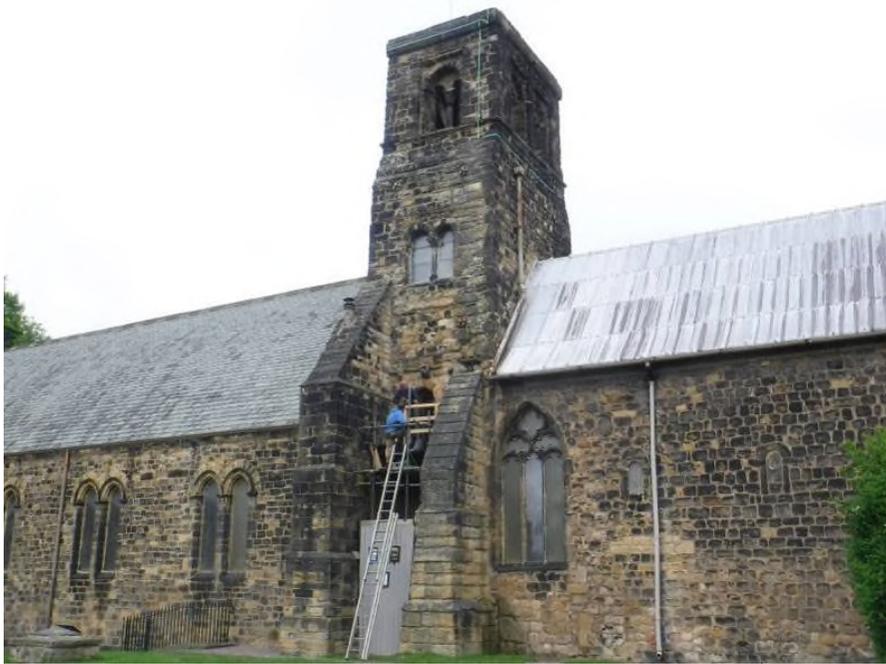
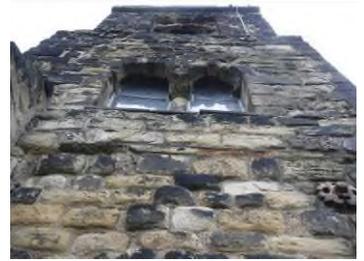
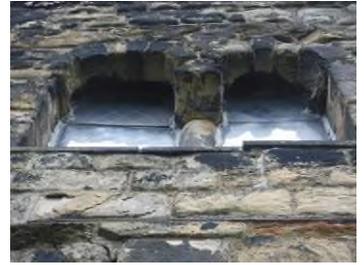
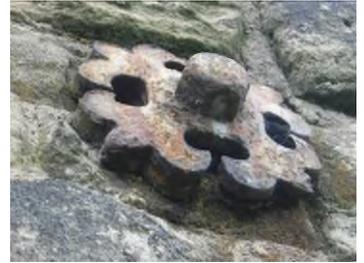
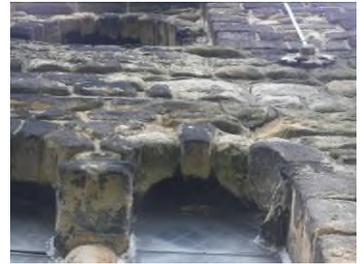
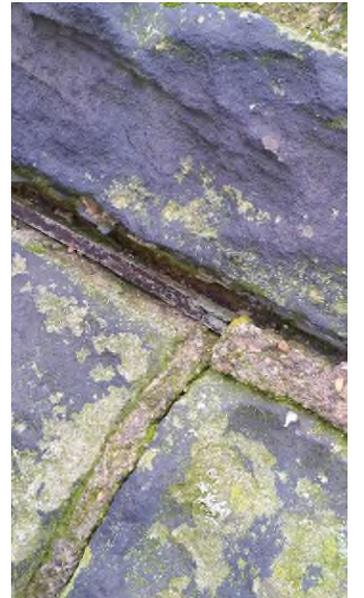
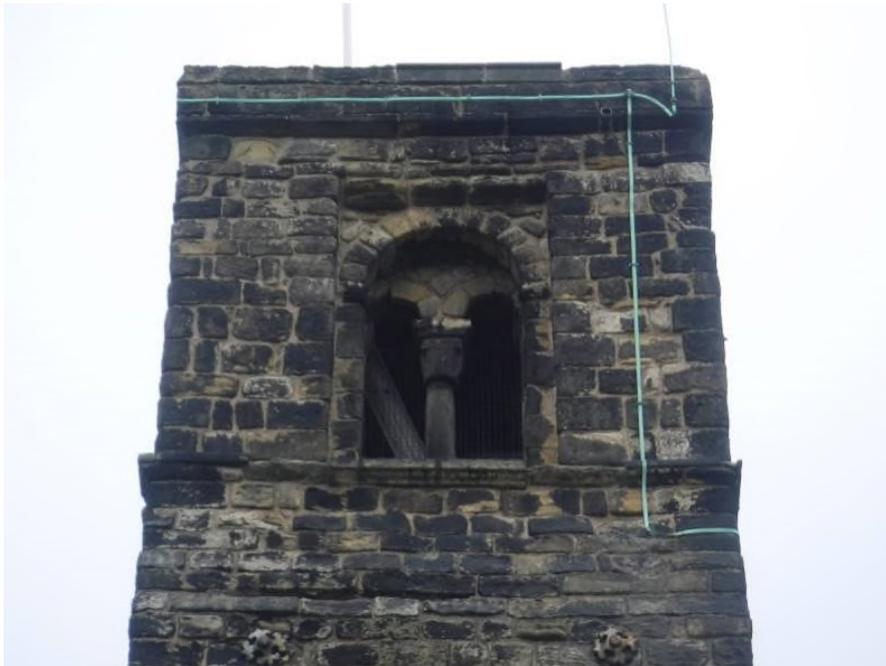
At the time of the inspection the access platform to the tower was being rebuilt and unable to inspect behind the scaffold sheeting below. The W buttress has a flue coming out of it and seems ok.

The belfry baluster looks ok. Comments for the deafening chamber twin arch opening are the same as the north side.

The cracking comes round on to the S W upper parrass there is also a bit by the E parrass, this elevation also has horizontal bands of steel in.

Recommendation: see comments in the summary

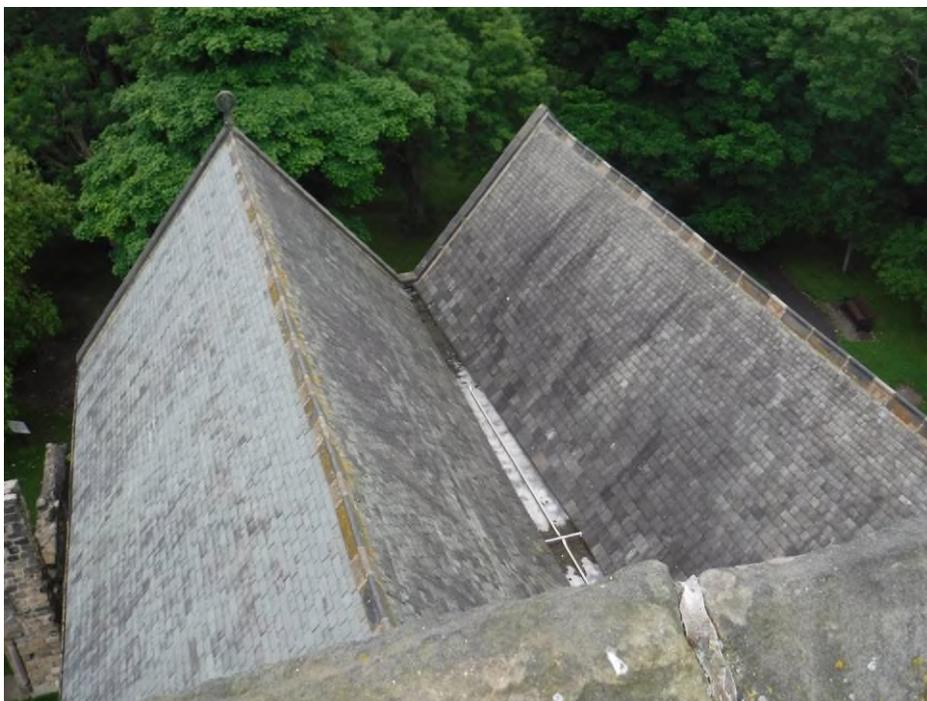
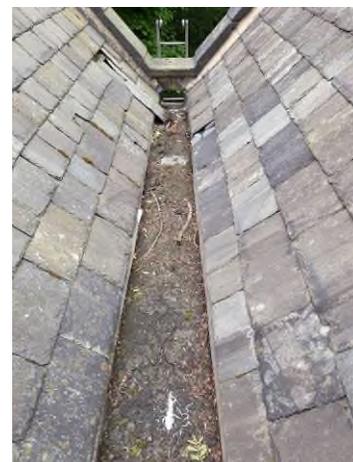
The nave was reslated in 2005 with Westmorland to the outer slope and reclaimed to the inner. This was repeated in 2008 to the north aisle. Half of the stone ridges were renewed. Stainless steel box gutter between. Lead flashing thefts in 2009 resulting in lead replacements.

At the W end the slates have been broken by intruders getting into the box gutter, the E end suffers even more badly.

The E and N porches are in Westmoreland, and patchy in places. There is a general low level need for various cracked and slipped slates to be replaced around the job.

Recommendation: procure quotation for general roof maintenance repairs.

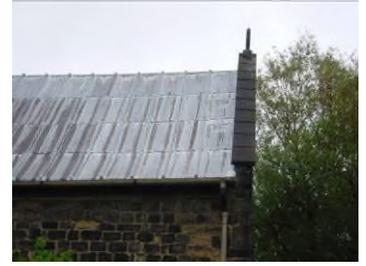
M Chancel:

Some patching at the E end in the past, the roof is a bit stained from the copper clips and its age but generally sound. Some horizontal splits identified at last QI but no water penetration obvious inside.

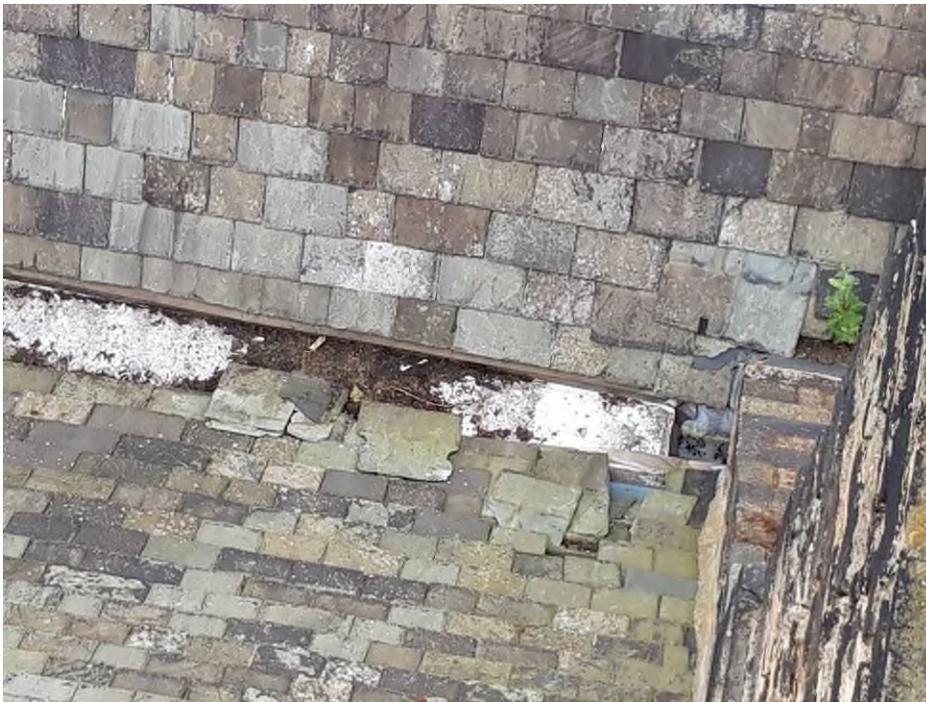
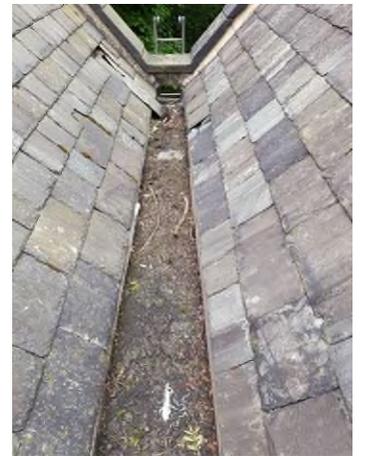
Nave:

Central gutter

Ridge bedding and tiles are all ok, some loose slates. Abutment flashing to tower ok and cement pointed to the rebated water table but looks ok.

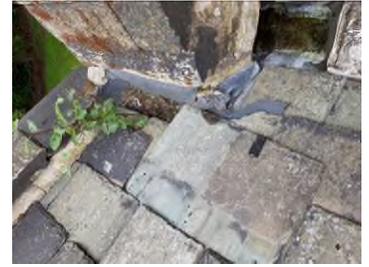
North Aisle:

Same as the nave apart from both water tables are cement pointed and are sound. Abutment to the tower at west end slates missing.

South side of north aisle abutment to tower has poor back gutter detail.

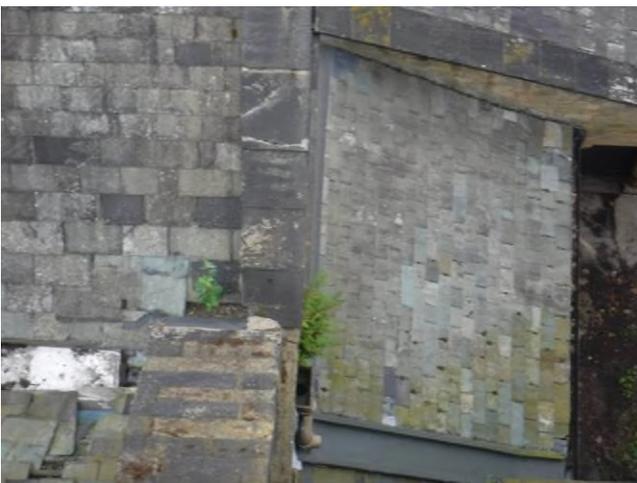
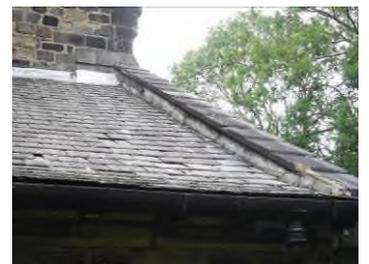
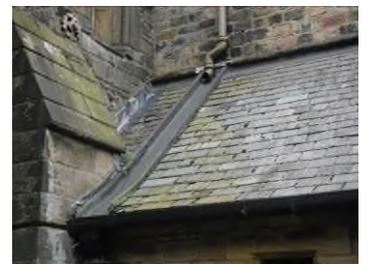
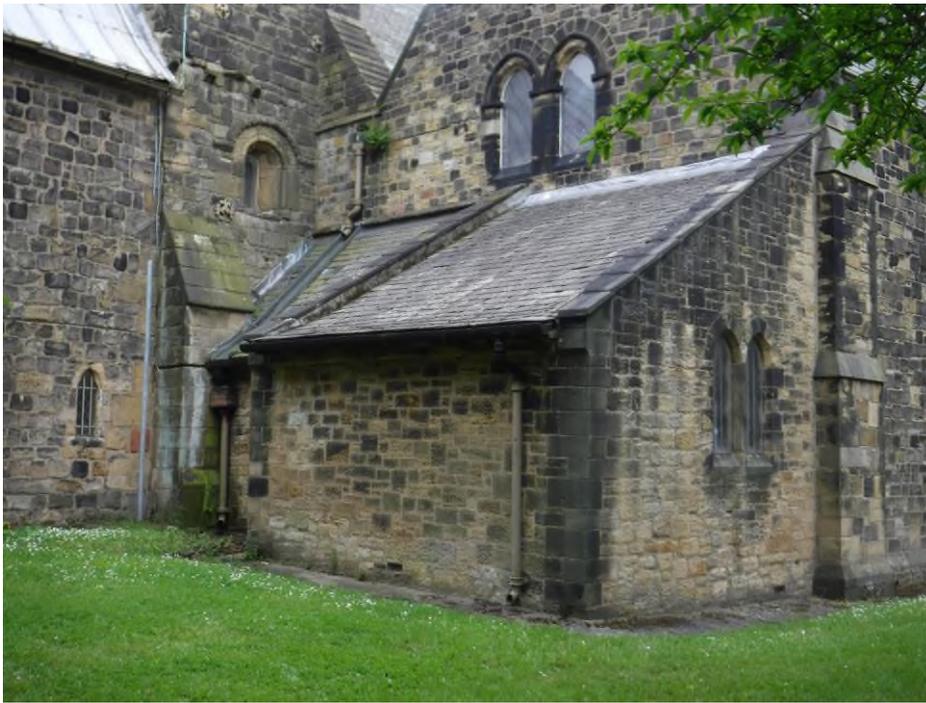
Vestry:

Back gutter clogged and high level planting.

Both of these roofs are patched and not in the best conditions. Their flashings have been lost over time and been replaced by lead alternative which are tearing and looking slightly worn. There are a few slates missing where intruders have tried to get up on to the roofs in the past, some slates slipped as well.

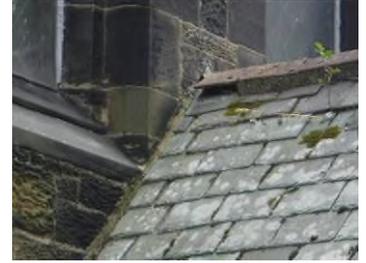
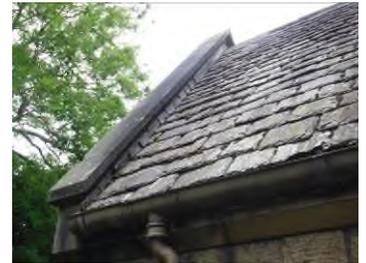
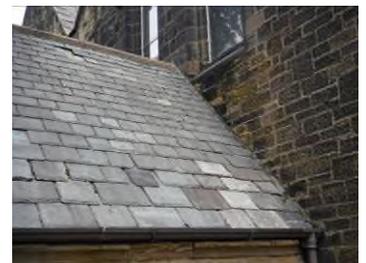
West Porch:

Ridge bedding missing at the abutment to the W nave gable, abutment flashing to the gable is in cement and cracked in places but generally ok, some of the slating cracked as well. It's abutment to the nave wall is in cement and doesn't look very obvious what is there. On the S side there is slate loss and some bad patching in the past.

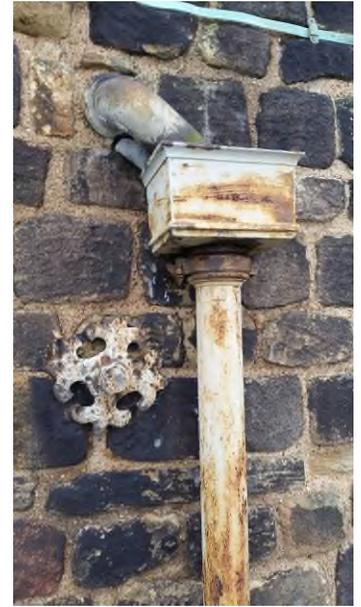
Cracked tower pipe

Chancel gutters both sides need replacement and connections to downpipes repaired and refixed. Downpipes are probably ok but should be checked by roofer. Internal tower downpipe at belfry level is blocked.

Recommendation: seek quotation for repairs to system

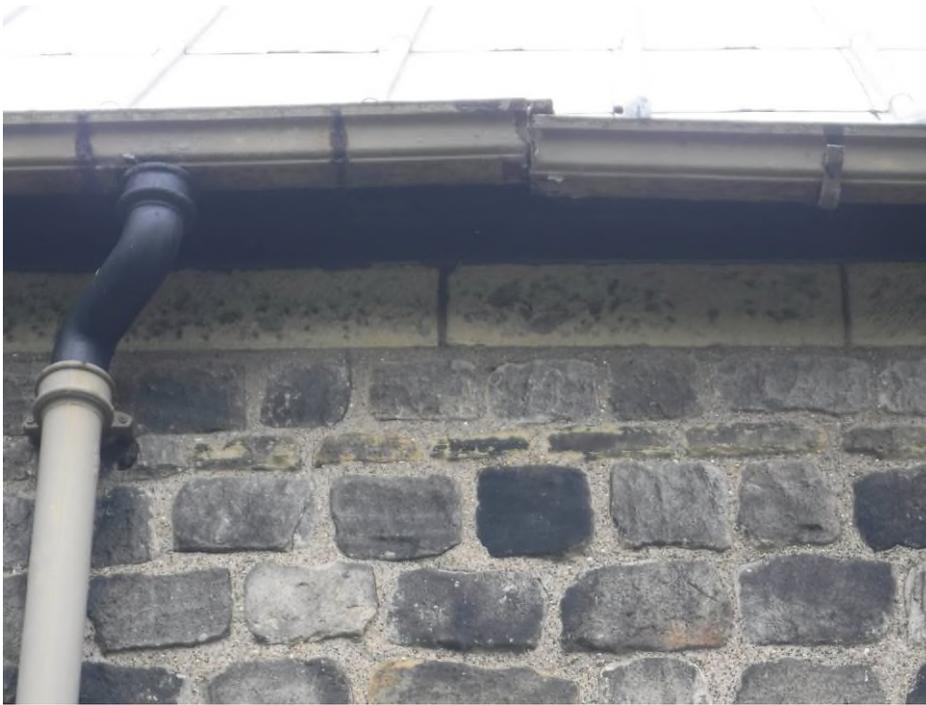
Chancel north backfall

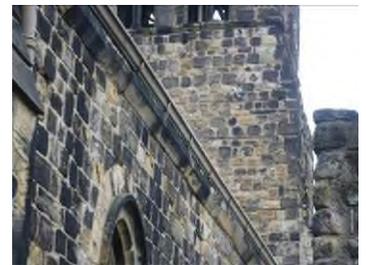
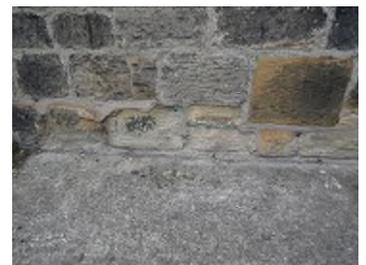
South side – Over sailing cornice to hold up the guttering has open joints, some open joints to part of the stonework, cement pointed in various ages, a couple of the plinth stones have lost their face and the bottom part of the wall the pointing is slightly poor but it will all survive.

Four windows, three of which are twin lancets the hood moulds have seen some wear and above them the relieving arches pointing is poor in some instances, some water penetration from the hood moulds because of open jointing and there is delamination of the arch stonework. The cills have been patched in cement and that is breaking up in places. Windows are covered in polycarbonate are a bit dusty and cobwebby but fair. The glass is diaper and some of it is polycarbonate covered of various opacity.

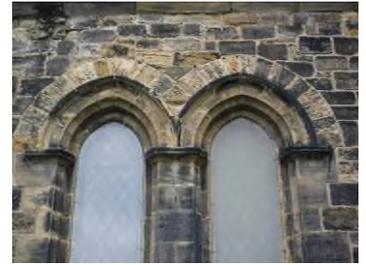
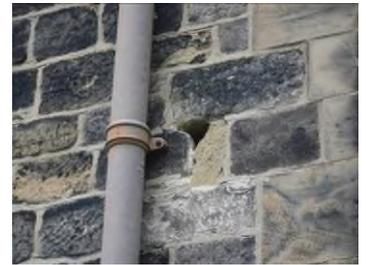
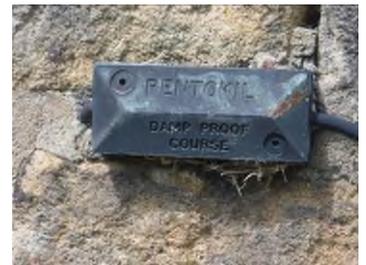
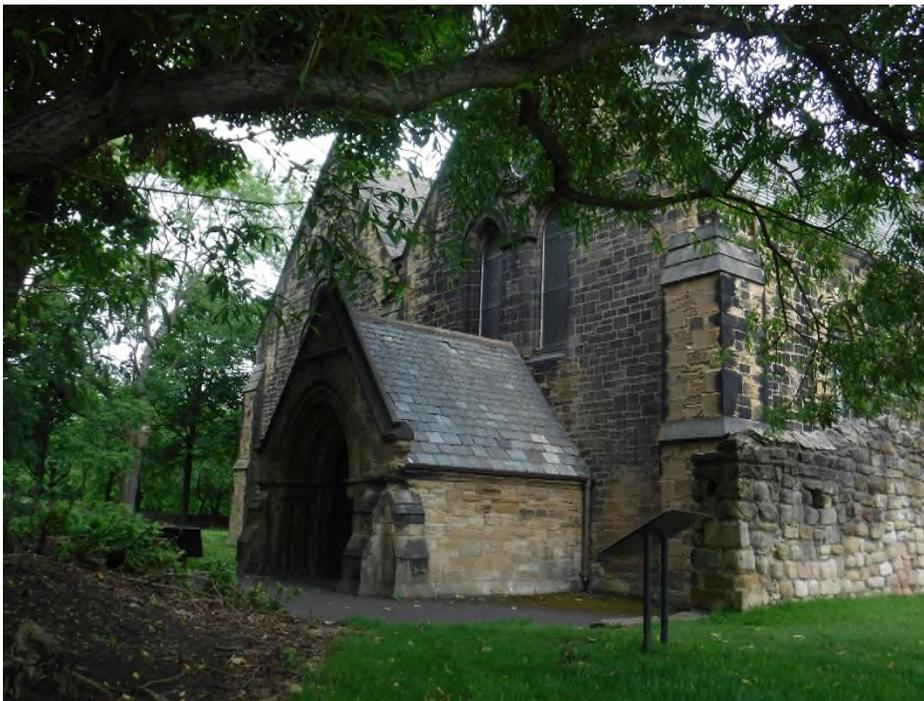
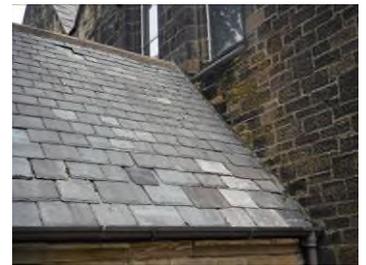
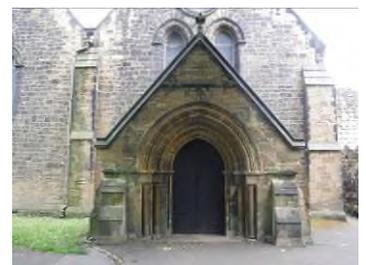
West side – Large feature gable with rebated water tabling, some of the high level stonework beneath the water tabling on the S side is a little worn but that is probably just the pollution been washed away, the walling over all is generally sound. Two twin light lancet with circular light above, permanently pointed in polycarbonate glazing in grey mortar looks poor, the jointing of the

polycarbonate is breaking down. The stonework of the windows is all ok. Buttress between that and the N aisle is a little worn at high level but satisfactory.

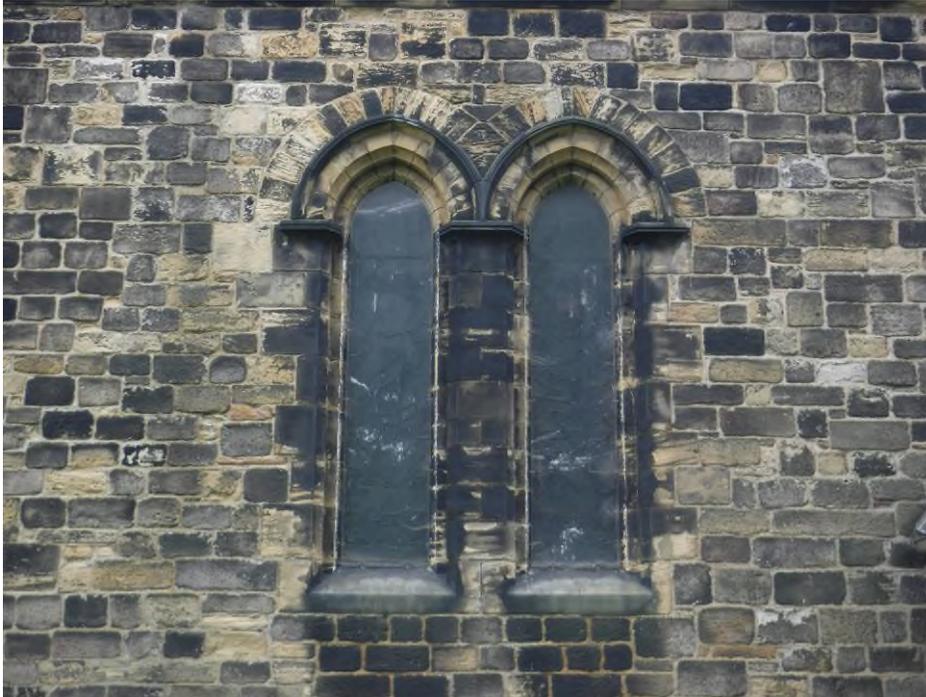
This has more modern over glazing in polycarbonate- more see through. But there are some cobwebs, behind this is pictorial glass. Some wear to the ashlar losing its crust slightly but not really problematic. Arches are in better condition on this side.

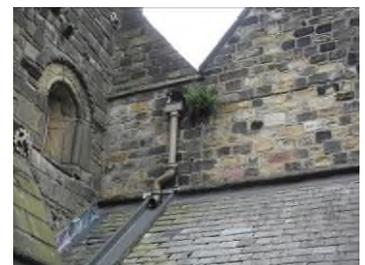
East side – Gable above the vestry's water table looks ok, the walling itself is alright apart from slight erosion to the N side above to the right of the windows. Twin light lancets, hoodmould is ok, generally alright, the ceiling of one of the lancet cills on the S side doesn't look right, large horizontal joint perhaps from cabling close to where the hopper outlet is, where there is some greenery.

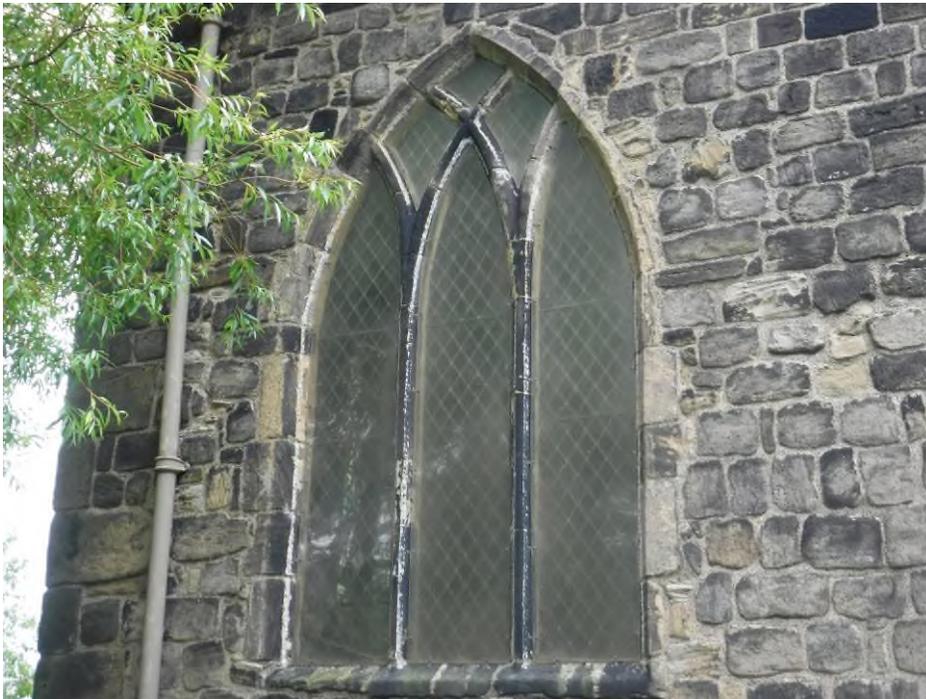
North side – There is a minor crack in the middle of the walling above the single lancet up at high level, there is some cracking inside at low level to the blocked in N door, so I wonder if there is something going on here, the crack doesn't descend down to the ground. However, it's not an issue, just something to keep an eye on.

- 1) Wide tracery three light, no hoodmould to this. Slight wear to the upper parts and possibly a crack to the inner crossing transom but seems ok.
- 2) Narrow, vertical window with pictorial glass has lost a little bit of pointing to the apex. Below that blocked in N doorway is all sound.
- 3) Square shaped three light with circular tops, slight erosion to the frame at the top, seemingly sound, quite slender.
These three windows have aged polycarbonate to them.
- 4) Small window with some wear to the arch stone this has a new combination metal guarding and polycarbonate cover.
Below that a piece of metal in the wall, above it is a big horizontal piece of steel and you can see how it is jacking to the left hand side, to the right of this window is the down tape which all looks very scruffy and various bits of cable that have been cut and that needs to be tidied up.

Recommendation: include removing the north chancel embedded steel as part of the tower repair works

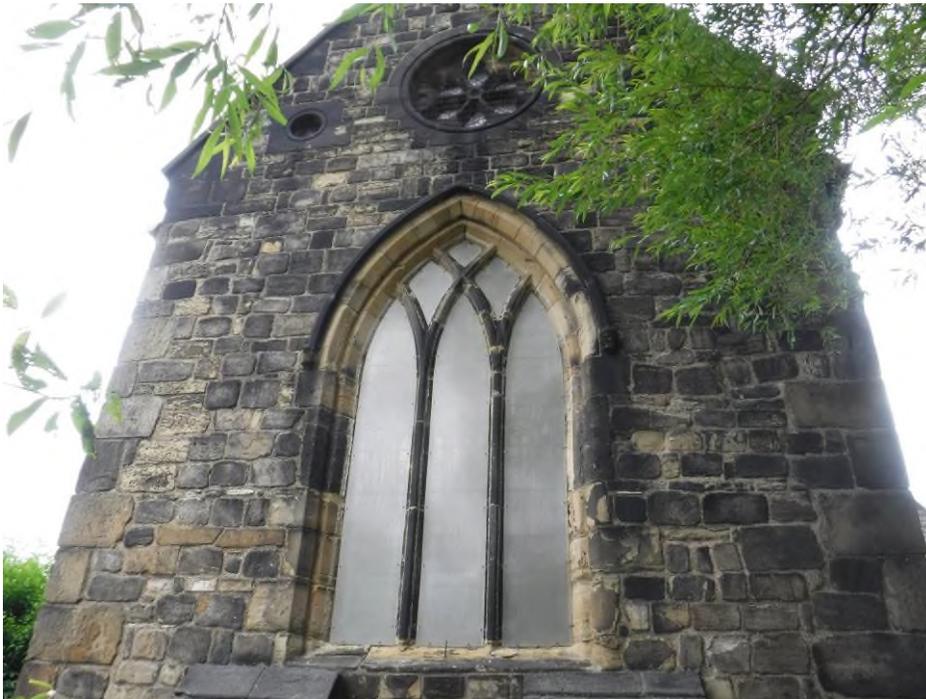
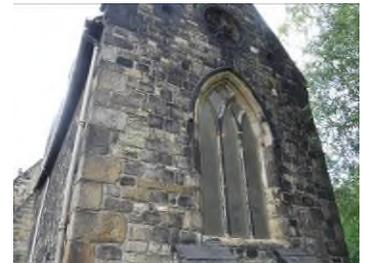
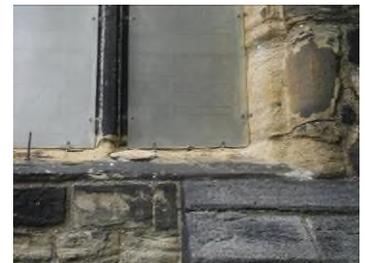
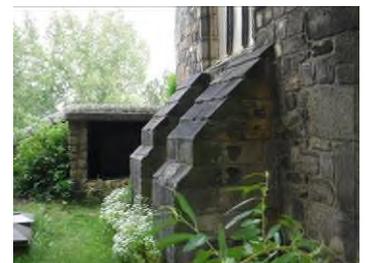
Cross looks ok as does the water table. The general walling is ok, at low level are two massive buttresses and a mini one in between.

Large central wide tracery three light with some erosion to the bottom of the mullions and cill. The arch dressings are ok. The label stop on the S side is badly eroded. Hoodmould looks ok, above that is a large circular window with three small porthole style windows around it, the big circular has rusting metal mesh covering it as do the little portholes.

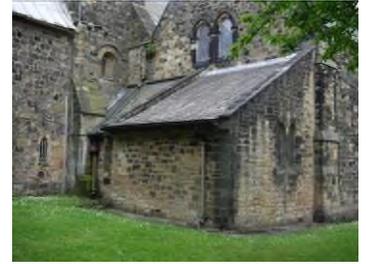
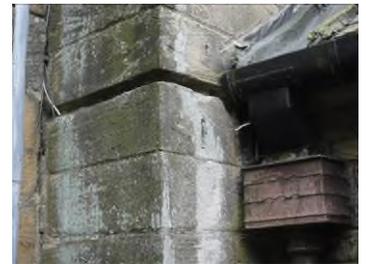
Unused door- decoration pretty poor. Stonework generally ok, there is a snapped stone probably at a hinged location. The projecting vestry door is unused, the handle is missing and painted in-situ rather roughly.

The stonework could do with a bit of dusting off but it is sound enough, it is rather a forgotten corner here. Should it be fenced off or might that make it worse?

The N side has a pair of single lancets together with slight wear to the stonework but nothing troublesome the windows are guarded with clear polycarbonate behind that. Sandwiched in between it are some rusting metal security bars, suggesting of cracking at high level to the abutment to the buttress, is it moving fractionally if it is as its only 1mm.

Recommendation: update doors and ironmongery decoration.

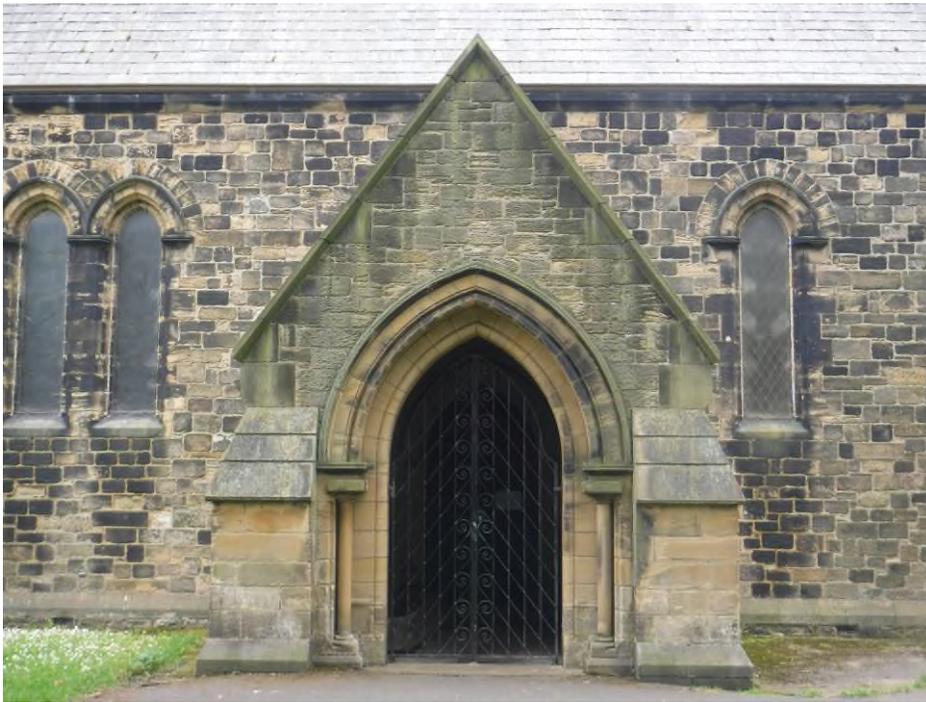
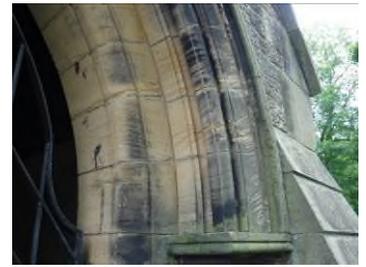
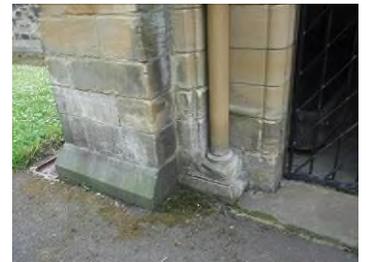
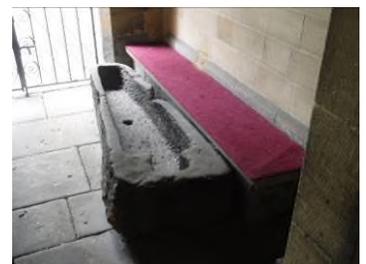
Some light loss of the surface crust to the ashlar buttresses but ok.

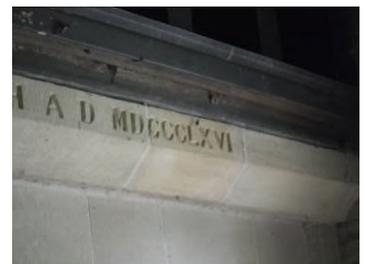
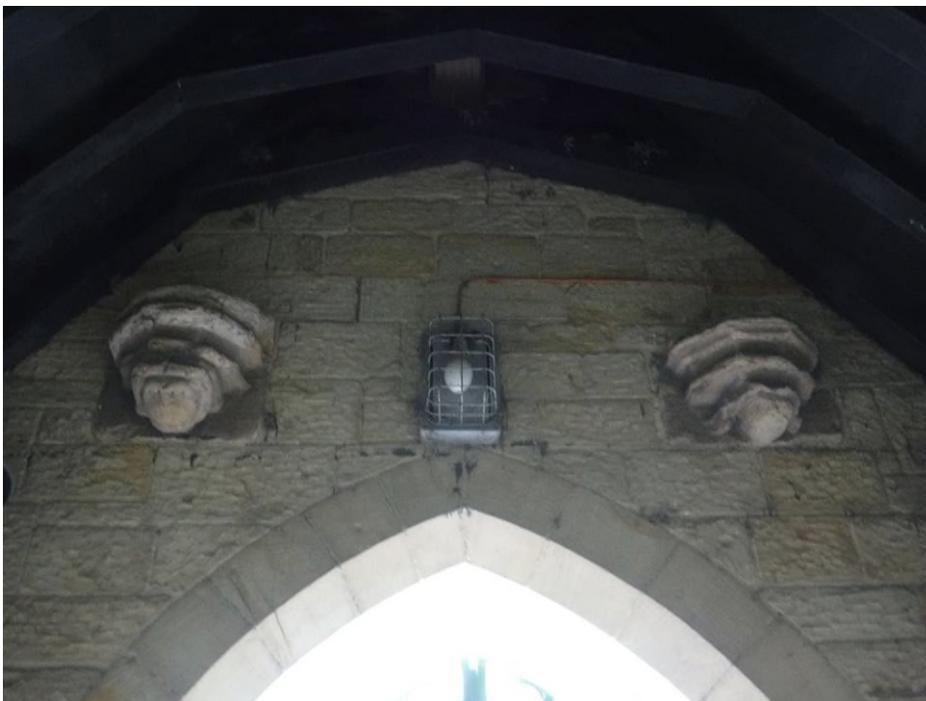
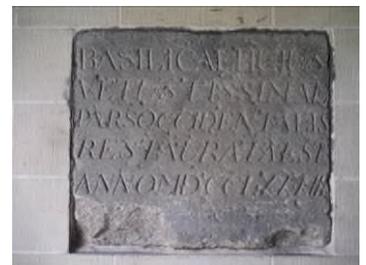
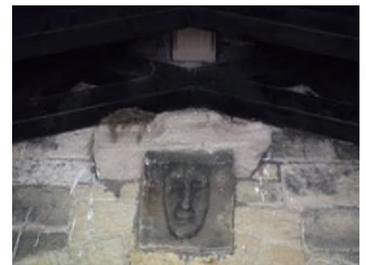
Internally- Open rafter ceiling. Walling is ashlar and okay. The North wall has some open joints at the dressings. The aisle entrance stonework is good, although it has bird marking. The moulded archway to the nave has some open joints to it. The door is in good condition.
