**QUINQUENNIAL INSPECTION REPORT
OF
JARROW, ST. PAUL**

**DIOCESE OF DURHAM
ARCHDEACONRY OF SUNDERLAND
DEANERY OF JARROW**

QUINQUENNIAL INSPECTION AND REPORT

December 2020

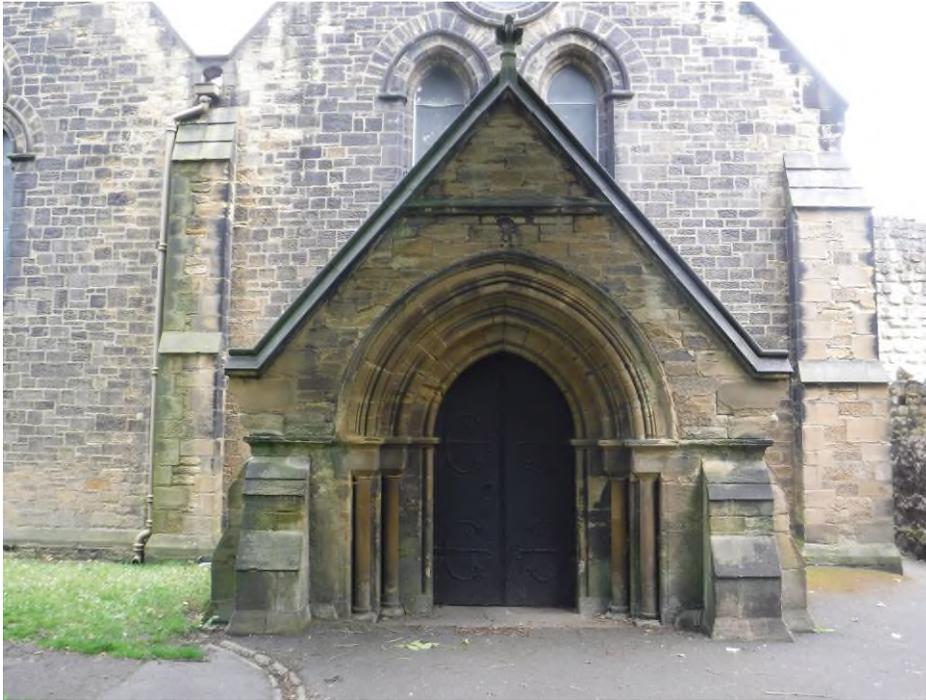
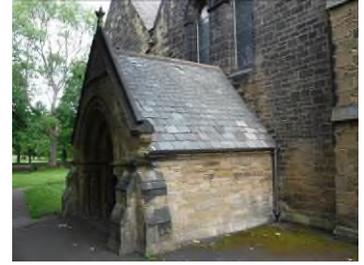
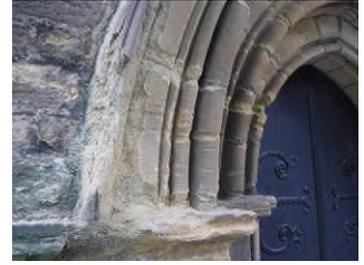
Bit of graffiti on the N wall some open joints on the S side. Couple of open joints on the buttresses.

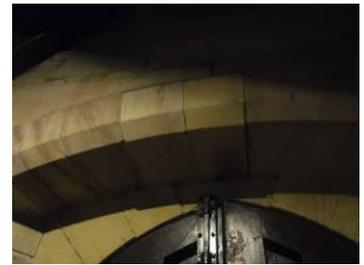
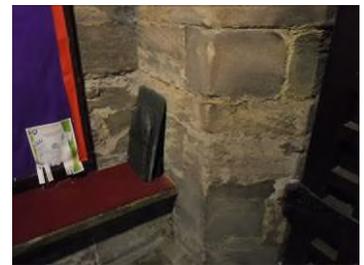
The W doorway has been heavily repaired in cement mortar and this has led to the breakdown of the stonework at the joints, it is such a shame because it has become a mess. It has affected all of the arch and the jamb stonework. More

damage can be done in removing the cement. It really needs a conservator report or experienced stonemason to report on remedial proposals. The nook shafts are ok apart from a loss of surface on one them. The ground feels a little bit too high for their bases. Perhaps that has ironed out a step, perhaps they brought the tarmac level up a bit higher to do that. Door within it is fine.

Inside- Open timber roof. The walling is all ashlar apart from the W. There is spalling to the stonework on all porch sides apart from the W gable of the nave. Internal gable keystone has dropped- as seen at last QI) suggesting eaves spread although this is not obvious on the outside. The flooring is concrete with a 3mm crack at the church entrance.

Recommendation: procure remedial report on stonework

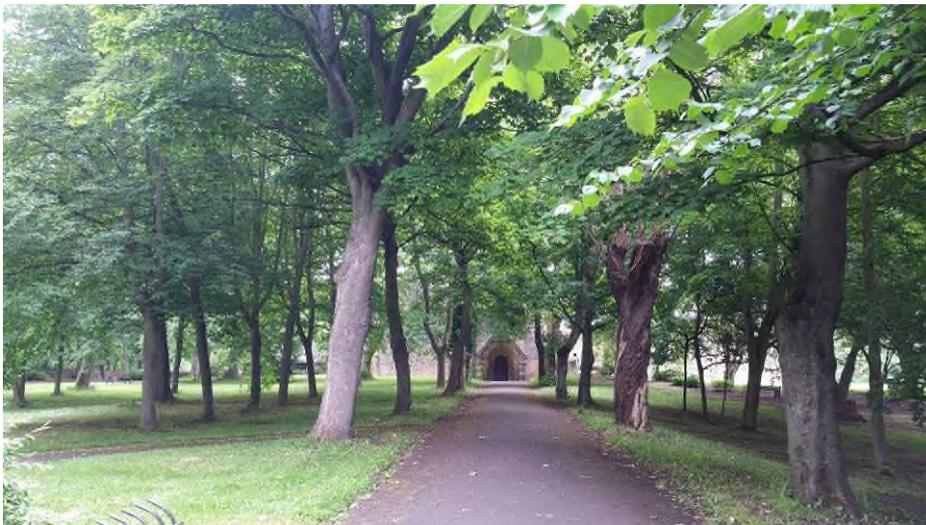
The church has a closed graveyard in the care of the Local Authority. It is grassed with mature trees. It has stone boundary walls and gates to the entrances at the W and W. Whilst in mostly good condition, there are areas of cracking and open joints to walling and gate piers. There are quite a significant amount of mature trees on the site, it would be interesting to know if these are covered by tree preservation orders and if the Local Authority are managing them well. There are some trees affecting the north side - that are expected to be remedied in 2021.

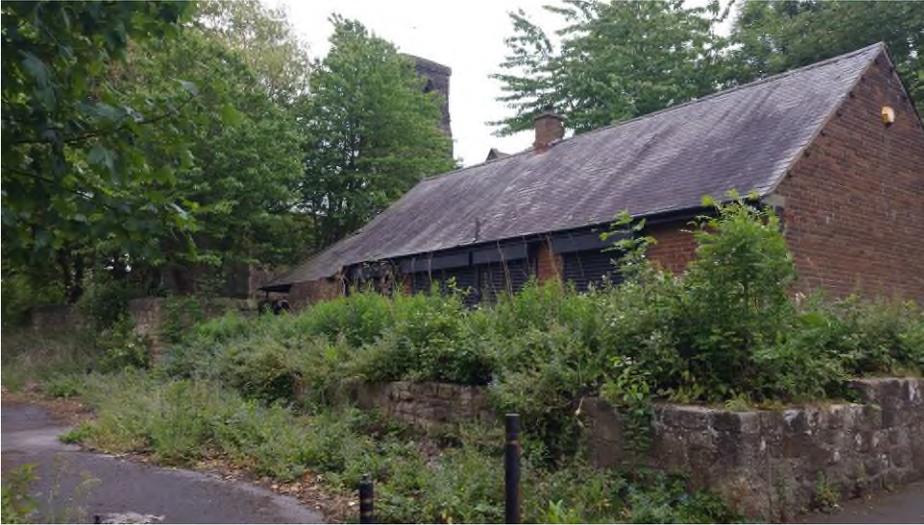
East Side

Boundary not easily discernible. Part of it forms the boundary wall of the cottage. Looking rather run down now.

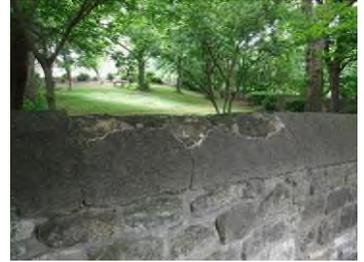
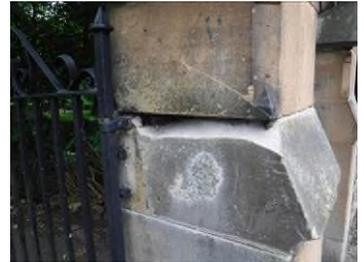
Entrance gates on the N side are good but the piers are cracking because of iron expansion of the hinges and this should be attended to. It is the principal public entrance to the site, and it is important that it doesn't appear run down. The sign board adjacent to it looks a little tired now.

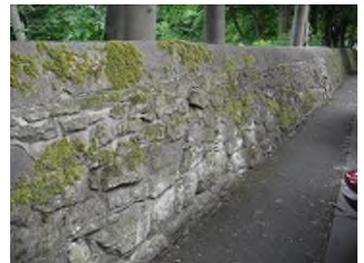
Wall is suffering from three trees close to the boundary which are bursting the walls and this has been advised to the Local Authority who are responsible for repair. Works are planned for 2021. North gate pier top courses have moved and require repair.

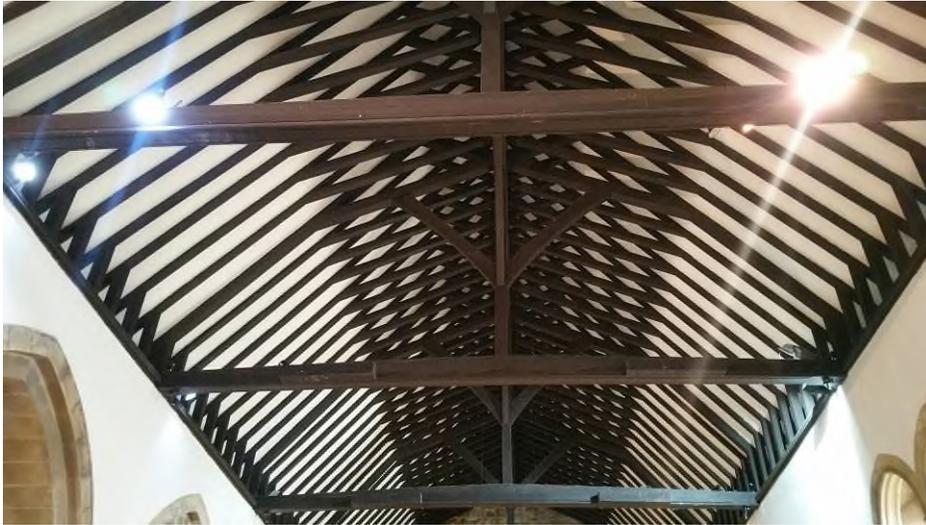
- **Ceiling** – The nave and aisle roofs are open and formed of five bays by trusses, with a lower ridge, scissor beams and strutting up to a higher ridge. The rafters are infilled with boarding and some of the joints can be seen. But all ok.
Former leak at the E end of the box gutter that's shared between the nave and aisle needs decorating.

Recommendation: partial redecorate walls, repoint open joints and bed down loose slabs in flooring, repair floor viewing panel

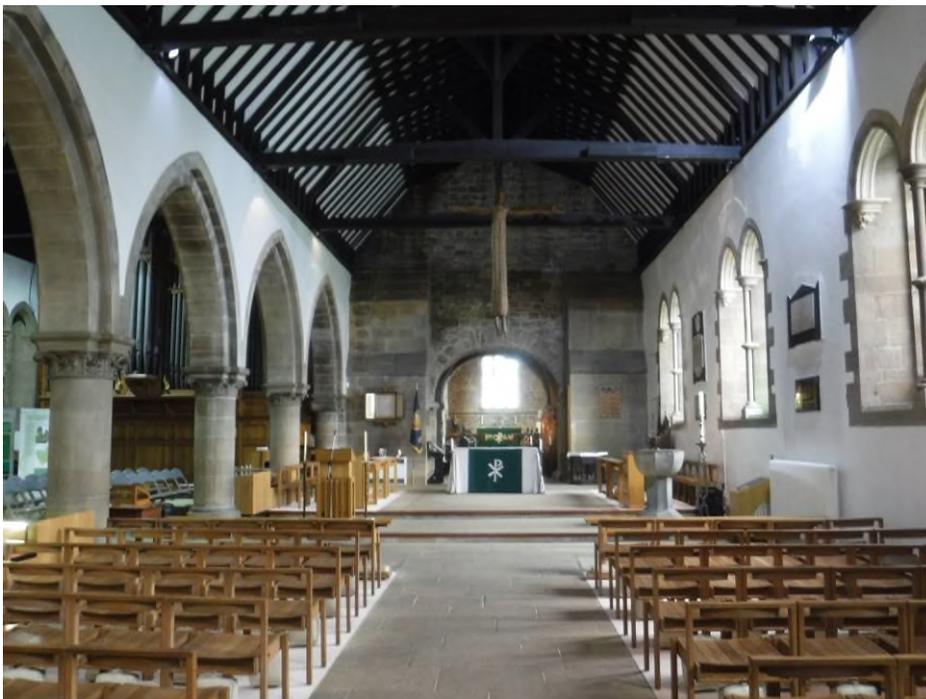
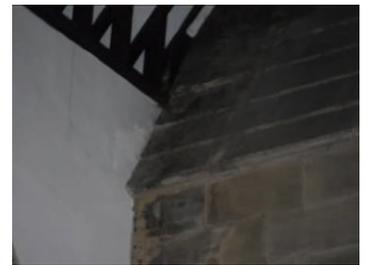
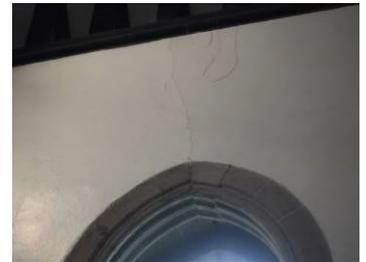
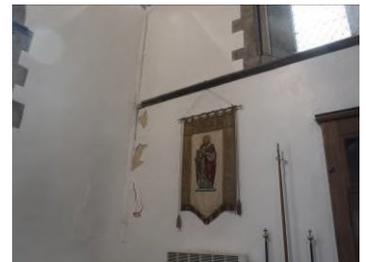
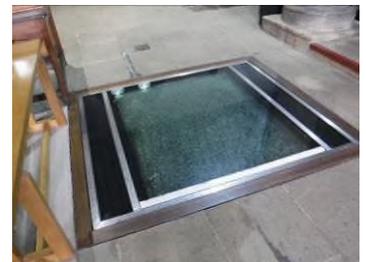
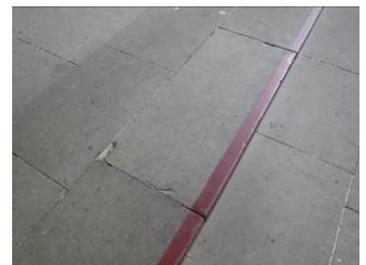
- **Walls** – The walls are painted white. There has been plaster loss in the past but only the skim coat and this has been decorated over recently.

- **Floor** – The flooring throughout the church is sandstone paving and there are some open joints, particularly to the trafficked areas. The glazed in floor panel allows a view of the lit C 7th foundations of the north wall of the nave of the Saxon western church. It has condensation on the underside obscuring the view.
- **Windows** – The windows within the nave and aisle are all in good condition, although there is some erosion to the cills of a couple of them on the S side.

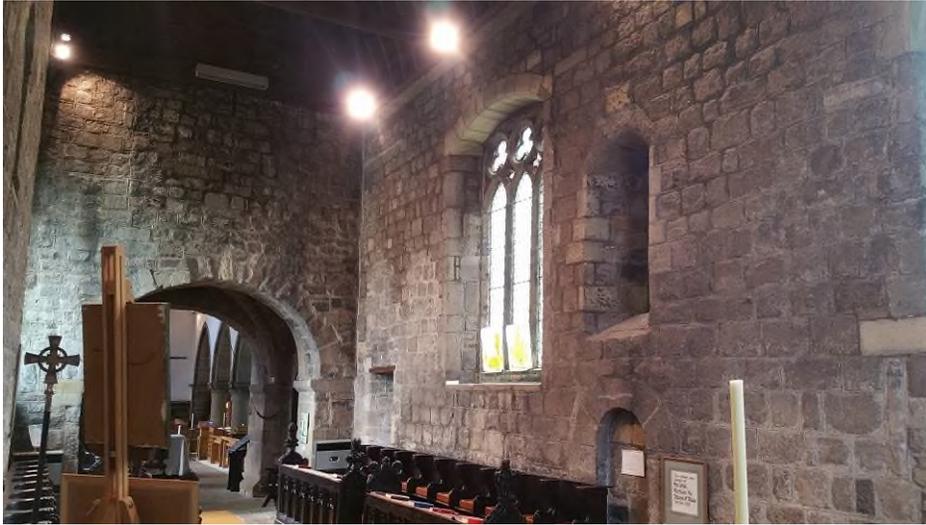
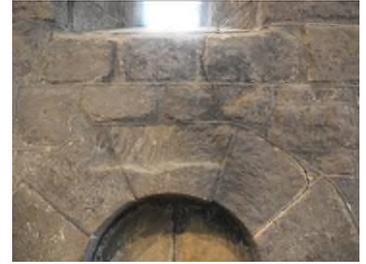
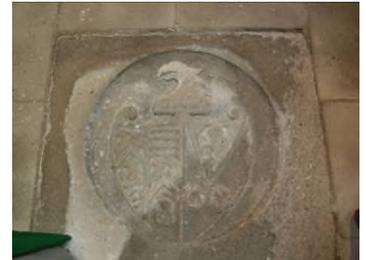
D Chancel:

- **Ceiling** – curved rafter roof supported by large principal beam trusses.
- **Walls** – Exposed stonework that received a repaint in cement pointing with surface ribbon decoration. Little can be done other than keep the external pointing in lime to let the wall breathe as best as possible. The alternative is to remove it, repaint in lime and then limewash it. There are other more pressing issues to contend with.
Crack at the N door commented on in the external section, otherwise everything else is ok.

- **Floor** – Couple of open joints at the sanctuary steps and sinking paving slabs adjacent to the floor memorial in the chancel, where the older paving is eroded and deteriorating.

Recommendation: repair flooring

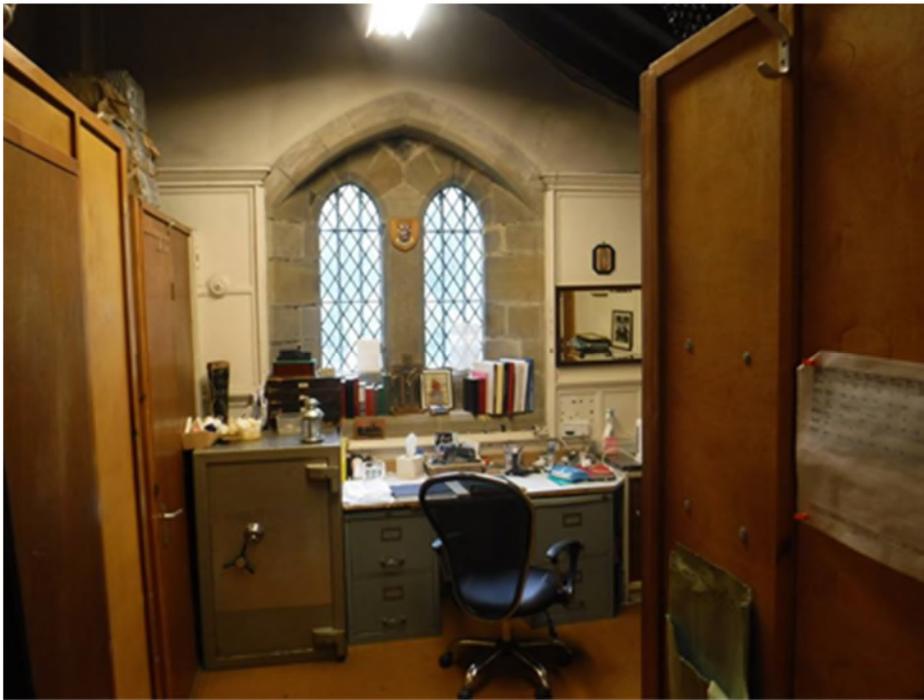
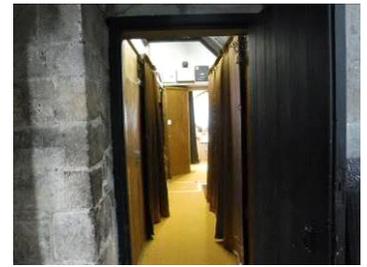
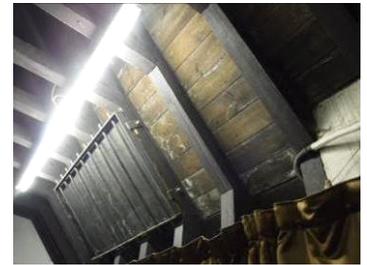
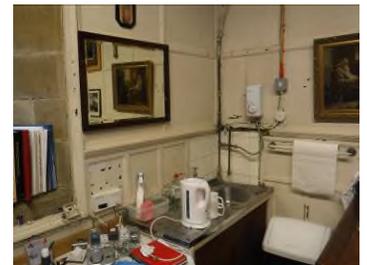
D Vestry and corridor:

- **Ceiling** – The board panelling at the first aid kit could be redecorated. Some ceiling paint peeling.
- **Walls** – painted plaster. Some coming away at corridor water tank. Historical water staining. Vestry wall decoration is good
- **Floor** – The floor is squeaking slightly by the doorway.
- **General** – It has multiple cupboards and these are containing garments, pamphlets, booklets etc. They also house the distribution board and electrical cabinets. There is also further electrical works above the entrance into the vestry and within the cupboard to the left-hand side of it.
- Has a sink and hot water heater.

Recommendation: repair floor and redecorate

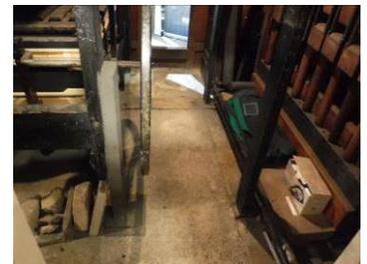
E Organ Chamber:

The arcade wall has had water ingress in the past and flaking plaster - from leaking valley gutter at the E end between the nave and aisle. This has since

been repaired. The room is full of organ so it's not really possible to tell what wall and ceiling condition is like.

Recommendation: investigate wall and ceiling condition in time.

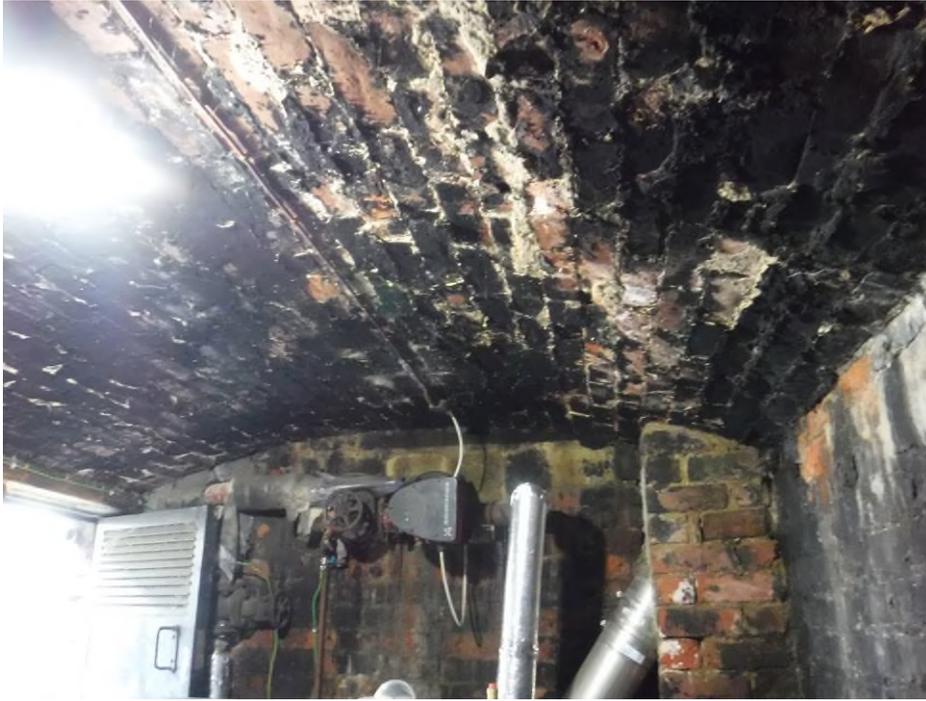
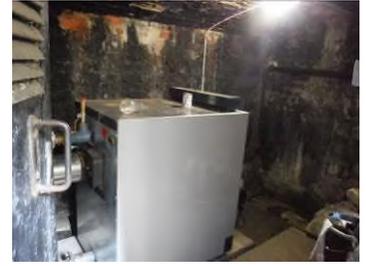
D Boiler House:

Brick vault ceiling with render coming away and the walls are also brick and somewhat sooty. Floor is on two levels in concrete and the room contains various bits of stonework and lumber and could do with a clear out. Contains a Harrier GTS boiler new in 2106 utilising the existing oil feed pipe that runs under the Monastery site from the remote oil tank. Metal door in frame jambs in the opening rusted a bit and needs easing. The retaining brickwork walls are ok, steps are a bit slippery, and stonework below is a little bit patchy but is ok.

Recommendation: ease door and sweep steps
