QUINQUENNIAL INSPECTION REPORT OF JARROW, ST. PAUL

**DIOCESE OF DURHAM
ARCHDEACONRY OF SUNDERLAND
DEANERY OF JARROW**

QUINQUENNIAL INSPECTION AND REPORT

December 2025

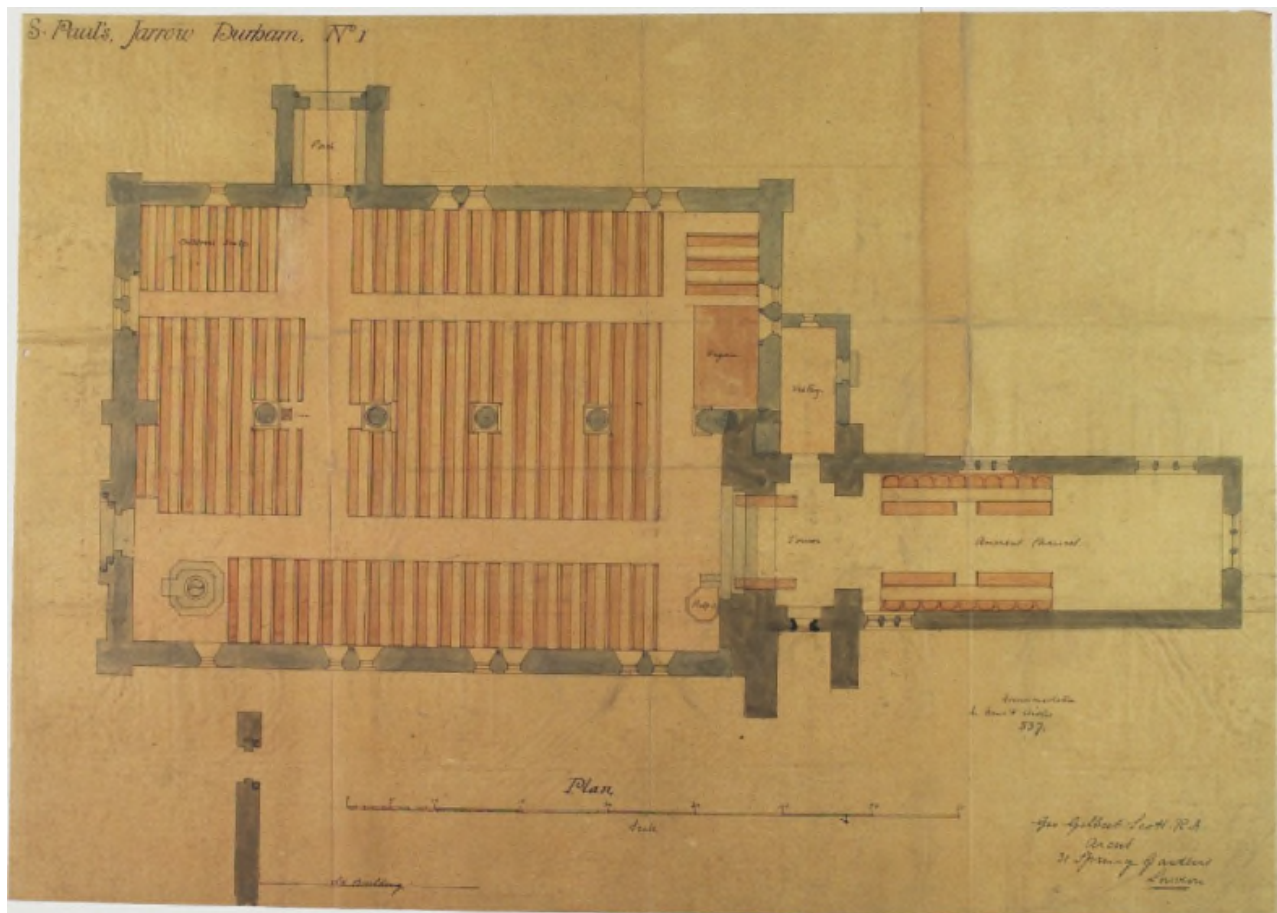
Plan of 1866-1867 signed by Scott from Lambeth Palace Library. Note hand marked south window at ground floor of tower- that is now infilled with stonework- perhaps intended as a doorway?

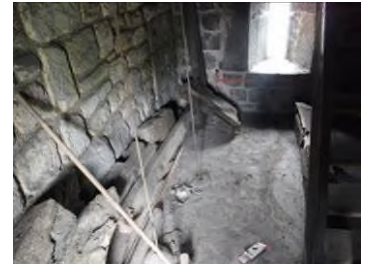
- D Bells:** There are two bells hung in a steel frame in the tower, they have been previously identified as of an early date, one with medieval inscriptions and the other due to its shape. The metal parts of the frame and fittings are rusting, guessing that these are at the date of the Victorian re-build by Scott. There is evidence that there is still a bit of primer on parts of the iron work suggesting that the parts that are built into the wall which are surround by concrete are still primed, there doesn't appear to be an expansion of rust. Howard Smith has visited since the last QI. Hardly rung. One bell rope to S side broken.

Incidentally the older oak frame timbers are still retained within the tower. I wonder how old the timber is. Might this be converted into fundraising furniture or objects?

Recommendation: Clean down rust and paint with inhibiting paint. Fix rope. Establish age of redundant bell frame.

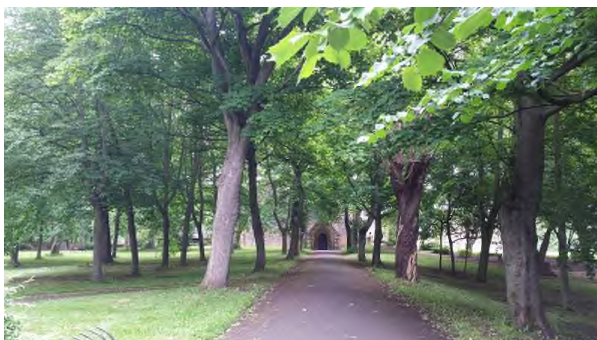
It is closed and the responsibility lies with Sunderland City Council. There are no standing gravestones, they have all been laid flat. Within the site are mature trees and it is unsure if these are covered by a tree preservation order.

Three trees previously reported to be threatening the N boundary wall as the graveyard is higher than the external ground levels have been trimmed.

The N boundary wall has been repaired in the areas that 3 trees above were pushing the wall, and the gate piers that have moved caps, the W is in good condition apart from one of the gate piers which has rusting iron breaking the stonework. The junction down to the S wall where it turns into brickwork is breaking up a bit and is this the responsibility of Historic England? The W and E wall is mostly covered with ivy and no easy to inspect but it looks ok.

Recommendation: see inspection section

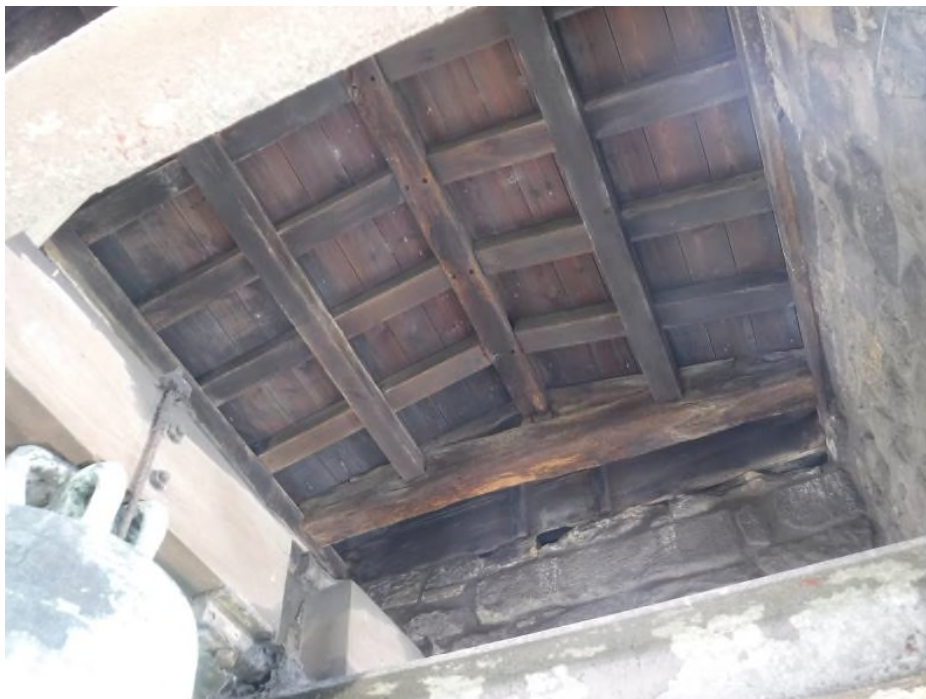
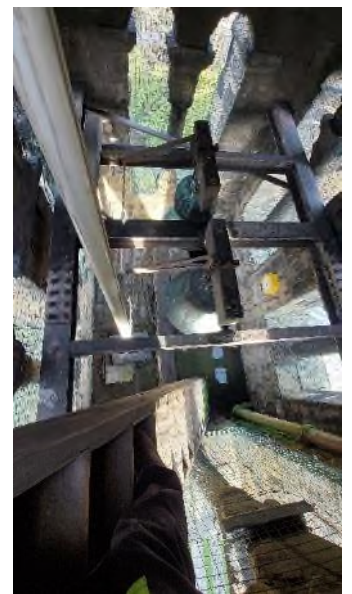
C Belfry:

- **Ceiling** – Roof timbers are ok, no water penetration through the leadwork. Timber a bit gnarled but to be expected.
- **Walls** – The walls comprise large stones with belfry openings. General walling is ok. The balusters are wasting at their joints but they look sound.

- **Floor** – Lead covered, with low upstand- maybe 50-75mm and full of water, it has an overflow lead pipe under the roof downpipe bend exit. It was blocked at the inspection, and to be cleared. It's very small. The ponding was reported at the last QI and hadn't been addressed. It may now be leaching into the tower walls as it has breached the top of the upstand and overflowed. There may be signs of this penetration at the chancel east wall. There must be a leak in the floor as water goes down to lower levels. Everything here is wet and not good for the tower.

The roof hatch covering is breaking up now and the perimeter frame of it is broken it needs replacing, there needs to be a grab handle at the top of the stair.

The belfry openings are covered by copper mesh and that is clearly not effective as there have been birds getting in here, they seem to be broken mostly at the bottom part and they all need fixing back.

The access stair up to the roof is sturdy but has a bit of damp to it, I don't think it has got a problem just yet but in the S E corner there is heavy ponding and there is some dirt and one of the strings is sat in that dirt so it is just getting wetter and wetter over time, it needs a proper sweep out in here.

Recommendation: sweep up floor, investigate if the floor drains water out and the lead floor if leakproof, check light works, replace hatch, provide grab rail, ensure bird mesh is effective, prime the bell frame, check bell operation, unblock the downpipe, check stair foot is ok

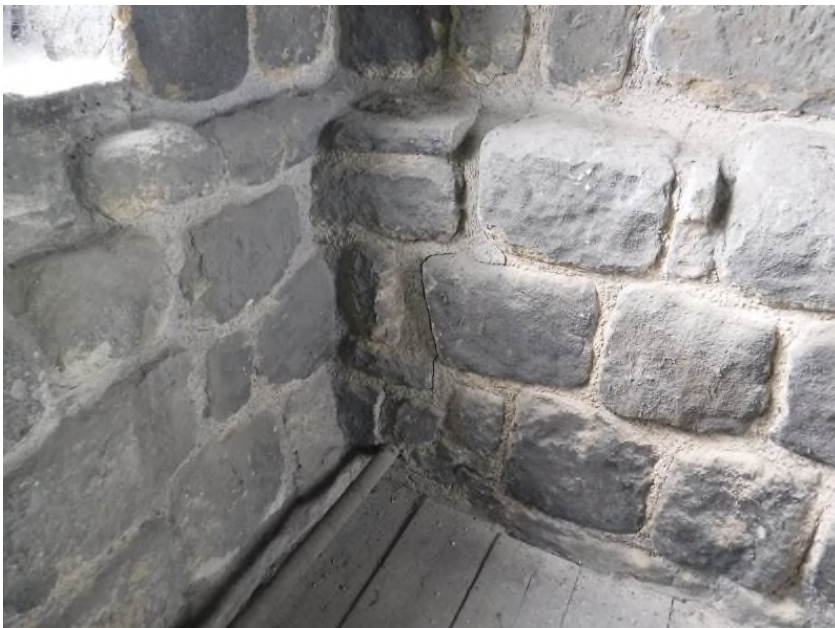
2020 image

- **Floor** – The floor has a bell hatch with loose floorboards in, there is also a piece of rotten plywood placed over a hatch in the floor which is rotten.
- **Windows** – The windows have diamond leaded glazing. Is this a more modern edition because there is what looks like old bird droppings on the tie bars, so perhaps these were infilled in later years? It has polycarbonate and this is breaking down, the joints are breaking down on the S side they are very cobwebby and they really need a clean down to be inspected further. There is something odd about the position and design of the central baluster in the arch- it isn't in the middle of the wall- it's towards the inside, and the capital outside is cantilevered to catch the arch.

- **General** – In the S W corner just below the window cill there is a crack running through the joint just above the tie rod and this is reflected on the masonry on the outside, there is also a shear crack on the corner of the S W window jamb as it joins on to the cill. Also on the N as well as the S. The cill seems to be the most affected. It's obvious that this is the weak corner on the tower.
- **Recommendation:** clean down the glass and inspect. Clean up floor and ceiling, check for rot, repair hole in floor.

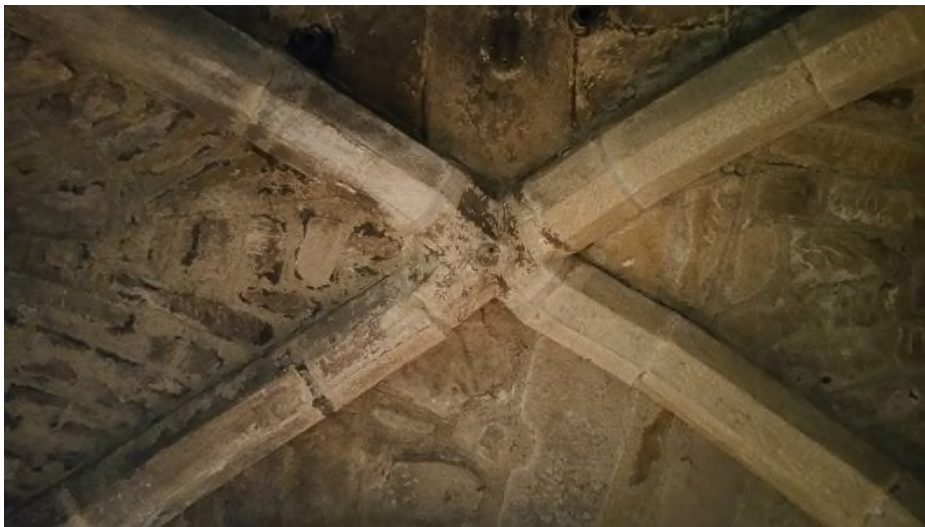
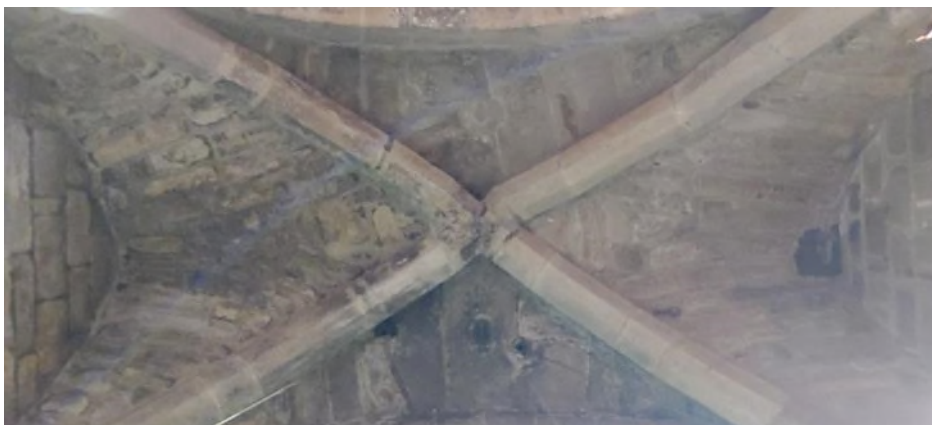
2021

- **Ceiling** – The crossing comprises stone ribs and stone vaulting. The ribs are twisted slightly, due to ground settlement as the engineer reports. There as been water penetration in the ceiling and splashes on the floor.

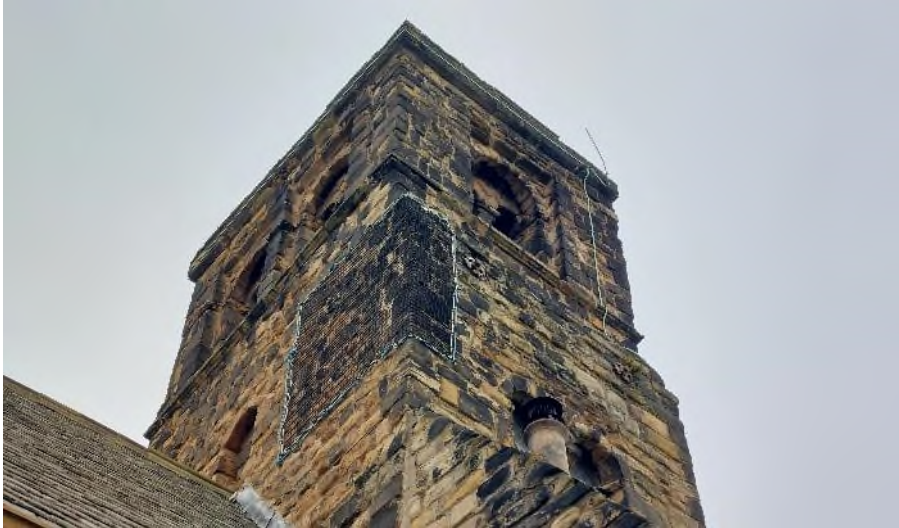
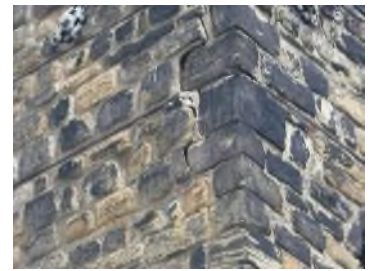
2020 image for comparison

This has the most serious cracking at the S W corner at the deafening chamber level and in-between the tie rods, the corner was coming apart at the last inspection. Since then the joints have been packed and a net added to stop them falling out. The new lime mortar packing is sturdy and the stones (from the ground) don't look to have moved or that the mortar joints have opened up. Is the net checked? and it is worth considering if the net can come off.

There are also four noticeable bands of bedded metalwork in the stonework that starts from the corbel projection and there are four levels above that, there is also a further crack forming more towards the centre above the apex at the stonework above the top parrass, the belfry stonework and balusters all looks ok above it. It hasn't changed since the last inspection.

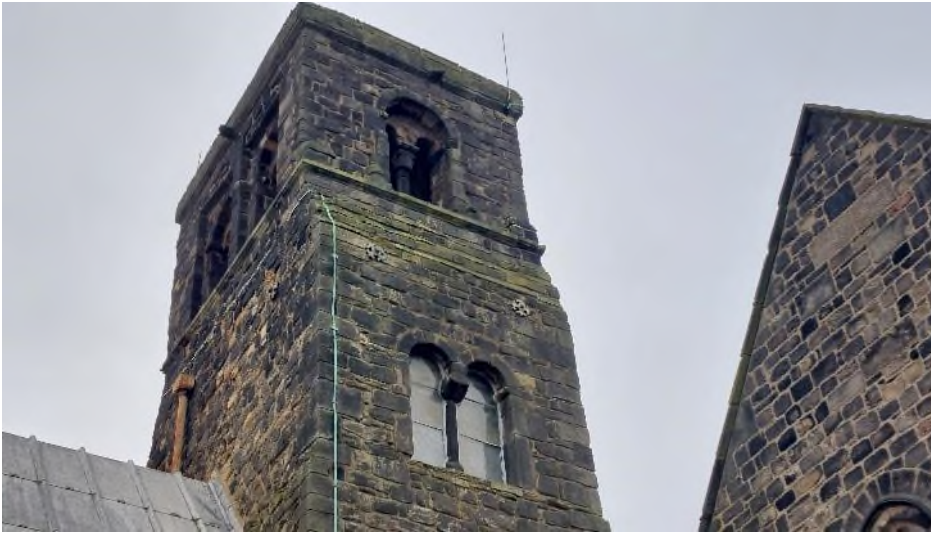
- **North Elevation –**

The down tape comes down on this side, albeit crosses over on the E and comes from the S E corner, there is also another terminal on the N W corner.

This elevation has tie rods showing at two stages, they seem ok, Is the crack running down from the deafening chamber ceiling tie rod pattress, coming down to the springing point of the arch, this was recorded by Wiggins in 2001 and looks the same.

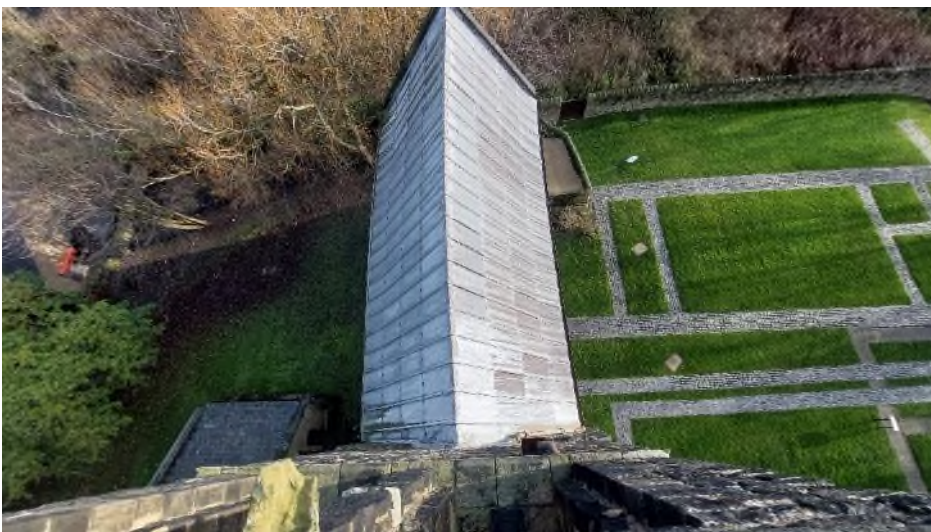
M Chancel:

The chancel is a leaded roof of some age now (1930's?), Some patching at the E end in the past. The lead has oxidation and chemical reaction to impurities marking and is one to watch.

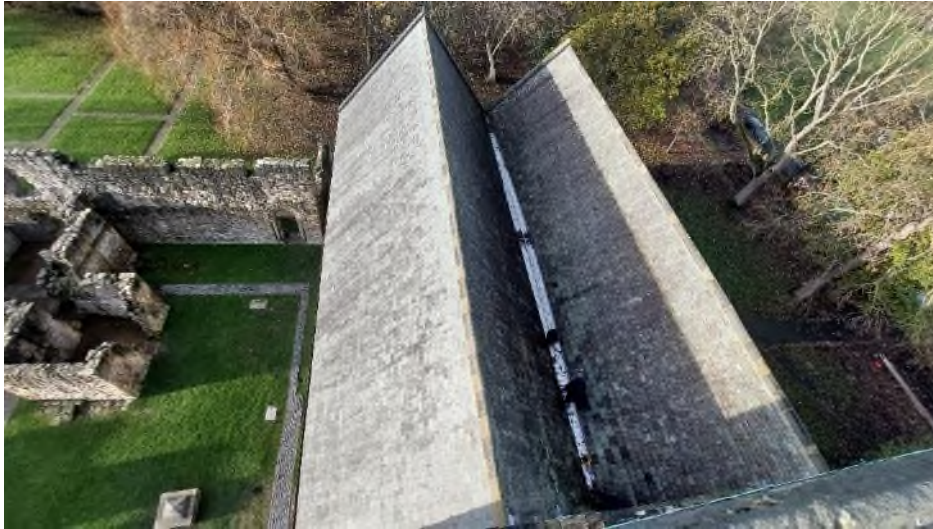
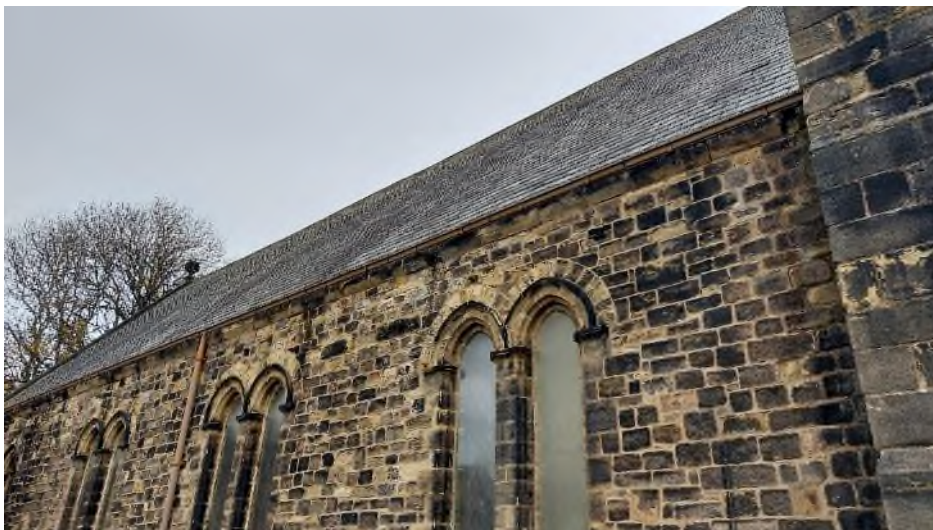
B Nave:

Roof is joined to the north aisle by a box gutter, draining at both ends.

The nave was reslated in 2005 with Westmorland to the outer slope and reclaimed to the inner. This was repeated in 2008 to the north aisle and now the south slope reclaimed are slipping. Half of the stone ridges were renewed. Stainless steel box gutter between. Lead flashing thefts in 2009 resulting in lead alternative replacements.

At the W end the slates have been broken in the past by intruders getting into the box gutter, The configuration at the east end of the box gutter is complicated by the tower buttress. The box gutter travels through it by a s/steel chute (reported to be ok). Above that is a gutter to manage the junction of the buttress and south slope eaves, made further complicated by the gable upstand.

Recommendation: repair east end box gutter aisle roof junction with buttress.

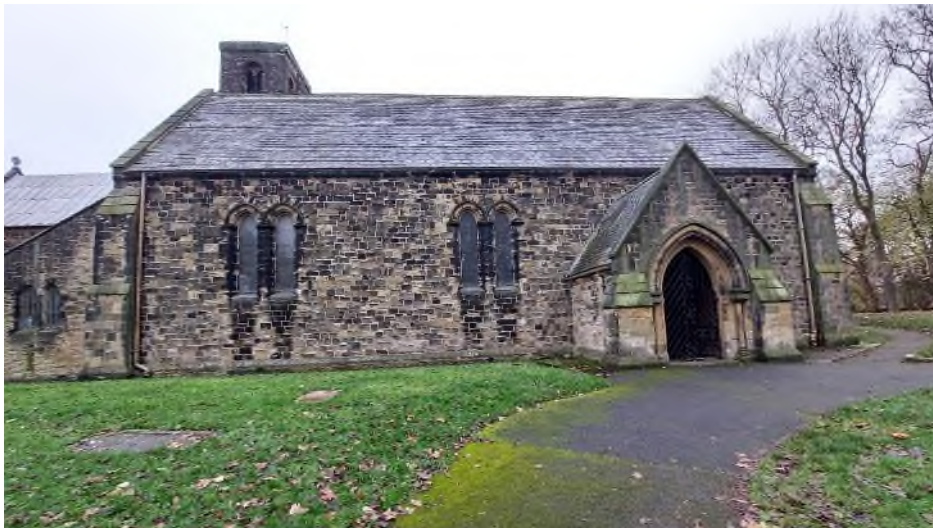
- **North Aisle:**

Same as the nave apart from both water tables are cement pointed and are sound.

Recommendation: none

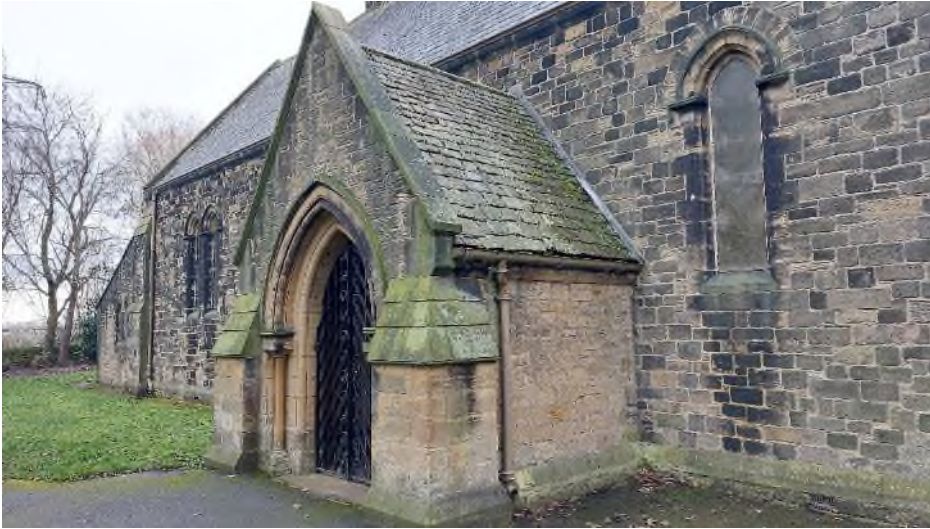
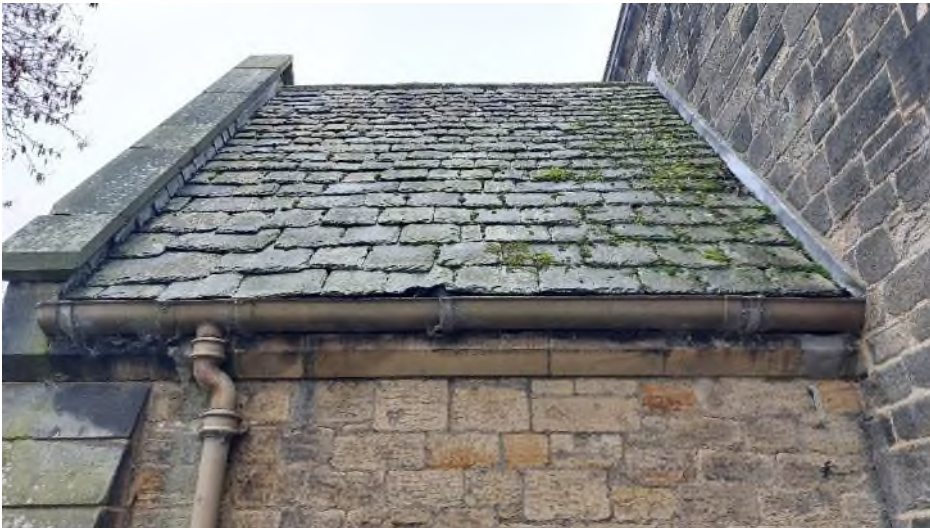
E North Porch:

Slating looks sound, lead abutment flashings intact (not cement covered like the W porch). Is this a possible lead theft location?

Recommendation: consider covering lead in mortar

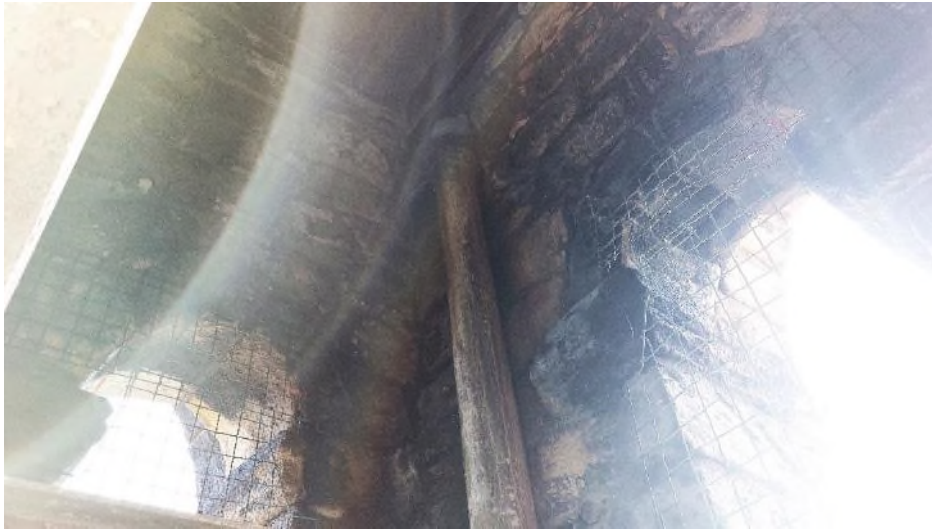
The major problem is the blocked tower downpipe, inside the belfry) which was blocked at the last QI so it's been overflowing for at least 5 years within the tower.

See tower section for observations. It's time to redesign the system to omit the pipe and go back to spitters to remove the maintenance problem.

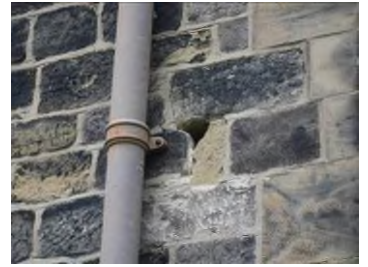
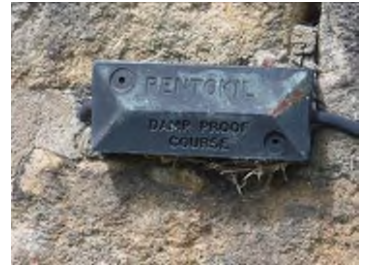
Four windows, three of which are twin lancets the hood moulds have seen some wear and above them the relieving arches pointing is poor in some instances, some water penetration from the hood moulds because of open jointing and there is delamination of the arch stonework. There is a daylight gap seen from inside to the Westernmost window where the arches meet. The cills have been patched in cement and that is breaking up in places. Windows are covered in polycarbonate are a bit dusty and cobwebby but fair. The glass is diaper and some of it is polycarbonate covered of various opacity.

Evidence of earlier copper tape damp proof system.

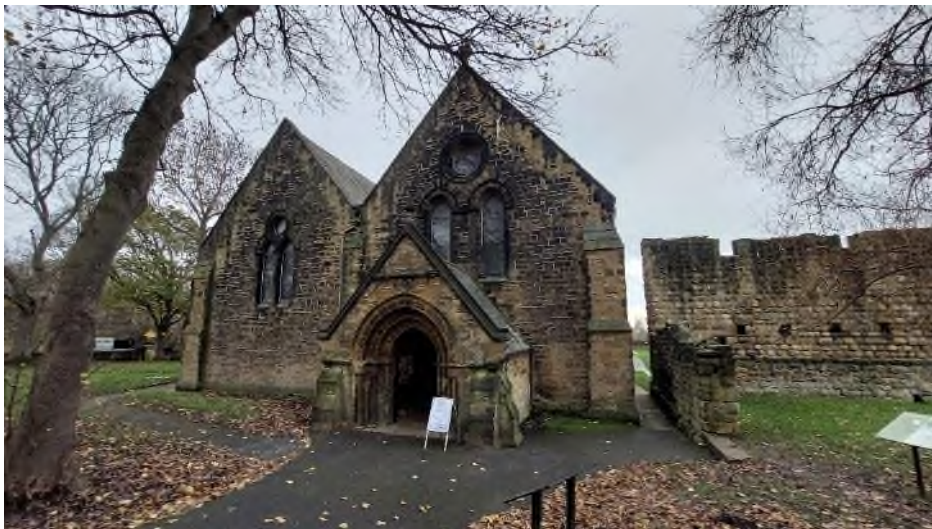
West side – Large feature gable with rebated water tabling, some of the high level stonework beneath the water tabling on the S side is a little worn but that is probably just the pollution been washed away, the walling over all is generally sound. Two twin light lancet with circular light above, permanently pointed in polycarbonate glazing in grey mortar looks poor, the jointing of the polycarbonate is breaking down. The stonework of the windows is all ok. Buttress between that and the N aisle is a little worn at high level but satisfactory.

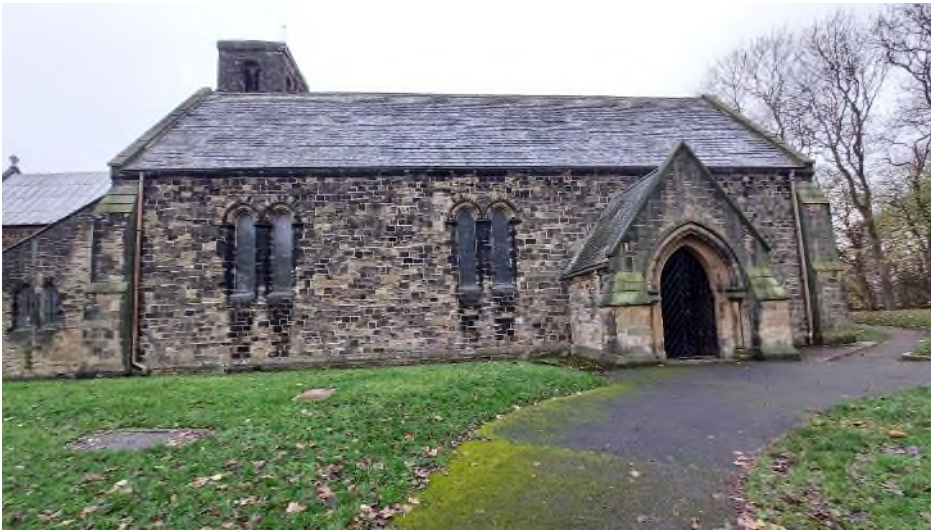
West side - this is a smaller version of the N aisle window where the three forms are all joined into one, they look ok, just some water wearing away of the pollution up at the upper levels but all sound as is the buttress on the corner.

North side – Some open joints to the gutter support corbel, the walling itself is all sound. Same design of windows as the aisle on the S.

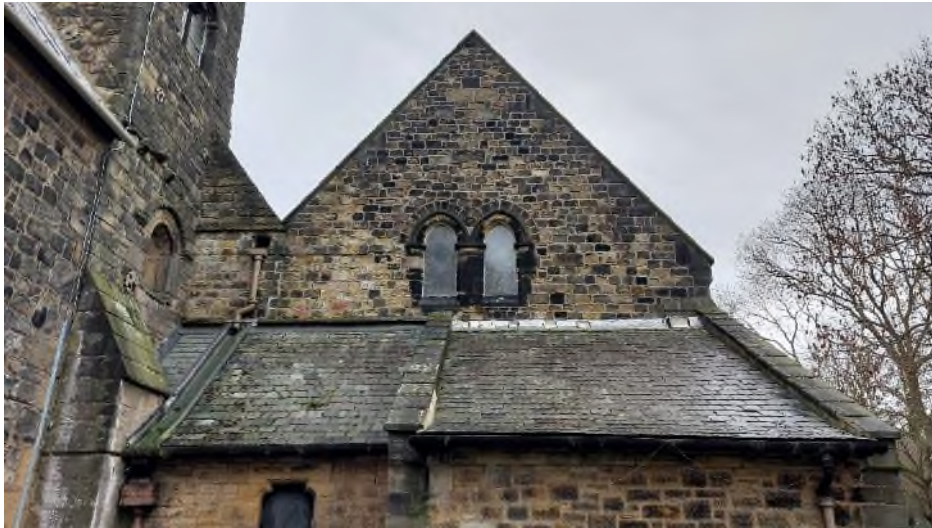
Gable above the vestry's roof looks ok, the walling itself is alright apart from slight erosion to the N side above to the right of the windows. Twin light lancets, hoodmould is ok, generally alright, the ceiling of one of the lancet cills on the S side doesn't look right, large horizontal joint from cabling close to where the hopper outlet is, where there is some greenery.

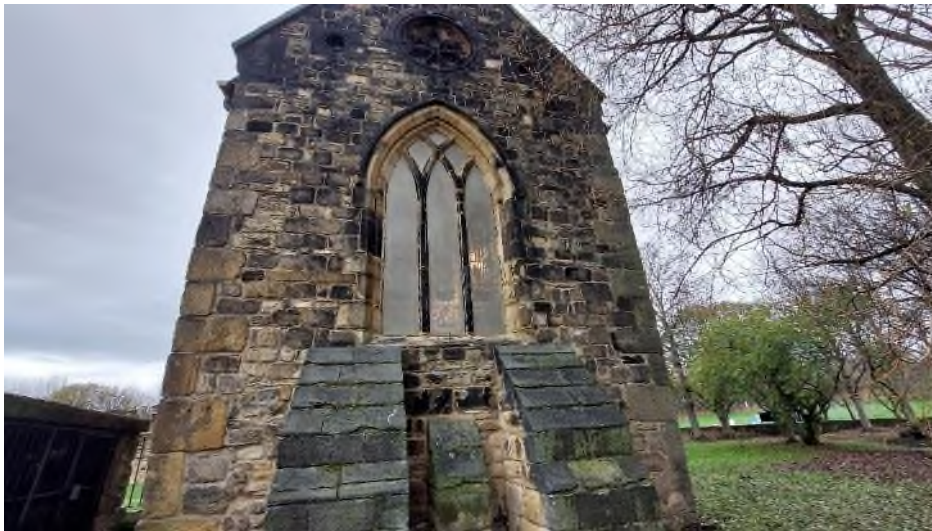
Cross looks ok as does the water table. The general walling is ok, at low level are two massive buttresses and a mini one in between.

Large central wide tracery three light with some erosion to the bottom of the mullions and cill but not advancing. The arch dressings are ok. The label stop on the S side is badly eroded. Hoodmould looks ok, above that is a large circular window with three small porthole style windows around it, the big circular has rusting metal mesh covering it as do the little portholes.

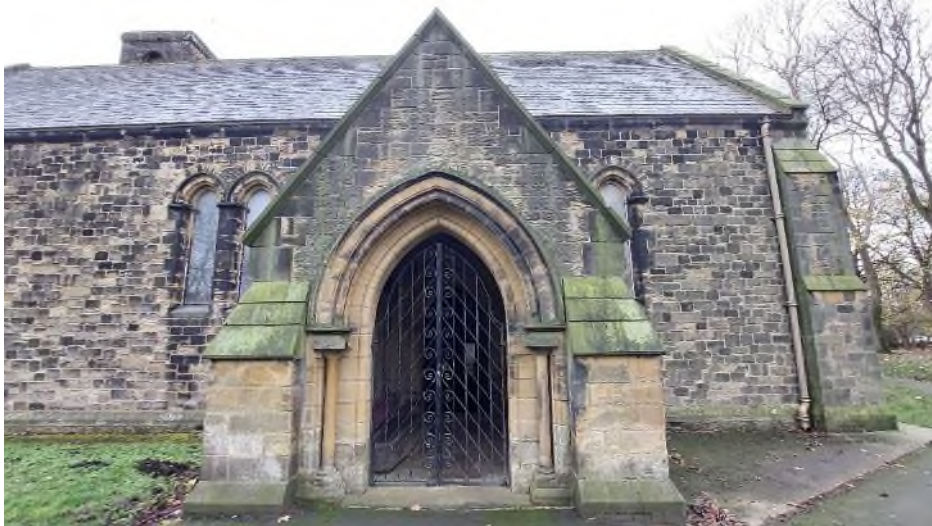
Some light loss of the surface crust to the walling, buttresses but ok.

Internally- Open rafter ceiling. Walling is ashlar and okay. The North wall has some open joints at the dressings. The aisle entrance stonework is good, although it has bird marking. The moulded archway to the nave has some open joints to it. The door and gate is in good condition.

Recommendation: none

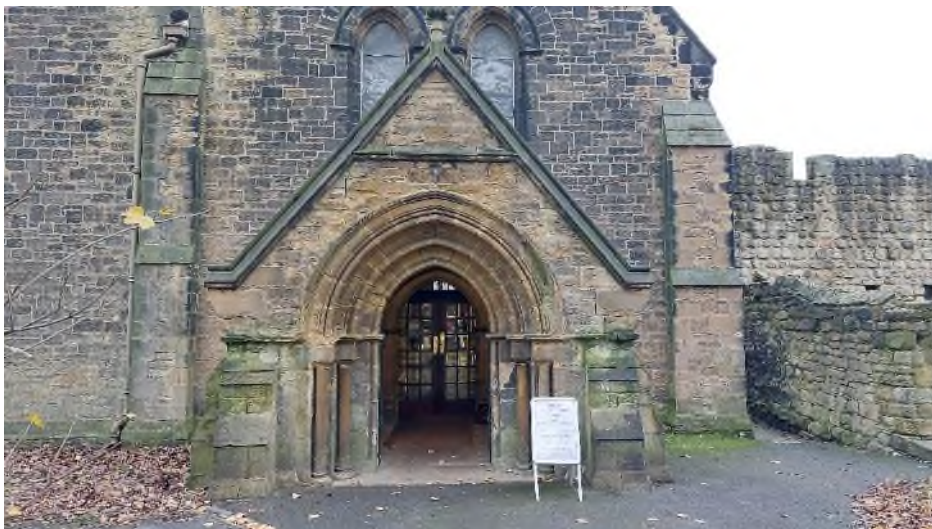
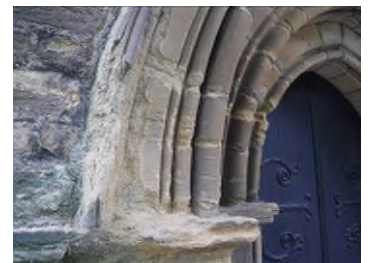
An addition, 22 years after the church was built. Likely added to protect the Nave from west winds and a possible internal reordering (the font was on the right as you went in, but is now towards the east end of the nave).

Open joints on the S side. Couple of open joints on the buttresses.

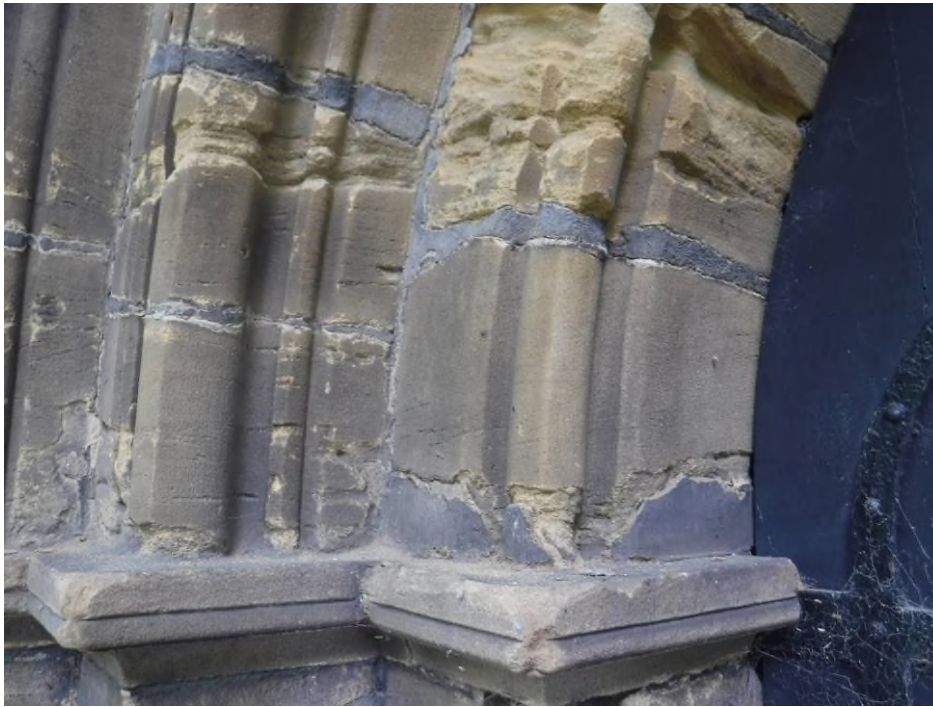
2020

The W doorway has been heavily repaired in cement mortar and this has led to the breakdown of the stonework at the joints, it is such a shame because it has become a mess. It has affected all of the arch and the jamb stonework. More damage can be done in removing the cement. It really needs a conservator report or experienced stonemason to report on remedial proposals. The N capital has broken off The nook shafts are ok apart from a loss of surface on one them. The ground feels a little bit too high for their bases. Perhaps that has ironed out a step, perhaps they brought the tarmac level up a bit higher to do that. Door within it is fine.

Recommendation: procure remedial report on stonework

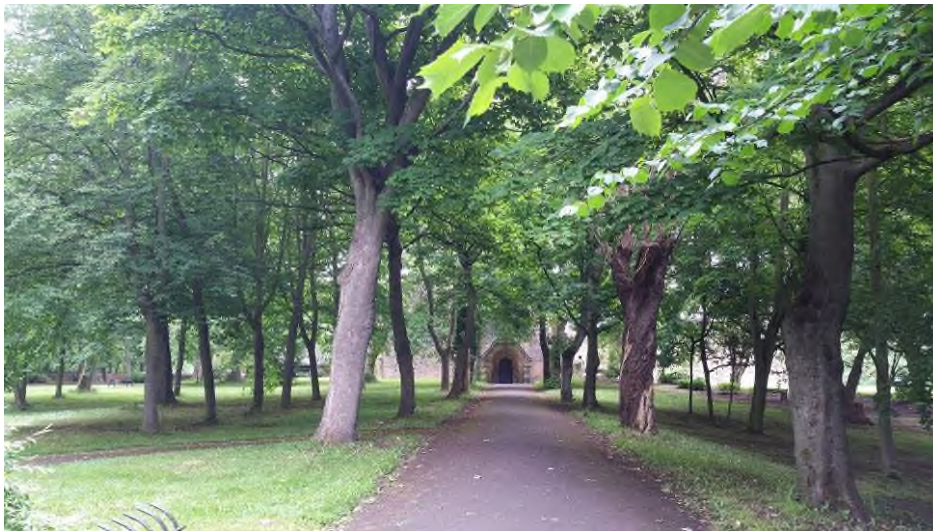
The church has a closed graveyard in the care of the Local Authority. It is grassed with mature trees. It has stone boundary walls and gates to the entrances at the W and W. Whilst in mostly good condition, there are areas of cracking and open joints to walling and gate piers. There are quite a significant amount of mature trees on the site, it would be interesting to know if these are covered by tree preservation orders. The Local Authority are managing them well. Trees affecting the north side have been reduced.

Recommendation: keep vegetation down by the cottage to discourage opportunity for anti social gathering, repair north sign board, reset west gates

and repair piers, establish boundary ownership and thus responsibilities as the south is breaking down and needing timely repairs.

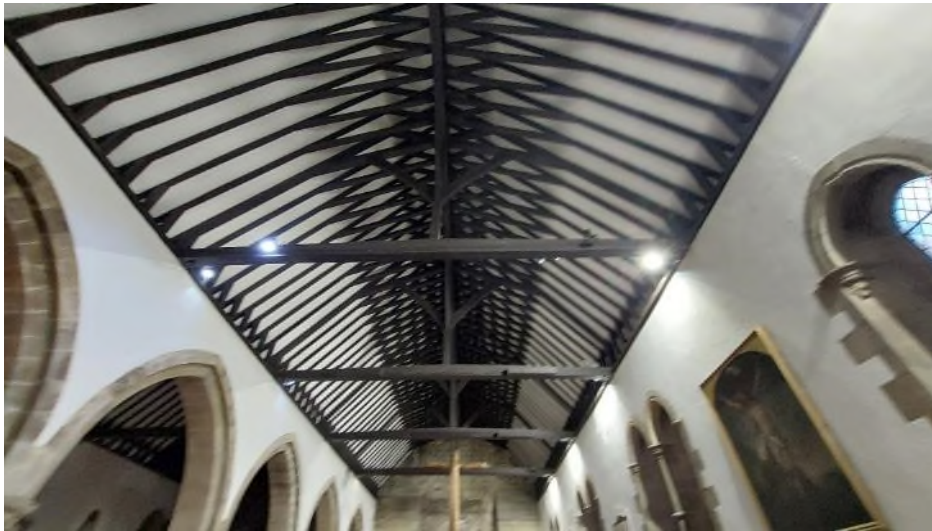
- **Ceiling** – The nave and aisle roofs are open and formed of five bays by trusses, with a lower ridge, scissor beams and strutting up to a higher ridge. The rafters are infilled with boarding and some joints are open. But all ok.

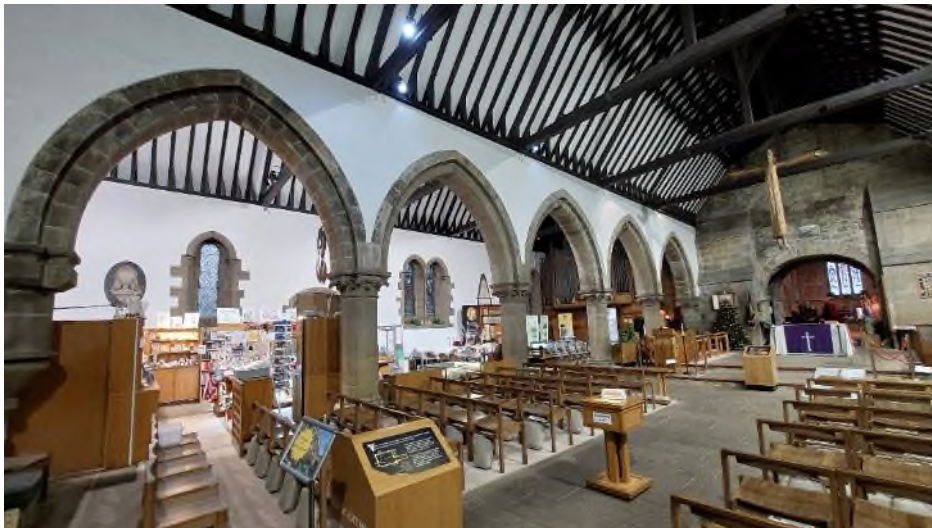
Arcade all looks fine.
