QUINQUENNIAL INSPECTION REPORT - APRIL 2021

# ALL SAINTS CHURCH

LOW MOOR ROAD, LANGLEY PARK, CO. DURHAM, DH7 9TZ

JDDK Architects

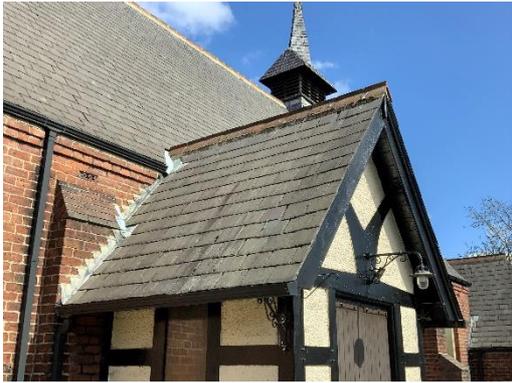
**Porch Roof**

<p><b>Condition</b></p> <ul style="list-style-type: none"> <li>• Generally in good condition. No missing slates, although one or two are slipping and others have chipped corners.</li> <li>• Mortar pointing and bedding to ridge tiles is sound, although beginning to weather out of the joints at the top edge.</li> <li>• Lead flashings are in good condition.</li> </ul>	
	<p><b>Repair Needs</b></p> <ul style="list-style-type: none"> <li>• Monitor slates and refix any which continue to slip, or are blown off.</li> </ul>	M

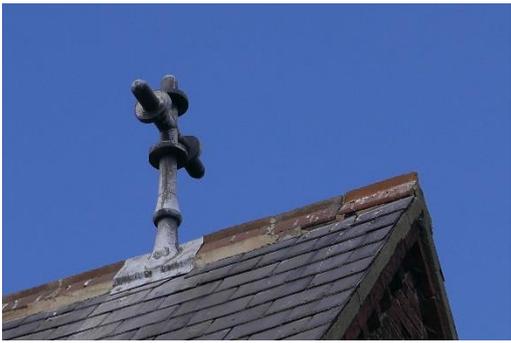
<p><b>Condition</b></p> <ul style="list-style-type: none"> <li>• Generally in good condition. No missing slates, although one or two are slipping and others have chipped corners.</li> <li>• Mortar pointing between ridge tiles is weathering out in some areas. When water gets into the bedding, frost will begin to lift the ridge tiles.</li> <li>• Ridge tile bedding has cracked away at the East gable.</li> <li>• Minor cracking to the mortar verge at the East gable.</li> </ul>	
	<p><b>Repair Needs</b></p> <ul style="list-style-type: none"> <li>• Monitor slates and ridge tiles and refix any which continue to slip, or are blown off.</li> <li>• Monitor cracks in mortar verge and carry out repairs should any fall out before the next inspection.</li> </ul>	<p>M</p> <p>M</p>

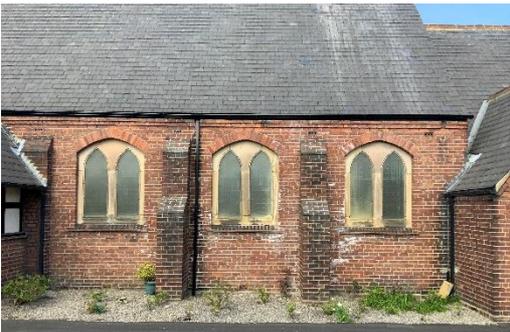
South Elevation of the Nave

<p><b>Condition</b></p> <ul style="list-style-type: none"> <li>● The saturation and efflorescent noted in the previous report is very noticeable, suggesting that the brickwork is continues to dry out, and perhaps a result of a long dry spell without rain to wash it away.</li> <li>● Pointing is generally in good condition, although there are some small areas needing attention in the longer term.</li> </ul>	
	<p><b>Repair Needs</b></p> <ul style="list-style-type: none"> <li>● Brush off the worst of any remaining efflorescence.</li> </ul>	<p>M</p>

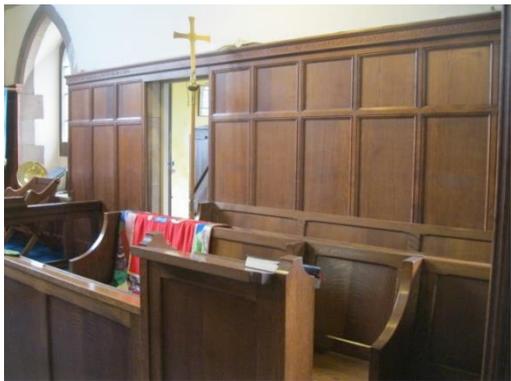
<p><b>Condition</b></p> <ul style="list-style-type: none"> <li>• The screen between the Nave and the Chancel is in sound condition with no loose elements evident.</li> <li>• The oak panelling in the Chancel and Sanctuary is also in sound condition and is in no need of attention.</li> <li>• The new oak panelling around the WC/kitchenette is in sound condition.</li> </ul>

<p><b>Repair Needs</b></p> <ul style="list-style-type: none"> <li>• None at present.</li> </ul>

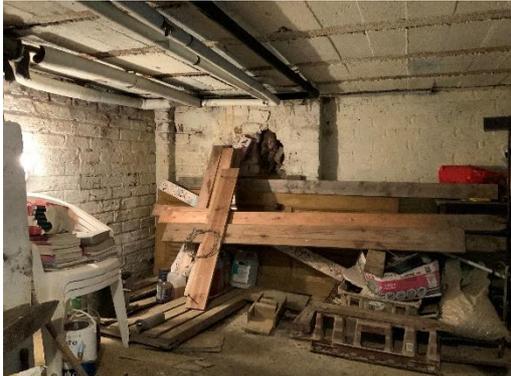
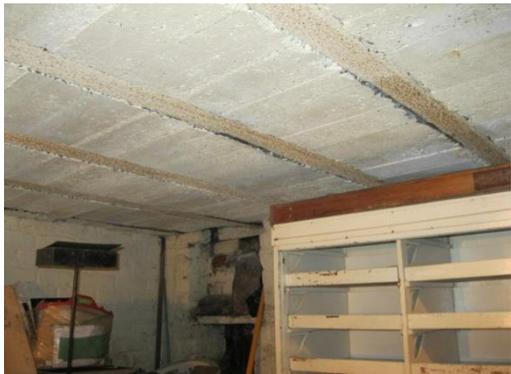
11.6 BASEMENT HEATING CHAMBER

<p><b>Condition</b></p> <ul style="list-style-type: none"> <li>• The fireproof plasterboard ceiling continues to show dampness and flaking paint, particularly above the door, but this does not appear to be getting worse and the board remains sound.</li> <li>• The concrete floor is damp, although no standing water was observed.</li> <li>• The steel RSJ's framing the lowered ceiling below the organ and the RSJ door lintel are all rusting due to the damp environment, and anti-corrosion painting is required.</li> <li>• The exposed heating pipework will benefit from having all joints in the insulation taped up to minimise thermal bypass, helping efficiency.</li> </ul>

<p><b>Repair Needs</b></p> <ul style="list-style-type: none"> <li>• The steel RSJ's need to be wirebrushed and then repainted with a high-quality metal primer and paint.</li> <li>• The joints in the insulation on the heating pipework should be taped up.</li> </ul>	<p>C</p> <p>D</p>

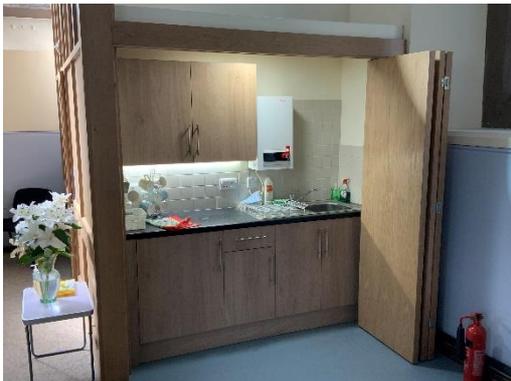
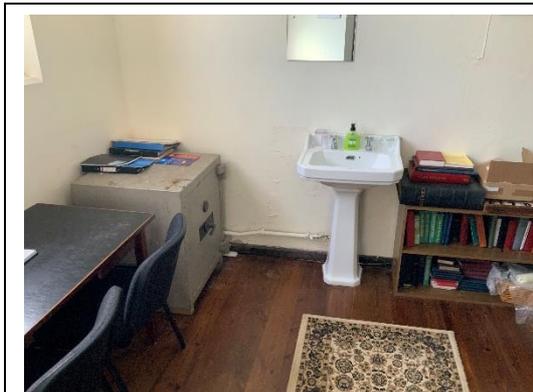
<p><b>Condition</b></p> <ul style="list-style-type: none"> <li>Pews, pulpit and font are all in good condition, as noted previously. A number of pews were removed from the front and rear of the Nave to provide more space for community uses in 2019.</li> <li>In 2019, the font was moved to the front of the Nave to create more space for community uses. At that time, its height was reduced slightly by the removal of part of the stone plinth.</li> <li>The low screens in the Chancel are wobbly, but this is a design flaw, and no attention is needed.</li> </ul>

- The author understands that some woodworm treatment has been carried out to the altar since the last inspection.
- The sink in the South Vestry is dated, but in working order.
- The new WC and kitchenette are all in good condition.
