**INSPECTION OF CHURCHES MEASURE  
DURHAM DIOCESAN CHURCH SCHEME**

**CHURCH OF ST. MARY**

**LONG NEWTON**

**QUINQUENNIAL INSPECTION 2017**

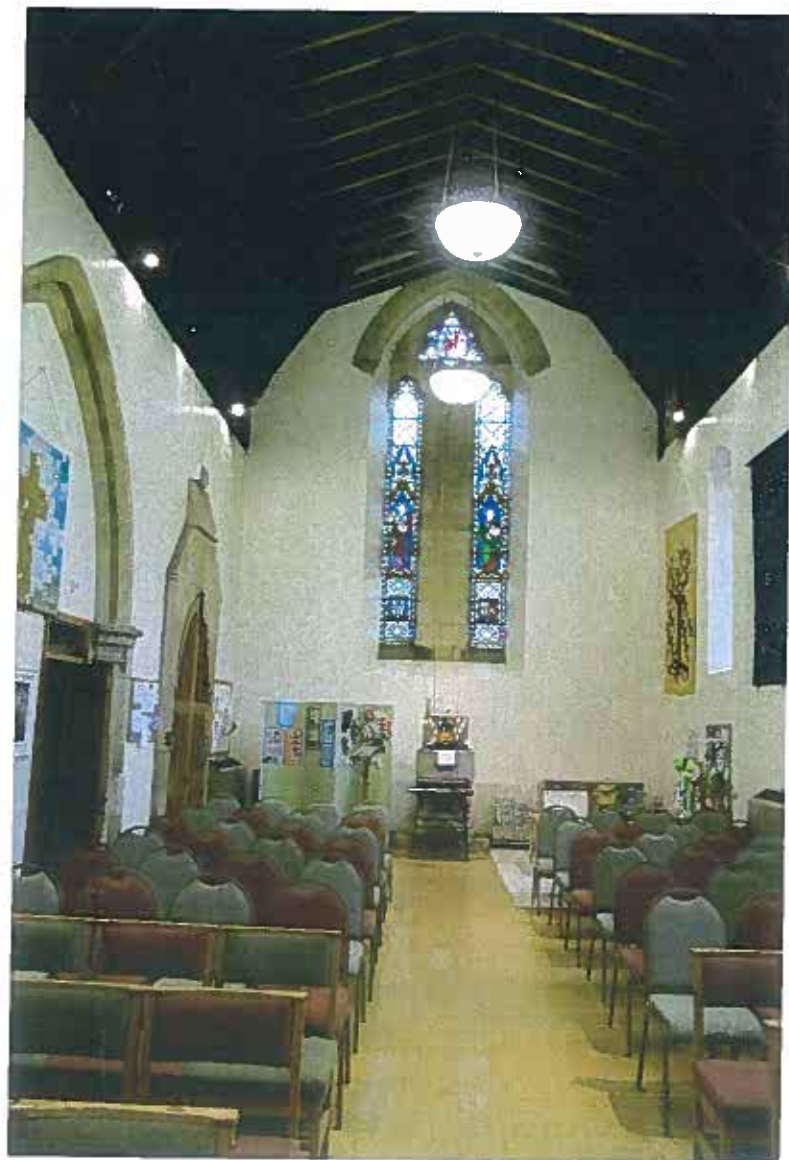
- 22 : Nave looking West to West Gable window and Font
- 23 : Organ renewal in progress.
- 24 : Organ Chamber incorporating electrical switch gear and storage
- 25 : Chancel, Altar and East Gable window
- 26 : Accessible Toilet
- 27 : View from Chancel into Londonderry Chapel
- 28 : Arcade detail between Chancel and Londonderry Chapel
- 29 : Gated entrance to Londonderry Chapel
- 30 : View to Chancel from Chapel
- 31 : East Gable Wall to Londonderry Chapel
- 32 : Coat of Arms stained glass window in West Gable to Londonderry Chapel recently restored
- 33 : Steep flight of steps serving Vault

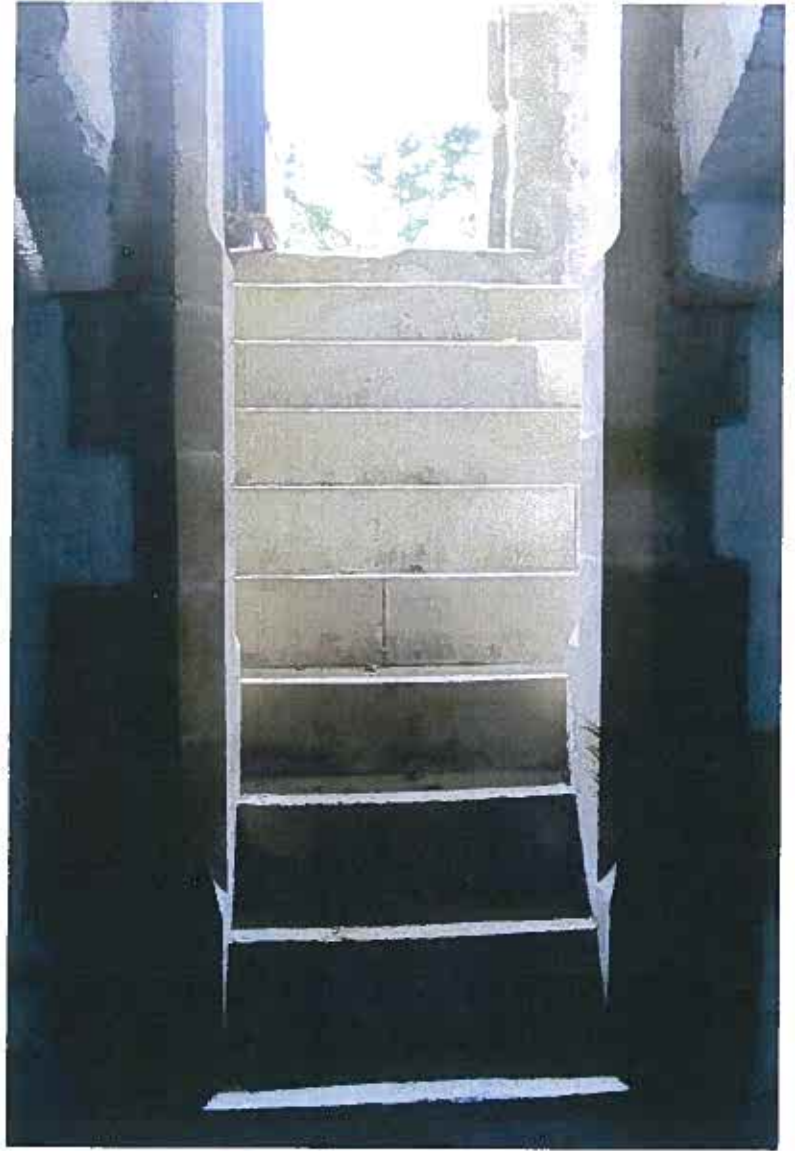
**6.10.4 Access** is via a steep flight of stone steps served by a dark stained boarded/framed external door which binds on the roof preventing full opening. It remains in need of thorough cleaning, some repairs, preparation and re-staining.

- h) Prepare and redecorate louvered door to Boiler Room per item 6.11.4 (B) £70.
- i) Clean, prepare and re-stain external door to Vault per item 6.10.4 (B) £50.
