# St John the Evangelist, Lynesack

Quinquennial Inspection

## CONDITION SURVEY 2021

Ian Wells B Arch RIBA AABC

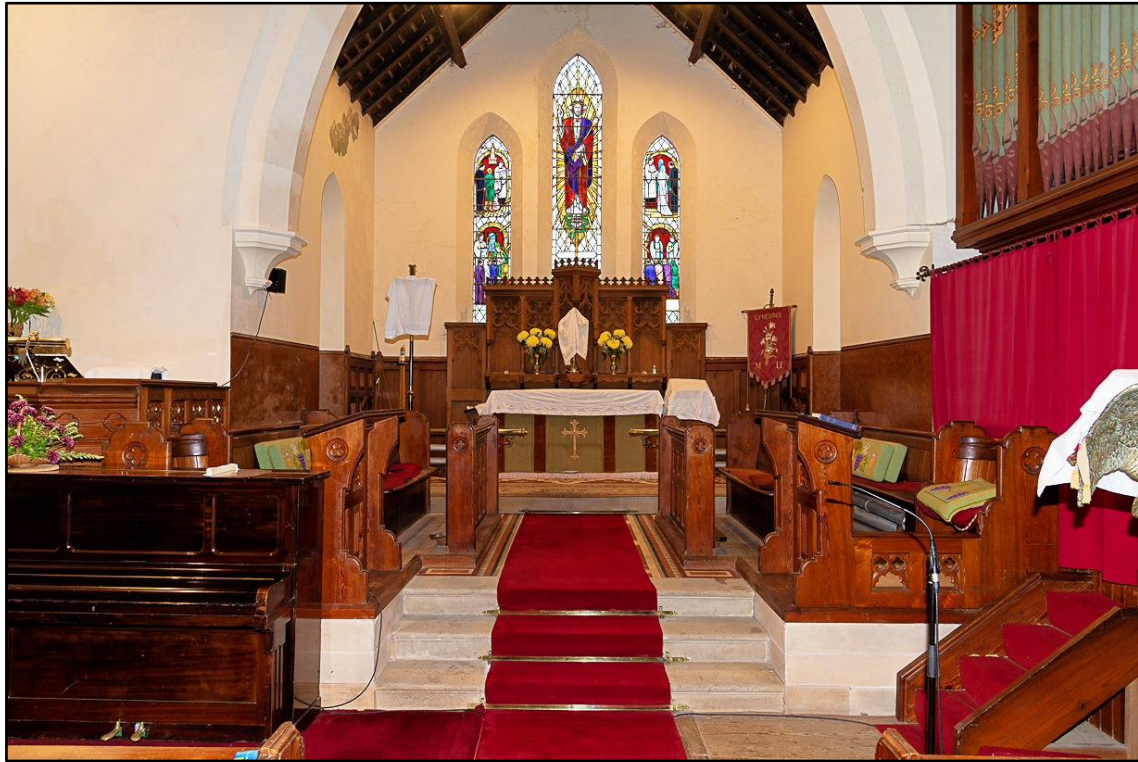
*Chancel looking east*

Note: A fine crack running up from the apex of the arched window. It does not seem to appear on the external face of the wall. Water ingress does not appear to be an issue.

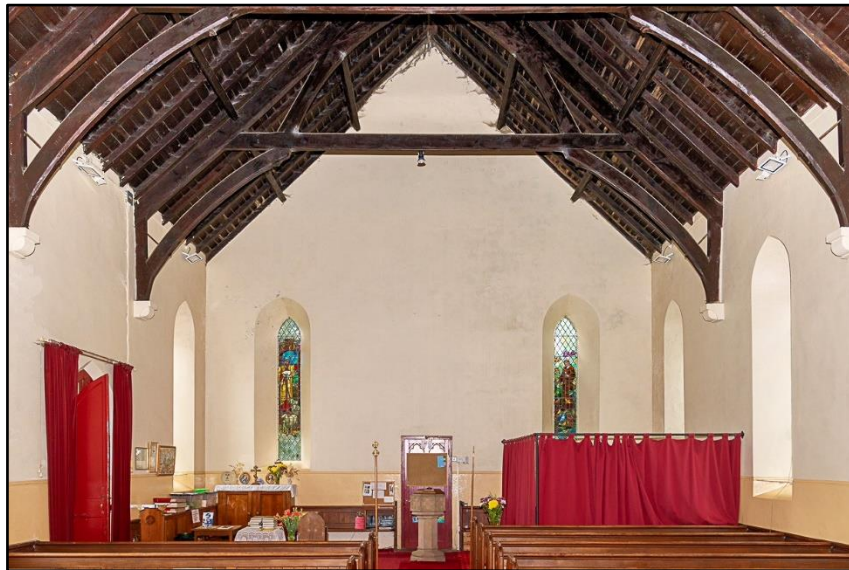
*Nave looking west*

Fissures in the pointing are apparent above the hood moulding of W2 and in the masonry above.

These have resulted in damage to decoration at southwest corner.  
Before redecoration, the external wall should be repointed in lime mortar.

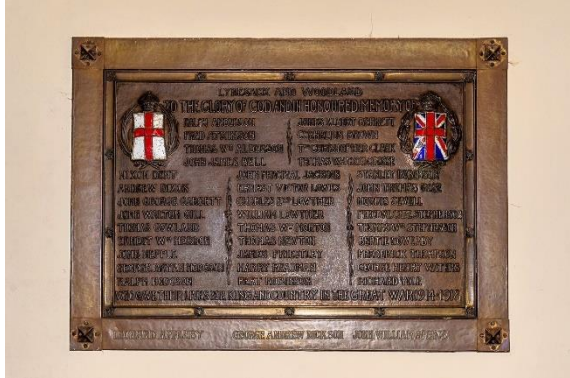
4.12	Monuments, tombs, plaques etc	<p><b>World War One Plaque</b> On the north wall of the nave. Hammered bronze.</p>

<p>For full details see this link to Northeast War Memorials Project. <a href="http://www.newmp.org.uk/detail.php?contentId=7902">http://www.newmp.org.uk/detail.php?contentId=7902</a> In very acceptable condition.</p>

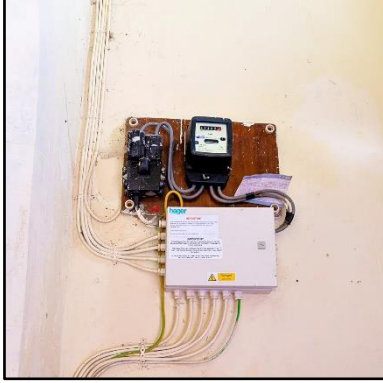
5.03	Gas installation	None.
5.04	Electrical installation	<p>An overhead supply hangs on a bracket which is fixed onto the southeast corner of the nave. It runs externally below the eave of the south elevation and enters the porch.</p>

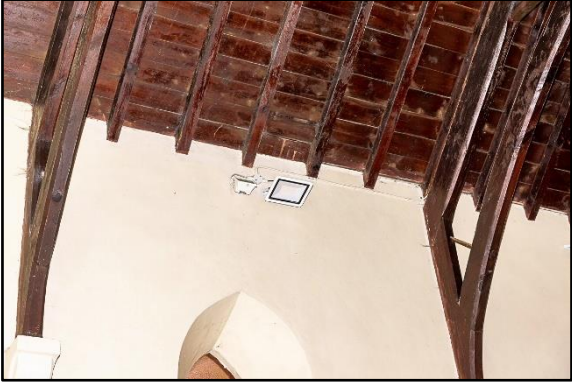
<p>The meters and distribution boards are located on the wall in the porch. The lighting is a mix of halogen up-lighting and LED down-lighting.</p>

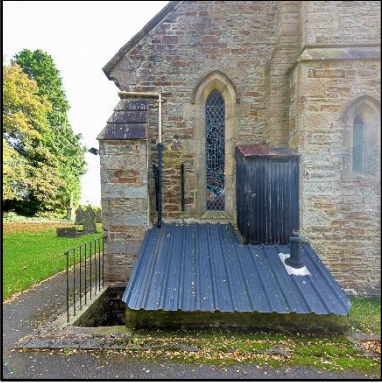
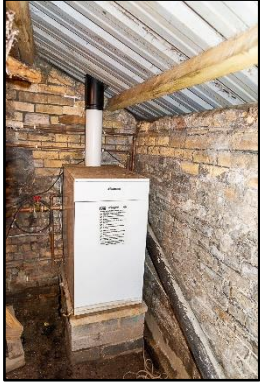
5.06	Oil installation	<p>An oil tank is in a shed to the north of the church. The previous report states that the tank is banded. The condition of the tank should be checked regularly by a specialist.</p> <p><b>Boiler</b></p> <p>The basement boiler room houses a modern oil boiler with a balanced flue.</p> <div style="display: flex; justify-content: space-around;">

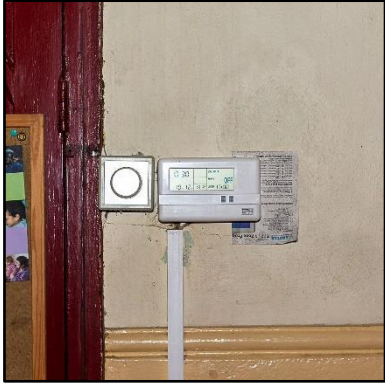
</div> <p>A modern 7-day timer and thermostat are fitted to the west gable.</p> <p><b>Heat Emitters</b></p> <p>The church is provided with low pressure hot water, large bore heating pipes and cast-iron radiators which appear to be original fittings in acceptable condition. Check regularly for leaks.</p>

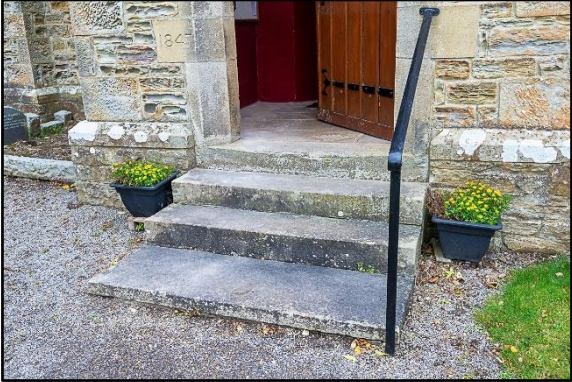
6.06	Hardstanding areas	<p><b>Footpaths</b></p> <p>The main path is finished in loose gravel macadam, soft edged to the grass, and well maintained. The rear paths are concrete. There is no path to the WC shed.</p> <p><b>Stone steps to the south porch</b></p> <p>These are in acceptable physical condition but would ideally be replaced with even steps, of a gentler grade, which would conform to current legislation for steps for the use of the ambulant disabled. This work could be combined with installing a ramp. See 6.09</p>
