# HOLY TRINITY CHURCH, MURTON

10-11 CHURCH LANE, MURTON, SEAHAM, CO. DURHAM, SR7 9RD

**SAMANTHA DIXON**

JDDK Architects Ltd

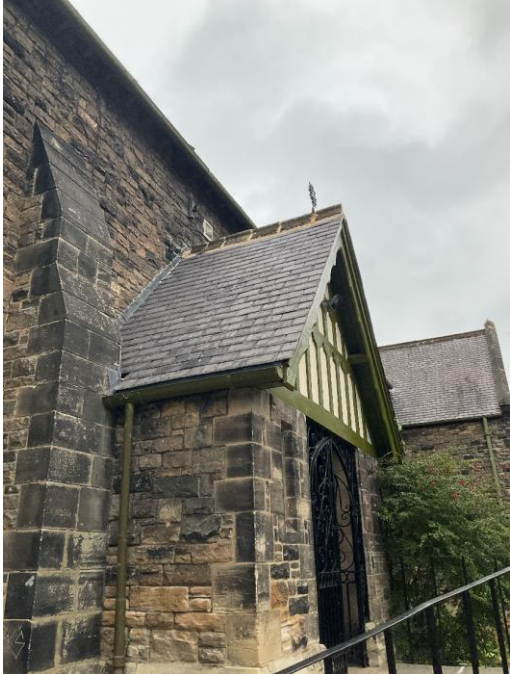
| | <b>Condition</b> <ul style="list-style-type: none"><li>• Ridge tiles look well bedded, possible recent work. Small section of ridge tile appears to missing at junction with nave wall.</li><li>• Flashing appears sound.</li><li>• Possible slate missing at base of west slope next to buttress on both sides.</li></ul> | |

| | <b>Repair Needs</b><br><br>Replace missing ridge tile.<br><br>Replace missing slate adjacent to buttress on both sides of porch roof or provide soaker flashing to cover hole. | B<br><br>B |

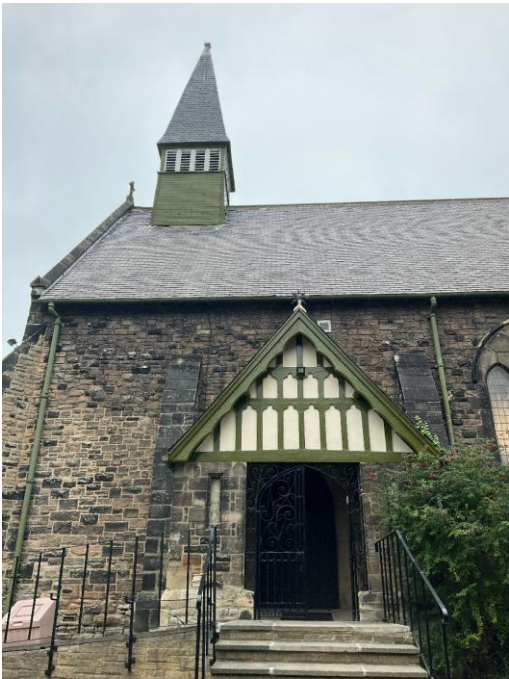
| | <p><b>Condition</b></p> <ul style="list-style-type: none"> <li>• South slope generally fine, a few chipped slates. One slate at high level looks to have slipped.</li> <li>• Section of flashing to base of spire is missing on southern slope.</li> <li>• North slope has a few missing slates and 1 appears to have slipped near spire.</li> <li>• Chimney appears sound.</li> <li>• A few missing slates to corner of spire roof on east slope.</li> </ul> | |

| | <p><b>Repair Needs</b></p> <p>Flashing to be repaired at base of spire.</p> <p>Replace missing slates to spire roof.</p> <p>Replace missing slates and refix slipped slates to main Nave roof.</p> | <p>B</p> <p>B</p> <p>B</p> |

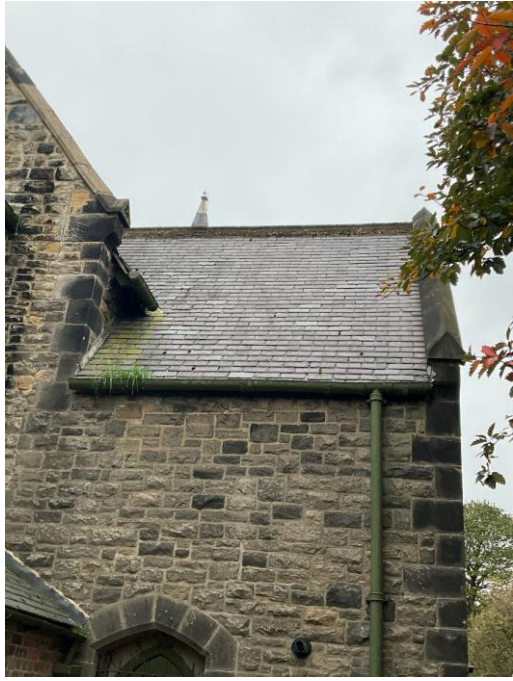
| | <b>Condition</b> <ul style="list-style-type: none"> <li>• Some moss growth on slates.</li> <li>• Ridge tiles appear well bedded.</li> <li>• Slates appear sound. With a few chipped corners.</li> </ul> | |

| | <b>Repair Needs</b> <ul style="list-style-type: none"> <li>• Monitor moss growth and remove with a wire brush if it starts to get excessive.</li> </ul> | M |

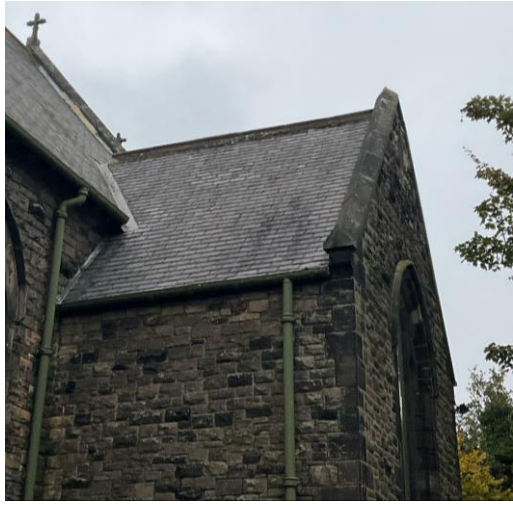
| | <b>Condition</b> <ul style="list-style-type: none"> <li>• Roof covering is generally sound.</li> <li>• Flashing is sound.</li> <li>• Ridge tiles are well bedded.</li> </ul> | |

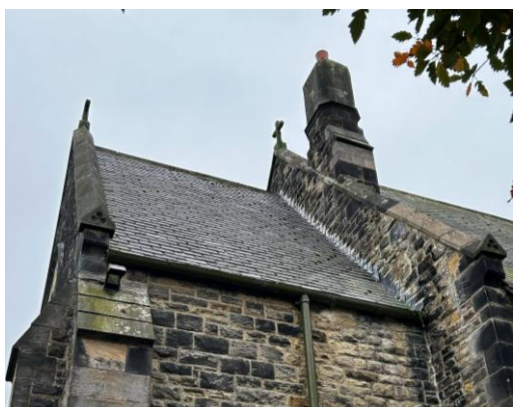
| | <p><b>Condition</b></p> <ul style="list-style-type: none"> <li>• Some moss growth on slates.</li> <li>• Slates appear sound and ridge tiles well bedded</li> <li>• Small area of bedding missing to ridge tile on south side.</li> </ul> | |

| | <p><b>Repair Needs</b></p> <ul style="list-style-type: none"> <li>• Monitor moss growth and remove with a wire brush if it starts to get excessive.</li> <li>• Repoint ridge tile.</li> </ul> | <p>M</p> <p>B</p> |

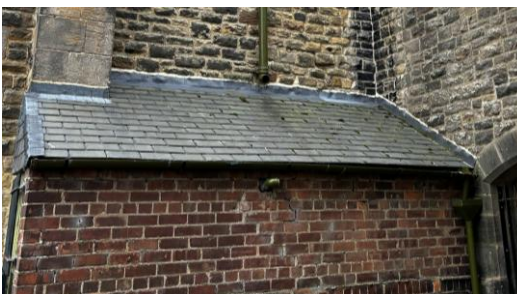
| | <b>Condition</b> <ul style="list-style-type: none"> <li>• Moss growth on slates.</li> <li>• Some stick non lead on flashing appears well adhered and pointed.</li> </ul> | |

| | <b>Repair Needs</b> <ul style="list-style-type: none"> <li>• Monitor moss growth and remove with a wire brush if it starts to get excessive.</li> </ul> | M |

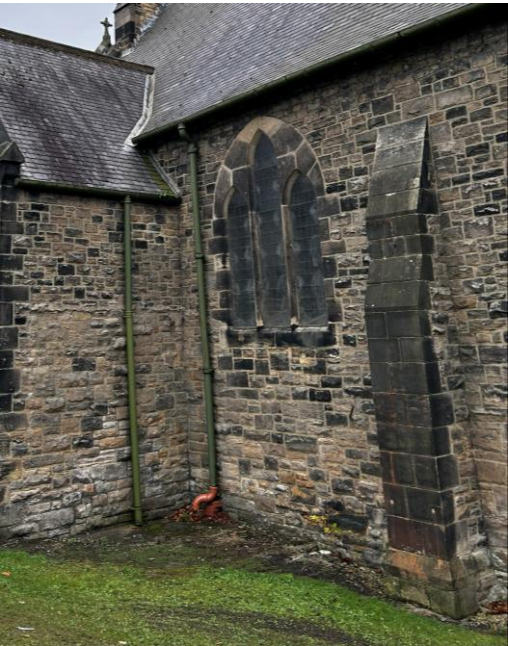
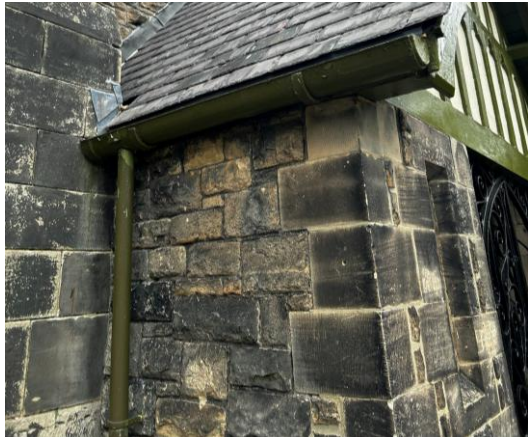
| | <p><b>Condition</b></p> <ul style="list-style-type: none"> <li>• Gutters and downpipes are generally in good condition.</li> <li>• Paint peeling to downpipe to west of porch and at top around gutter.</li> <li>• Gutters to boiler house, north transept and chancel north have vegetation growth.</li> </ul> | |

| | <p><b>Repair Needs</b></p> <ul style="list-style-type: none"> <li>• Clean and remove vegetation from gutters at earliest opportunity.</li> <li>• Redecorate rainwater goods where paint is peeling.</li> </ul> | <p>M<br/>D</p> |

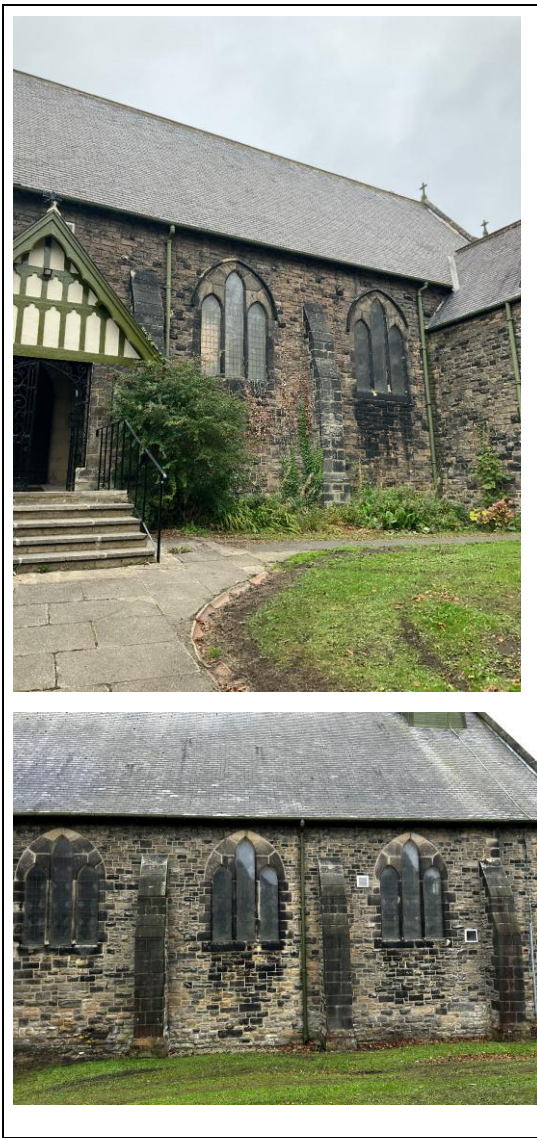
| | <p><b>Condition</b></p> <p><b>South Elevation</b></p> <ul style="list-style-type: none"> <li>• Stone and pointing are generally sound.</li> <li>• Some erosion at base to west of porch next to buttress.</li> <li>• Some areas of pointing missing around buttress ashlars.</li> <li>• Dark staining below windows to east of porch and to buttress ashlars.</li> <li>• Section immediately east of porch has ivy growing up wall.</li> </ul> <p><b>North Elevation</b></p> <ul style="list-style-type: none"> <li>• Stone and pointing are generally sound.</li> <li>• Some staining to window surrounds, buttress ashlars and below windows, particularly below the central window.</li> </ul> <p><b>West Gable</b></p> <ul style="list-style-type: none"> <li>• Stone &amp; pointing are generally sound.</li> <li>• Some staining below windows, to surrounds and buttress ashlars.</li> <li>• Water table appears sound and well bedded.</li> </ul> | |

| | <p><b>Repair Needs</b></p> <ul style="list-style-type: none"> <li>• PCC should consider removing the ivy growth from the stone walls to avoid future structural or moisture issues within the wall.</li> <li>• Re-point areas of missing pointing to the buttresses, using a suitable lime mortar.</li> </ul> | <p>M</p> <p>D</p> |

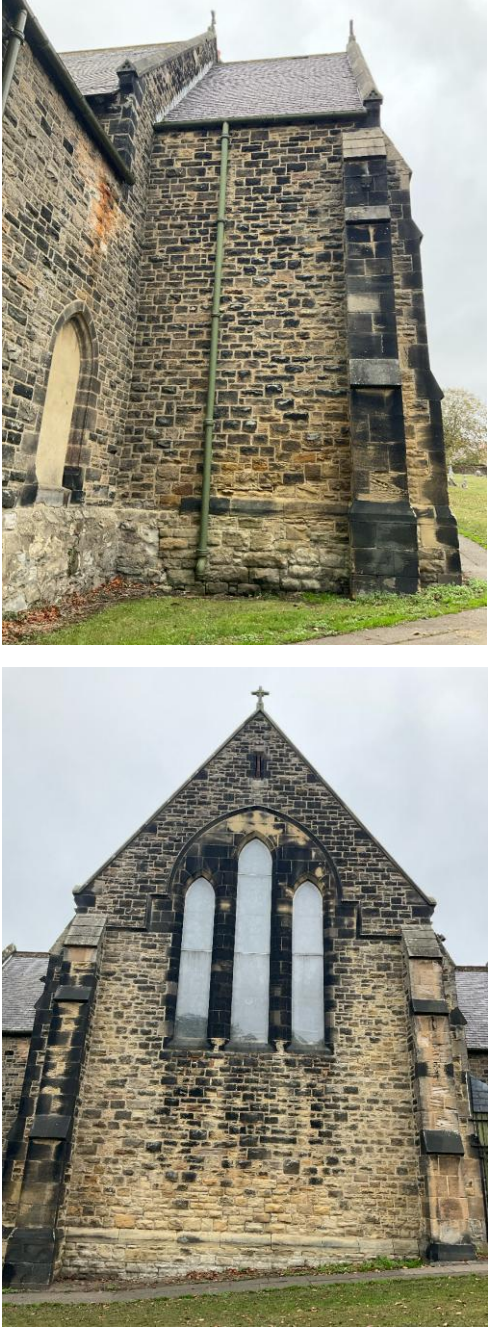
| | <p><b>Condition</b></p> <p><b>South elevation</b></p> <ul style="list-style-type: none"> <li>• Some erosion to stones to south wall around plinth stones.</li> <li>• Pointing appears sound.</li> <li>• Dark staining to buttress ashlar</li> <li>• Some damp around low level stone adjacent to downpipe.</li> </ul> <p><b>East Gable</b></p> <ul style="list-style-type: none"> <li>• Some dark staining to buttress ashlars and window surround and stones below window.</li> <li>• Stone &amp; pointing generally sound.</li> <li>• Water table and cross finial appear sound.</li> </ul> <p><b>North Elevation.</b></p> <ul style="list-style-type: none"> <li>• Dark staining in corner abutment with nave wall. This is likely to be linked to blocked gutters and water run-off over time.</li> <li>• Stone and pointing appear sound.</li> </ul> | |

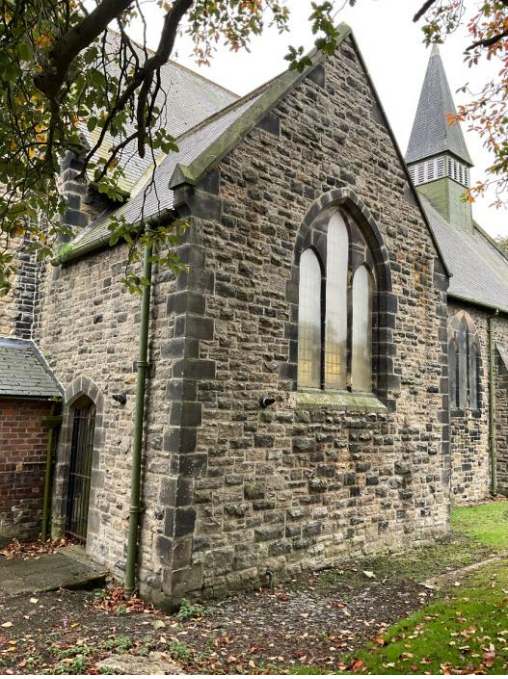
| | <p><b>Condition</b></p> <p><b>East Elevation</b></p> <ul style="list-style-type: none"> <li>• Some damp / efflorescence around vestry door surround.</li> <li>• Stone and pointing generally sound.</li> </ul> <p><b>North Gable</b></p> <ul style="list-style-type: none"> <li>• Joint in window cill stones have parted and missing pointing.</li> <li>• Dark staining to window surround and below window.</li> <li>• Stone generally sound and well pointed.</li> <li>• Gable water table well bedded and appears sound.</li> </ul> <p><b>West Elevation</b></p> <ul style="list-style-type: none"> <li>• Stone and pointing generally sound</li> <li>• Dark staining to quoins in corner.</li> </ul> | |

| | <p><b>Repair Needs</b></p> <p>Repoint open joint in window cill, with a suitable lime mortar.</p> | D |

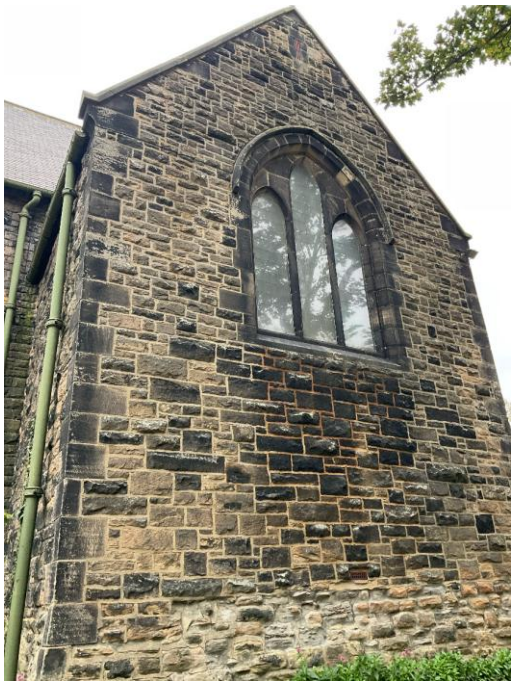
| | <p><b>Condition</b></p> <ul style="list-style-type: none"><li>• Stone and pointing generally sound.</li><li>• Dark staining below south gable window</li><li>• Rust staining to east facade at high level.</li></ul> | |

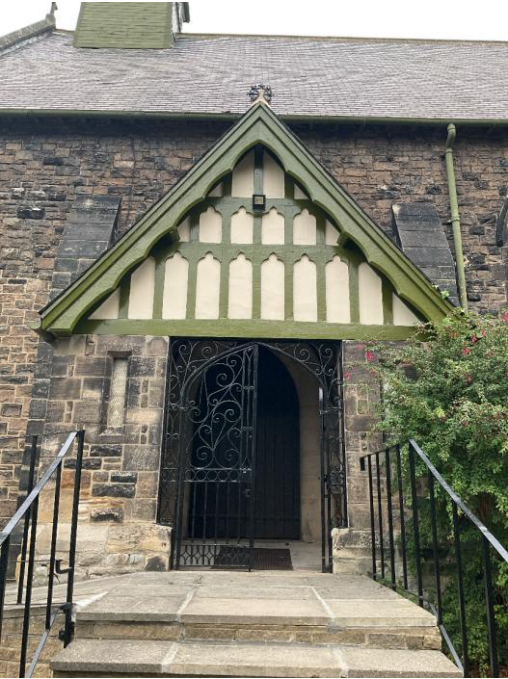
| | <b>Condition</b> <p>Some small areas of pointing missing at low level.</p> <p>Stone generally fine.</p> <p>One area of erosion to low level stone to west of entrance gates.</p> | |

| | <b>Repair Needs</b> <p>Repoint areas of missing pointing with suitable lime mortar.</p> | D |

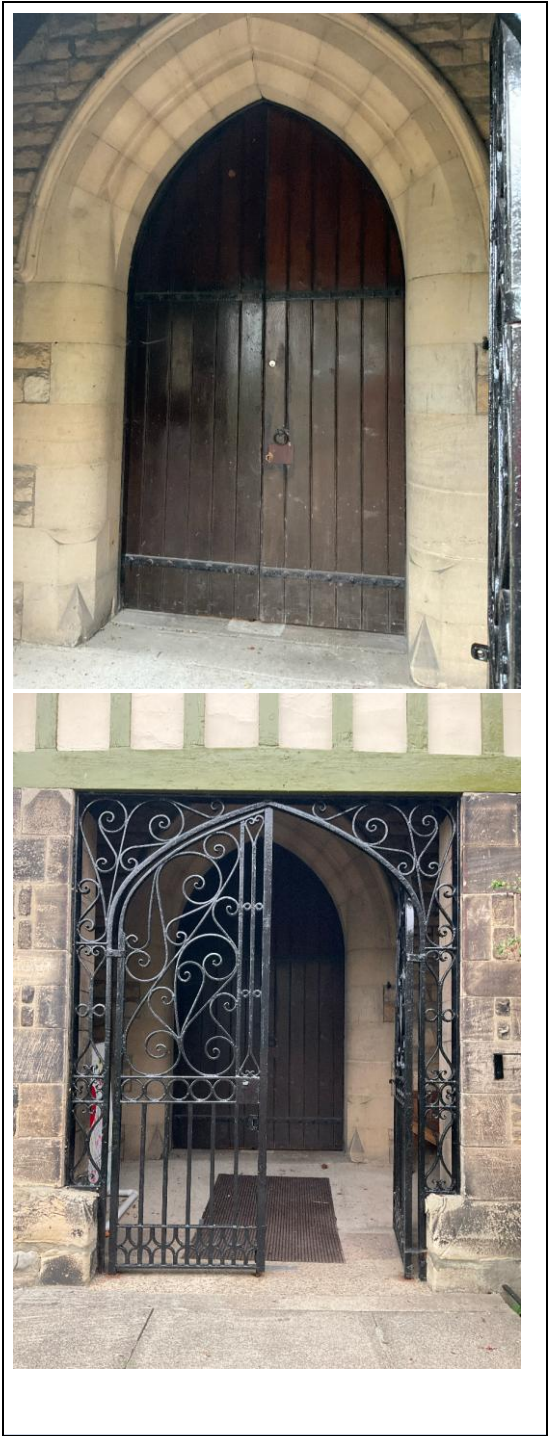
| | <p><b>Condition</b></p> <ul style="list-style-type: none"><li>• Porch door and gates sound.</li><li>• Vestry door is showing some signs of decay at base. This is likely due to the high moisture content in this area.</li><li>• Paint finish to Boiler house door is eroding and peeling on door and cill timber.</li></ul> | |

| | <p><b>Repair Needs</b></p> <ul style="list-style-type: none"><li>• Repaint boiler house door and timber cill.</li></ul> | D |

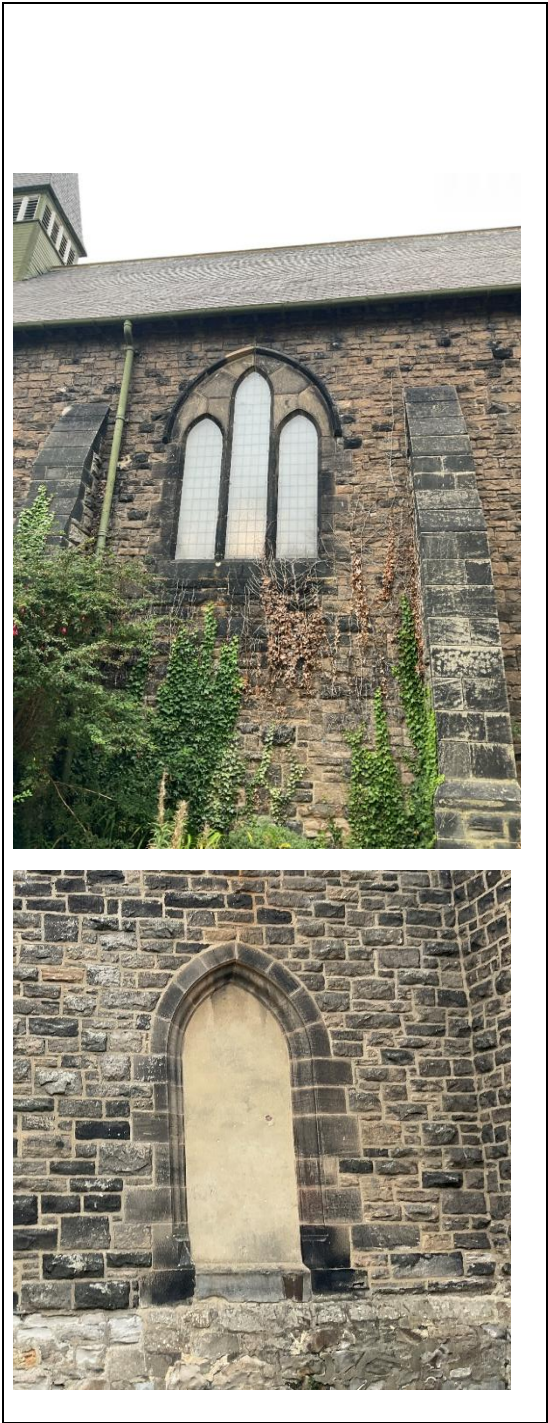
| | <p><b>Condition</b></p> <ul style="list-style-type: none"> <li>• Areas of damage to stone surround on 2 windows east of porch.</li> <li>• Polycarbonate &amp; glazing appears sound.</li> </ul> | |

| | <p><b>Repair Needs</b></p> <p>Monitor damaged stone for further decay.</p> | M |

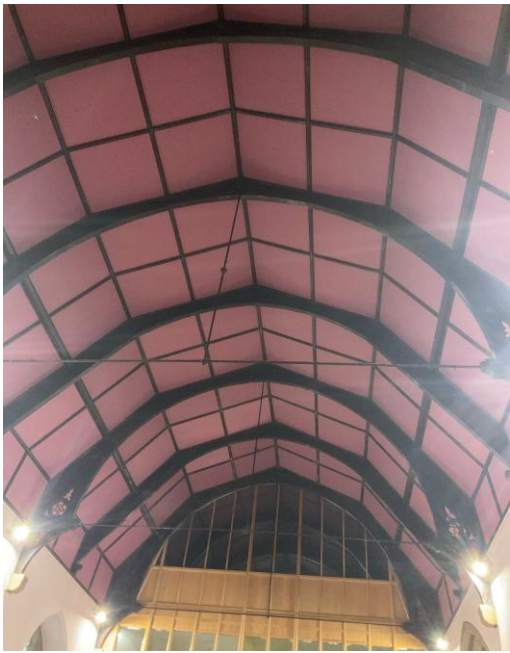
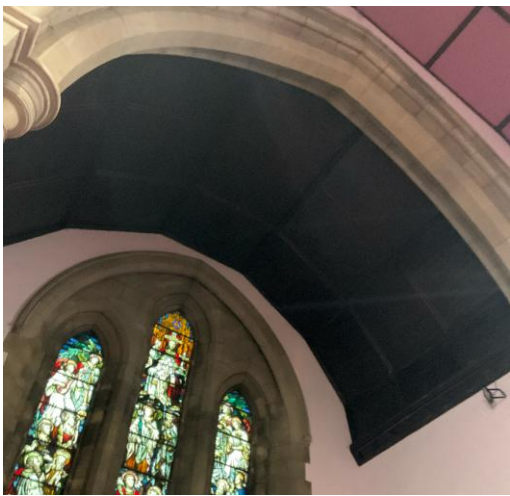
| | <p><b>Condition</b></p> <p>Coffee room, kitchen, WC and porch and lobby areas – ceiling in good condition.</p> <p>Vestry - generally sound with one panel on western side with bubbling paint.</p> | |

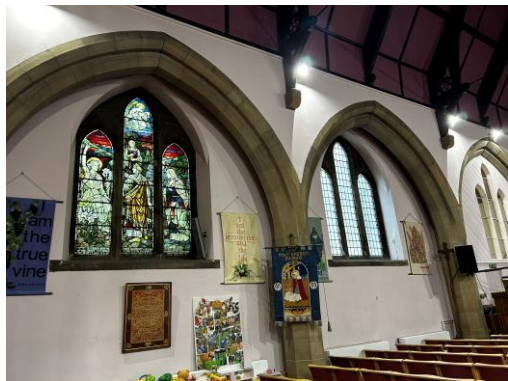
*Northern Wall in Nave*

- Plaster is generally in good condition.
- There is a crack below the western most window on the south wall.
- Paint finish is cracking above radiators along southern side.
- Some hair line cracks in northern wall paint.
- Efflorescence and dampness present at base of arches along northern wall, particularly towards the eastern end. Could be linked to drainage externally.

| | <p><b>Repair Needs</b></p> <p>Monitor dampness and efflorescence around the vestry door and northeast corner of the Nave.</p> | M |

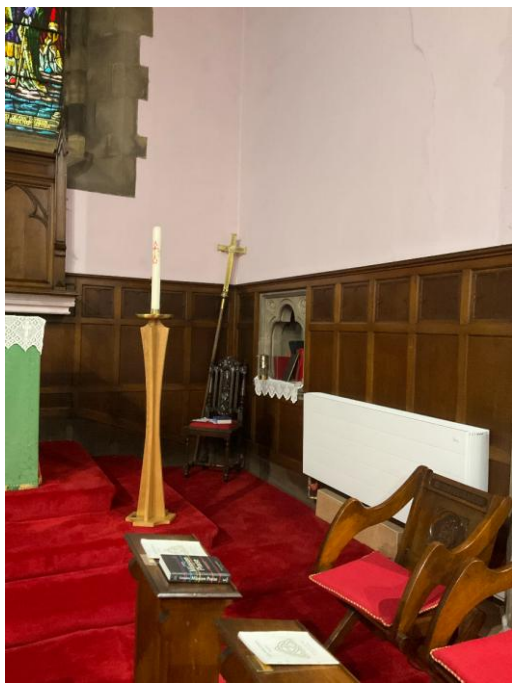
| | <p><b>Condition</b></p> <ul style="list-style-type: none"> <li>• Panelling in chancel is sound.</li> <li>• Glazed softwood screen is sound. Some cobwebs.</li> <li>• Dark oak screen is sound.</li> <li>• Vestry boarded infill- generally sound some marks, chipping to paint at low level.</li> </ul> | |

| | <p><b>Repair Needs</b></p> <p>Repaint vestry panelling.</p> | E |

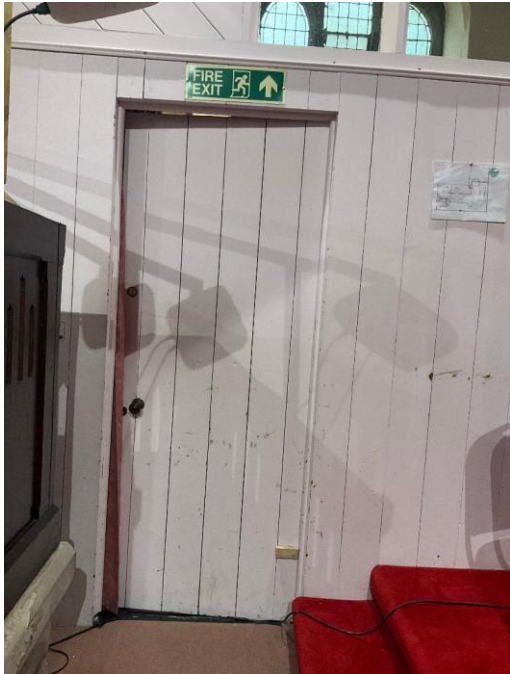
| | <b>Condition</b> <ul style="list-style-type: none"><li>• Vestry inner door generally sound with chipped paint.</li><li>• Self-closing fire door to office on first floor doesn't fully click shut.</li><li>• Self-closing fire door on ground floor into the stair doesn't fully click shut.</li><li>• Double Doors in lobby &amp; nave don't fully click shut.</li></ul> | |

| | <b>Repair Needs</b> <p>Self-closing fire doors that are not fully closing to be assessed in the first instance by a joiner to review if any adjustments to door closers or latches. If not consult with a specialist.</p> | A |

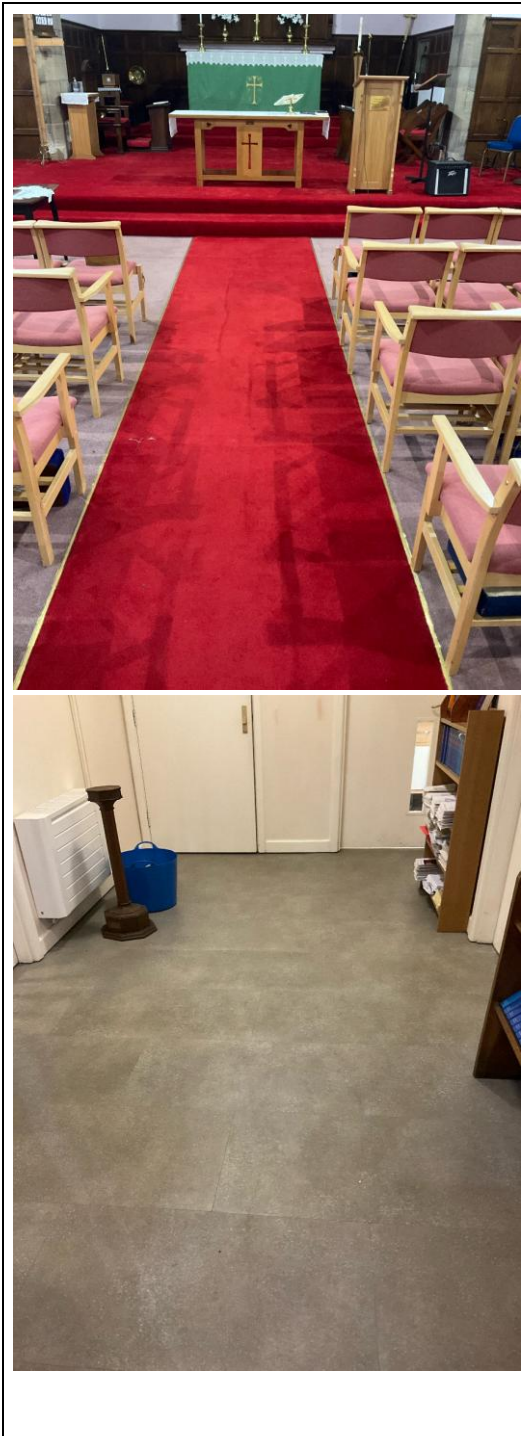
| | <b>Condition</b> <ul style="list-style-type: none"> <li>• Carpets generally sound, some staining to lighter carpet areas under the seating.</li> <li>• LVT has been fairly recently laid and in good condition.</li> <li>• Stair carpet in good condition.</li> <li>• Stair balustrades &amp; handrail all sound.</li> <li>• Upstairs carpets all fine.</li> </ul> | |

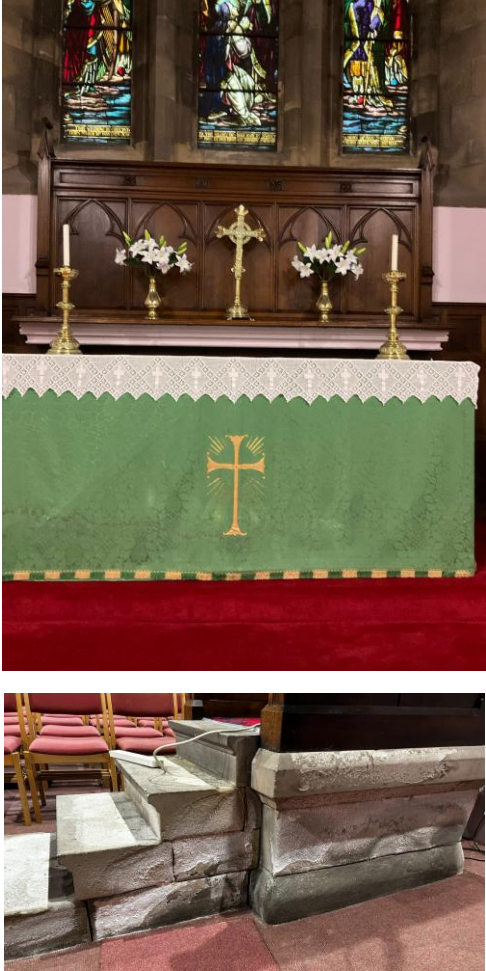
| | <b>Description</b> <ul style="list-style-type: none"> <li>• Reredos with modest carved tracery and florets over a shelf behind a ply altar.</li> <li>• Simple light oak altar and credence table</li> <li>• Dark oak Bishop's chair 1938,</li> <li>• Prie-dieu</li> <li>• Two Pugin chairs</li> <li>• Carved 17<sup>th</sup> century chair</li> <li>• Timber pulpit on stone base in nave</li> <li>• Decorative carved timber eagle lectern.</li> <li>• Stone font with oak lid located in the lobby.</li> </ul> <b>Condition</b> <ul style="list-style-type: none"> <li>• Alter and reredos generally sound. Some water staining to alter cover fabric.</li> <li>• Stone base to pulpit showing efflorescence and dampness.</li> <li>• Chairs and prie-dieu appear sound.</li> </ul> <b>Repair Needs</b><br>Monitor efflorescence and dampness to base of pulpit. | M |

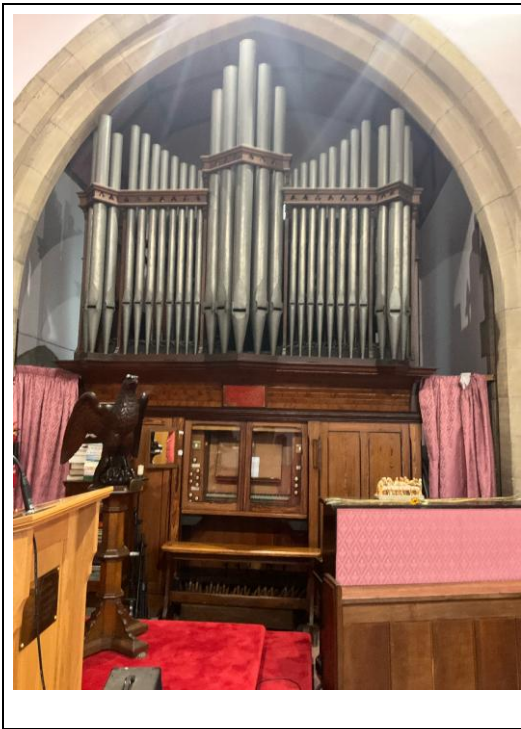
| | <p><b>Description</b></p> <p>Two manual pipe organ with oak case, glass doors by Vincent 1884</p> <p><b>Condition</b></p> <p>Good. Logbook shows organ was last tuned in 2022.</p> <p><b>Repair Needs</b></p> <p>Arrange organ service / tuning.</p> | <p>M</p> |

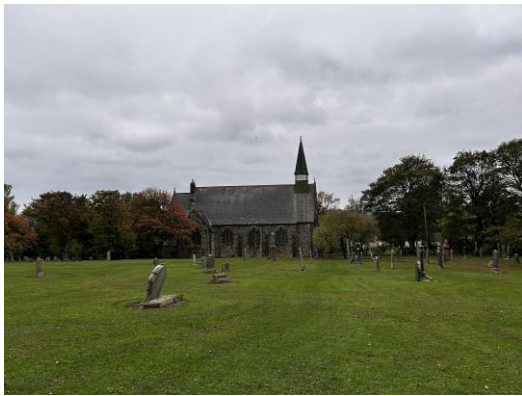
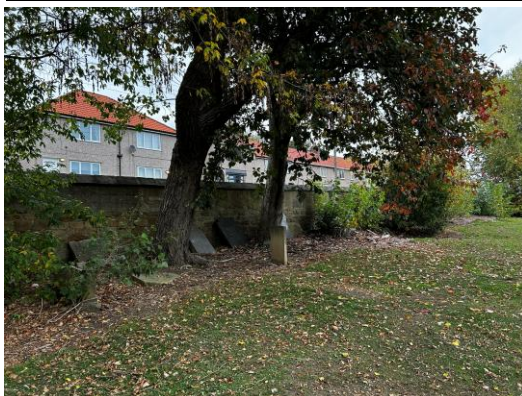
| | <p><b>Condition</b></p> <ul style="list-style-type: none"> <li>• Path adjacent to north transept has a line of slabs that have settled creating a lip between the adjacent slabs, which could become a potential trip hazard.</li> <li>• West boundary wall and fence appears sound.</li> <li>• North boundary has areas of missing render and brickwork is exposed. Otherwise appears well pointed and relatively stable.</li> <li>• East boundary wall and fence appears in reasonable condition.</li> <li>• South fence is sound.</li> <li>• Stone wall fronting road requires some repointing on the roadside.</li> </ul> | |

| | <p><b>Repair Needs</b></p> <ul style="list-style-type: none"> <li>• Depending on maintenance responsibility - Repoint stone wall on road side.</li> </ul> | D |
