St JOHN'S CHURCH NEVILLES CROSS
(305)

QUINQUENNIAL REPORT
on the architect's inspection on

21 April 2022

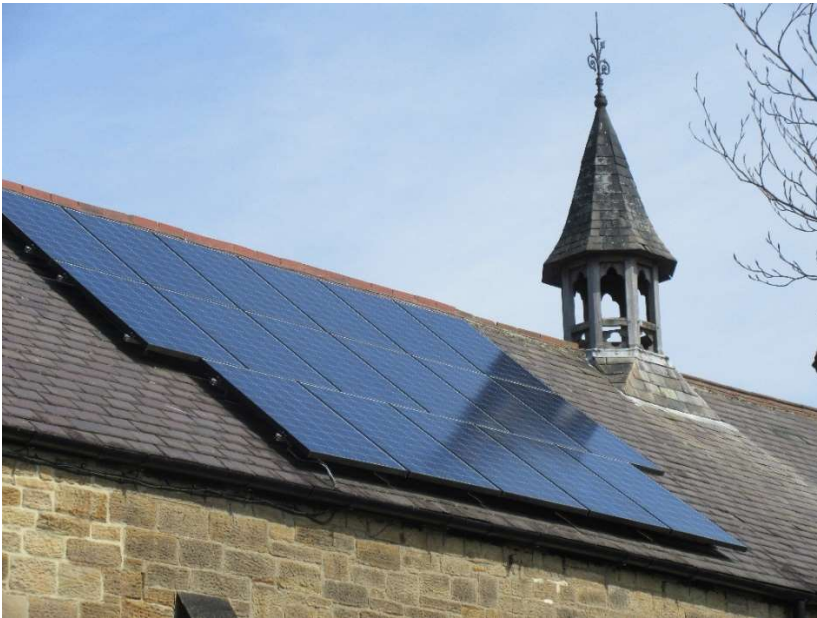
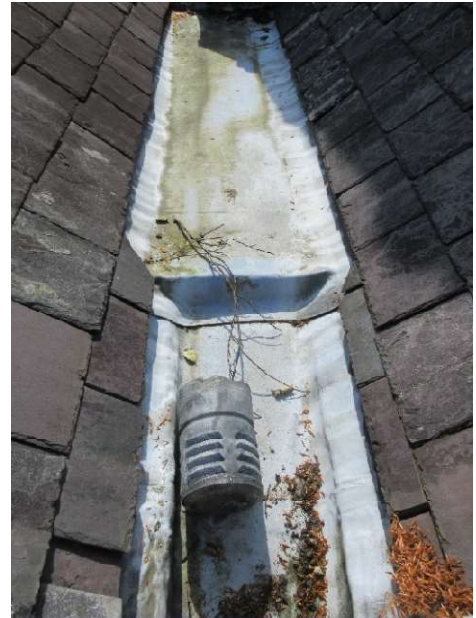
13. A timber framed octagonal ridge vent turret has mitred corner slates. One slate at its S eave missing. Lead cover over the base and surrounding slates appears sound.

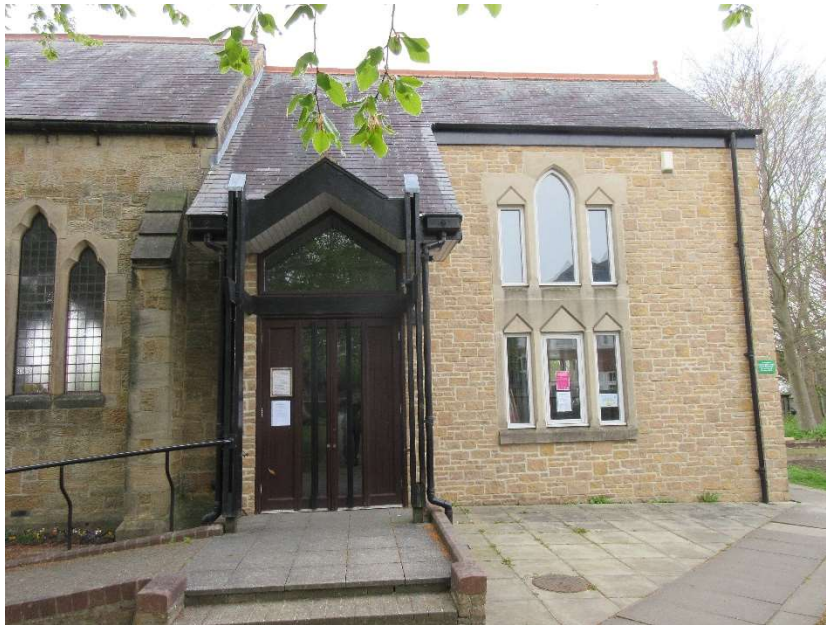
41. A large amount of stained softwood at the Extension – N porch, structural posts, shiplap boarding, doors and N and W window frames. Two windows (N first floor and W ground floor) show rot in their bottom beads, needing either careful joinery replacement (stained hardwood) and staining or general replacement of the whole remaining timber windows in upvc. Otherwise the stain is fair and will need restaining to the original recommended cycle or at least every 7 years (bottom beads and cills more frequent) in the existing colours.

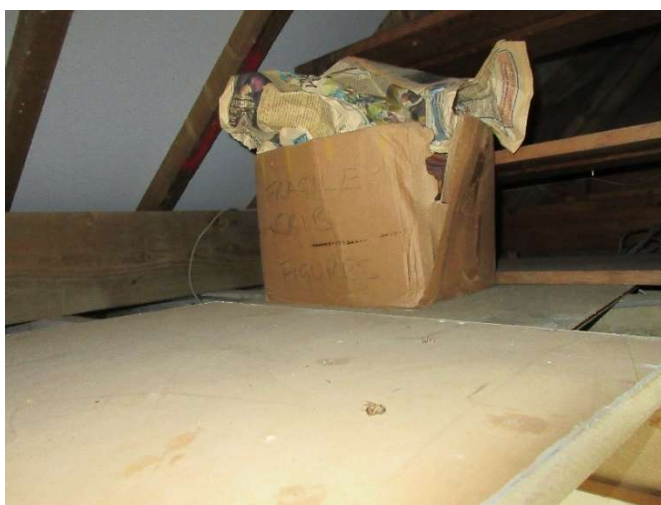
43. At Chancel two curved brace trusses and single massive purlins for the long spans. Exposed rafters and horizontal sarking. All timber dark varnished softwood with no visible defect.
44. At Nave four scissor trusses propped on corbels, three purlins and thick vertical sarking now lined underneath with insulated plasterboard.
45. In Vestry painted sarking boards and rafters on two purlins on a monopitch truss between the Vestry and Organ chamber. Truss infilling forms part of the room partition.
46. Organ and Baptistery have sarking and rafters on N-S purlins spanning to the gables. Rafters now concealed in Baptistery. No visible defect.
47. In Extension a glulam beam supports six scissor trusses, purlins and rafters, all exposed in the upper Meeting Room. Other parts of the roofs concealed except small void over Office boarded, without apparent insulation.

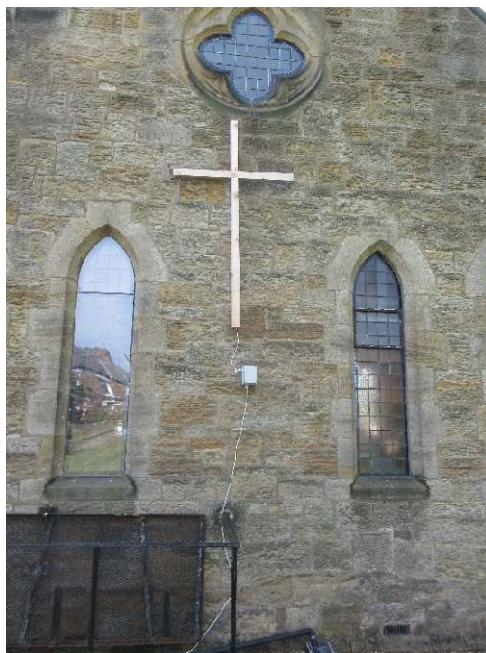
94. In the cellar cables hang where the ceiling is missing, one with a taped connection which is poor practice if cables live. Fixed wiring is intact MICC but a metal surface switch rusts. A working wall light from a plastic socket. A backlit wooden cross has been added outside the N gable. Oddly off centre.

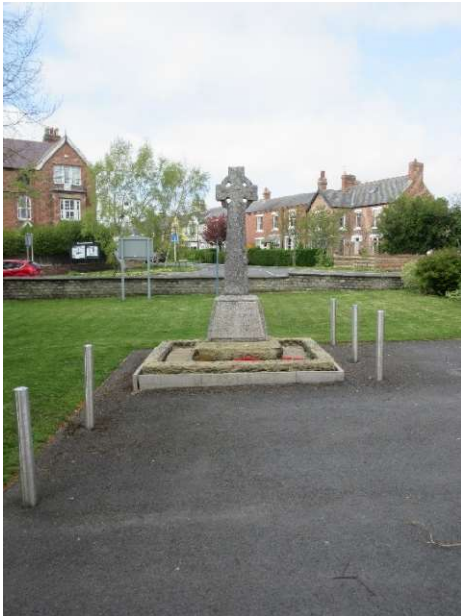
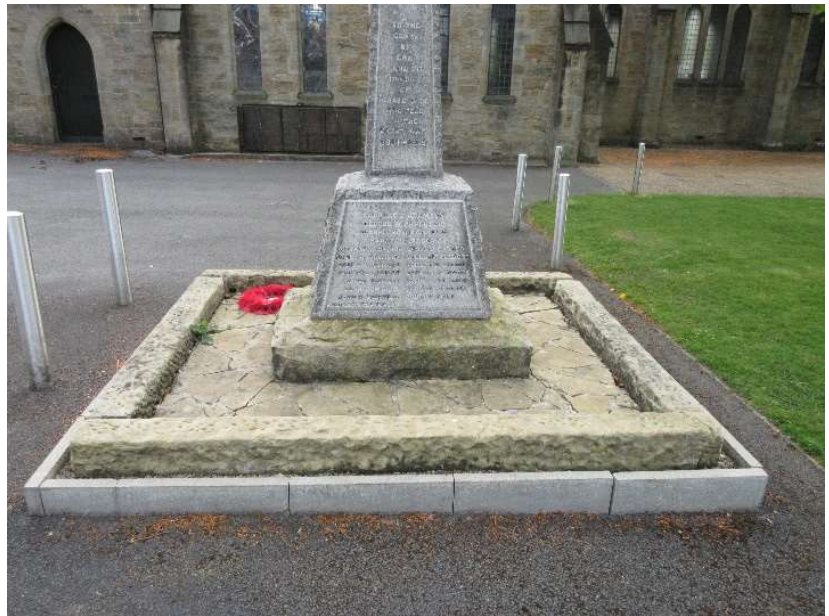
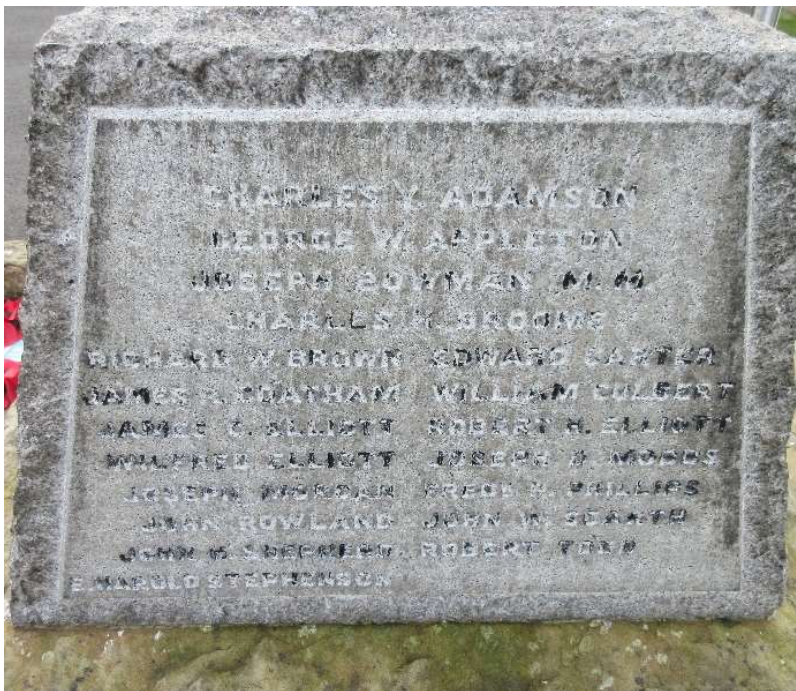
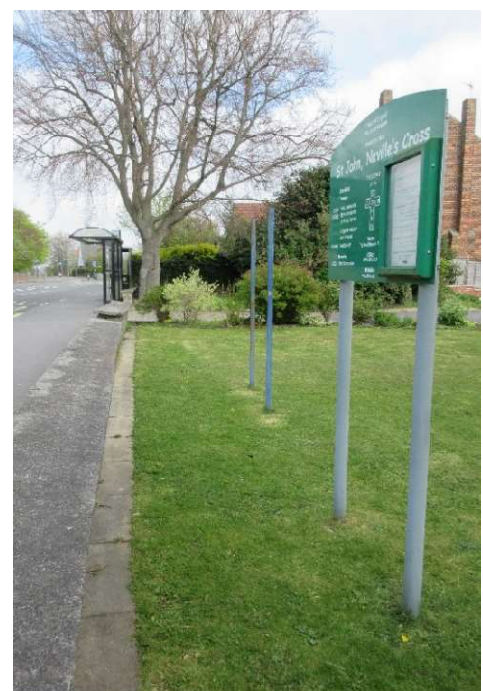
108. A granite cross war memorial with flag surround, two kerbs in different materials which tend to spread, and very different plain stainless steel bollards. The names are cut into the granite and painted. Although the lettering in very durable granite remains intact most paint is lost, making it almost illegible. A small trial of careful do-it-yourself repainting with enamel paint may be worthwhile.
