**QUINQUENNIAL INSPECTION REPORT  
OF  
NEW BRANCEPETH, ST. CATHERINE**

**DIOCESE OF DURHAM  
ARCHDEACONRY OF AUCKLAND  
DEANERY OF DURHAM**

**QUINQUENNIAL INSPECTION AND REPORT  
OCTOBER 2020**

**David Beaumont BA (Hons) Grad Dip, RIBA, AABC**

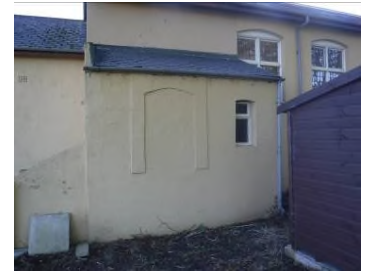
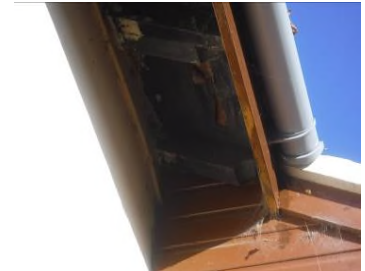
The fascias have been redecorated recently though the undersides of them, where the exposed rafter feet are coming through the wall head aren't, and the paint is flaking away from that, it would be wise to get onto those and also to establish if there is any rot in them. The S side of the cantilevered entrance canopy's decoration is breaking down.

**Recommendation:** monitor the boiler room roof, consider decorating soffits

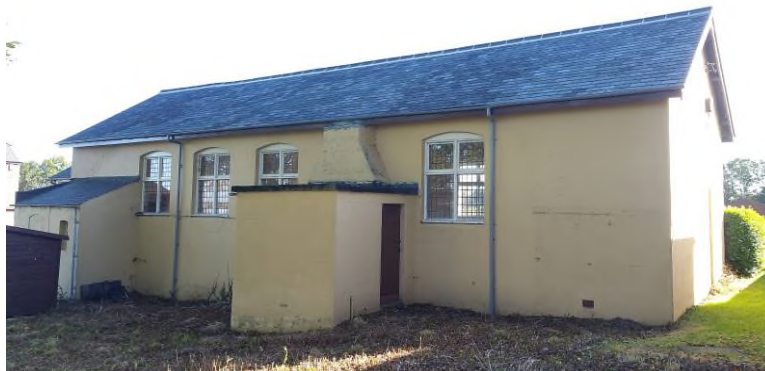
The walls are all rendered onto brickwork and they have in the past lost part of their render at low level, this has been patched over since the last inspection and as a consequence all on the entrance side looks ok.

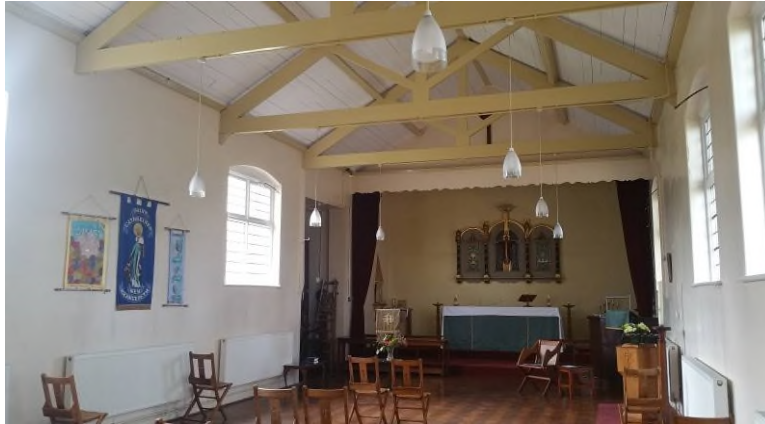
- B** Five trusses form the main nave space, supporting purlins onto ceiling boarding. Every second truss has a projecting supporting member going down into the wall head and the truss condition looks fine. There is some slight possible deflection to the penultimate s beam as the gap has opened up on the truss post-but looks historic. Is there rot at the purlins at the n end? Or is this decoration marks?

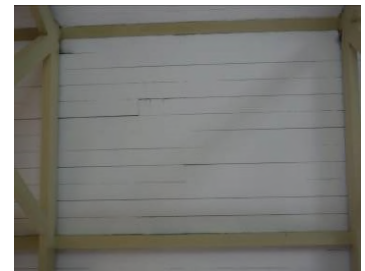
- E** **Sanctuary:**  
Boarded ceiling, be worth understanding what type of boarding it is, possibly fibre board which looks fair.  
All the other ceilings within the church are plaster and look in good condition.  
**Recommendation:** establish type of ceiling board material.

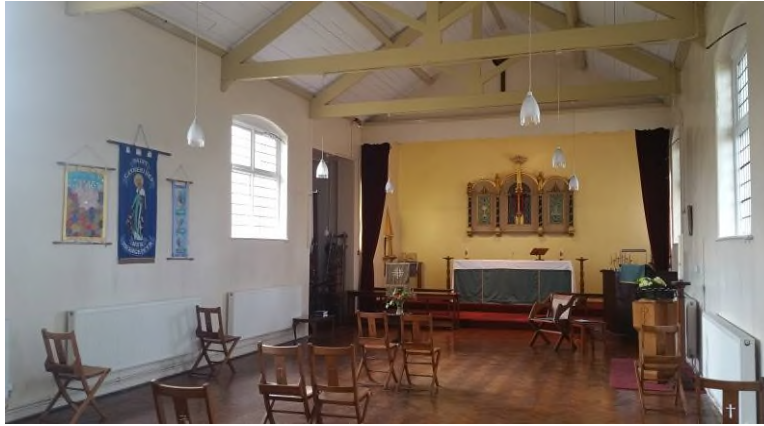
**Chancel Arch:** There is no separate chancel structure- it is within the end of the nave. There is fret cut board on the last truss to form a division between the nave and the chancel, which also has curtains to it, that looks ok.

**Recommendation:** none

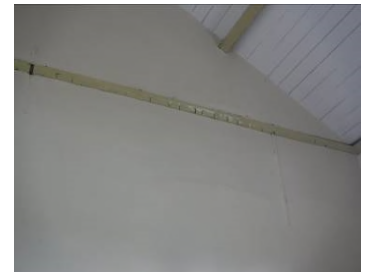
The walls throughout the building are plastered and decorated and have been decorated quite recently after a further round of plaster repairs particularly at the organ chamber.

**Nave** – The N end of the nave was quite a poor arrangement and that has now been attended to and recovered very well, however there is a little bit of timber that is showing rot at the eaves line. The warden advises that it has been treated and is dormant. It could be removed to improve the decoration of the gable. There is no access into the space behind it- over the kitchen and vestry. There looks to be the ghost of a blocked in opening at the apex.

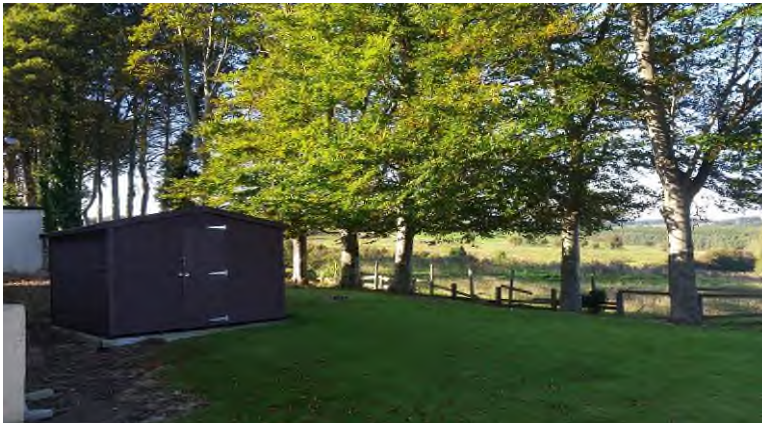
**E side** – This side has field fencing, rather broken down in timber with sheep fencing and barbwire looks a bit scruffy, is this the responsibility of the church? Next to this a line of eight Beech trees planted quite closely together but they do provide a good wind break.
