Christ Church, New Seaham

Diocese of Durham  
Archdeaconry of Sunderland  
Deanery of Easington

Quinquennial Inspection Report  
June 2025

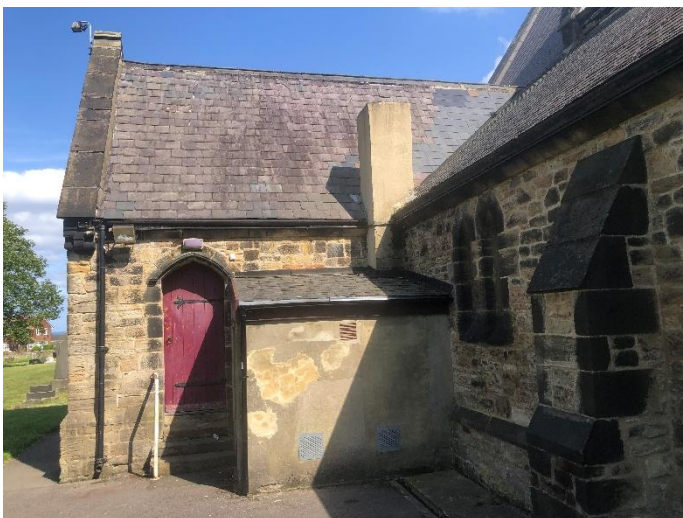
Fig. 8 (IMG\_8870)

| 1.0 | <p><b>WORKS CARRIED OUT SINCE PREVIOUS REPORT</b></p> <ul style="list-style-type: none"> <li>• Clearing gutters/downpipes and gullies</li> <li>• Minor repairs to roof slating, repointing of water tabling to chancel, valley gutter repairs (see Appendix B, Fig. 8)</li> <li>• Repointing of East wall and West wall in progress (Taylor Hastwell)</li> <li>• Glazing repair to church hall windows (Mar 2023)</li> <li>• Fitting of polycarbonate to church hall windows (Mar 2023)</li> <li>• Fire alarm test (April 2023)</li> <li>• Electrical services testing (May 2023)</li> <li>• Organ repair (July 2023)</li> <li>• Boiler service (Aug 2023)</li> <li>• Removal of storm damaged tree (Jan 2024)</li> <li>• Gas boiler repair (Feb 2024)</li> <li>• Repair to Church Roof (Mar 2024)</li> <li>• Locksmith (Apr 2024)</li> <li>• Lay new mains gas pipes (Aug 2024)</li> <li>• Repair to damaged gate posts (Sep 2024)</li> <li>• Fire Alarm testing (Feb 2025)</li> <li>• Gas boiler service and replacement of two taps (Mar 2025)</li> <li>• Slate repairs (Mar 2025)</li> <li>• Re-decoration of church hall, kitchen and prayer room (Feb 2025)</li> <li>• Maintenance and re-decoration of vestry (Mar 2025)</li> <li>• Maintenance and refurbishment of church doors (Jun 2025)</li> <li>• Making safe and removal of tree brought down in gale force winds (Jul 2025)</li> <li>• Removal of old gas cooker and installation of new gas cooker (Jul 2025)</li> </ul> <p>NOTE: Beyond previous QI report, records were not available. Refer to previous QI reports where needed.</p> |

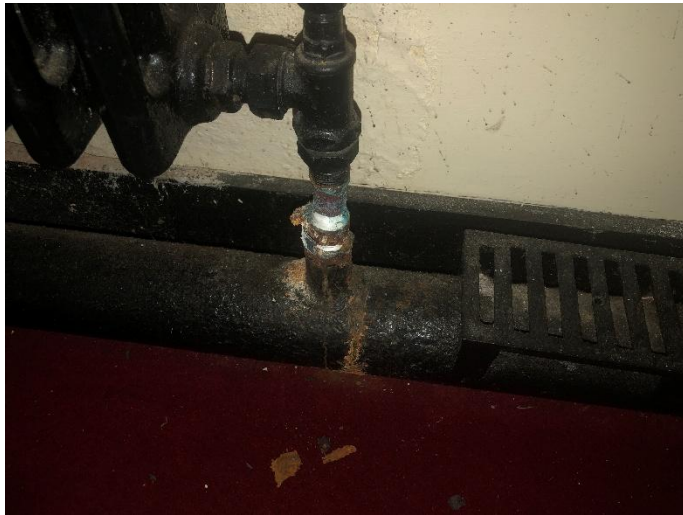
Fig. 9 (IMG\_8853)

| 14.1 | <p>The boiler (gas fired) is in the external boiler room. There are cast iron radiators and large bore pipework generally. Large bore pipework is likely to be slow response, and there are issues at pipe connections (see Appendix B, Fig. 9).</p> <p>There is a high level header tank in the nave. The gas meter is in the south aisle cupboard.</p> <p>There is electric water heating to servery and accessible WC.</p> <p>Continue to maintain heating equipment annually.</p> |

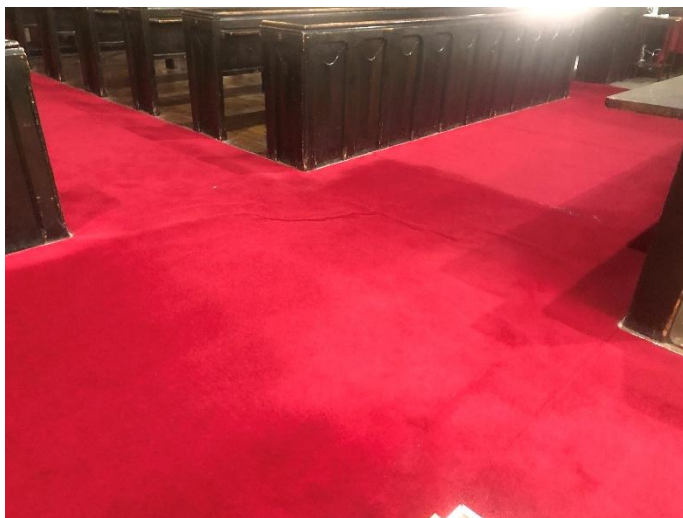
Fig. 10 (IMG\_8840)

| <b>INTERNAL INSPECTION</b> | |
|---|---|
| 10.1 | There is tongue and grooved flooring (softwood) under the (pine) pews in the nave and aisles, showing no signs of undue movement. Elsewhere, red pile carpet has been fitted with slight creasing at the junction of the nave aisle and entrance route, with stone paving to the south porch (see Appendix B, Fig. 10).<br><br>There are iron gratings over heating pipes to the central passageway (concealed by carpet). |

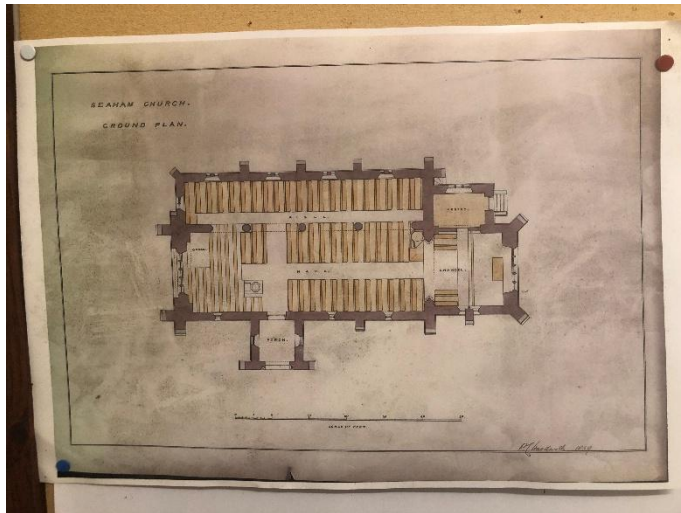
Fig. 16 (IMG\_8856)

| <b>A Background and General</b> | |
|---|---|
| A2 | <p>The church, built in 1857 for Frances Anne, Marchioness of Londonderry (as a memorial to the Marquis) to designs attributed to P C Hardwick, in the Gothic Revival Style with geometrical tracery (see Appendix B, Fig. 16).</p> <p>A South Aisle was added in 1862.</p> <p>Roofs are steeply pitched Welsh slate roofs. The walls are of local snecked sandstone with sandstone dressings and stepped corner buttresses.</p> <p>There is a 4-bay Nave, single bay Chancel, North Aisle, South Aisle and South Porch all with stepped buttresses</p> <p>There is a projecting north Vestry.</p> <p>A 2-stage bellcote with 3 lancets and cross sits above the Nave west end.</p> |
