**QUINQUENNIAL INSPECTION REPORT  
OF  
ST. MATTHEW, NEWBOTTLE, CO. DURHAM**

**QUINQUENNIAL INSPECTION AND REPORT**

**AUGUST 2020**

**David Beaumont BA (Hons) Grad Dip, RIBA, AABC**

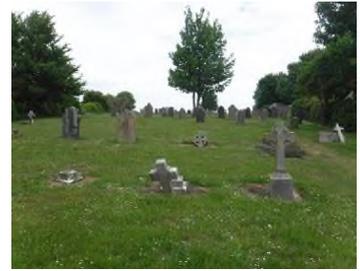
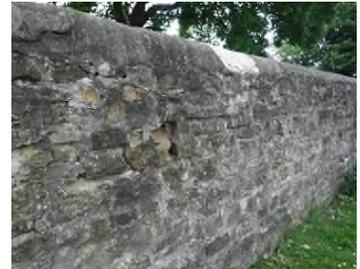
**South side-** Modest sheep fencing which then leads to the stonewall of the dwelling, this is ivy covered in most parts. Is the stonewall the responsibility of the dwelling?

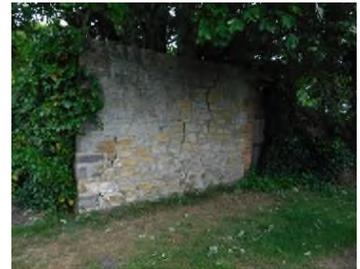
**East side-** Continuation of the dwelling stone wall, there is a large sycamore up against it in our grounds and beech trees in the south east corner.

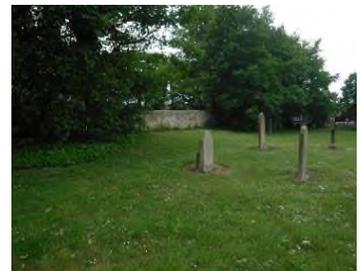
**South side-** This is a low stone retaining wall with iron railings. Two large trees on the boundary threatening it, both sycamore.

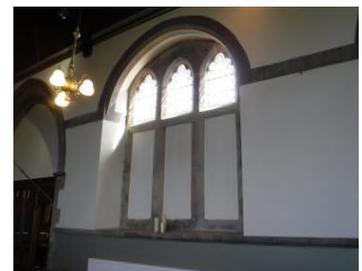
The walls are all painted apart from the stone dressings to windows and doors, the general painting scheme is good. Within the nave, the west wall at high level looks a little poor but I think what is happening is it is catching a lot of dirt that is up in the attic of the roof, so when the wind blows it dusts down the wall and there's little that can be done other than redecorate.

The west wall has a mustard yellow colour which works with the windows really well and reflects the yellow at the chancel.

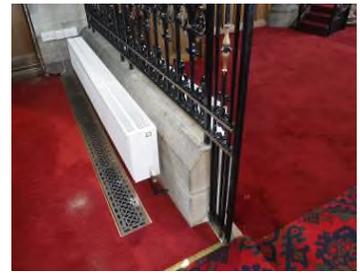
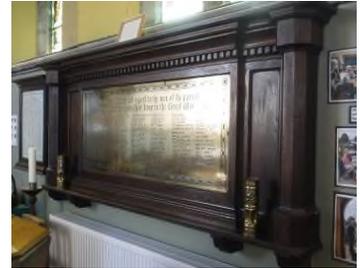
**Memorial chapel screen:** in two parts, one glazed and the other is open.

**Chancel screen:** decorative metalwork screen sat on low stone wall in good condition.
