## QUINQUENNIAL REPORT

*For the Parish Church of  
St. Matthew's Church, Newbottle*

**Report Date:** 24<sup>rd</sup> September 2025

Inspecting Architect:  
Becky Smith BA(Hons), MArch, ARB RIBA CR

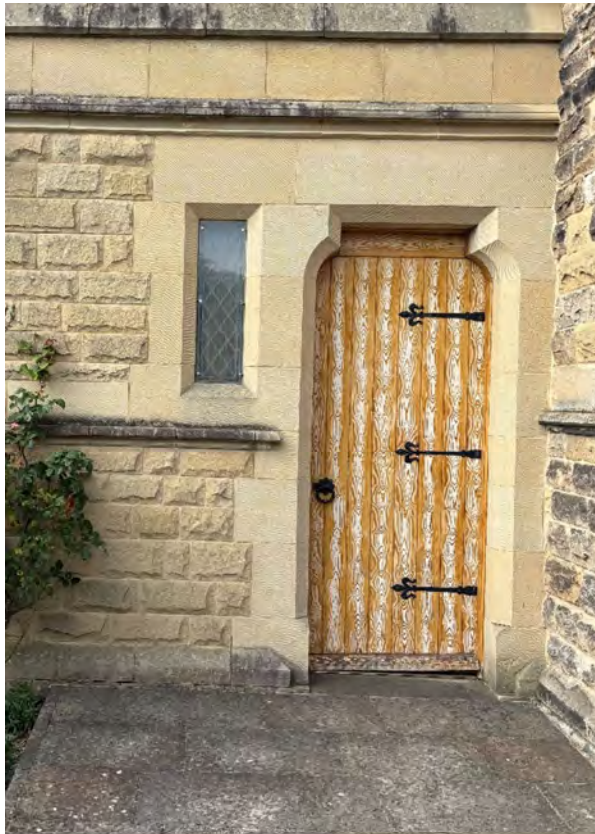
| Image & Location | Description | Condition | Repair Needs | Category |
|---|---|---|---|---|
| <u>Doors</u><br> | | <b>Accessible Entrance</b><br>Timber door is in fair but weathered condition. Finish has significantly degraded. | Sand down and redecorate / re-stain the door to provide renewed weather protection. | 3 |

Overview of accessible entrance door.

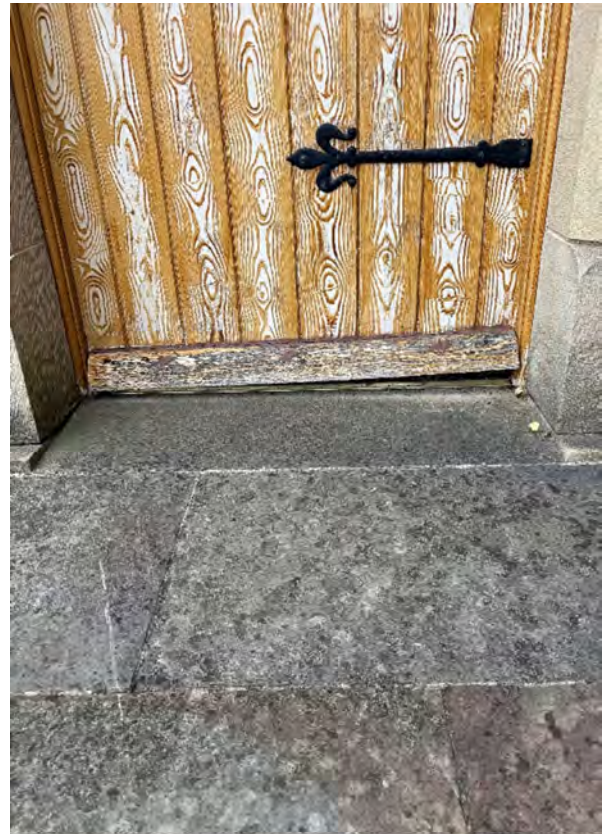
| Image & Location | Description | Condition | Repair Needs | Category |
|---|---|---|---|---|
| | | The Bottom rail to the door has lifted / warped and is show signs of rot and requires replacement/repair. | Sand down and redecorate / re-stain the door to provide renewed weather protection.<br>Replace the bottom rail. | 3 |

Evidence of detachment of bottom rail and loss of protective finish.

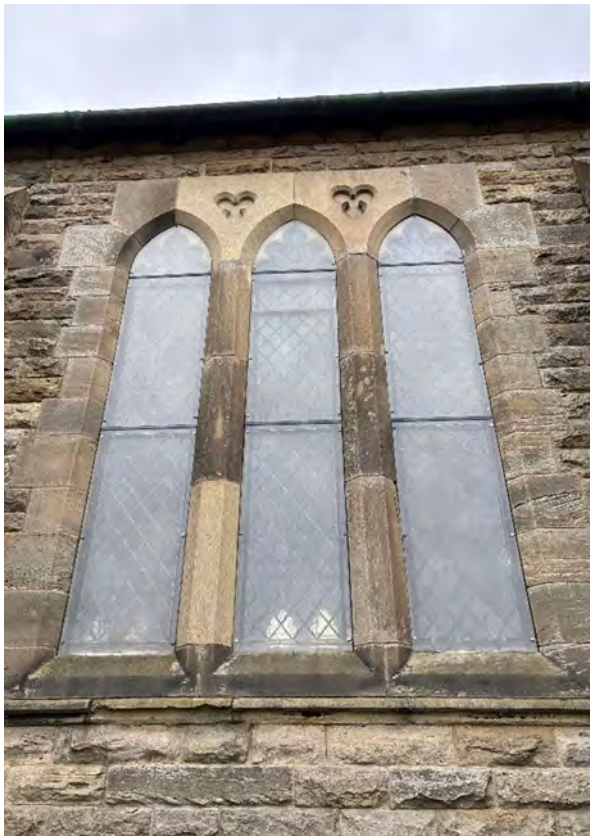
W4 – General overview of window.

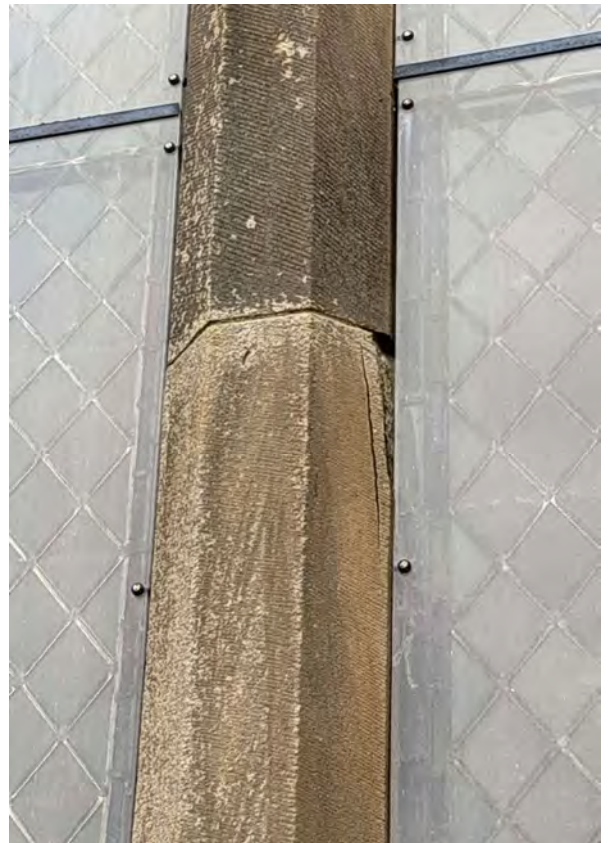
W4 – Weathering of stone to right side of mullion.

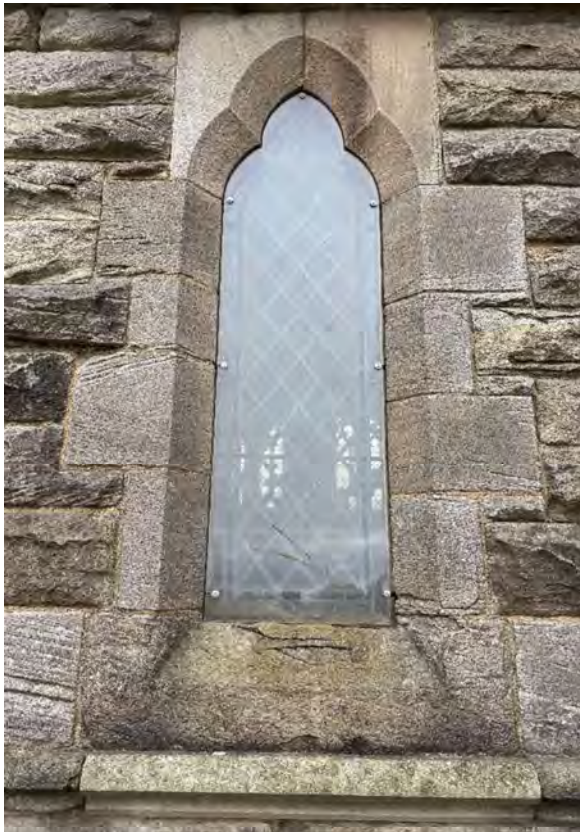
W11 – General overview of window.

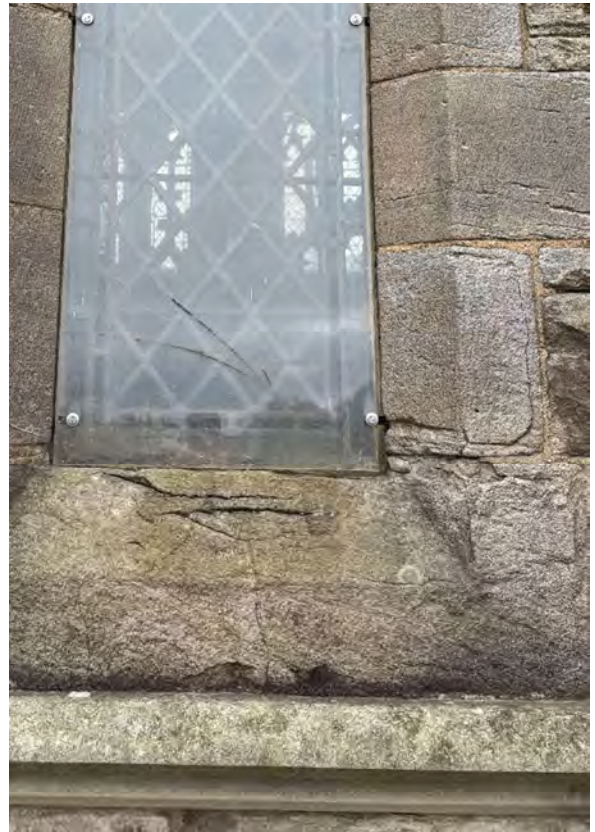
W11 – Delamination visible to cill and right side of stone tracery.

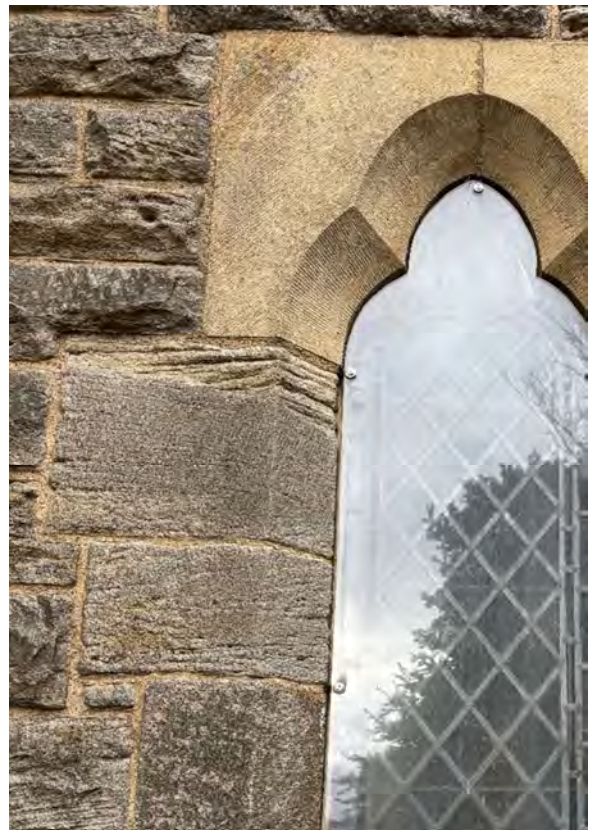
W12 – Some weathering of stone surround.

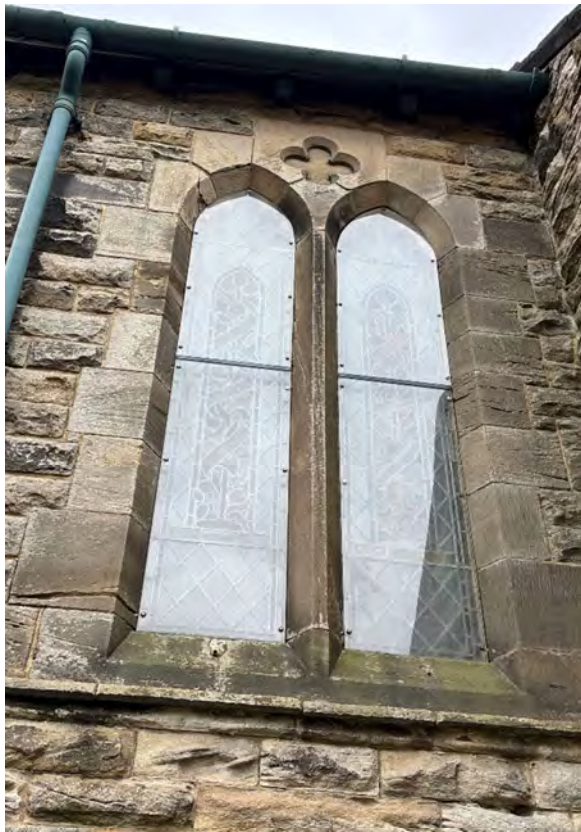
W12a – General overview of window.

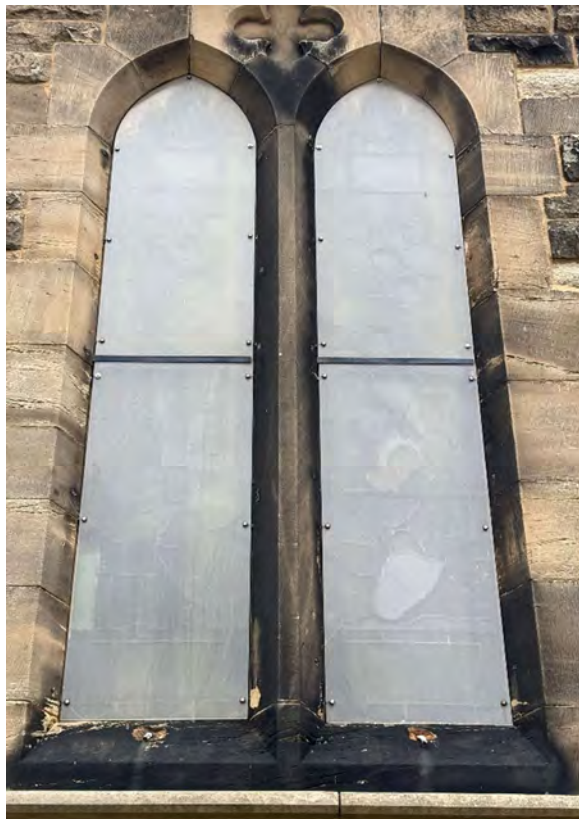
W15 – General overview of window.

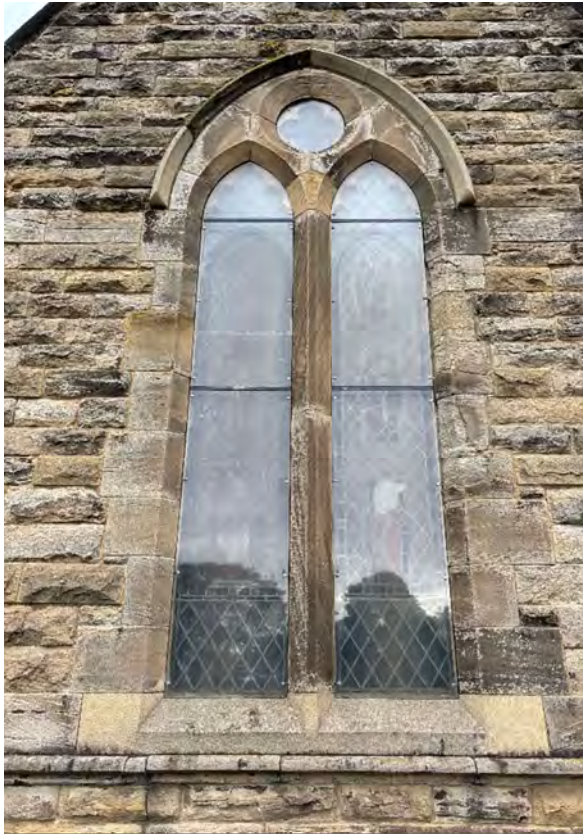
W18 – General overview of window.

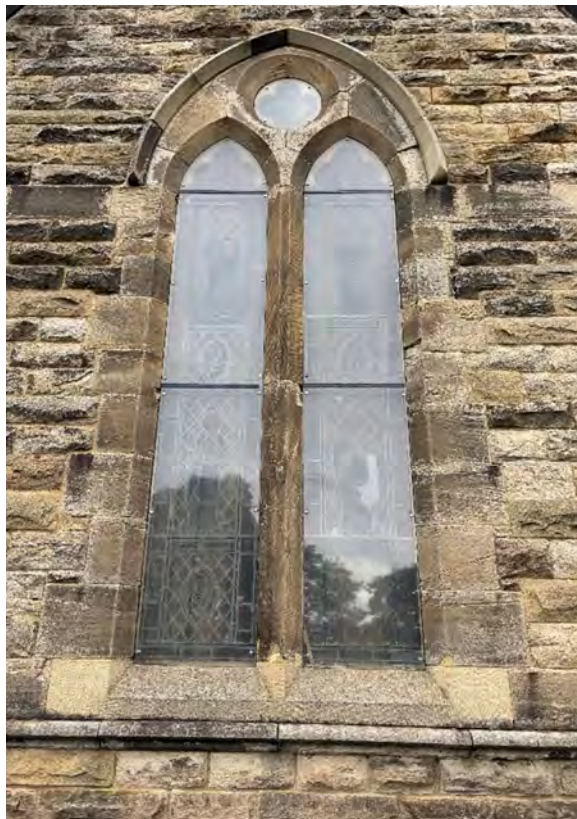
W19 – General overview of window.

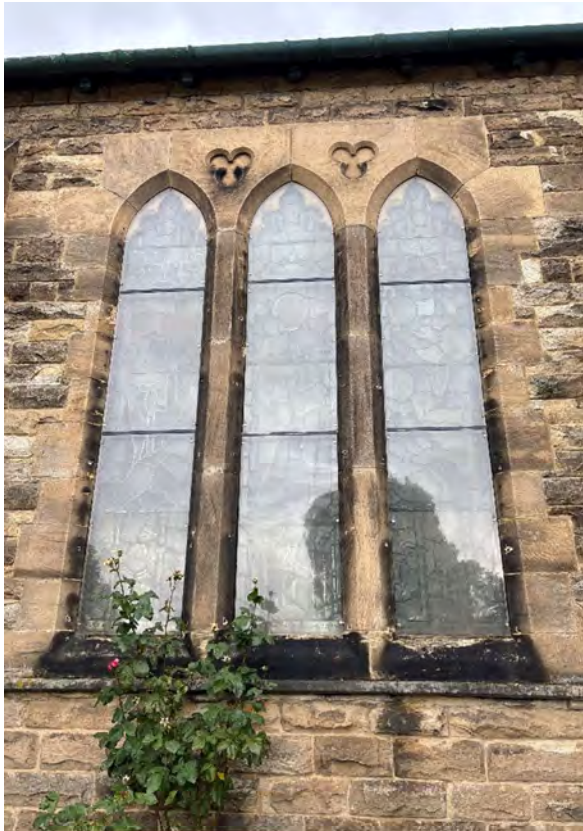
W21 – General overview of window.

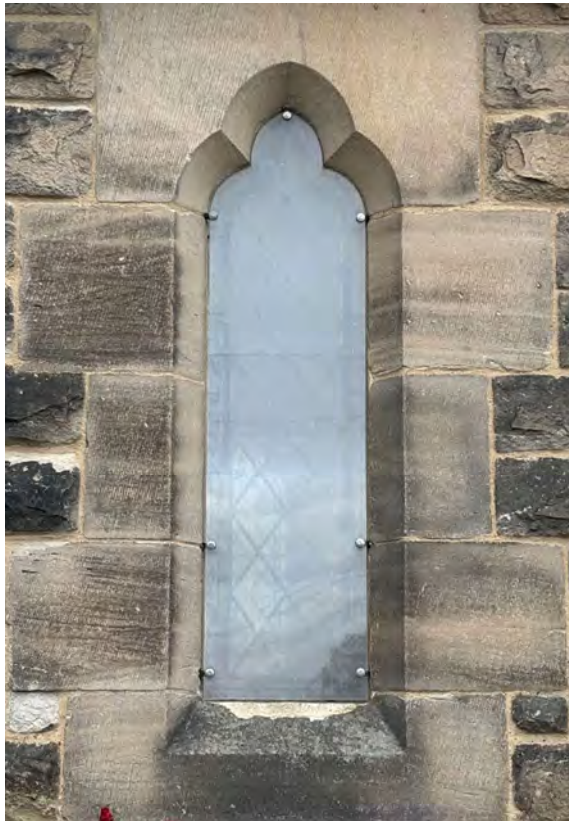
W25 – General overview of window. Some significant deterioration to cill.

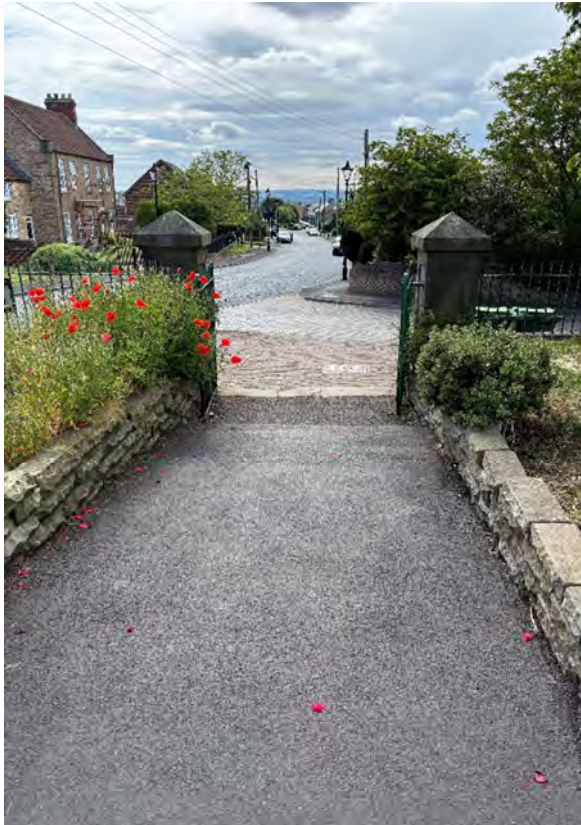
Approach to church – accessible route. However paving to entrance is uneven.

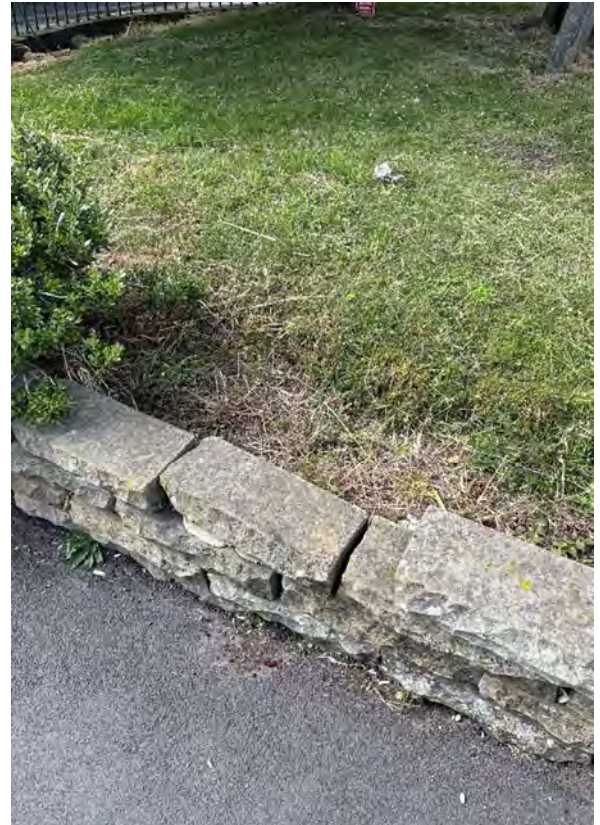
Some loss of pointing to low level kerb to path towards church.

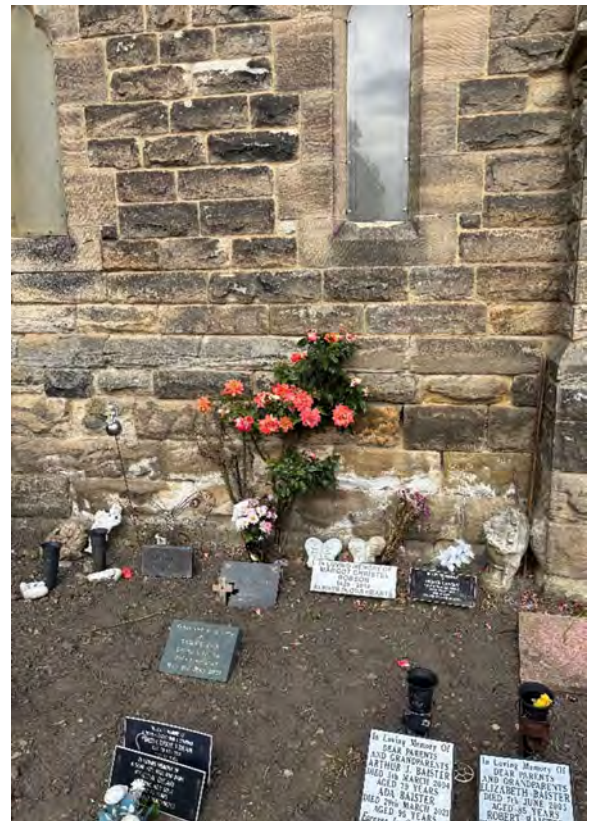
Memorials to base of church walls to South and West elevations.

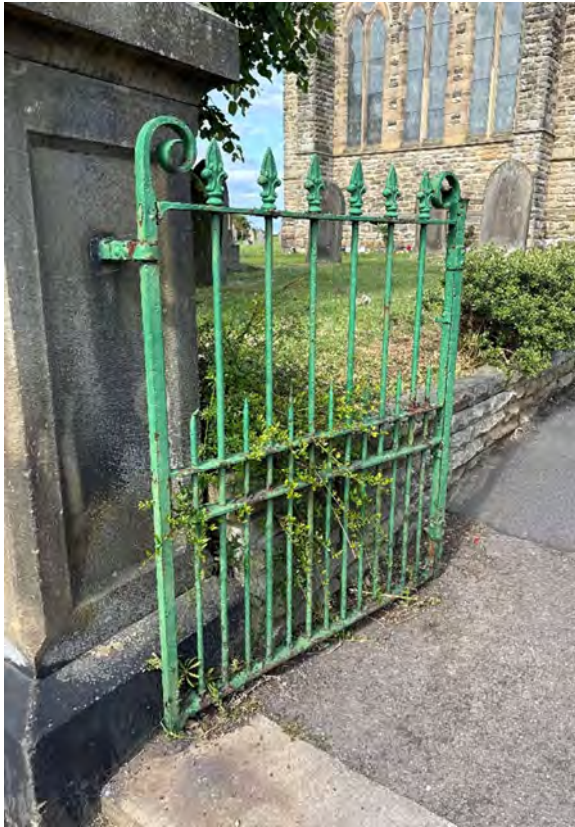
Flaking paint to entrance gates.

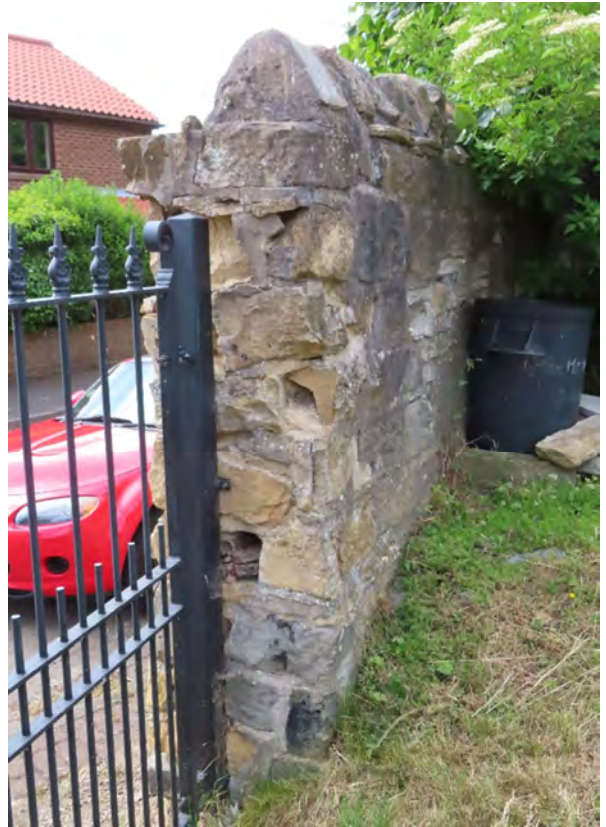
Loss of pointing & weathering to stone wall of entrance gates.

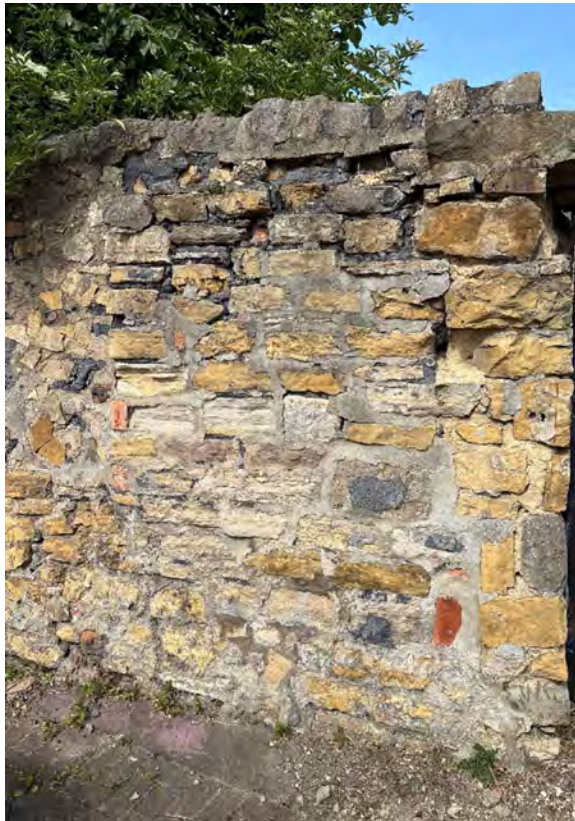
Significant areas of deterioration of stone and pointing to external entrance walls.

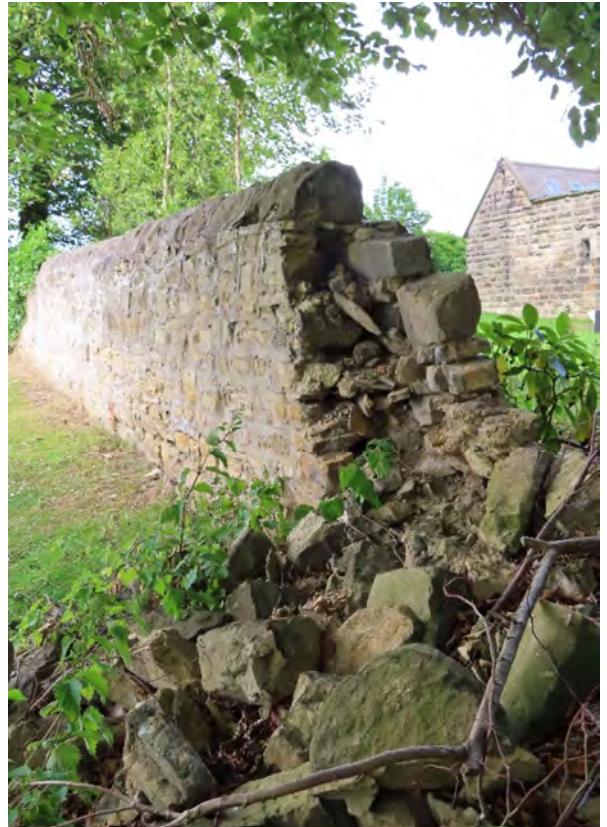
Area of fallen boundary wall to East.

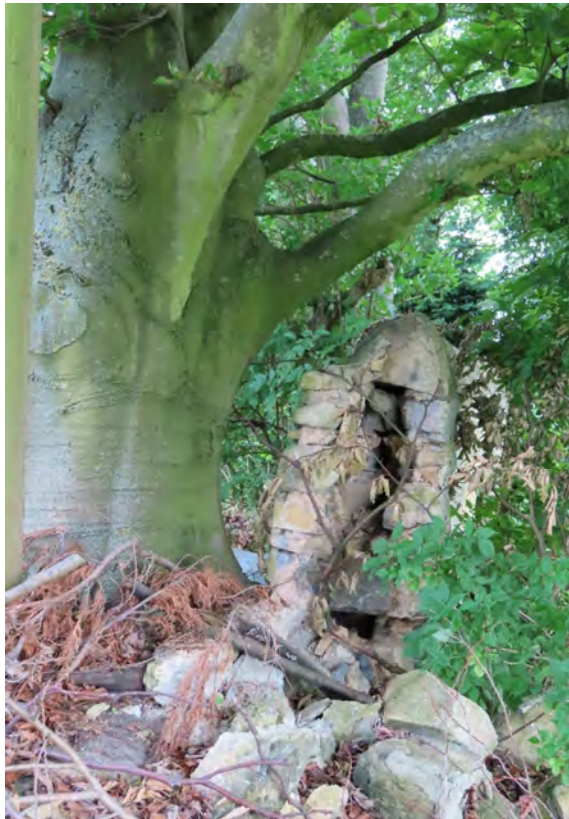
Proximity of tree behind fallen wall.

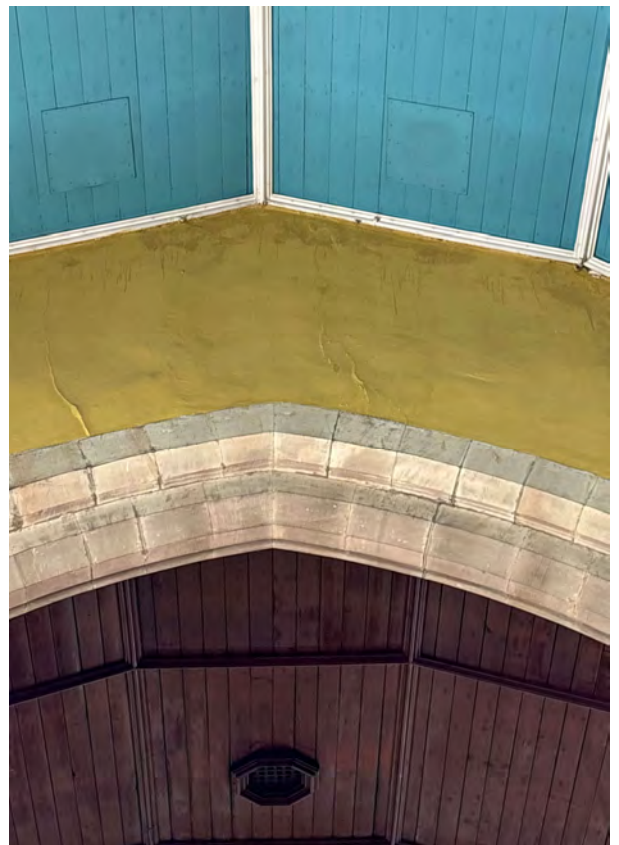
Blistering plasterwork to Chancel Return
