**QUINQUENNIAL INSPECTION REPORT
OF
NEWTON AYCLIFFE, ST. CLARE**

**DIOCESE OF DURHAM
ARCHDEACONRY OF AUCKLAND
DEANERY OF SEDGEFIELD**

**QUINQUENNIAL INSPECTION AND REPORT
February 2019
David Beaumont BA (Hons) Grad Dip, RIBA, AABC**

Address: St. Clare's, St. Cuthbert's Way, Newton Aycliffe, County Durham, DL5 5NT

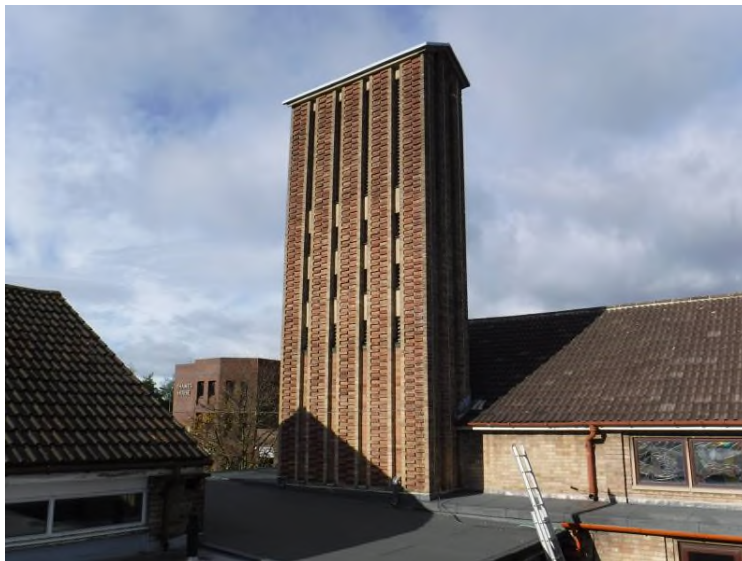
TOWER EXTERIOR

Not able to adequately see the roof covering. Suggest that it is could be ridged membrane type material with a tanalised timber trim. Likely to have had its gutters removed at the time of recovering. No apparent defects. The downpipe which drains the floors, exits on the south side.

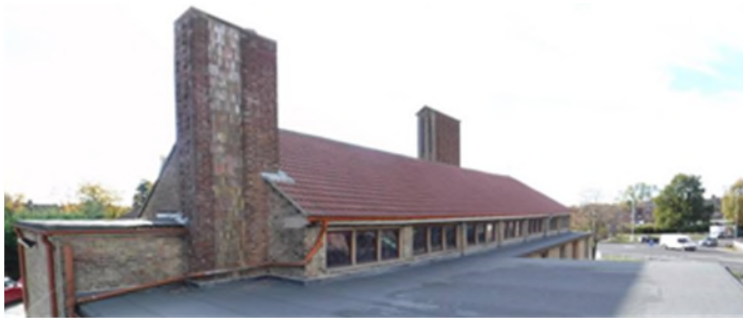
Nave, north and south slopes:

North side plastic downpipes to metal gutters, nave part restored as part of the 2016 nave roof recovering works.

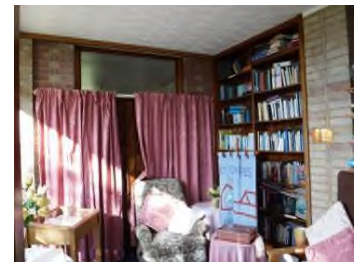
- Ceiling – Artex, generally ok.
- Walls – Brickwork sound. Interestingly this has enclosed the base of the tower, so this was previously an external wall, now been fitted out with book cupboards and you now lose sight of the entrance into the west porch. Walls are a continuation of the lobby double glazing. Glazed double doors into the room doesn't match.

Recommendation: none

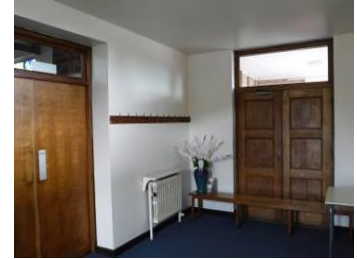
- Ceiling – Painted plaster.
- Walls – Painted plaster.
- Floor – Flotex type carpet on solid floor.
- General – All in reasonably good condition, the doors and windows are ok.

Recommendation: none

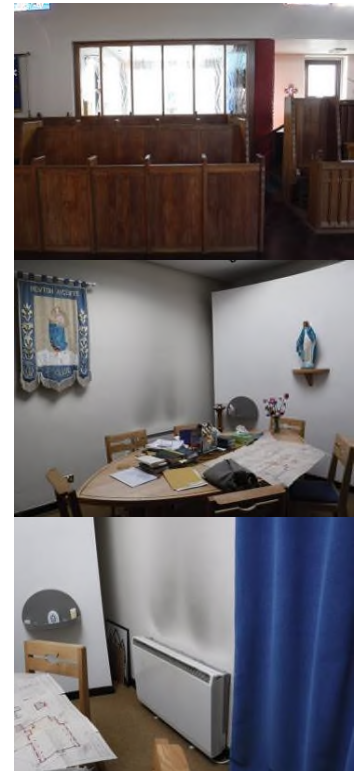
- **Lady Chapel:**

- Ceiling – Polycarbonate dome light, some bird marking on it, there is no ventilation to the room apart from a curtained opening into the nave (it is the warmest place in the building). Suspended ceiling with feature lighting in of vesica shape.
- Walls – Plaster painted, generally ok. There is a large curved feature wall for focus on the south side which is free standing wall and looks fine.
- Floor – Corded carpet on solid floor all looks ok.
- General – Very fine oak screen to the Nave, decorated only on one side (It's not decorated on Nave side). An intermediate shelf would assist storage. The room is heated by Creda Electric heaters and they are showing signs of dirt on the walls just above them. The room has a heavy curtain to separate it from the Nave.

Recommendation: none

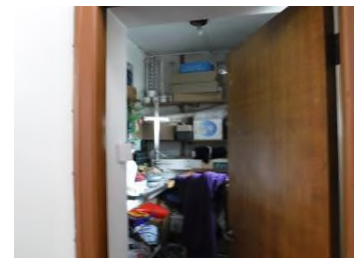
- **Sanctuary Store:**

- Ceiling – Fibreboard, very basic.
- Walls – Painted plaster, some cracking above the air extract.
- Floor – Continuation of the church parquet.
- General – Shelved out and full. Door ok.

Recommendation: none

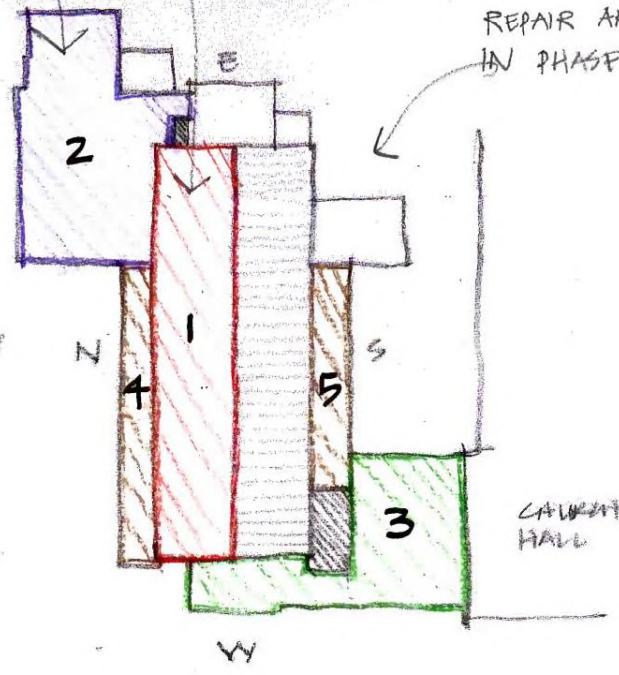
NEWTON AYLIFFE
ST CLARE
ROOF REPAIRS
27/02/14.

ALL FLAT ROOFS
APART FROM NAIVE.
IN CLAY DOUBLE
ROMAN.
THE S. SIDE WAS
REPLACED IN
CONCRETE DOUBLE
ROMAN - DATE
UNKNOWN

REPAIR AREAS
IN PHASES
