QUINQUENNIAL INSPECTION REPORT

CHURCH OF ST. MICHAEL & ALL ANGELS

7 IMPERIAL AVENUE, NORTON, STOCKTON-ON-TEES, TS20 2EW

AUGUST 2022

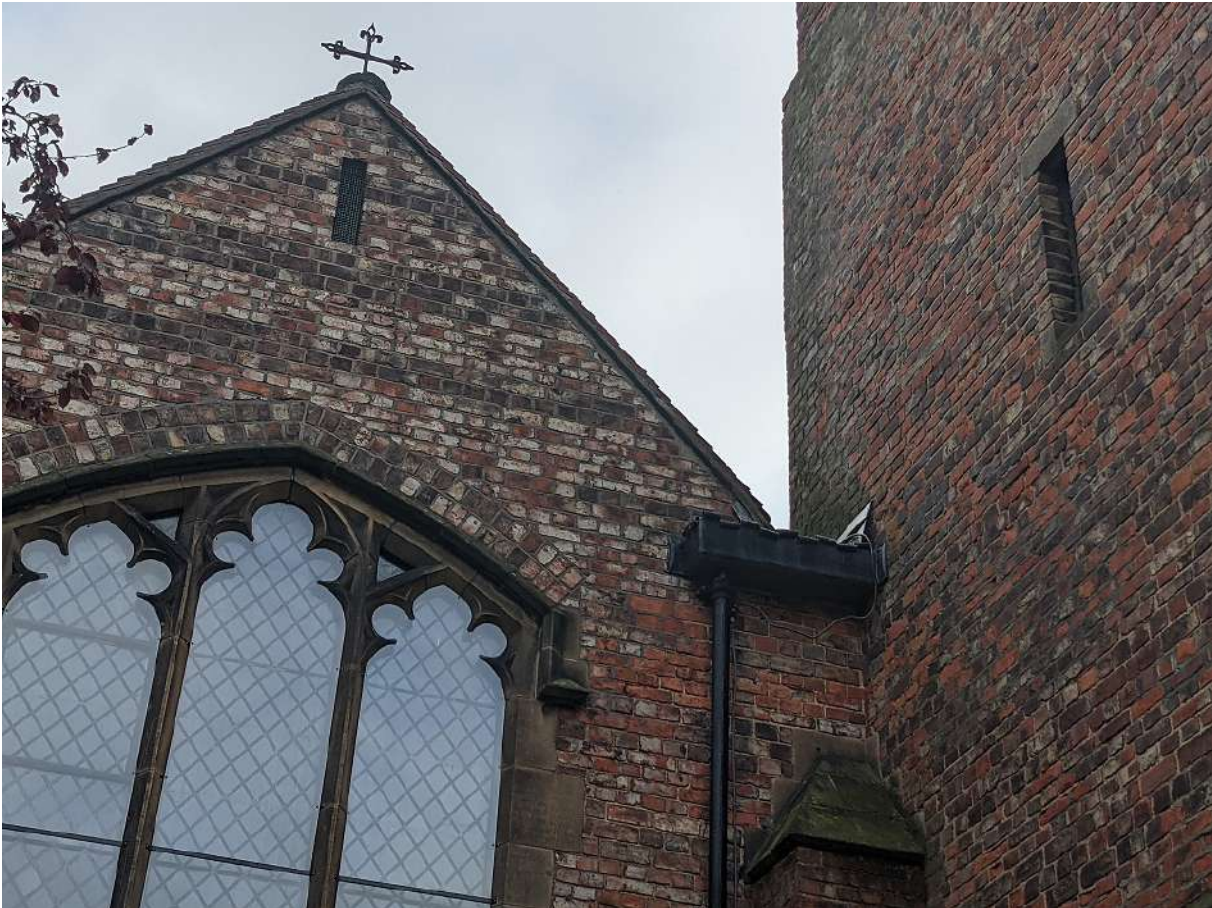
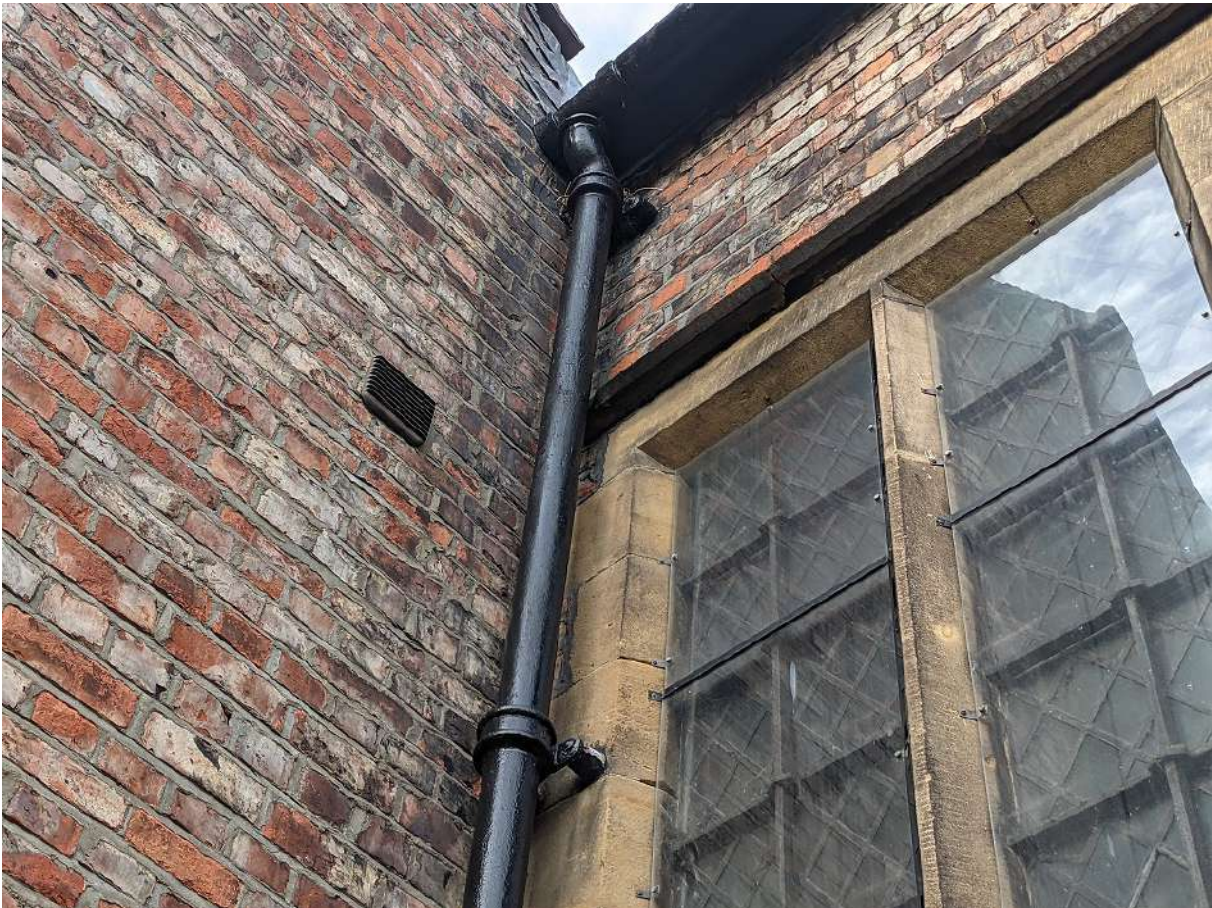
At east and west ends of the main valley gutter there are large decorative hoppers discharging into round plain downpipes; cast iron to the west end and plastic to the east end. All painted black.

At the south side of the chancel a cast iron hopper (at mid-height) and pipe takes surface water from the east end of the chancel-vestry gutter. Below the hopper a large diameter plastic pipe enters through the boiler house roof, across the boiler steps and out to an open gulley.

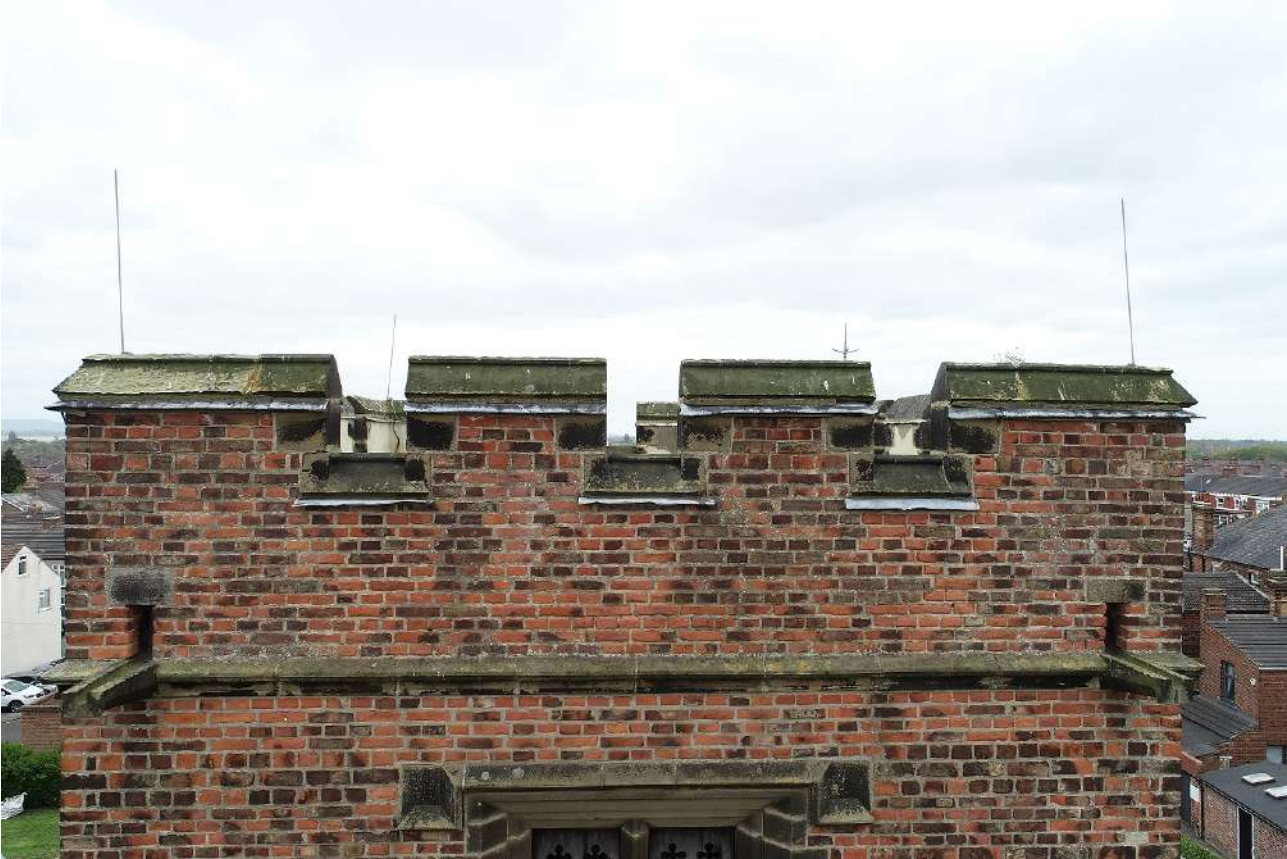
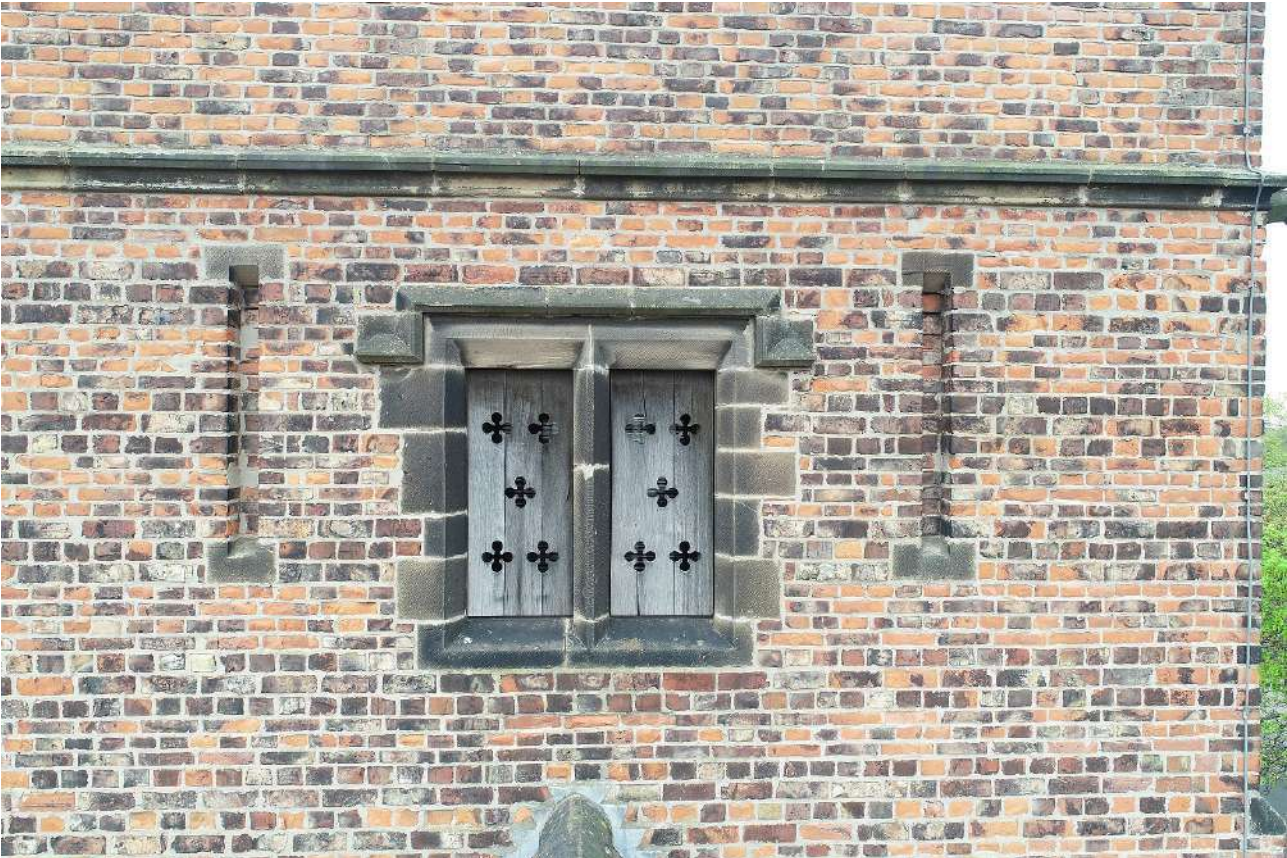
The internal face of the parapet is fully rendered using lime plaster in thin layers of moderate strength. A stainless-steel bottom bead was incorporated, and lead drips were installed to prolong the length of the render. All of this repair work was carried out in 2011.

Inspection via a drone has indicated that the lime render remains in a sound, good condition.

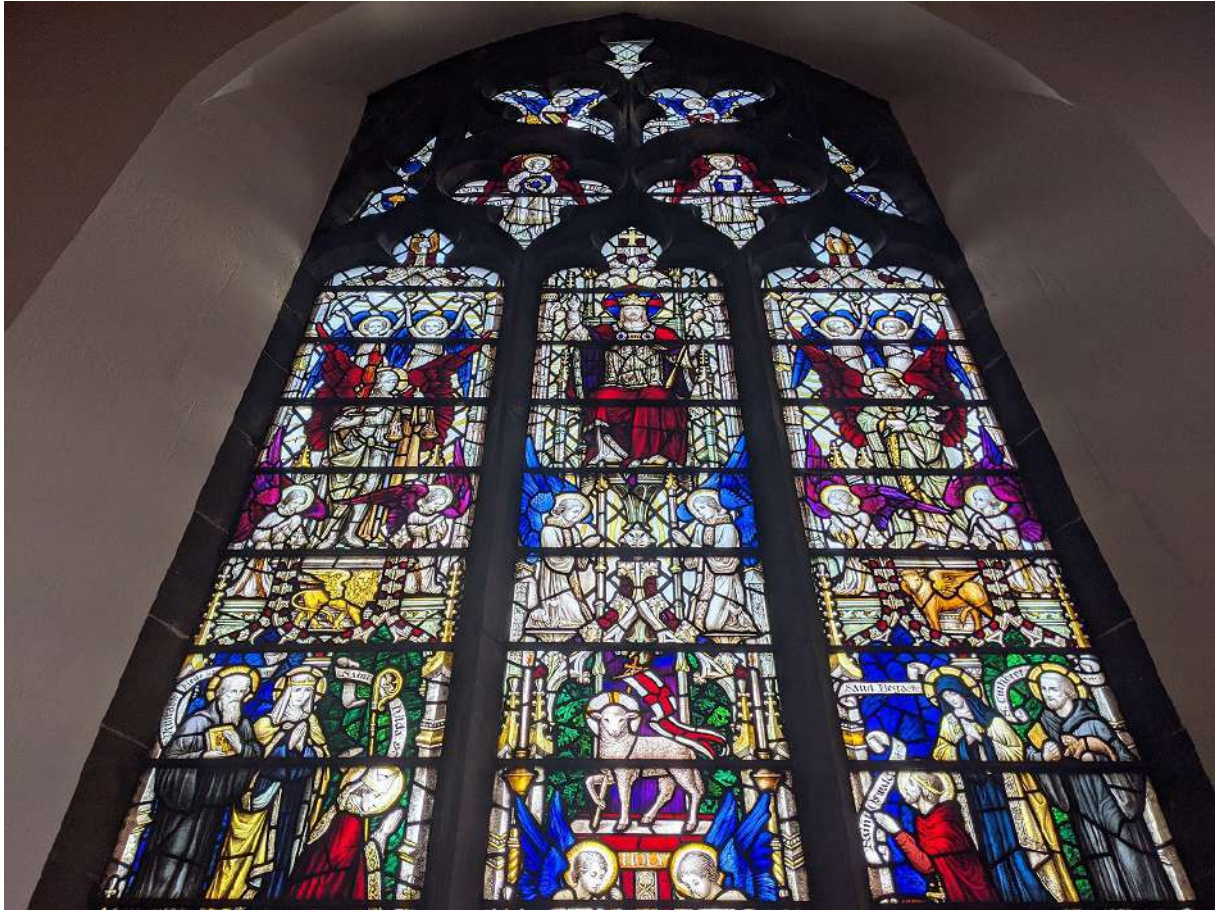
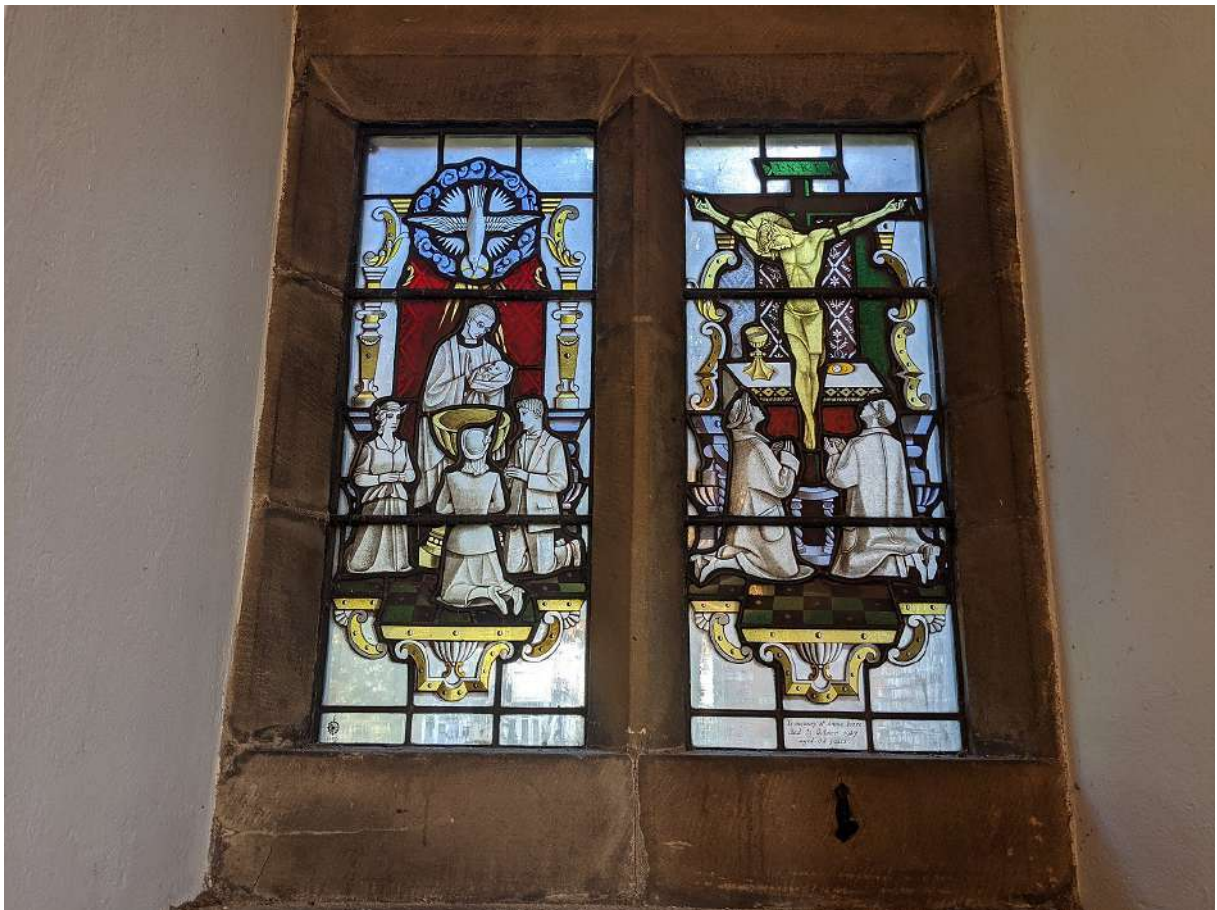
- 8.1.1 The previous QIR had raised concerns over the condition of the plain glass which was found to be cracked in many places and dirty. Recommendations were made for a general clean and overhaul.

This repair work has been actioned over the preceding quinquennial period and as such, the window glazing and protection is found to be in a much improved condition at the time of this QI.

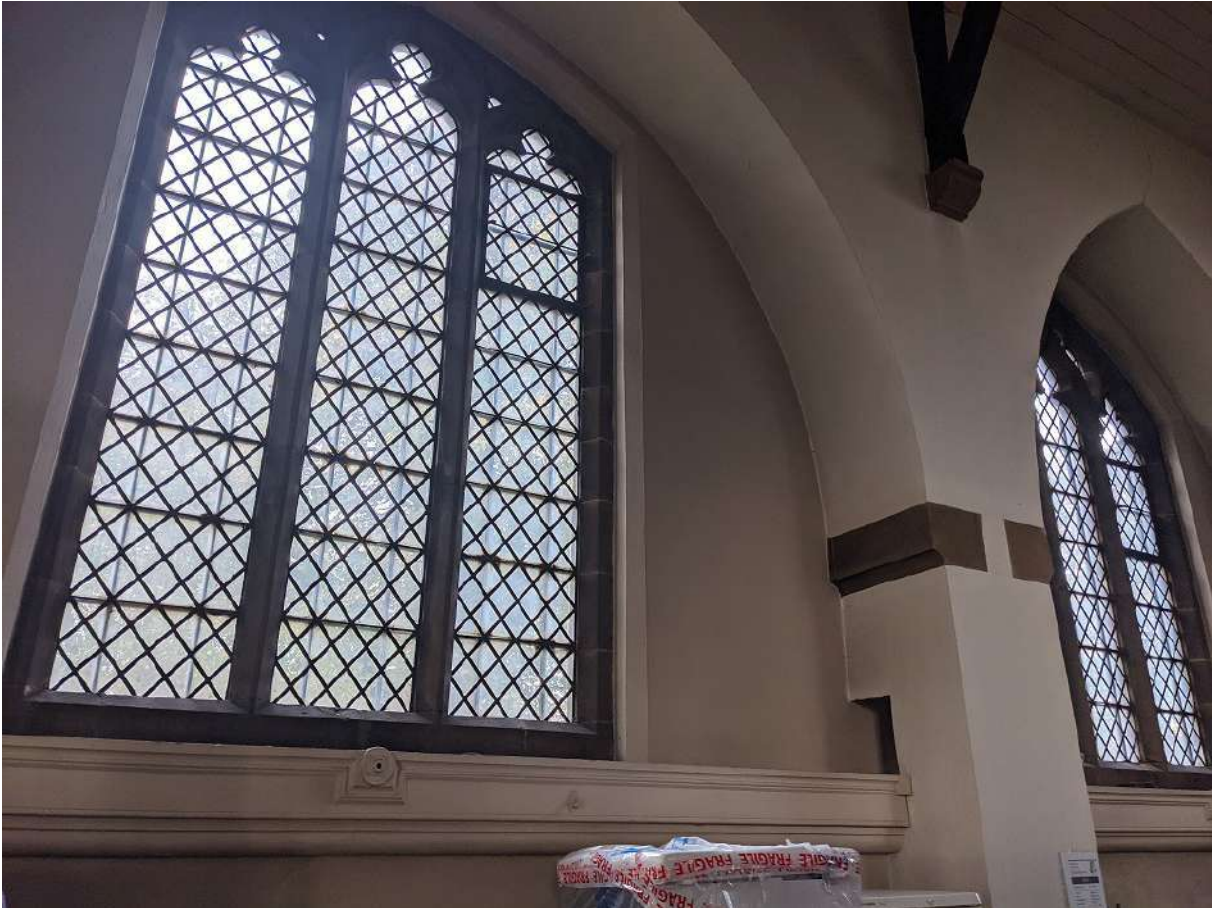
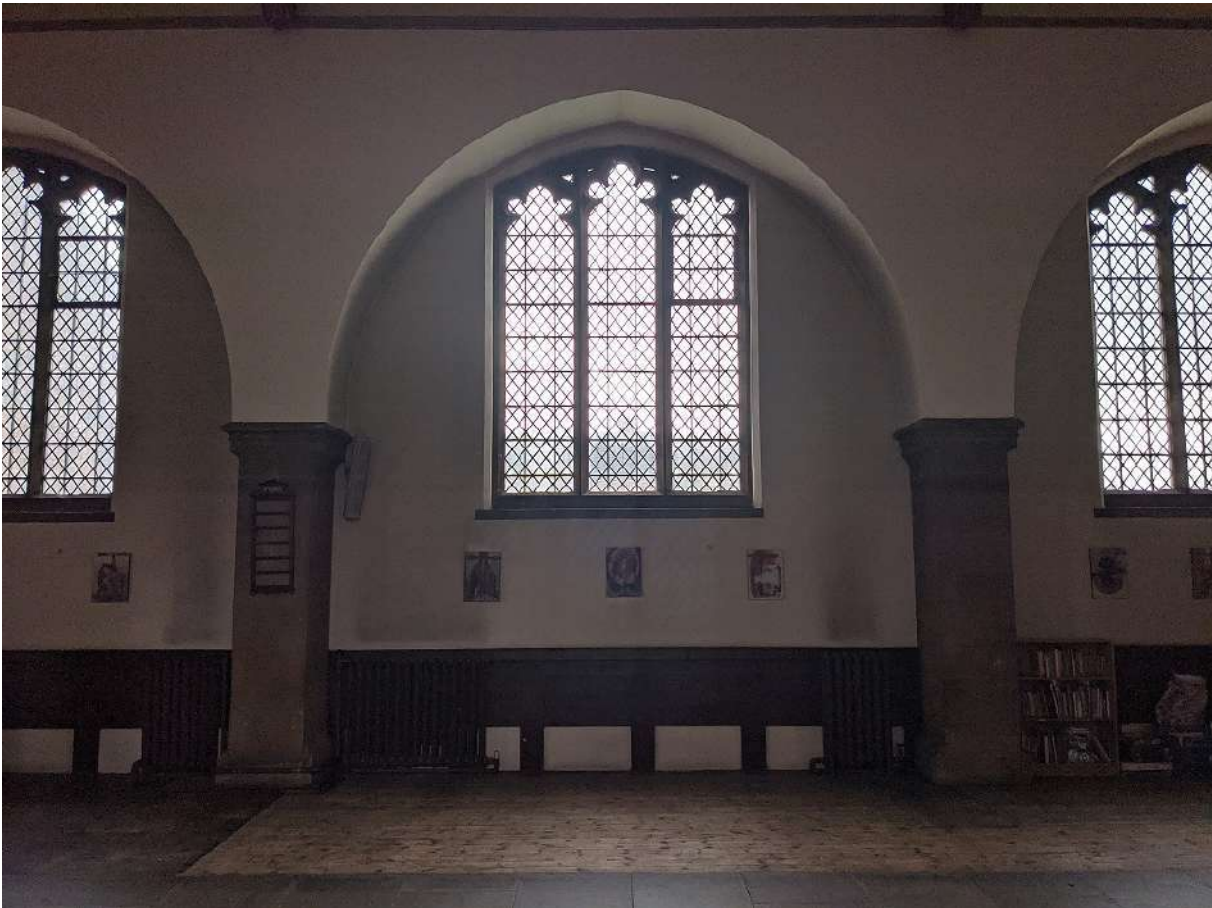
The manner of protection to the window would be better served by the introduction of UV protected polycarbonate.

R1		It is recommended that new UV protected polycarbonate is installed to the north aisle east window.
R4	8.1.2	It is desirable that new UV protected polycarbonate is installed to the chancel east window.
R2	8.1.3	It is recommended that a clean of the plain and stained-glass windows are carried out using deionised water by an ICON accredited glass conservator.
R4	8.1.4	It is desirable to commission a conservation report on the church windows by a competent and experienced ICON registered conservator.

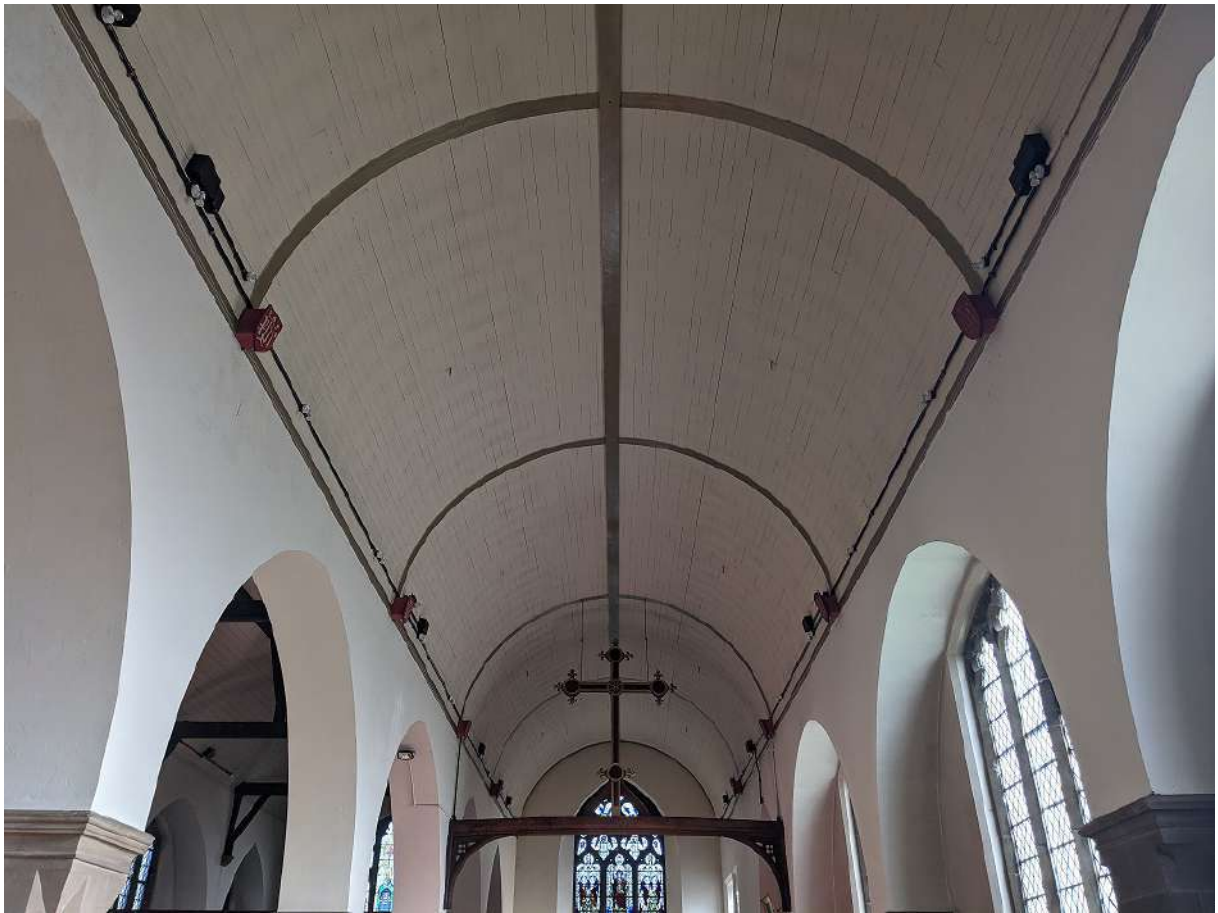
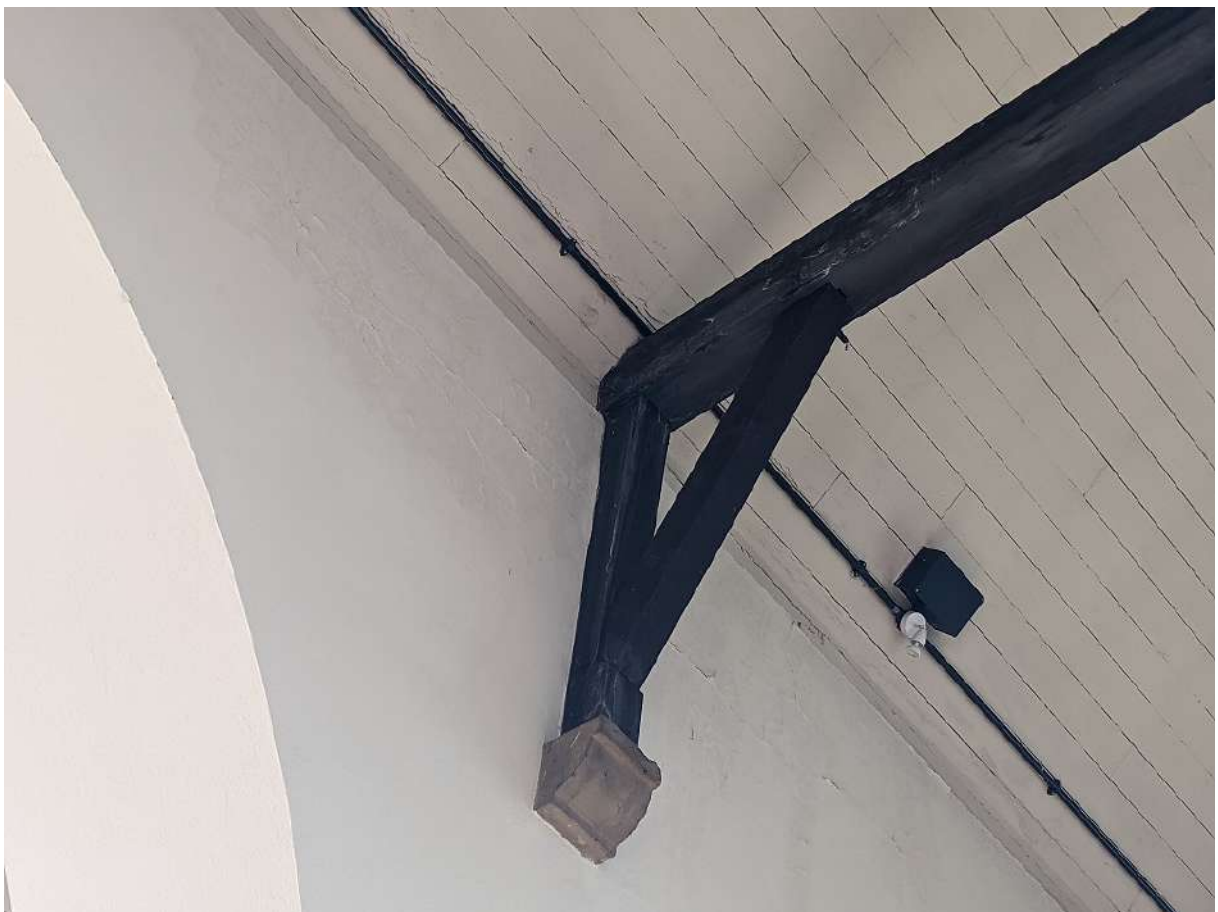
Within the north aisle/lady chapel there is exposed roof structure consisting of east-west ridge beams on posts on heavy cross beams which take support from stone corbels lower down the side walls.

12.2.1 Ceiling lining and exposed roof structure appears to be in a sound, satisfactory condition. Exceptions to this assessment are as follows:

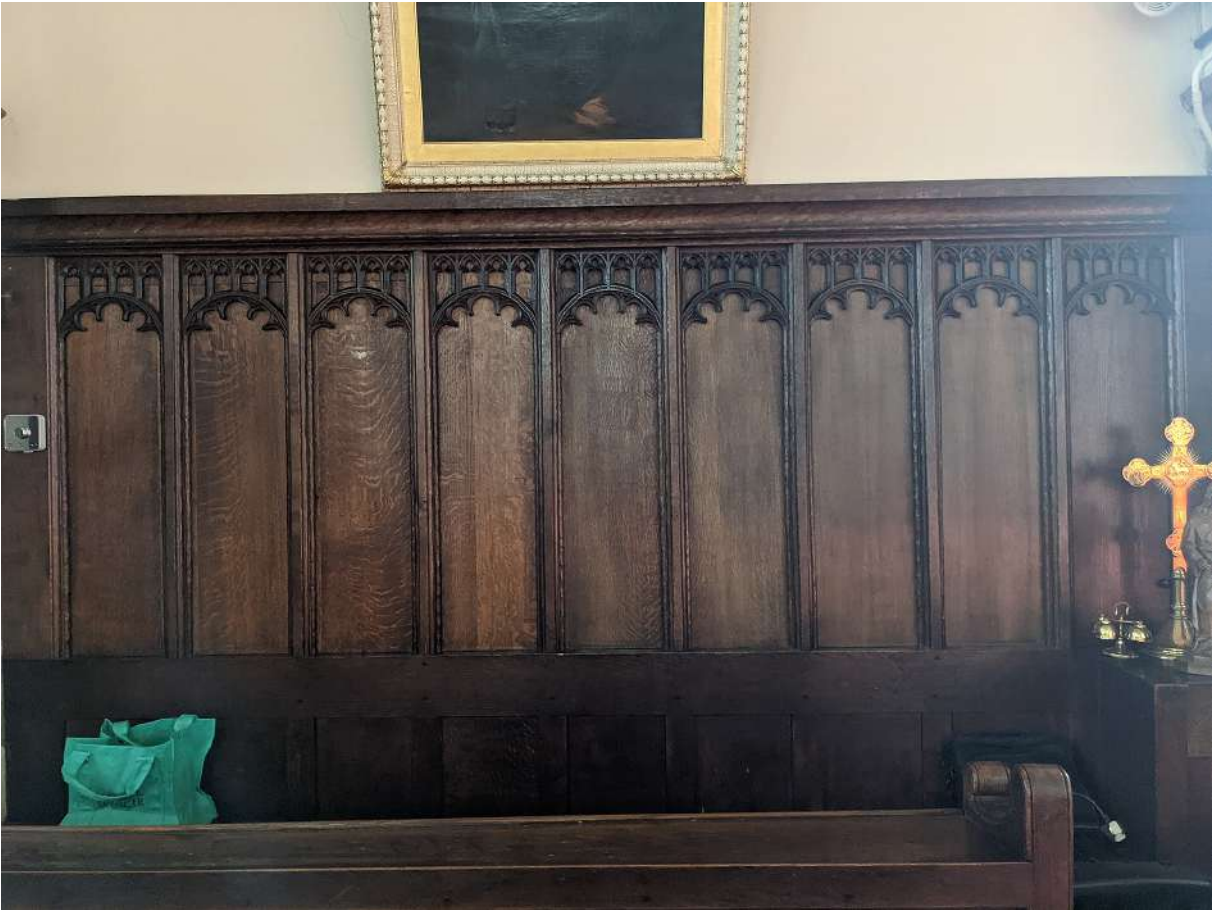
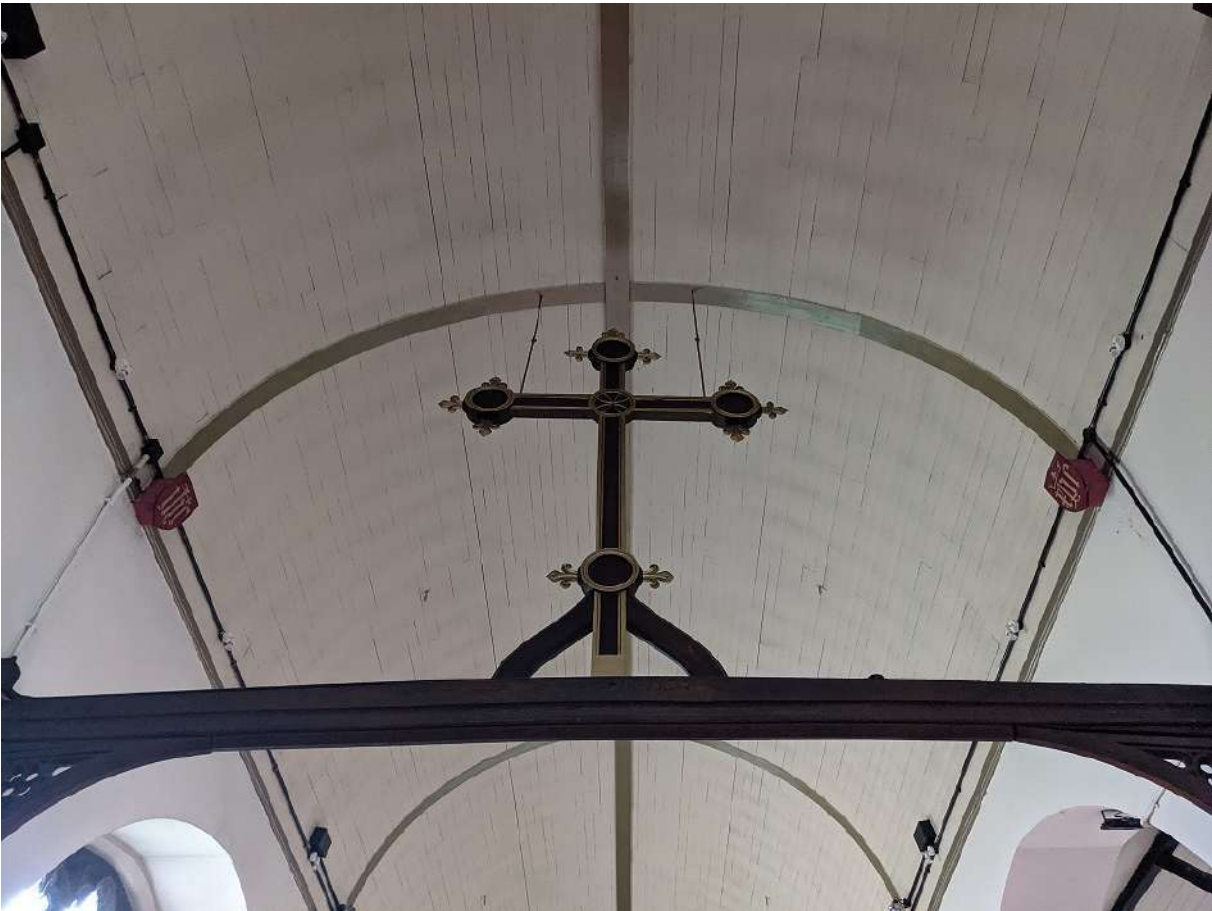
15.1.1 Floor coverings generally in a sound, satisfactory condition.

M	It is recommended that as a routine item of maintenance ensure that floor of the belfry (stage 3) is swept clear of dirt and debris.
----------	--

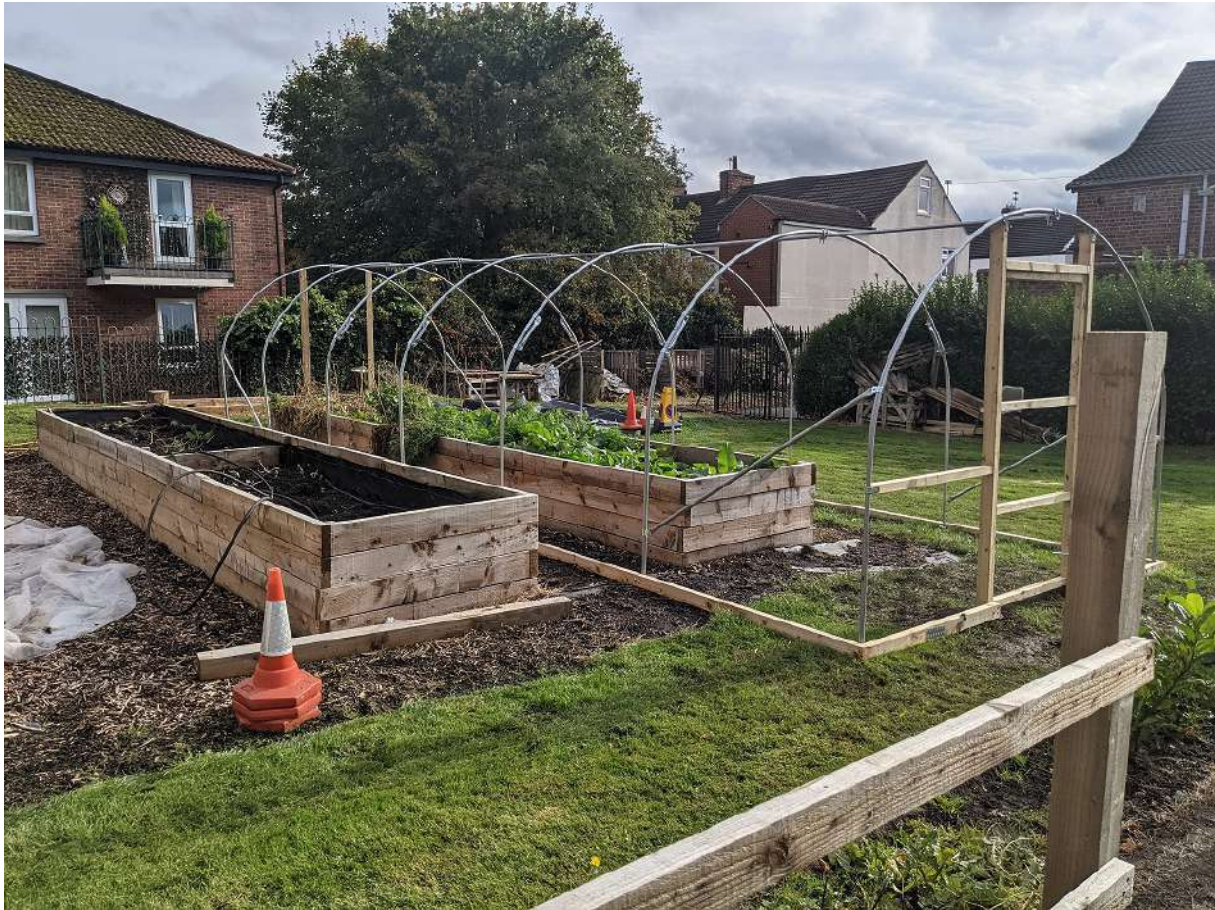
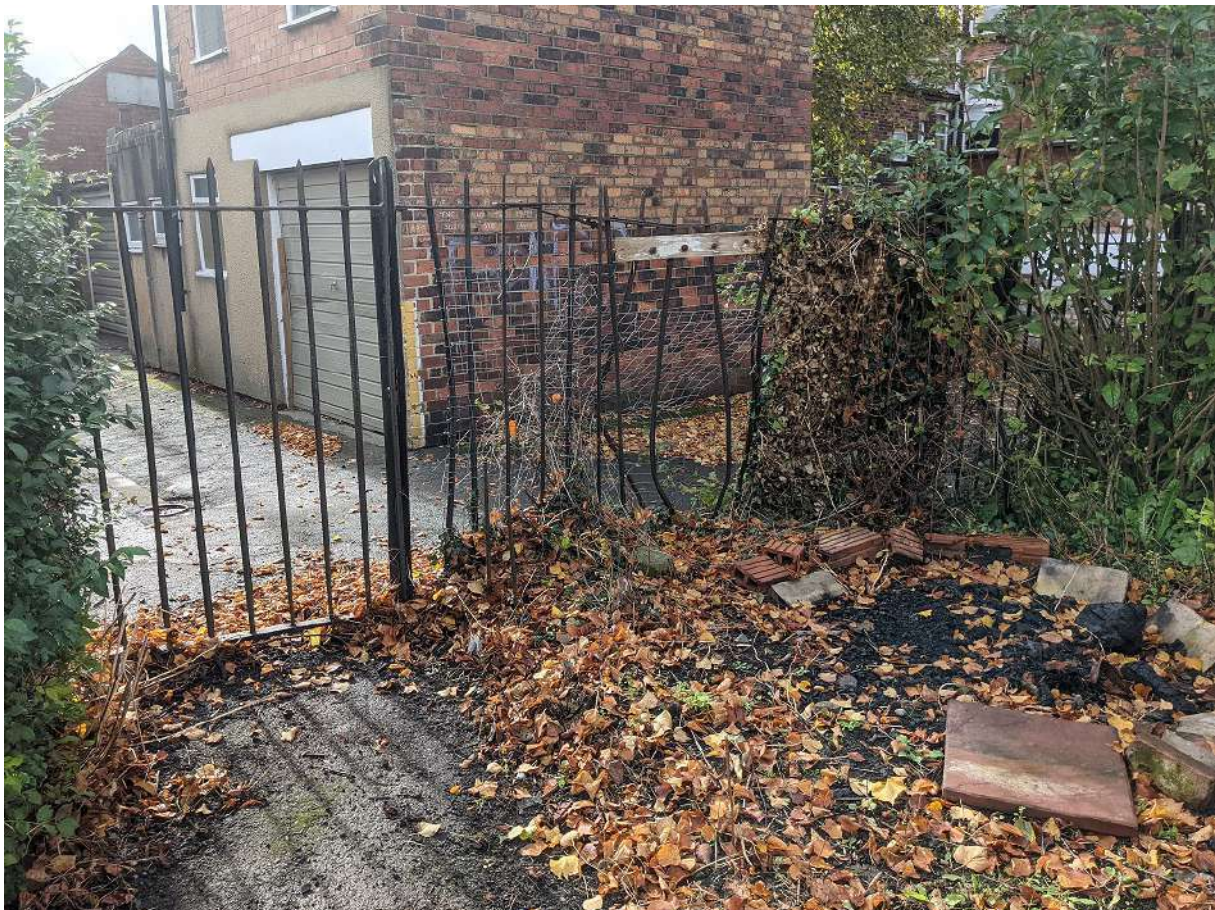
36.3 SOUTH BOUNDARY

36.3.1 Modern black steel railings, greatly obscured by hedgerow. Sections that are visible are all in a sound, satisfactory condition.

The exception being at the public access point at the southwest corner where some damage is noted.

R1	It is recommended to carry out repair to affected section of boundary railings.
-----------	---
