QUINQUENNIAL INSPECTION REPORT
OF
OWTON MANOR, CHURCH OF ST. JAMES THE APOSTLE

**DIOCESE OF DURHAM
ARCHDEACONRY OF DURHAM
DEANERY OF HARTLEPOOL**

**QUINQUENNIAL INSPECTION AND REPORT
January 2017**

David Beaumont BA (Hons) Grad Dip, RIBA, AABC

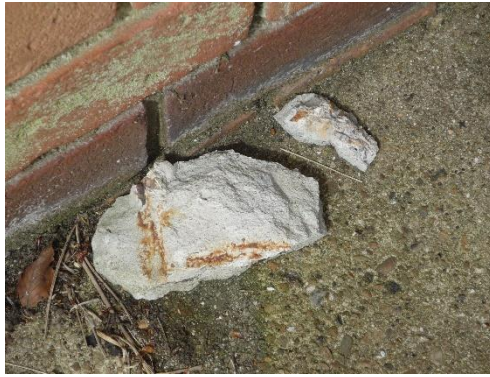
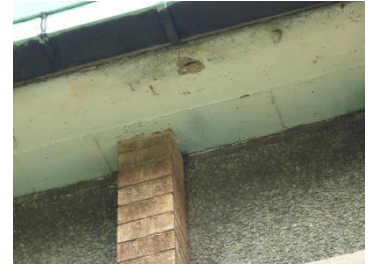
South chancel

- West side - concrete soffit which is showing some signs of wear. Brickwork is in fair condition. Entrance door to rear is okay, though it could do with cleaning up. Its concrete frame around it is okay though there is some loose pointing to the sides of it. The step below it is okay.

- The brickwork of the boiler room enclosure adjoining it is okay. Guarding to rusting galvanised window with decoration that needs updating. Slight shrubs at the bottom of the floor. To its side is a gas meter cupboard whose door is coming apart.

- East side – brickwork in reasonable condition. Some slight washout of the pointing at lower level and one brick missing it seems where there are leaves. The paving here isn't very good either and one galvanised window needs decoration.

Recommendation: redecorate or replace windows, redecorate door and gas meter doors, repair paving

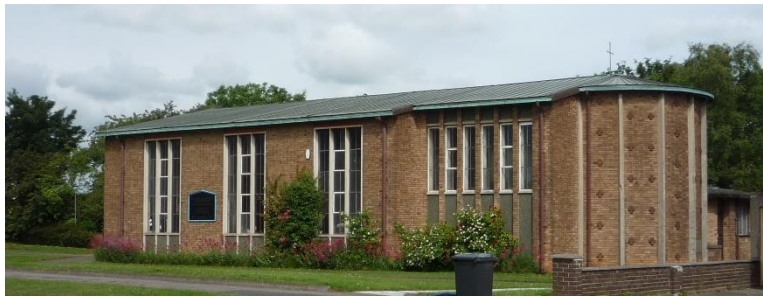
Nave:

- East side – brickwork same as chancel, in good condition.
- South side – some wear to the decoration on the soffit. Brickwork is in good condition, within that are three large concrete framed window apertures and these are showing some historical movement signs, not much since the last inspection. Working from left to right:

- Window 1 – this has a recent cracked pane in it and is in the best condition.
 - Window 2 – framing is in good condition. Generally, the window is okay.

- Window 3 – some slight movement to the base of the mullions to the aggregate panel. Cracking to the fixings to both ventilators.
- West side – brickwork in fair condition, slight cracking on the south west corner that has a glass tell-tale on it which hasn't snapped so there has been no change since the last QI. The open joints really do need re-pointing and properly with a matching mortar. The eaves overhang decoration is just about okay and there is no obvious concrete spalling.

- North side – same design as the south but now enclosed by the Stella Maris room. The condition of the walling and windows is much better on this side.

Recommendation: see summary comment on repair option, repoint open joint on walling west end of nave

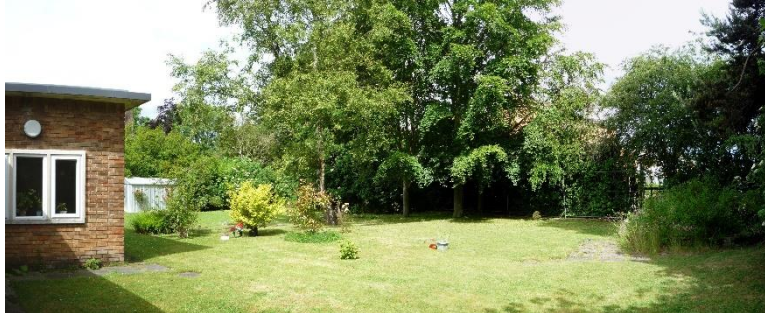
- D **North Boundary:**
Mixture of fencing where the old timber fencing has broken down on the neighbour side and there are Herras fencing panels loosely arranged with cable ties and rope to the eastern side of the boundary. Two beech trees and a silver birch.

The western end is rather overgrown and is quite dense with planting- no doubt to deter intruders but equally can be a hiding place. There is a back way to the vicarage garden. The rear area is all grassed with some ashes. At the eastern end there is a small area set aside for ashes.

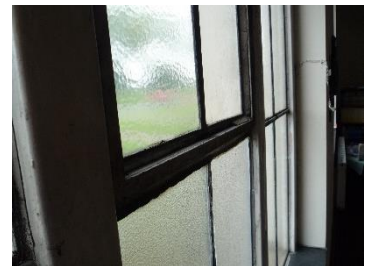
Nave:

- Ceiling – fibre board, in good condition. Exposed concrete frame in good condition.
- Walls – plastered wall in good condition. The windows within them are in varying states of glazing and have been commented on in the summary.
- Floor – hardwood herringbone block flooring in good condition.

Recommendation: none
