# **QUINQUENNIAL INSPECTION REPORT**

## **PENNYWELL, ST THOMAS**

**QUINQUENNIAL INSPECTION AND REPORT  
2017**

**David Beaumont BA (Hons) Grad Dip, RIBA, AABC**

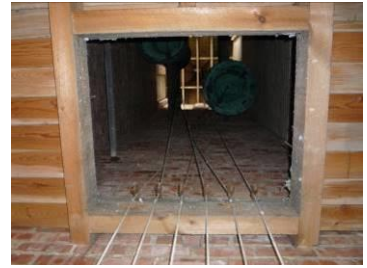
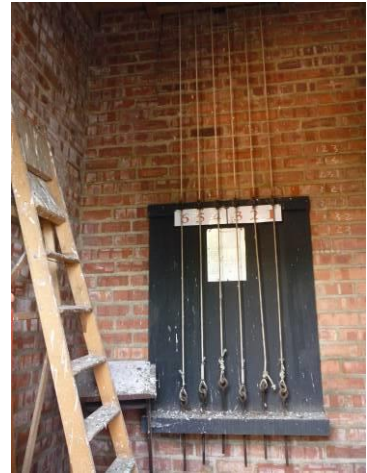
- B** Not possible to access the upper reaches as there is no ladder to the top. It contains bells from Monkwearmouth. There are signs of pigeon infestation and the room has some lumber within it. There is also a carpet to the floor and this could do with being removed along with the pigeon muck. The interior of the belfry at higher level needs a fuller investigation.

**Recommendation:** inspect at high level, remove pigeons, introduce netting to exclude them, clean up, remove carpet

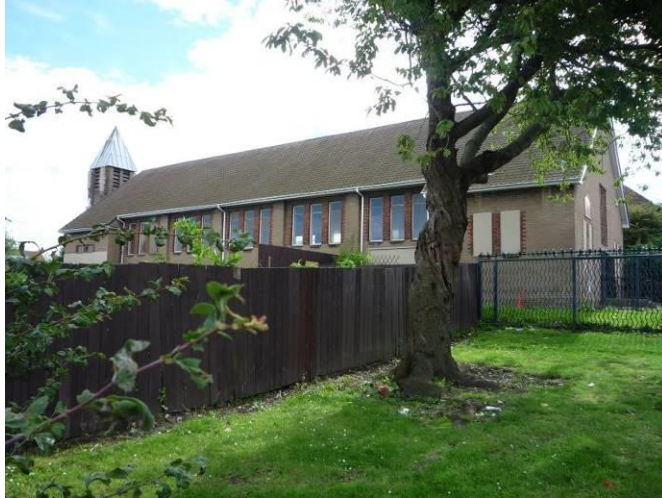
### Nave:

- North elevation – ridge okay.
  - East verge – new verge closures, a couple of tiles laminating but no action needed.
  - West verge – okay.
  - General – all of the tiling is well bedded and whilst there is some slight lamination to it, it looks okay.
- South elevation
  - East verge – as the south.
  - General – ridge has some loss of bedding. The condition of the tiles is poorer on this elevation and perhaps 10% of them are laminating. There is white paint at the eastern end and at the western end, one tile has collapsed in on itself. There may well be a requirement to replace the south tiling in 10-15 years or so.

**Recommendation:** replace missing south tile

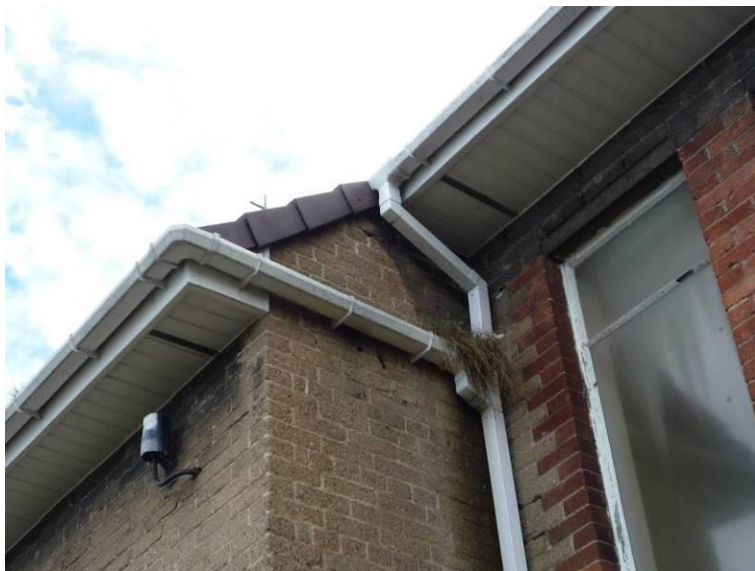
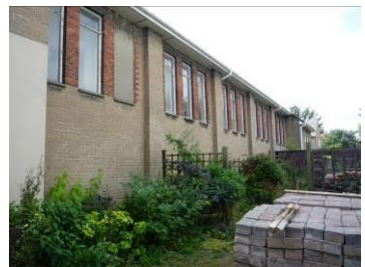
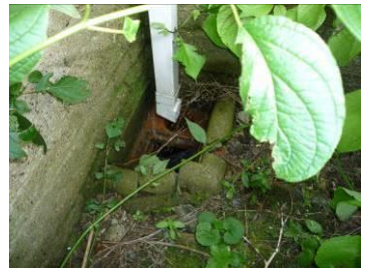
The building has been recently overhauled with new white

plastic rainwater goods, downpipes along with uPVC fascia's and ventilated soffits.

On the north elevation, the west store room gully grid is loose. The gully grid is missing to the nave at the west end. The eastern nave goes directly into the ground and needs clearing away to be seen.

**Recommendation:** clear away shrubs to inspect all gulleys, replace missing grids

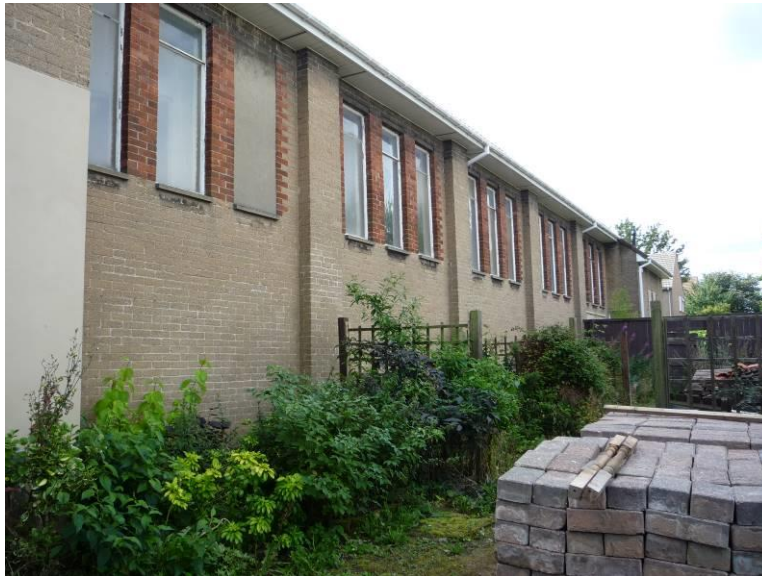
- D** **Entrance lobby:** brickwork in fair condition. Two windows have been bricked in and have been rendered over which is a more successful appearance than the west elevation. This elevation also houses the gas meter and alarm system that appears redundant as there is a wire swinging from it. Two new air bricks have been rather heavily handedly put in with cement. Light cracking to the top of the windows.

East return – damp staining on the wall as a result of blockage of the gutter above and slight open joints at previous gutter positions.

**Recommendation:** check alarm cable, repoint open joints

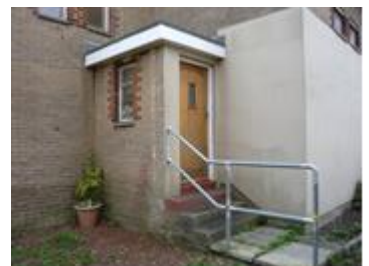
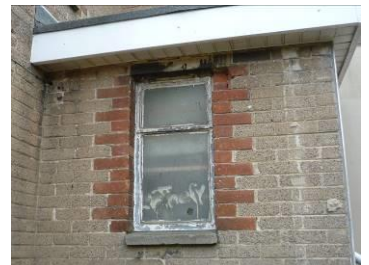
**C Lobby:** mineral felt flat roof and flashings. Masonry is okay, though a couple of the bricks are broken at the lintel support. It is not clear why....drill fixings for guarding perhaps. The window below it is in poor condition. It has steps leading to the rear door. The steps are okay, but the door catches slightly in the frame and its decoration is broken down now.

**Recommendation:** infill brick holes, ease and redecorate door

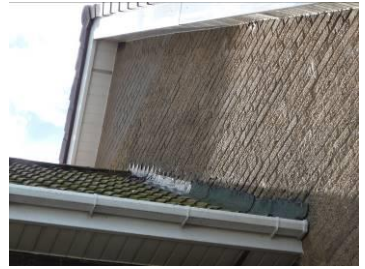
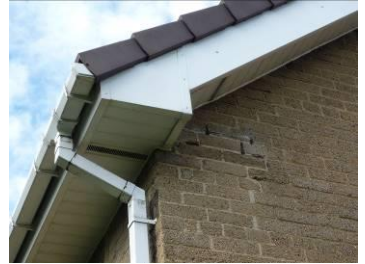
Southern side – same details as the north including the open joints at previous gutter fittings?

**Recommendation:** repoint brickwork

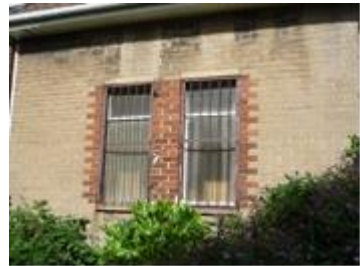
- D Lady Chapel:** not possible to inspect all of the wall as the enclosure at the base of the walls is locked. It holds the telecoms cabinet. Timber windows are in poor condition.

**Recommendation:** repair windows, inspect lower walls

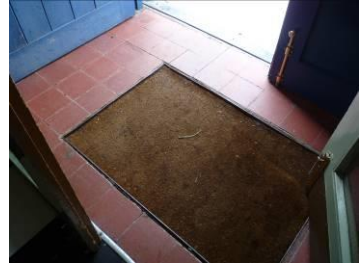
### **Entrance Lobby:**

- Ceiling - recently redecorated.
- Walls – plaster, slight hairline cracking to the western side and some areas that have been touched up in non-matching paint.
- Floor – new linoleum which replaced previous asbestos.

**Recommendation:** none

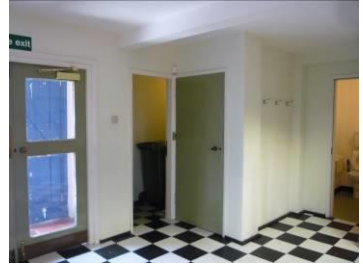
### **Lobby Store 1:**

Plastered out and to the same detail as the entrance lobby. This contains some lumber and the bins.

**Recommendation:** remove lumber

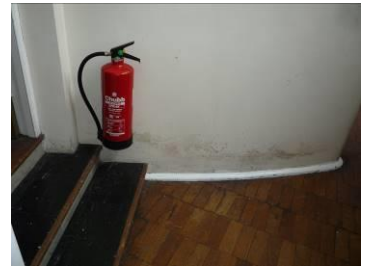
**D South east lobby:**

Same design as the north east. Slight hairline cracking, more pronounced over the lintel into the lady chapel but nothing major. Some tile creasing into the door above the nave which catches slightly in the frame and the latch doesn't retract very well. The room contains some lumber and candle stands too.

**Recommendation:** clean windows, clear lumber, ease and repair door, redecorate walls and ceilings.

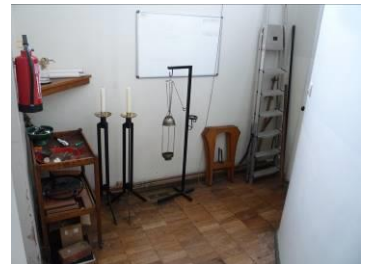
**E Vicar Vestry:**

Plastered ceiling and walls. Solid floor with carpet all okay. Slight creasing to the western wall and damp showing at lower level. Some heating pipes have been put through rather heavy handedly. The room is unventilated because the windows are sealed up – they are polycarbonate with decorative metal grills. The room contains cupboarding for vestments, no smell of damp, and an altar cupboard.
