QUINQUENNIAL INSPECTION REPORT

PETERLEE, ST CUTHBERT

**QUINQUENNIAL INSPECTION AND REPORT
October 2016**

David Beaumont BA (Hons) Grad Dip, RIBA, AABC

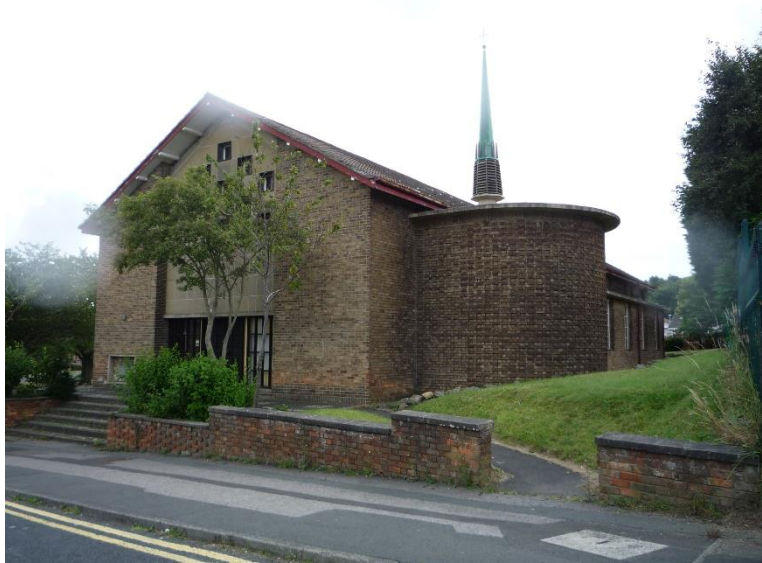
- E **Wheelchair access:** there is a ramped access to the west end by a two car drop off point. It is recognised that better disabled access or ramped access is required at the principal entrance at the north and this has been designed and is awaiting funds. Temporary wooden ramps overcome steps at the north.

Recommendation: carry out the designs for ramps in the future.

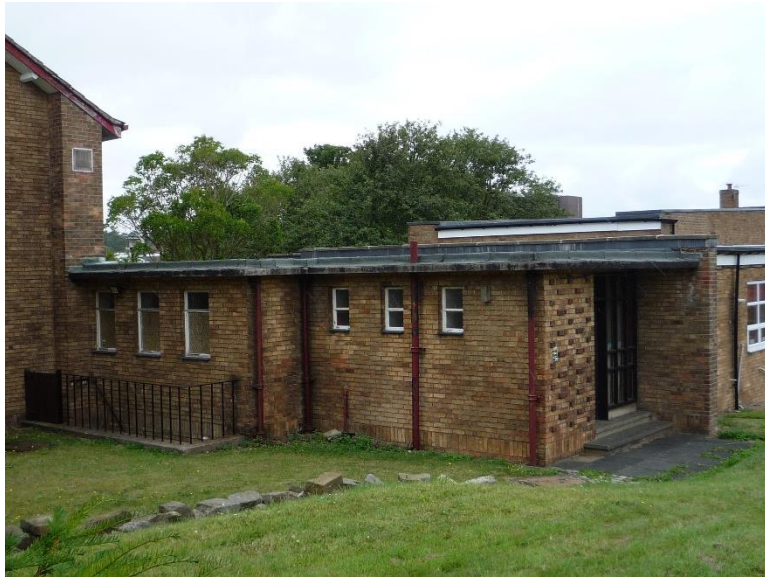
Clergy Vestry:

Slight open joints to the brickwork at the downpipe position. Metal windows decoration is coming away.

Recommendation: repoint open joints and decorate windows

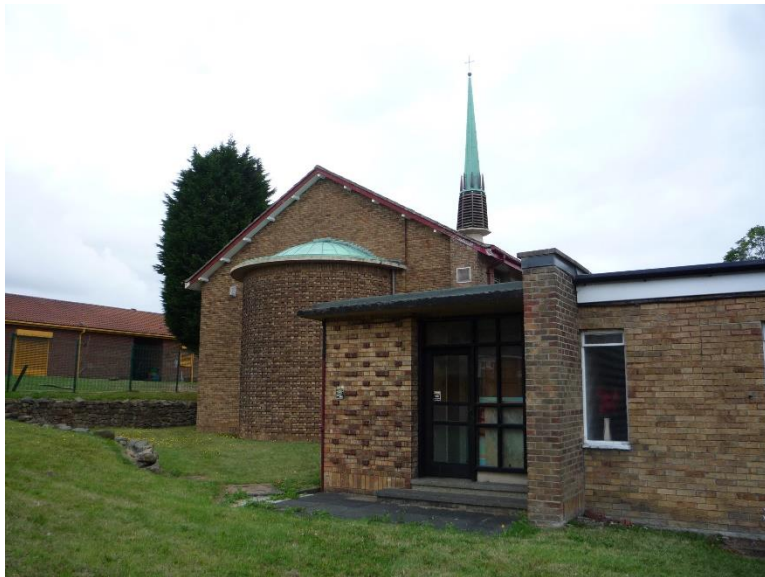
Apse:

The overhanging parapet decoration has faded now.

Recommendation: redecorate soffit

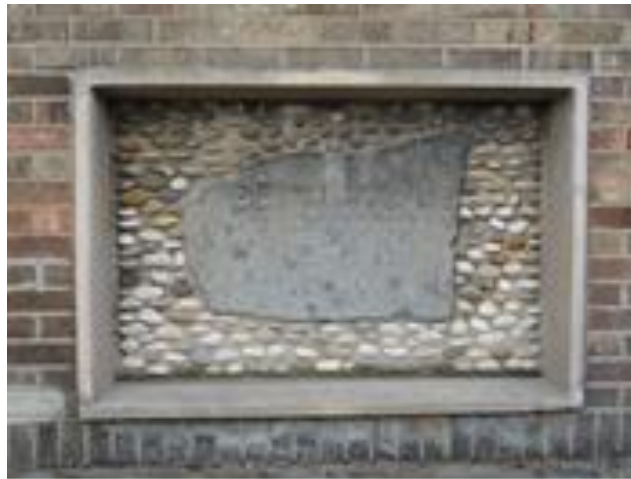
There is some dirt showing to the commemorative panel. The ornamental slate within the concrete frame and cobble surround has eroded so much so that it is illegible now.

Recommendation: redecorate soffit,

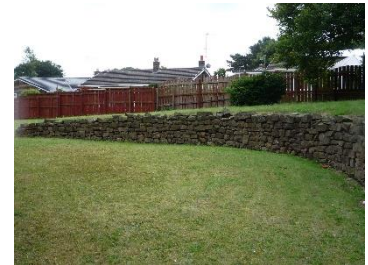
E East Side:

This has fencing onto housing which appears to be in acceptable condition. It would be interesting to establish whether this is under church ownership and as a consequence, liability. During the inspection, an adjoining householder was able to access the grounds from the rear of his property and use the south side as a shortcut.

Recommendation: establish ownership and repair liability

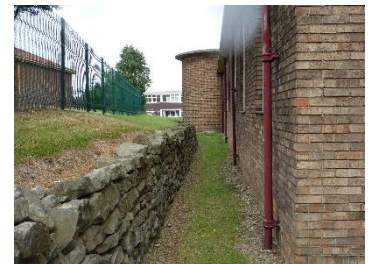
- South side:

This has a low retaining wall in drystone walling which is reasonably satisfactory though it doesn't have a coping. This retains a grass bank that leads up at higher level to a metal mesh fence which doesn't contribute to the church surroundings.

Recommendation: none

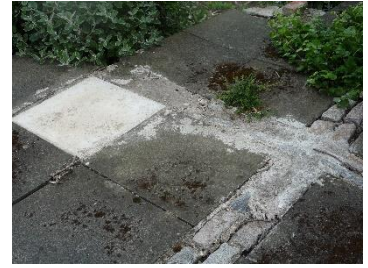
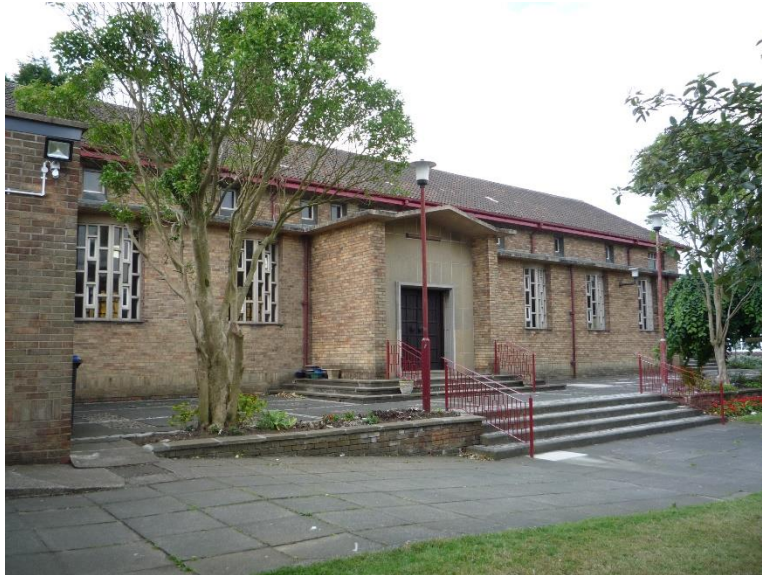
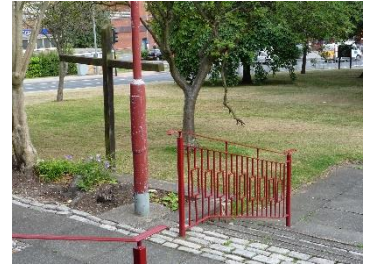
North side:

A large terraced area is created with granite set picking out a rectangular pattern with precast flags within, with occasional mosaic or granite set squares, which are part of the architect's original design feature. They are somewhat undulating now. Whilst not yet a trip hazard, if they are not maintained, they will be in the near future.

The north retaining wall is in fair condition, though there are some slabs missing at higher level. The drainage holes in the retaining walls are filling and need cleaning out. It will be important to keep the trees down to a manageable size. In the north-west corner, there is a cherry tree which can only expand. Beyond the north terrace is a large grassed area in good condition.

Recommendation: manage planting and clear out drainage pipes

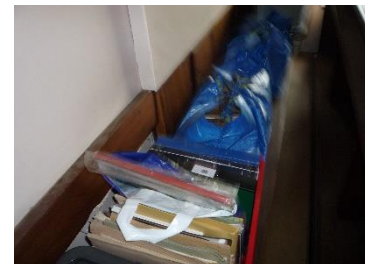
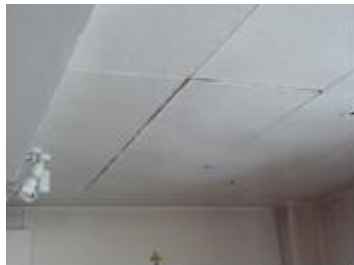
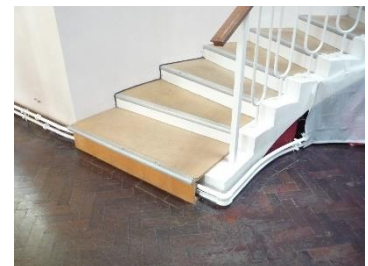
- **Balcony:** contains the organ and pews for a choir and is accessed by a wide spiral stair. The foot of the stair has been boxed in to provide protection to a heating pipe. The vinyl covering is ageing. Beneath the stair soffit there is extensive storage for children activities materials behind a curtain. The balcony pews are acting as storage.

Ceilings under the balcony are suspended fibre board panels and uneven

Recommendation: none

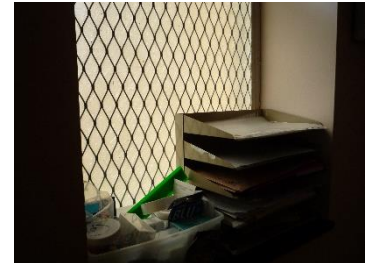
E Choir vestry:

- Ceiling – fibreboard.
- Walls – painted plaster.
- Floor – parquet flooring showing quite heavy wear.
- General – a large room adjacent to the clergy vestry with walk in cupboard for vestments. Fittings include Clavinova piano, music shelves, wall mounted electric transformers for lighting.
- Door – the door to the corridor requires redecoration.

Recommendation: consider decoration

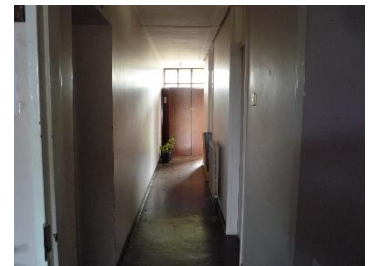
E Corridor:

- Ceiling – in fibreboard.
- Walls – painted plaster, somewhat knocked about now.
- Floor – thermoplastic tile with some gaps towards the west entrance door.

Recommendation: consider decoration

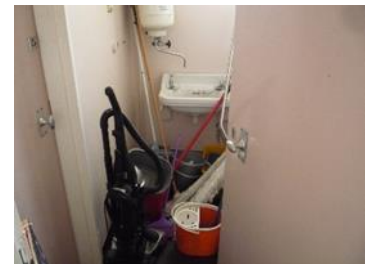
E WC and sink room:

- Finishes – as corridor and requires updating. The room is not used for sanitary purposes, but has generally become the cleaners sink.

Recommendation: consider decoration

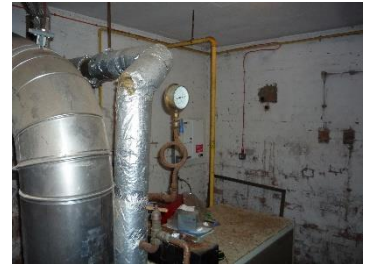
- E **Boiler Room:**
 - Ceiling – painted over panelling – fibreboard perhaps (no asbestos declared the church).
 - Walls – walls and brickwork have been painted over with some of the decoration failing.
 - Floor – concrete and patched slightly.
 - General – the room contains Hamworthy Broadstone boiler with expansion vessel and Grundfos pump. The room is dry and has a submersible sump pump reported to be working. Decoration needs updating.

Recommendation: consider decoration
