# REKENDYKE St JUDE

St Jude's Terrace, South Shields  
(115)

## QUINQUENNIAL REPORT

**6 May 2021**

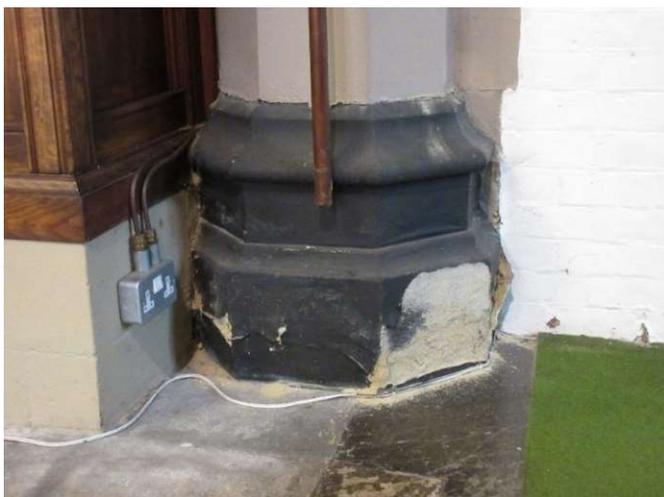
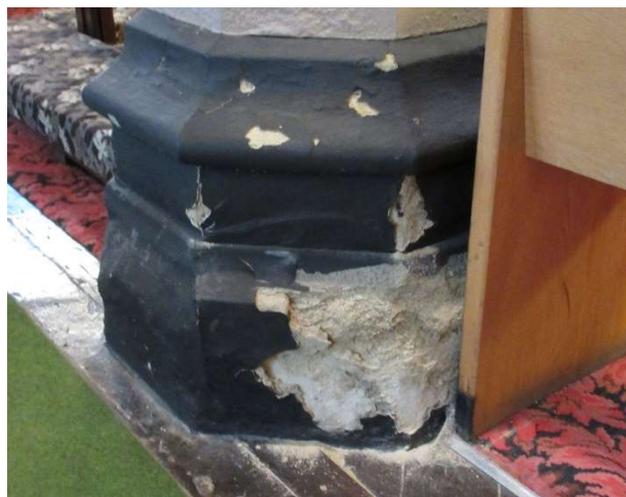
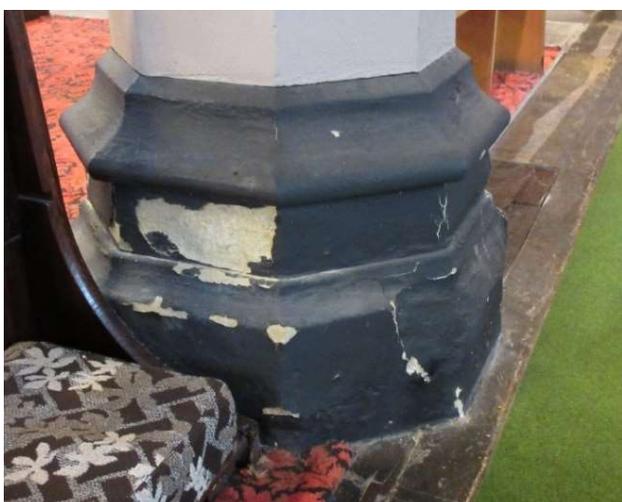
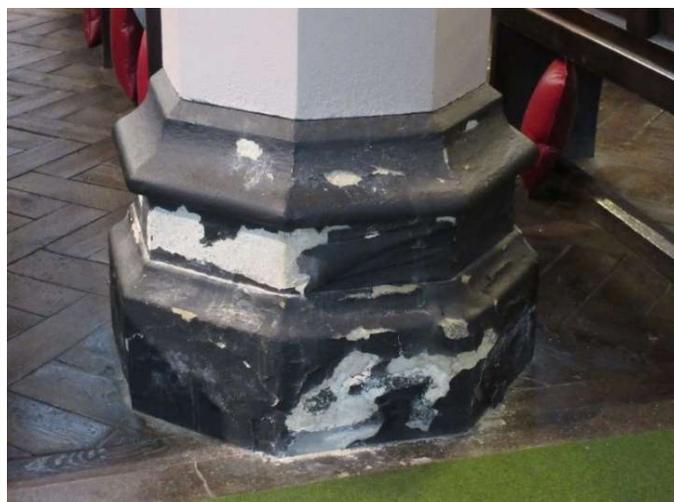
45. Octagonal stone columns and chamfered four centred arches. Matt paint at capitals and shafts, eggshell on bases. Sound except rising damp trapped behind the paint shows as:
  - Most base paint is hollow and parts of the paint and stone surface is missing at SE respond and all three S bases, slightly less at N arcade
  - Worst is NE respond where decay reaches up into the lower two stones of the half shaft behind the pulpit, spreading sand on the respond base and the pulpit floor

Paint and stone loss outside and inside the pulpit continues slowly

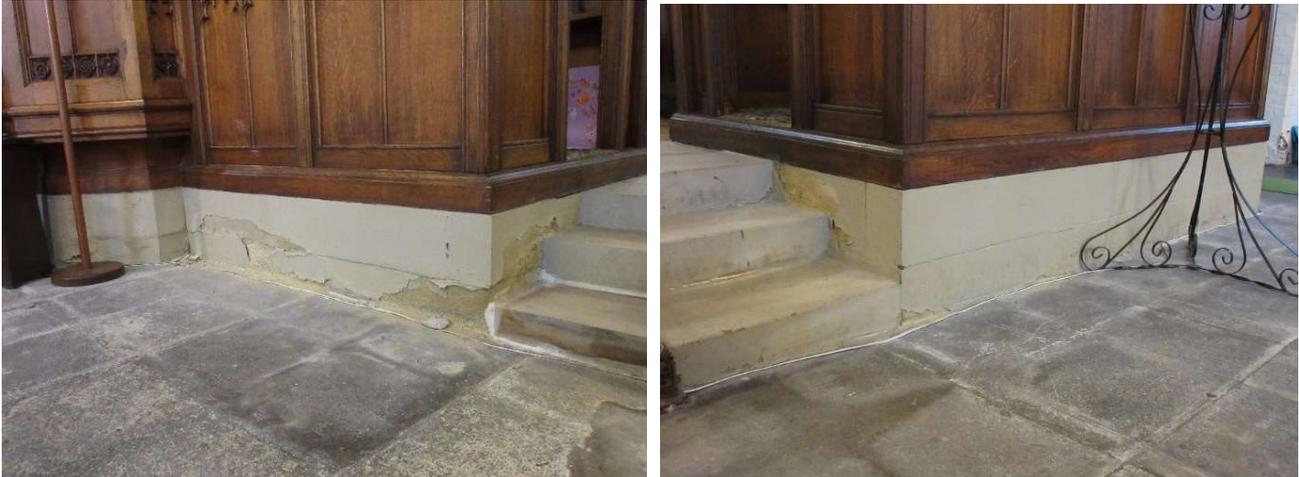
62. Chancel floors granolithic in two colours with minor cracks. A centre carpet runner. Softwood platforms under the choir stalls. Painted stone steps.
63. A good oak communion rail. Wide gates, dragging slightly on the carpet.
64. The painted stone riser N of the Chancel steps and its returns each end of the three Chancel steps have lost paint and stone decay due to rising damp slowly progresses. The lowest stone step was replaced due to damp damage.

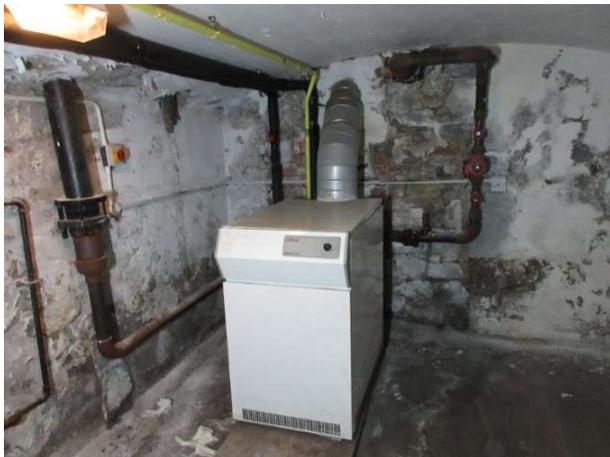
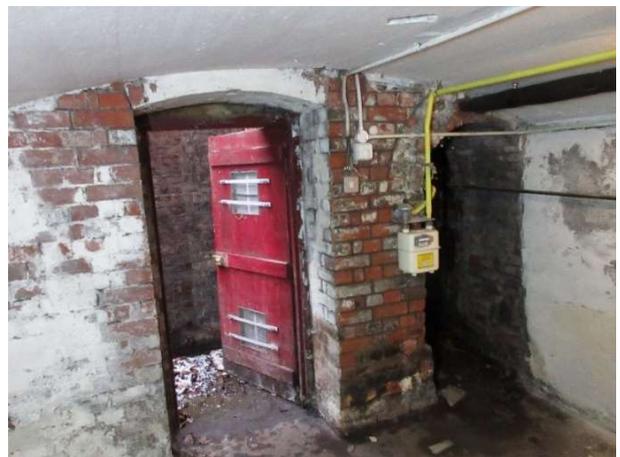
76. Gas boiler and froststat in basement under the Vestry. The concrete vaulted chamber is tidy and dry without sump or drain. A pump and bypass on the single circuit. Boiler air inlet in door. System reasonably effective but all such churches are prone to cold draughts dropping from the clerestories and W window.
